# National Transportation Safety Board

**WPR23FA225**

## **ACCIDENT SITE EXAMINATION**

Location: McCall, Idaho  
Date: June 12, 2023  
Time: 10:29 Mountain Daylight Time  
Airplane: N3138C, Cessna R182

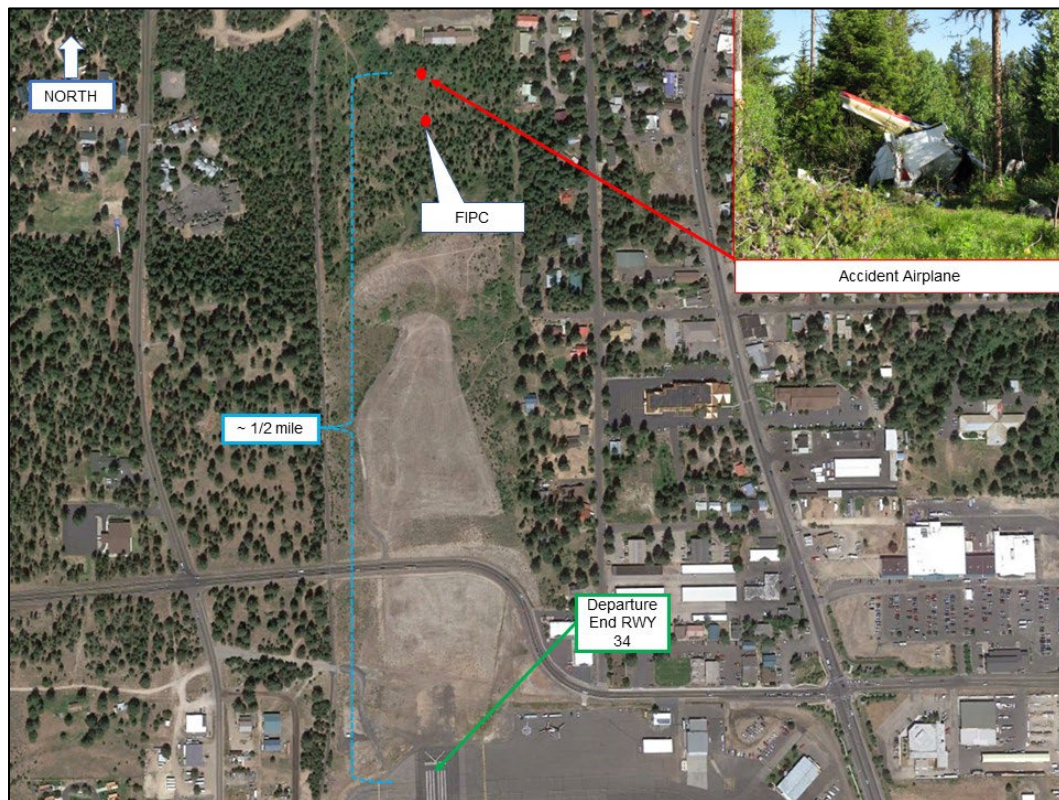
**Figure 1: view of accident site diagram**

Examination of the accident site revealed that the airplane impacted trees about ½ mile north of the departure end of runway 34. The first identifiable point of contact (FIPC) was a 150 to 175 ft tall tree that had damaged limbs near its top. The debris path was oriented on a heading of about 335° magnetic and was about 225 ft in length from the FIPC to the main wreckage, as seen in figure 1. Portions of the left-wing, left-wing tip and left aileron, were observed throughout the debris path. Several damaged trees were observed throughout the debris path. The fuselage

came to rest on its right side against a tree, on a heading of about 020° magnetic at an elevation of 5,033 ft mean sea level.

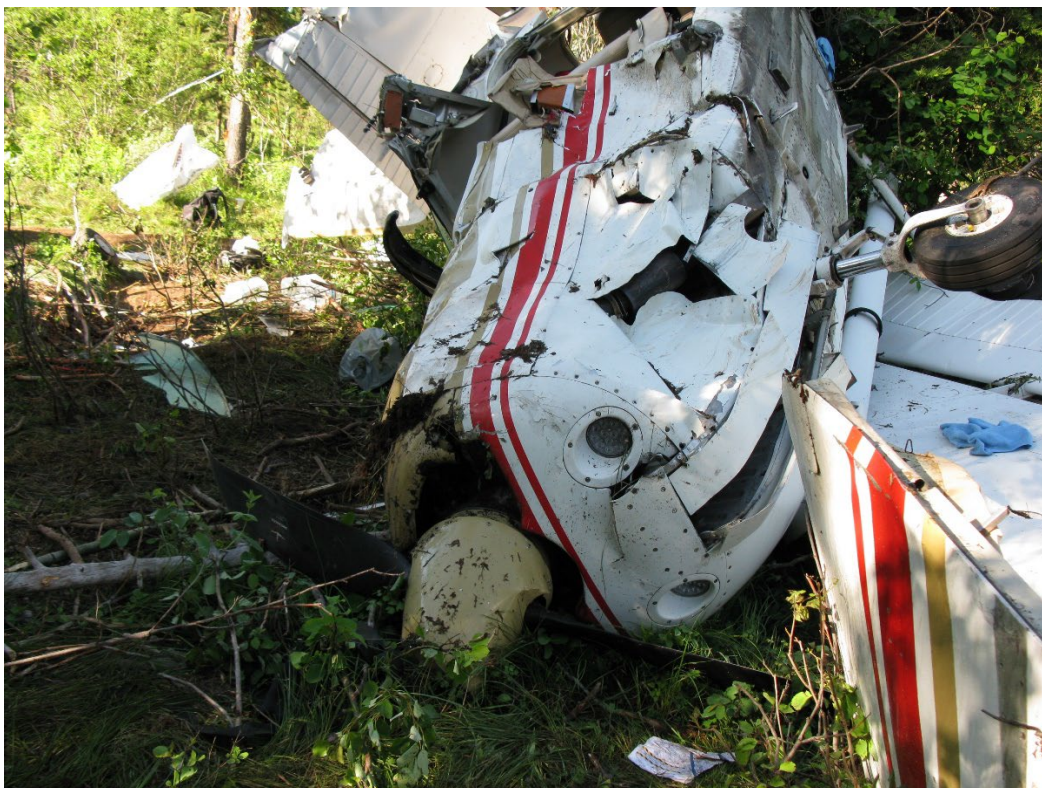
**Figure 2: front view of accident airplane**

The fuselage was mostly intact. The engine cowling, engine and propeller remained attached. Crushing and bending was observed throughout the cowling, consistent with impact damage. The engine cowling and forward portion of the fuselage were impact damaged and displaced to the left. The forward section of the fuselage, near the pilot door post had impact damage and was partially separated. Cut marks on the door post were consistent with first responder efforts to extract the pilot. The landing gear remained attached via the fuselage mounts and was extended. The left main landing gear, fracture separated near the tire.

The forward section of the cockpit was impact damaged. The instrument panel was impact damaged with multiple instruments displaced.

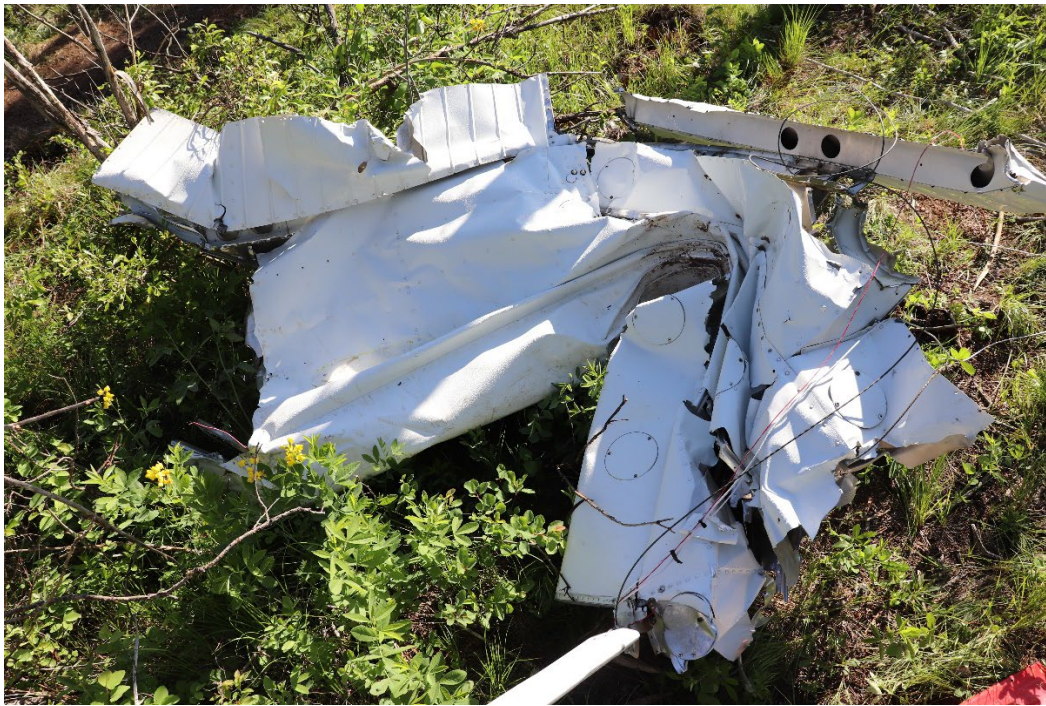
**Figure 3: view of left wing outboard section**

The left wing separated from the fuselage at the wing root and fragmented into numerous sections. An inboard section of about 6 ft remained tethered to the fuselage by various wires. The left wing aileron control cable was observed exiting the fuselage near the wing root under significant tension. The left flap remained attached via its mounts. The flap was observed partially extended. The fuel cap was separated and not observed with the wreckage. The bottom side of the wing surface exhibited hydraulicing. Crushing and bending was observed throughout the inboard wing section. The outboard section of the left wing was observed in the debris path and was bent in a semi-circular shape. The aileron remained attached via its mounts. Crushing and bending was observed throughout the outboard wing section.

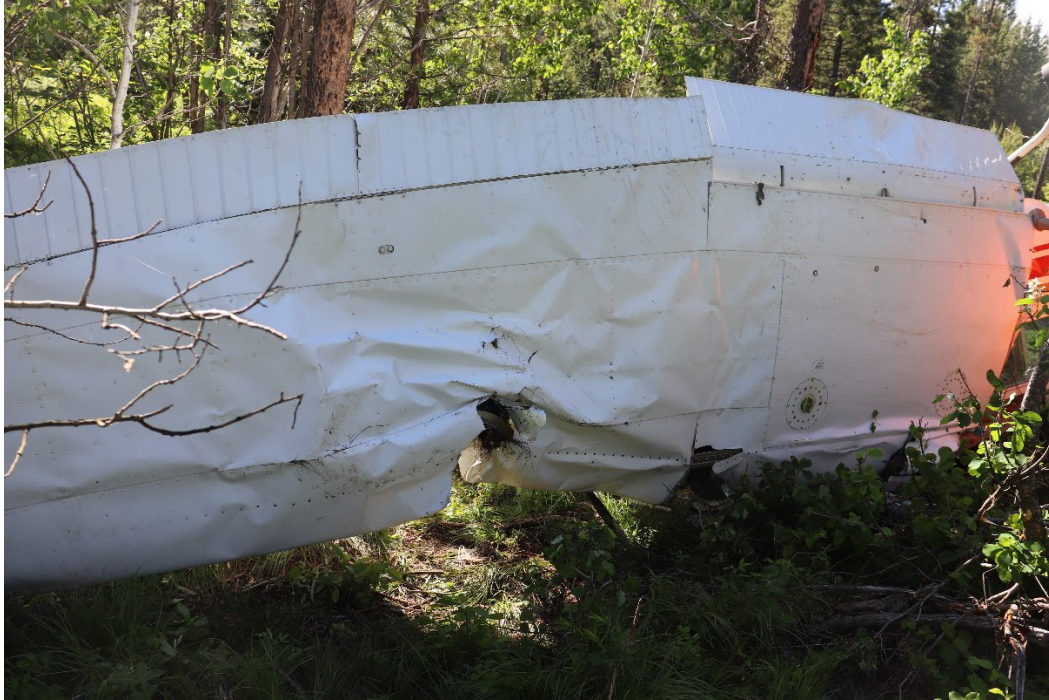
**Figure 4: view of right wing**

The right wing separated from fuselage at the wing root and remained tethered to the fuselage by various wires. The wing was twisted and came to rest under the fuselage. Crushing and bending was observed throughout the wing span. The right flap and aileron remained attached via their mounts. The flap was observed fully retracted. The right wing aileron control cable was observed exiting the fuselage near the wing root under significant tension. The right main fuel tank fuel cap was observed in place and secure.

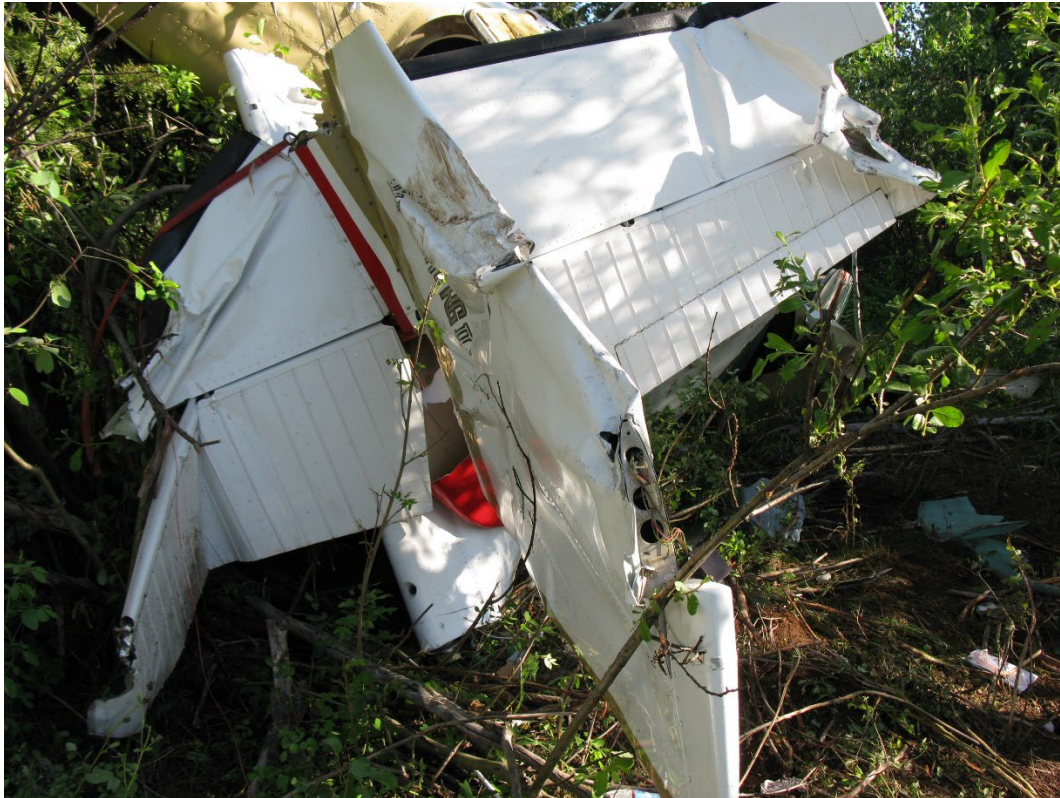
**Figure 5: view of empennage**

The empennage separated from the aft fuselage, near the leading edge of the horizontal stabilizer and was tethered to the fuselage by various wires. The vertical stabilizer, rudder, horizontal stabilizers, elevator, and elevator trim tabs remained attached and secure to their respective mounts. Both elevator and rudder flight control cables remained attached to their respective mounts. The rudder and elevator control cables were observed exiting the aft fuselage under significant tension. Crushing and bending was observed throughout the empennage.
