# National Transportation Safety Board

WPR23FA247

## **ONSCENE AND WRECKAGE EXAMINATION REPORT**

Location: Murrieta, California  
Date: July 4, 2023  
Time: 1357 Pacific Daylight Time  
Airplane: Cessna 172N, Registration N5243E

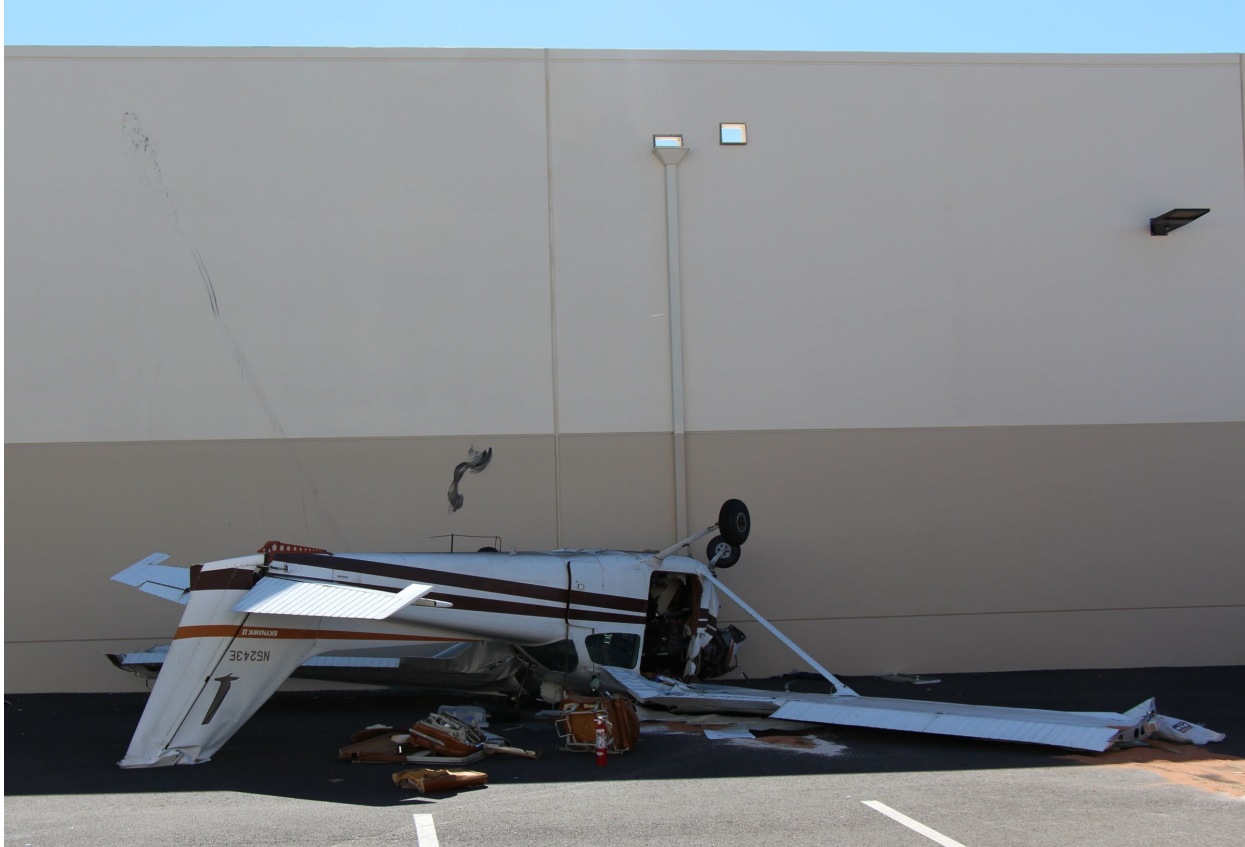
**Photograph 1: Airplane at accident site**

The airplane came to rest inverted in an industrial complex approximately 0.3 nm from approach end of runway 18 on an orientation of 125° magnetic. All major structures were accounted for at the accident site. The airplane was adjacent to an approximately 50 foot tall building, which displayed a diagonal transfer mark that extended nearly the vertical length of the building. A dark black transfer mark was observed on the same wall about 5 ft from the ground and multiple horizontally oriented striations were below the black mark. An additional black transfer mark was located a few inches from the striations.

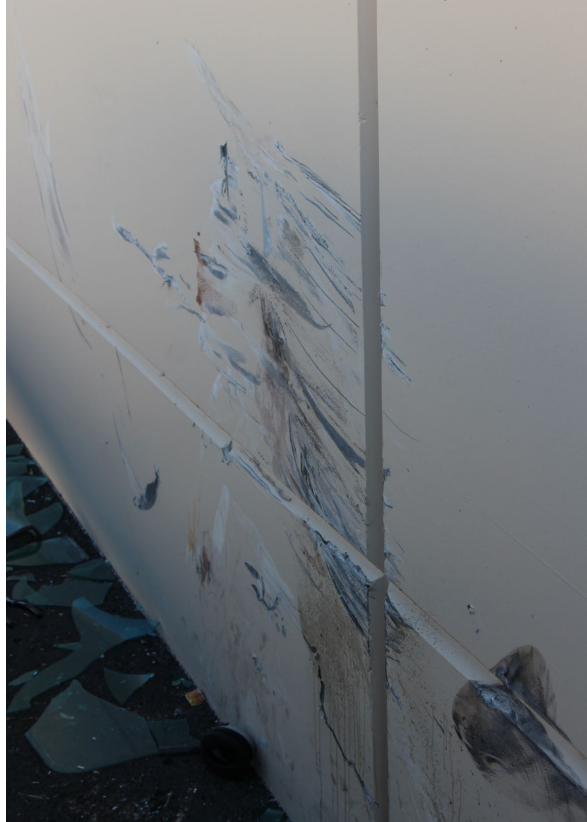
**Photograph 2: Striations on adjacent building**
