## **NATIONAL TRANSPORTATION SAFETY BOARD**

### **ENGINE/AIRFRAME EXAMINATION**

**WPR23FA256**

Location: Saint Maries, Idaho  
Date: July 6, 2023  
Aircraft: Cessna 182N, Registration N703Z, Serial #18260582  
NTSB IIC: Starr Blum

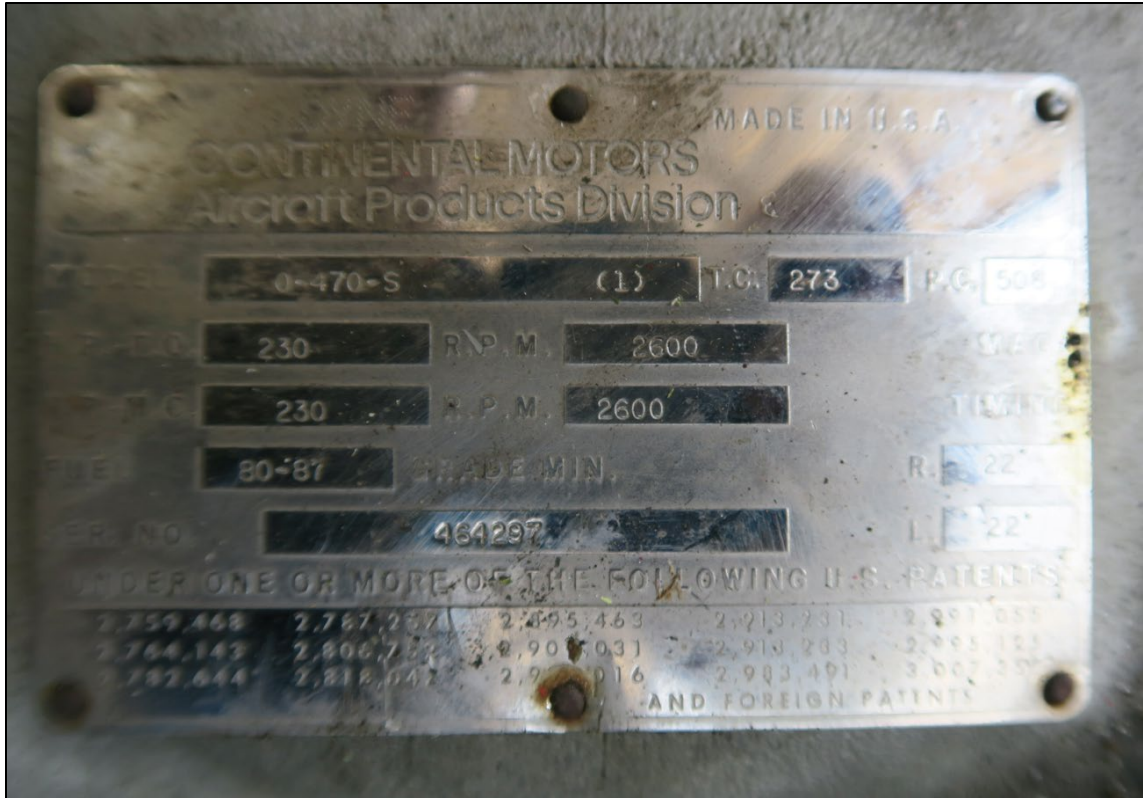
Photo 1. Engine data plate.

The Lycoming O-540-S, serial number 464297. At the accident site the tachometer indicated that the airplane's total time was 9,242.43; Hobbs 3550.3. (Photo 1).

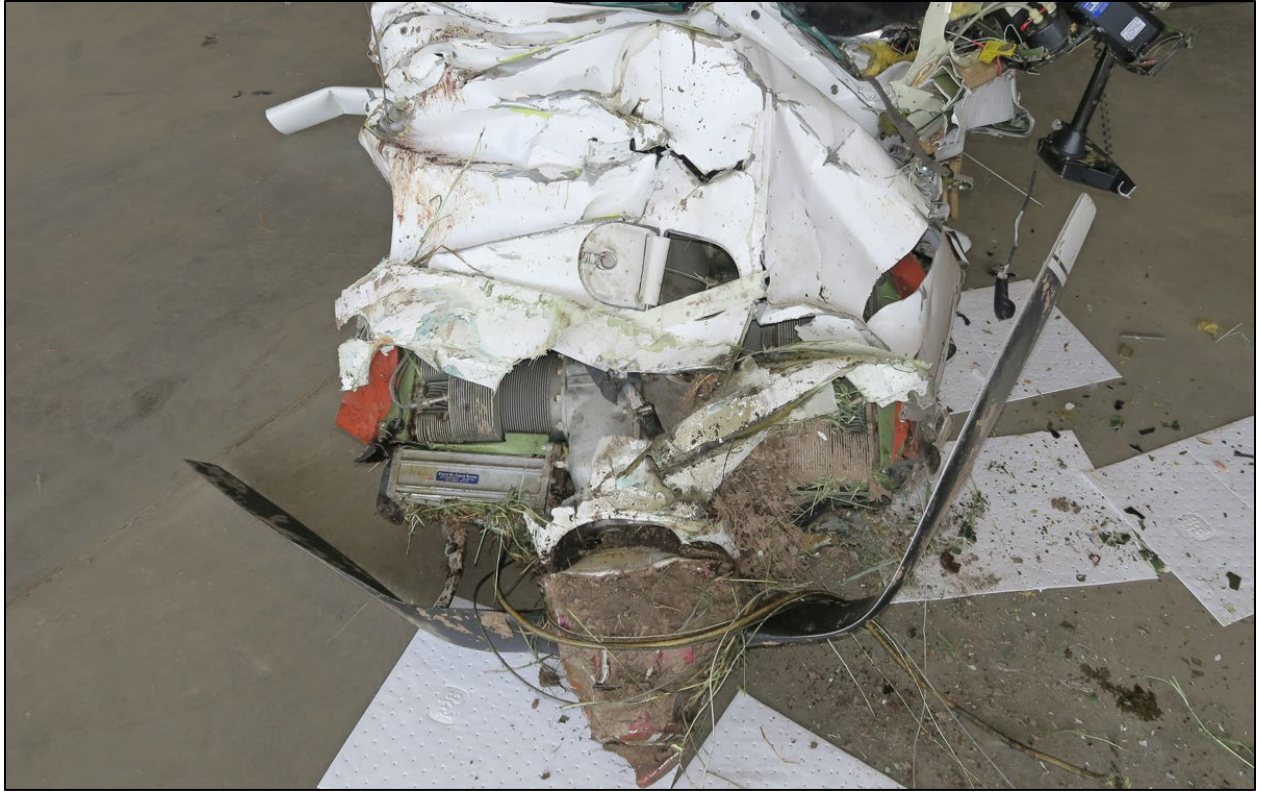
*Photo 2. View of propellor.*

The two bladed McCauley propeller was bent aft about 40°; neither blade exhibited rotational signatures. (Photo 2).

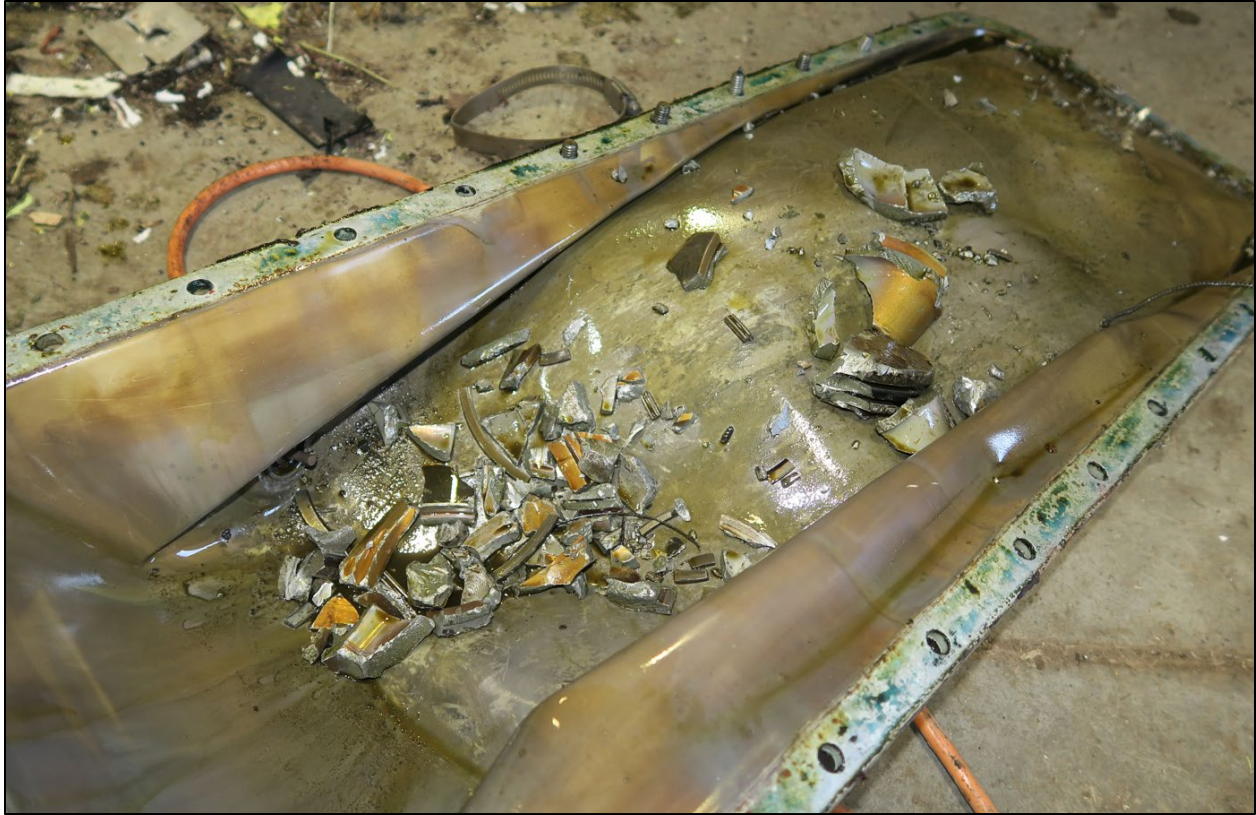
Photo 3. Oil drain pan.

The oil sump drain was removed and retained oil. There were numerous shards and pieces of aluminum and steel internal components such as the piston. (Photo 3).

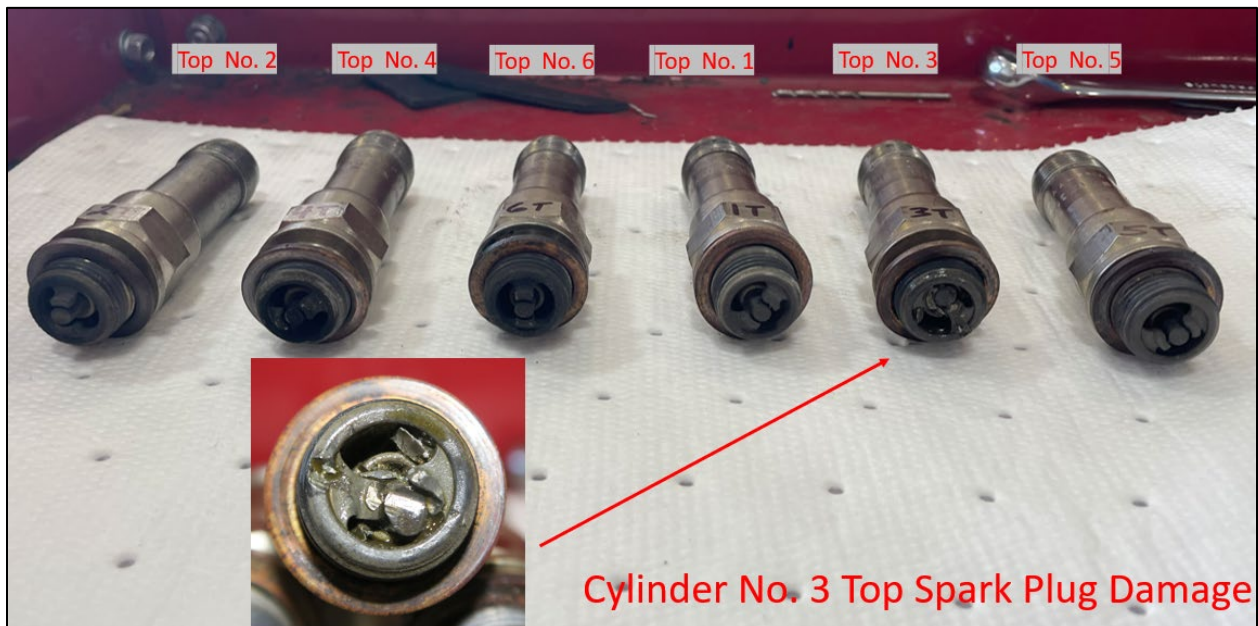
Photo 4. Top spark plugs.

Investigators removed the upper spark plugs, all of which had an oily film and were dark. The No. 3 spark upper spark plug did not have a gap between the post electrodes, and damage consistent with impact was visible. (Photo 4).

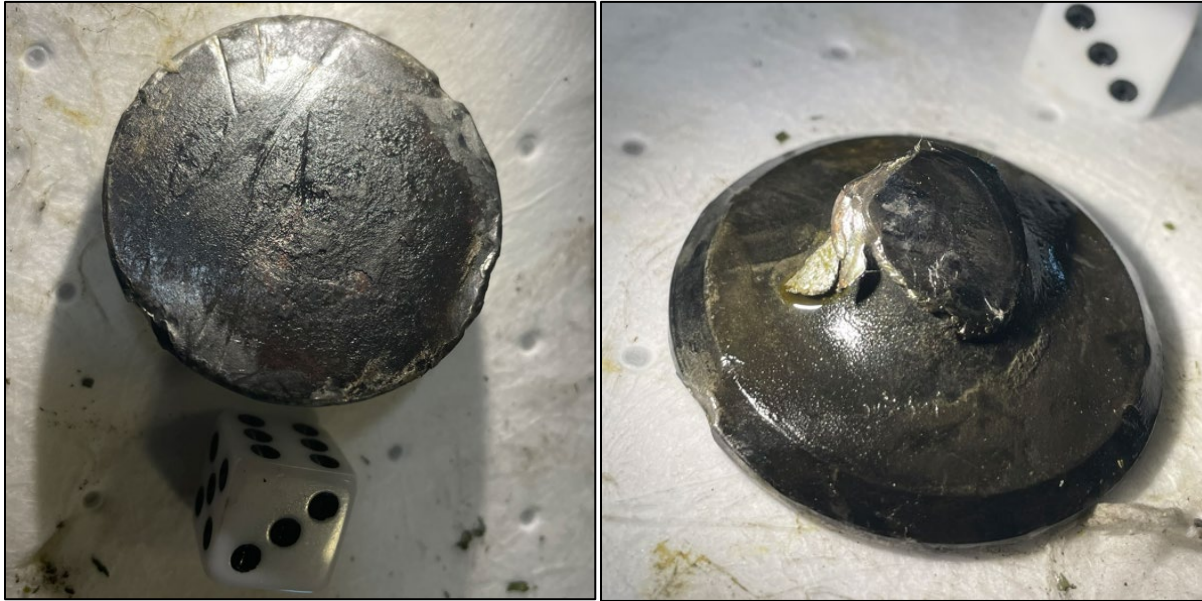
*Photo 5. No.3 valve head.*

A borescope was used on the No. 3 cylinder; the exhaust valve had separated, and there were numerous pieces of metal in the cylinder. The piston was not observed. The valve head was found on the cam shaft. (Photo 5).

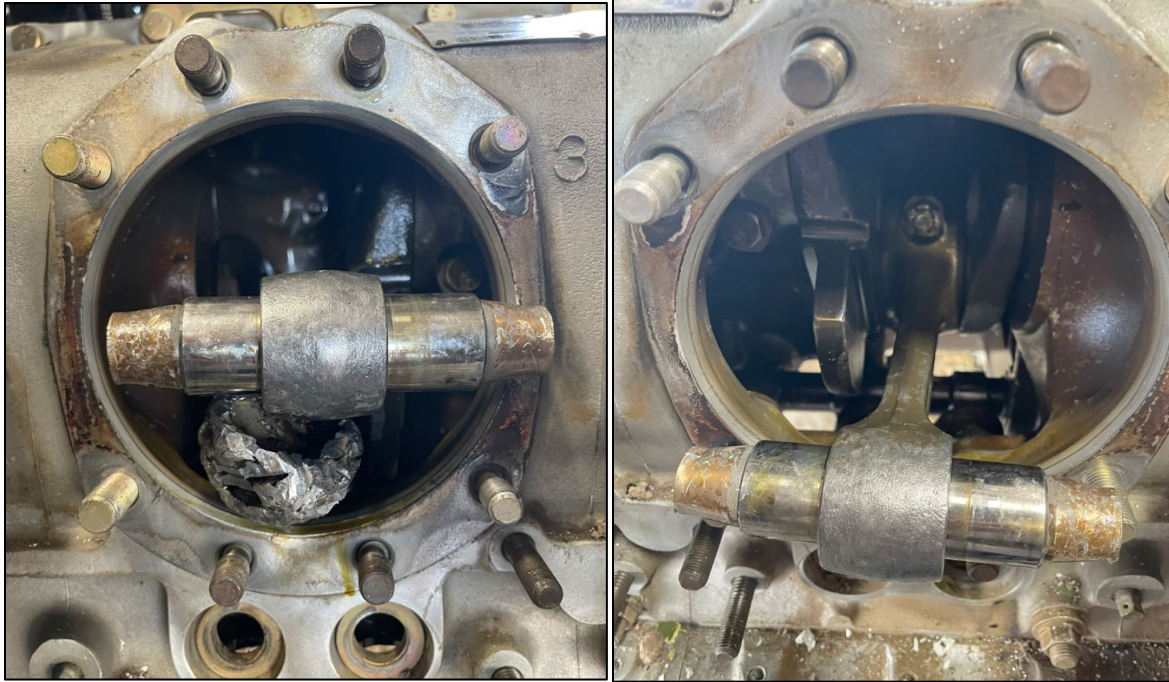
*Photo 6. No. 3 piston and connecting rod.*

Removal of the No. 3 cylinder revealed the cylinder had numerous gouges consistent with metal consumption in the barrel; two large pieces of aluminum were present. The intake pushrod and tube were bent. The piston connecting rod was bent aft. (Photo 6,7,8).

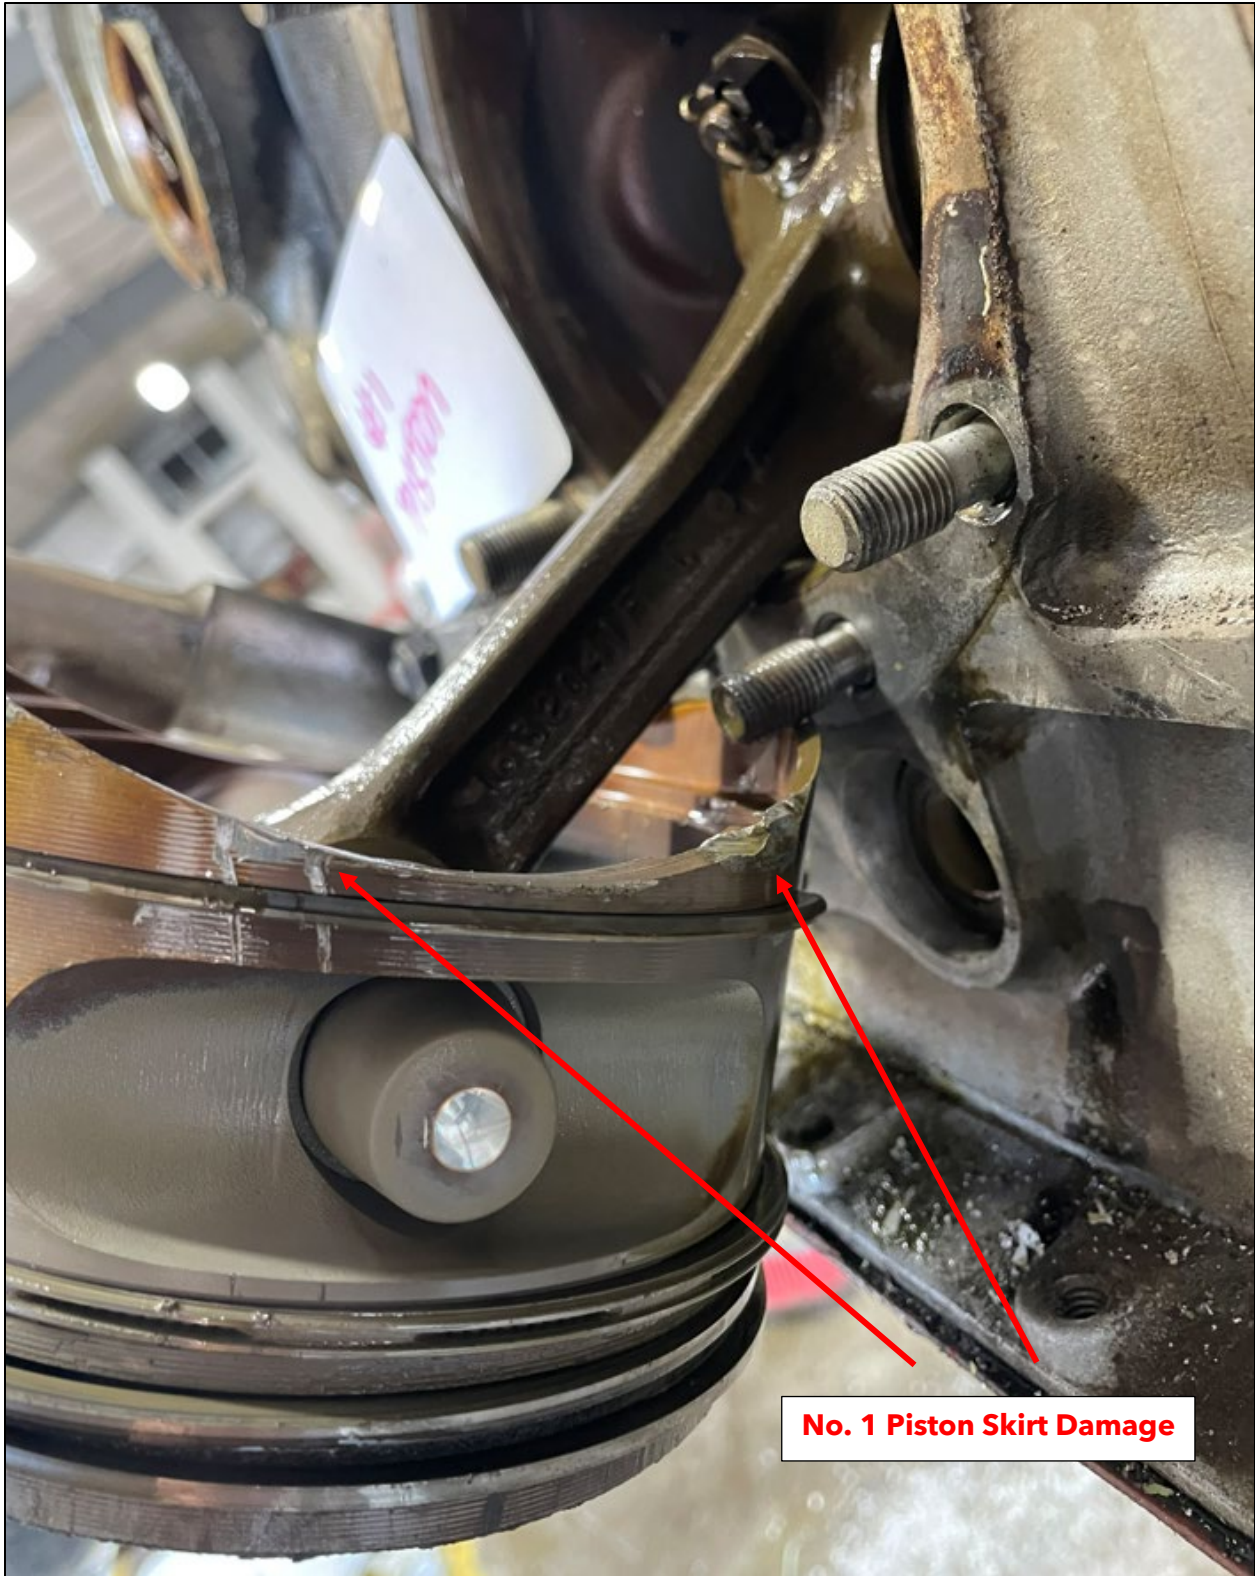
Photo 9. No. 1 piston

The No. 1 cylinder was removed and revealed gouging to the piston skirt and metal fragments. Removal of the No. 5 cylinder revealed small metal pieces in the barrel cylinder and gouging to the piston skirt. Inside the No. 6 cylinder there were numerous pieces of metal in the piston skirt. (Photo 9, 10).

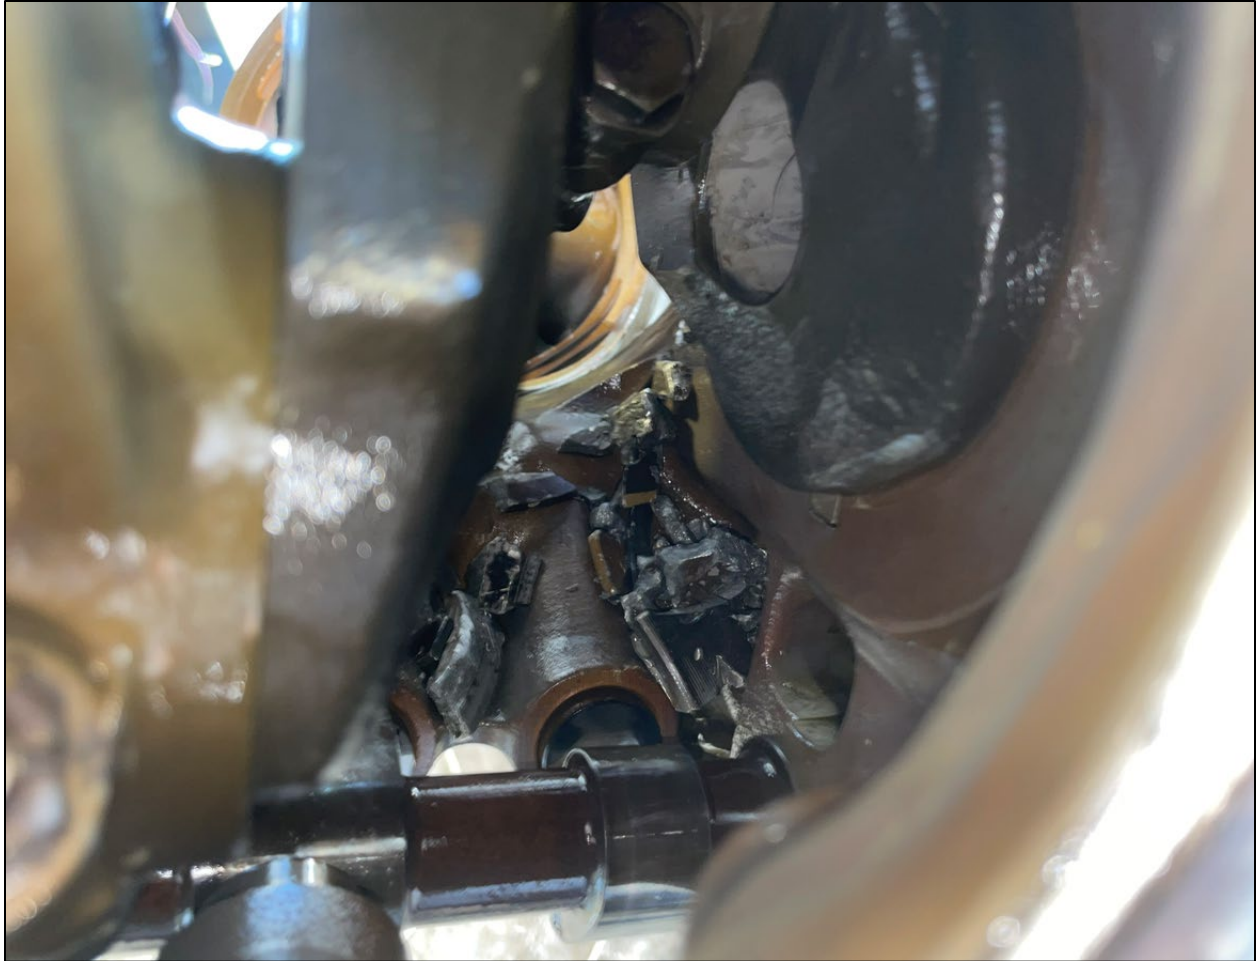
*Photo 10. View of metal from cylinder No. 6 piston skirt.*

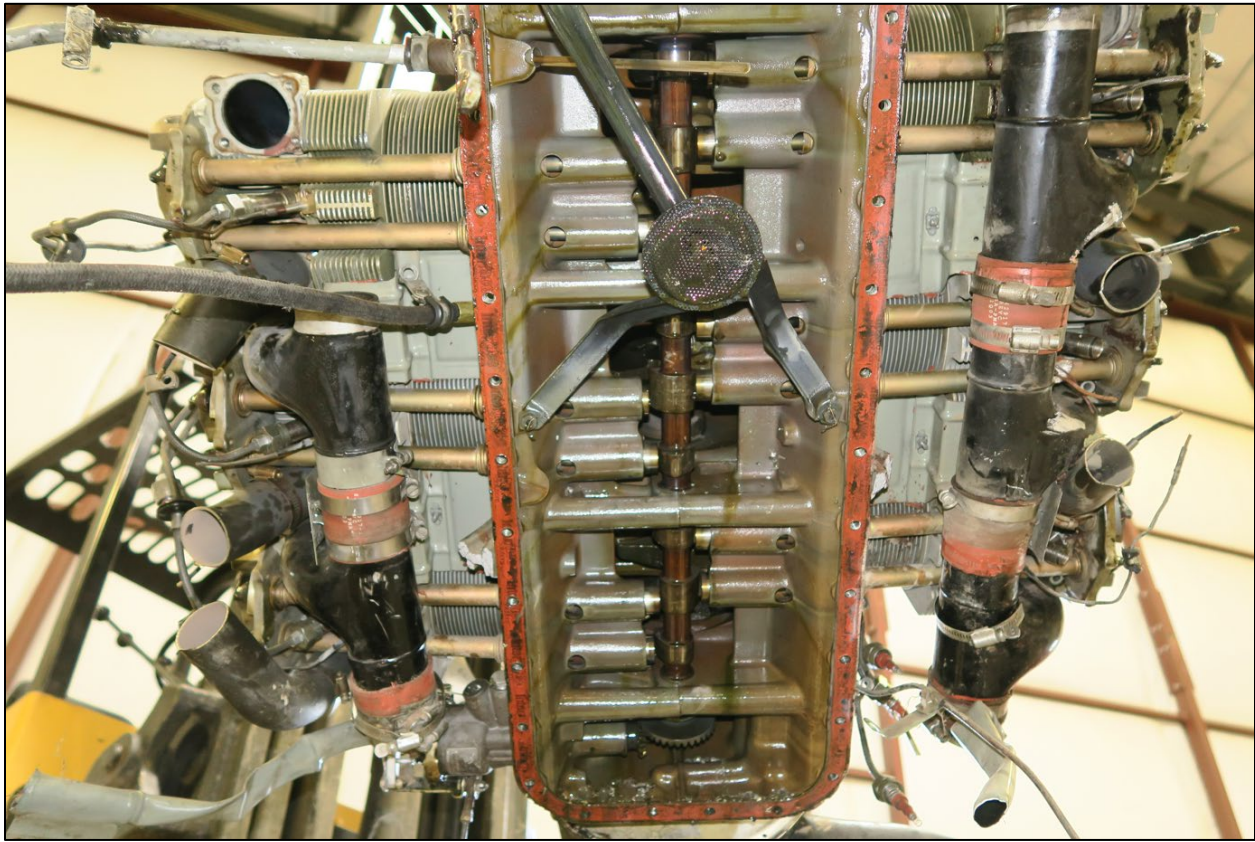
Photo 11. View of camshaft.

Inside the crankcase, the camshaft and lifter (tappet) heads did not reveal damage. The camshaft lobes and heels appeared to have normal wear with no spalling noted. The drive train could be rotated, and all connecting rods were moving freely. (Photo 11).
