# National Transportation Safety Board

WPR23FA256

## **MATERIALS LABORATORY**

Factual Report 24-076

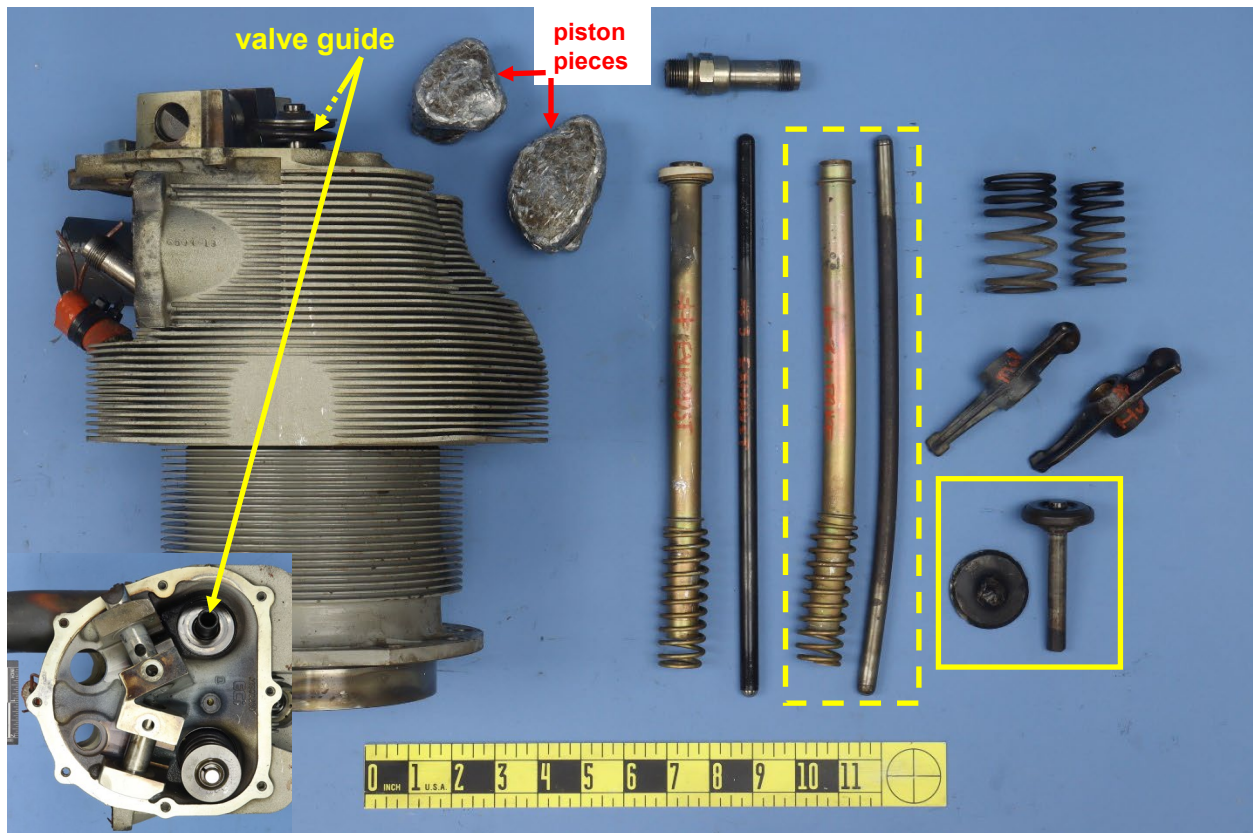
Figure 1 is an as-received photo showing all of the parts received for this case. The parts focused on in this examination were the fractured exhaust valve, the valve guide and cylinder 3. The exhaust valve fractured at the neck where the head meets the stem and both pieces are highlighted by the yellow box in the photo. Yellow arrows point to the general location of the exhaust valve guide. The fracture surfaces of the head and stem were documented before and after cleaning with an anionic detergent. The intake valve push rod along with its tube and spring are highlighted by the dashed yellow box. To the left of the yellow dashed box is the exhaust valve push rod with its corresponding tube and spring. Red arrows point to the recovered piston pieces. Both piston pieces were examined for fracture features, but none were found as the surfaces were too damaged.

**Figure 1.** Photo of all parts received with the exhaust valve pieces highlighted within the yellow box and yellow arrows pointing to the valve guide location on the engine. The dashed yellow box encloses the bent intake push rod to the right of its mating tube and spring. The red arrows point to the recovered piston pieces.

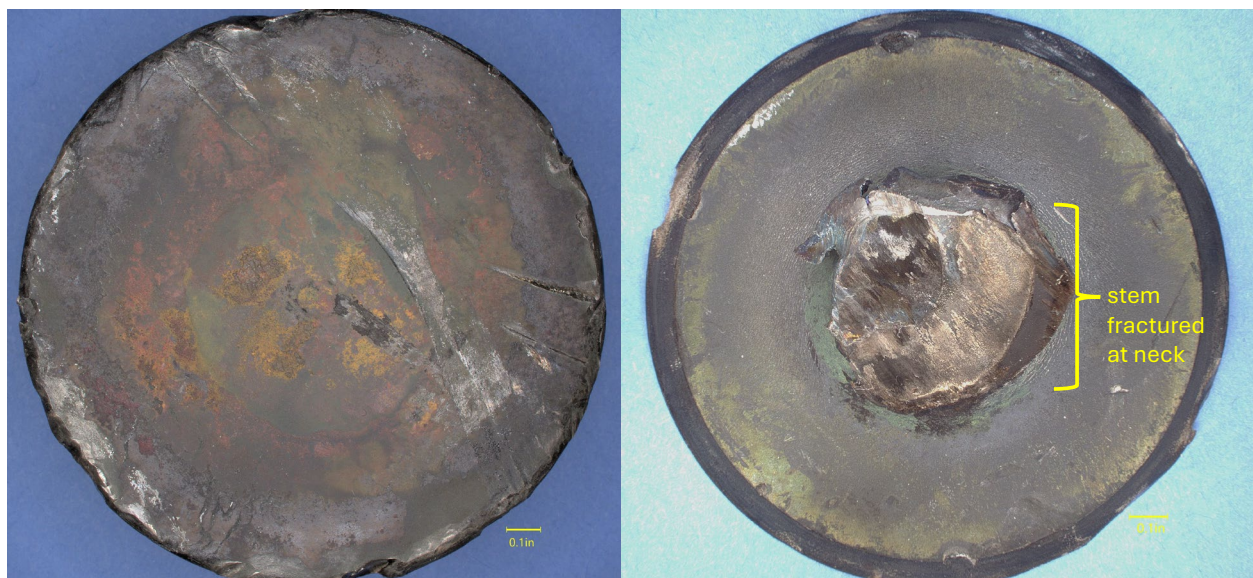
Figure 2 shows the valve head (face and neck) after cleaning. Cleaning with detergent and later acetone had no effect on revealing fracture features. As can be seen, the valve head fracture surface is completely obliterated, and no fracture mechanism information could be obtained.

**Figure 2.** Images of exhaust valve head. The left photo shows the valve face while the right photo shows the fractured neck of the valve in the center.

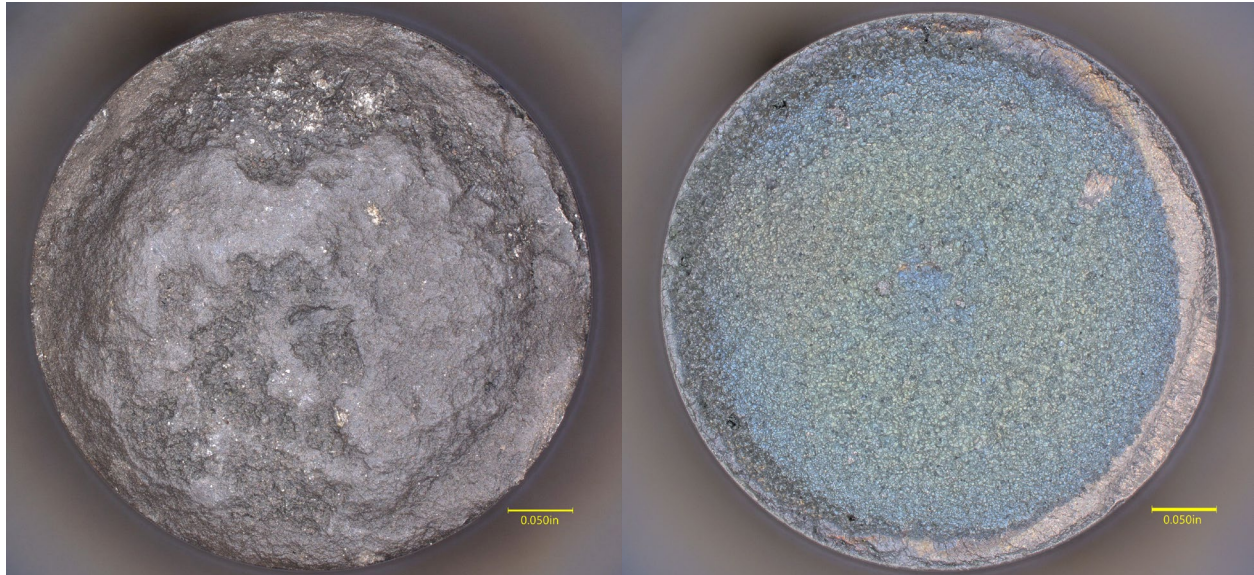
Figure 3 is a top view of the fractured stem before and after cleaning. With scrubbing and ultrasonic cleaning, the stem fracture surface revealed an intergranular fracture surface subject to further examination. Before and after cleaning side views of the thermally discolored and carbon buildup of the fractured exhaust valve stem are shown in figure 4. Vigorous cleaning did not remove the discoloration. A few small gouges were found on the exhaust valve stem surface near the rotocoil. Images in figure 5 are backscattered electron (BSE) images of couple of these gouges. The top of both valve stems where the rocker arms come in contact were examined for

**Figure 3.** Top view images of fractured exhaust valve stem. The left photo is before cleaning while the right photo shows the fracture surface after cleaning.

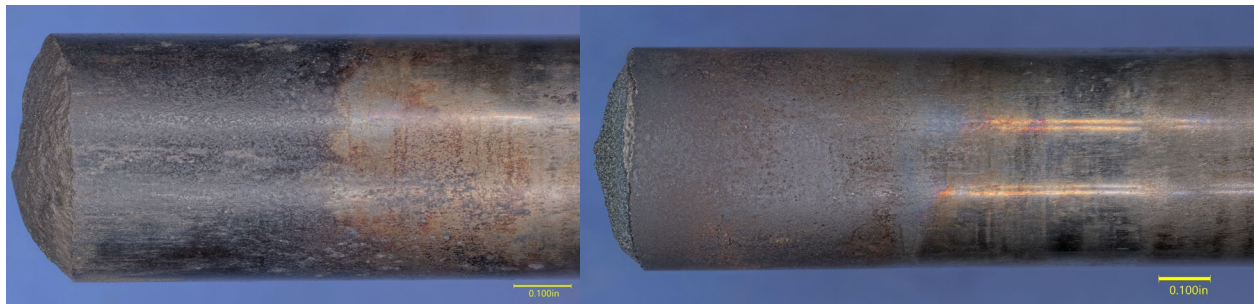
**Figure 4.** Side view images of fractured exhaust valve stem. The left photo is before cleaning while the right photo shows the fracture surface after cleaning.

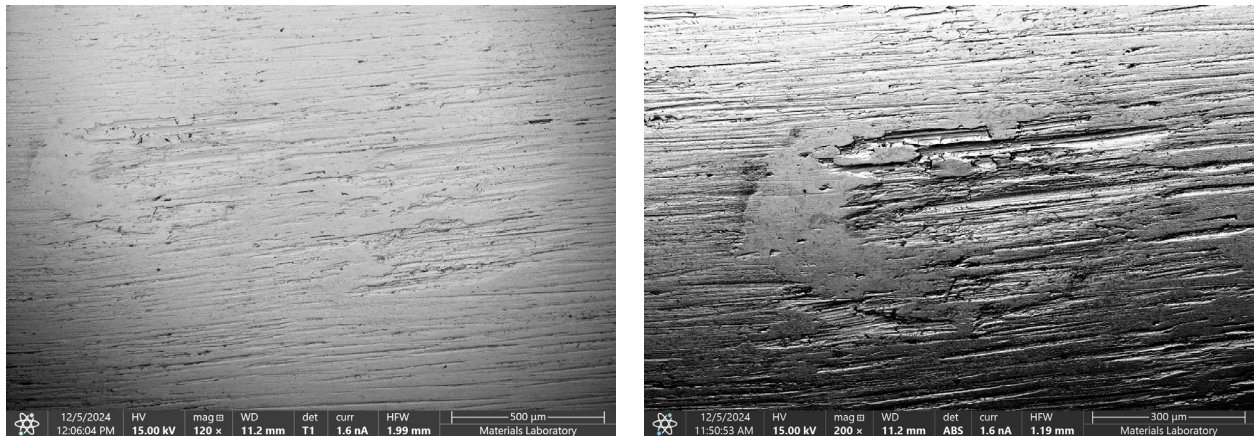
**Figure 5.** Left image shows two gouges next to each other on the stem surface near the top of the exhaust valve. The right image is a higher magnification view of the left-gouge in the left image.

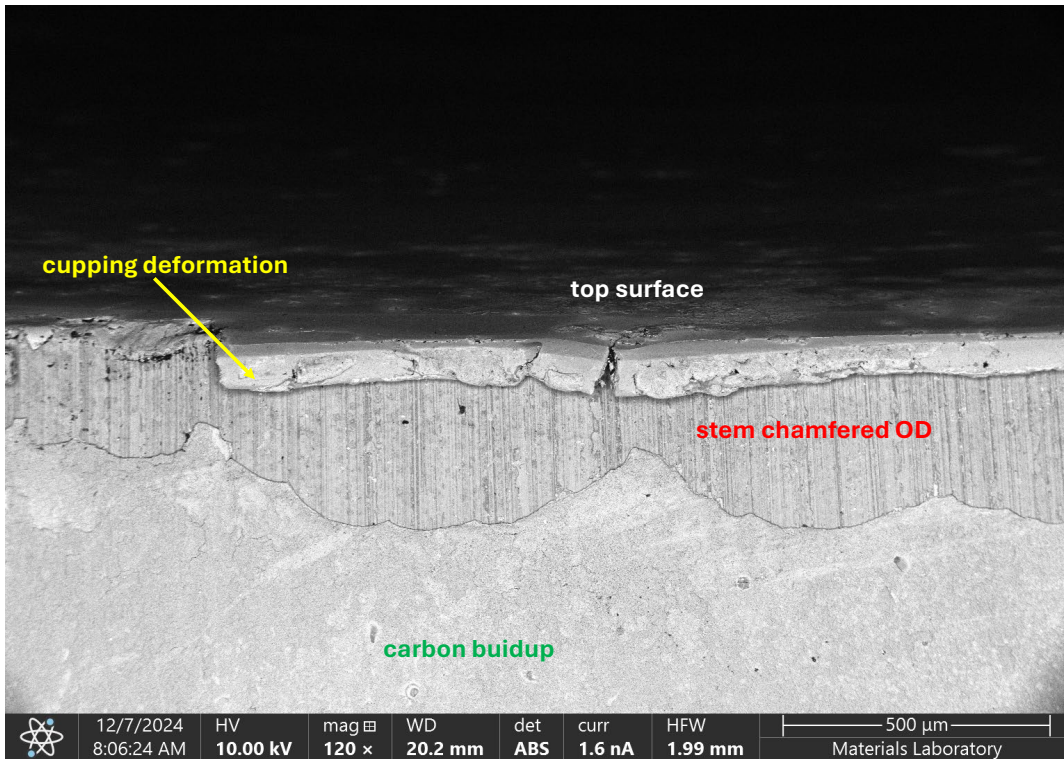
wear markings. While the top of the intake valve showed no visible wear marks, the top of the exhaust valve showed significant wear in the form of material deformation cupping over to the outside surface of the chamfer. Scanning electron microscope (SEM) images of the deformation are shown in figures 6 and 7.

**Figure 6.** Side straight-on view of exhaust valve at the very top of the stem showing the cupping deformation wear.

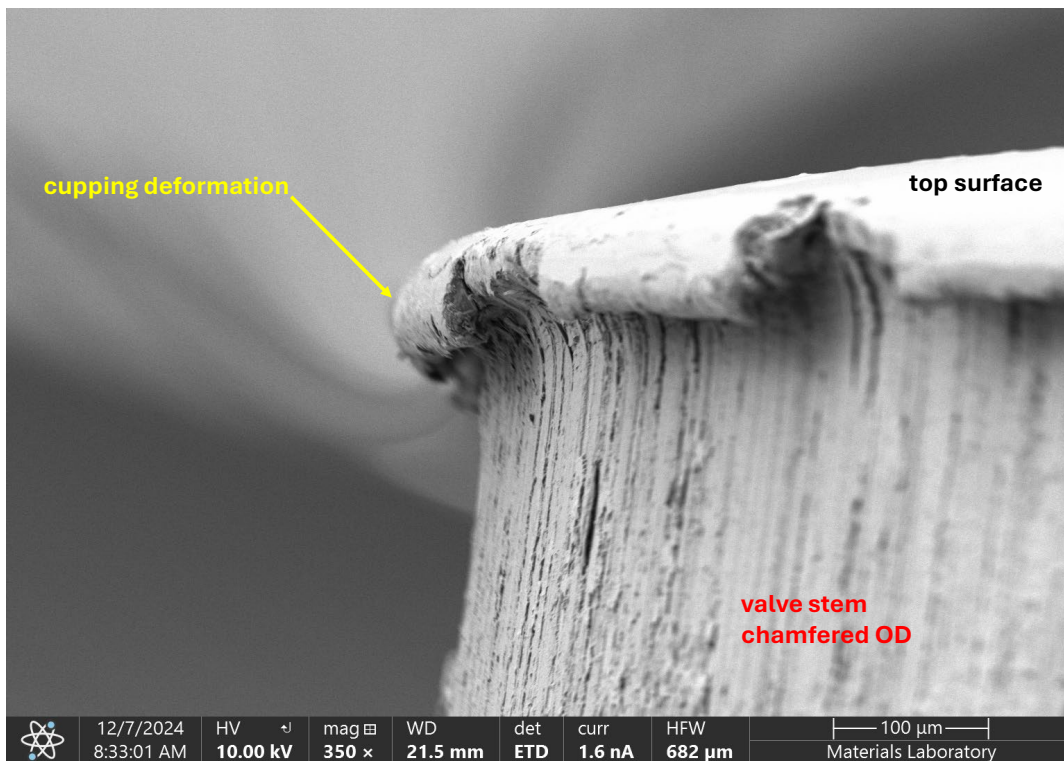
**Figure 7.** Corner side view of the exhaust valve at the very top of the stem showing the cupping deformation wear.

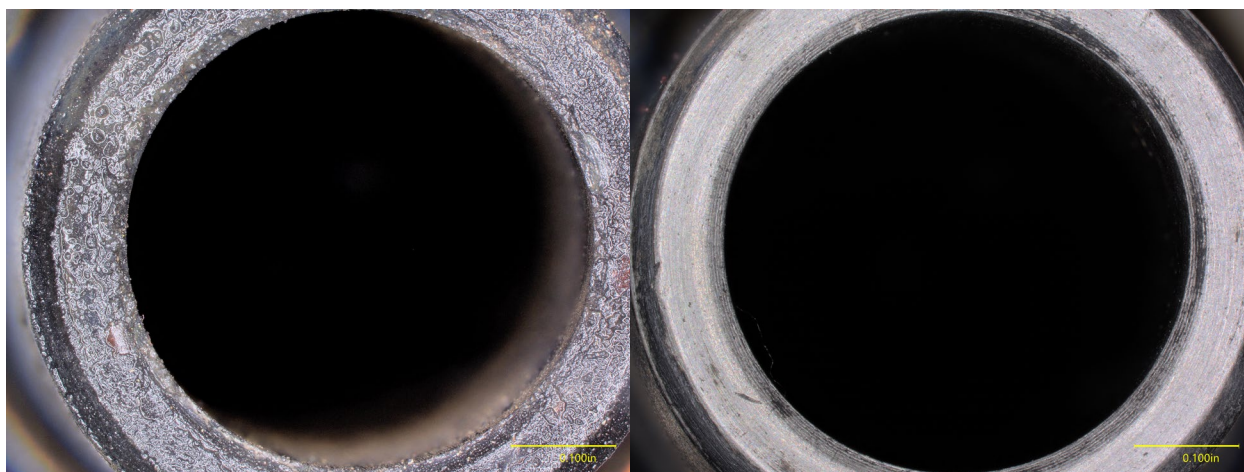
Before and after cleaning of the top of the engine exhaust valve guide are shown in figure 8. No cracking was found at the top of the guide after cleaning. Figure 9 shows exhaust valve guide images taken using a borescope before (left) and after (right) cleaning. The top images in figure 9 were taken near the top of the guide while the bottom images were taken near the bottom of the guide. No cracking or scoring marks were observed in the guide shaft. The average outside (OD) diameter of the exhaust valve stem was determined to be 0.431 inches while measurements of the inside diameter (ID) of the exhaust valve guide was taken at four different locations and are shown in Table 1 below.

**Figure 8.** Top view images of exhaust valve guide showing no surface cracking around the top of the guide. The left photo is before cleaning while the right photo is after cleaning.

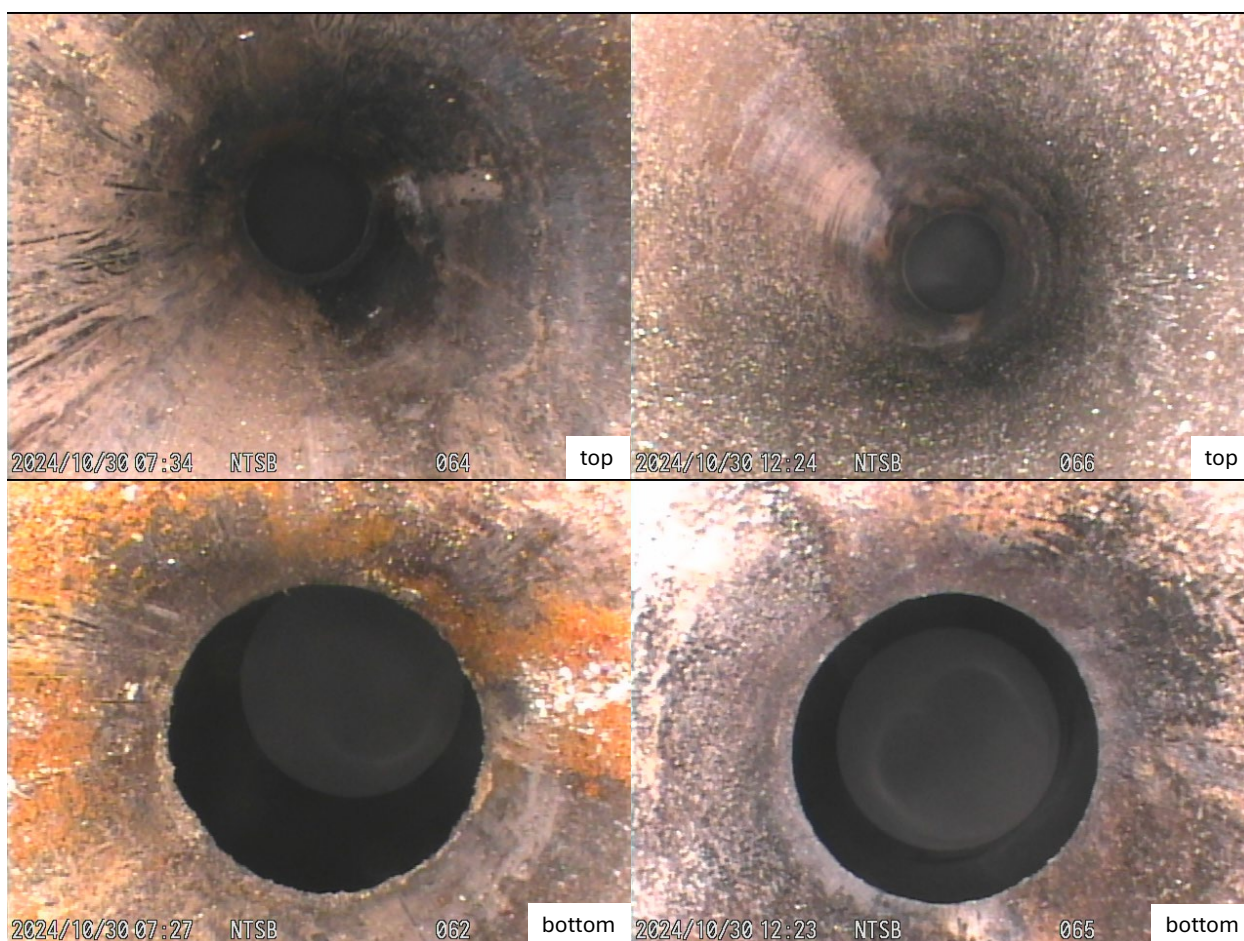
**Figure 9.** Borescope images of the exhaust valve guide before (left) and after (right) cleaning. Top images were taken near the top of the guide while the bottom images were taken near the bottom of the guide.

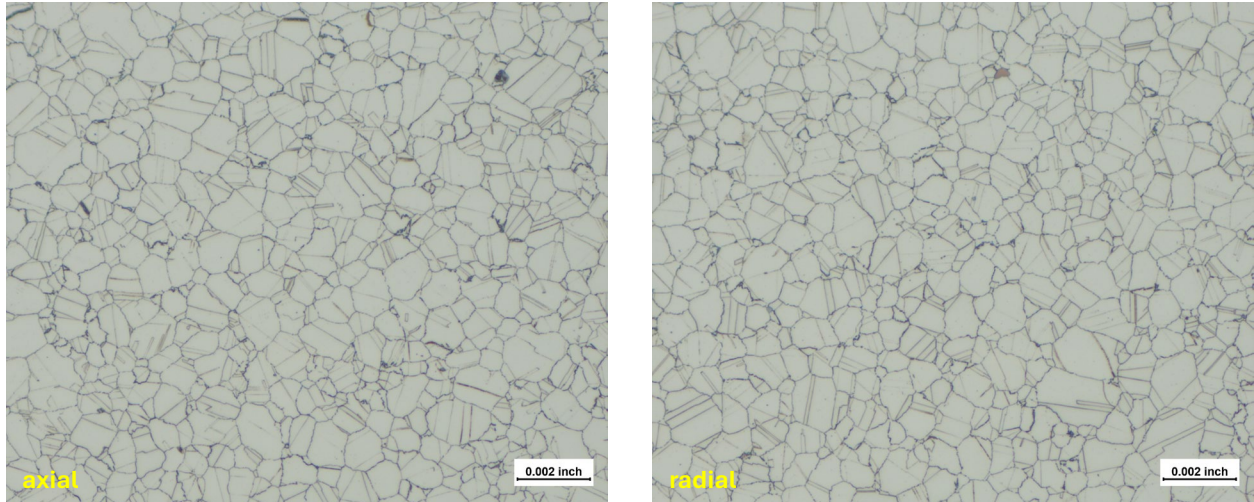
SEM are documented in Figures 10 - 12. Figure 10 shows the core grain structure of both the radial and axial sections. Figure 11 is a radial metallographic image of the stem edge showing a coating on the outside of the stem. The coating was determined to be chromium using energy dispersive spectroscopy (EDS). The coating thickness was measured to be 0.00003 inches (0.762 microns) and is relatively uniform in thickness and continuous in this area. The SEM images in figure 12 show the edge coating at two different magnifications. The yellow arrows in the images point to the chromium coating at the edge. The lower magnification top image shows the coating is non-uniform in thickness and non-continuous in some areas. The higher magnification bottom image shows coating thickness measurements at two different locations. The thicker coating area is 1.196 microns (0.00005 inches) while the thinner coating area is 0.5061 microns (0.00002 inches). Note that in both images the coating is non-uniform and non-continuous. No chromium coating was present on either edge of the radially cross-sectioned valve stem during microscopic examination.

**Figure 10.** Metallographic microstructural core images showing the grain structure and are both at 200X magnification.

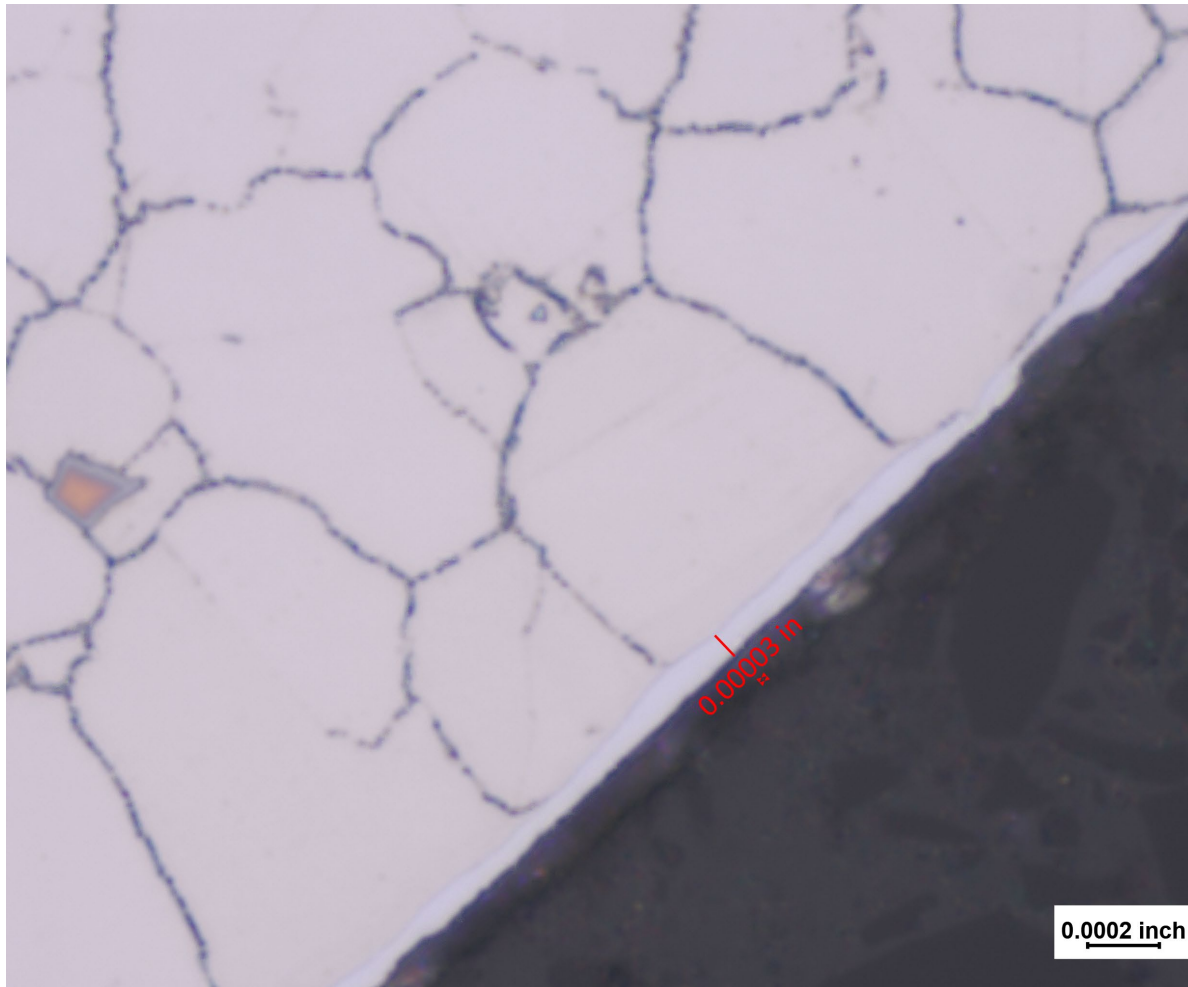
**Figure 11.** Metallographic image showing the edge coating on the radial cross-sectioned stem at 1000X magnification.

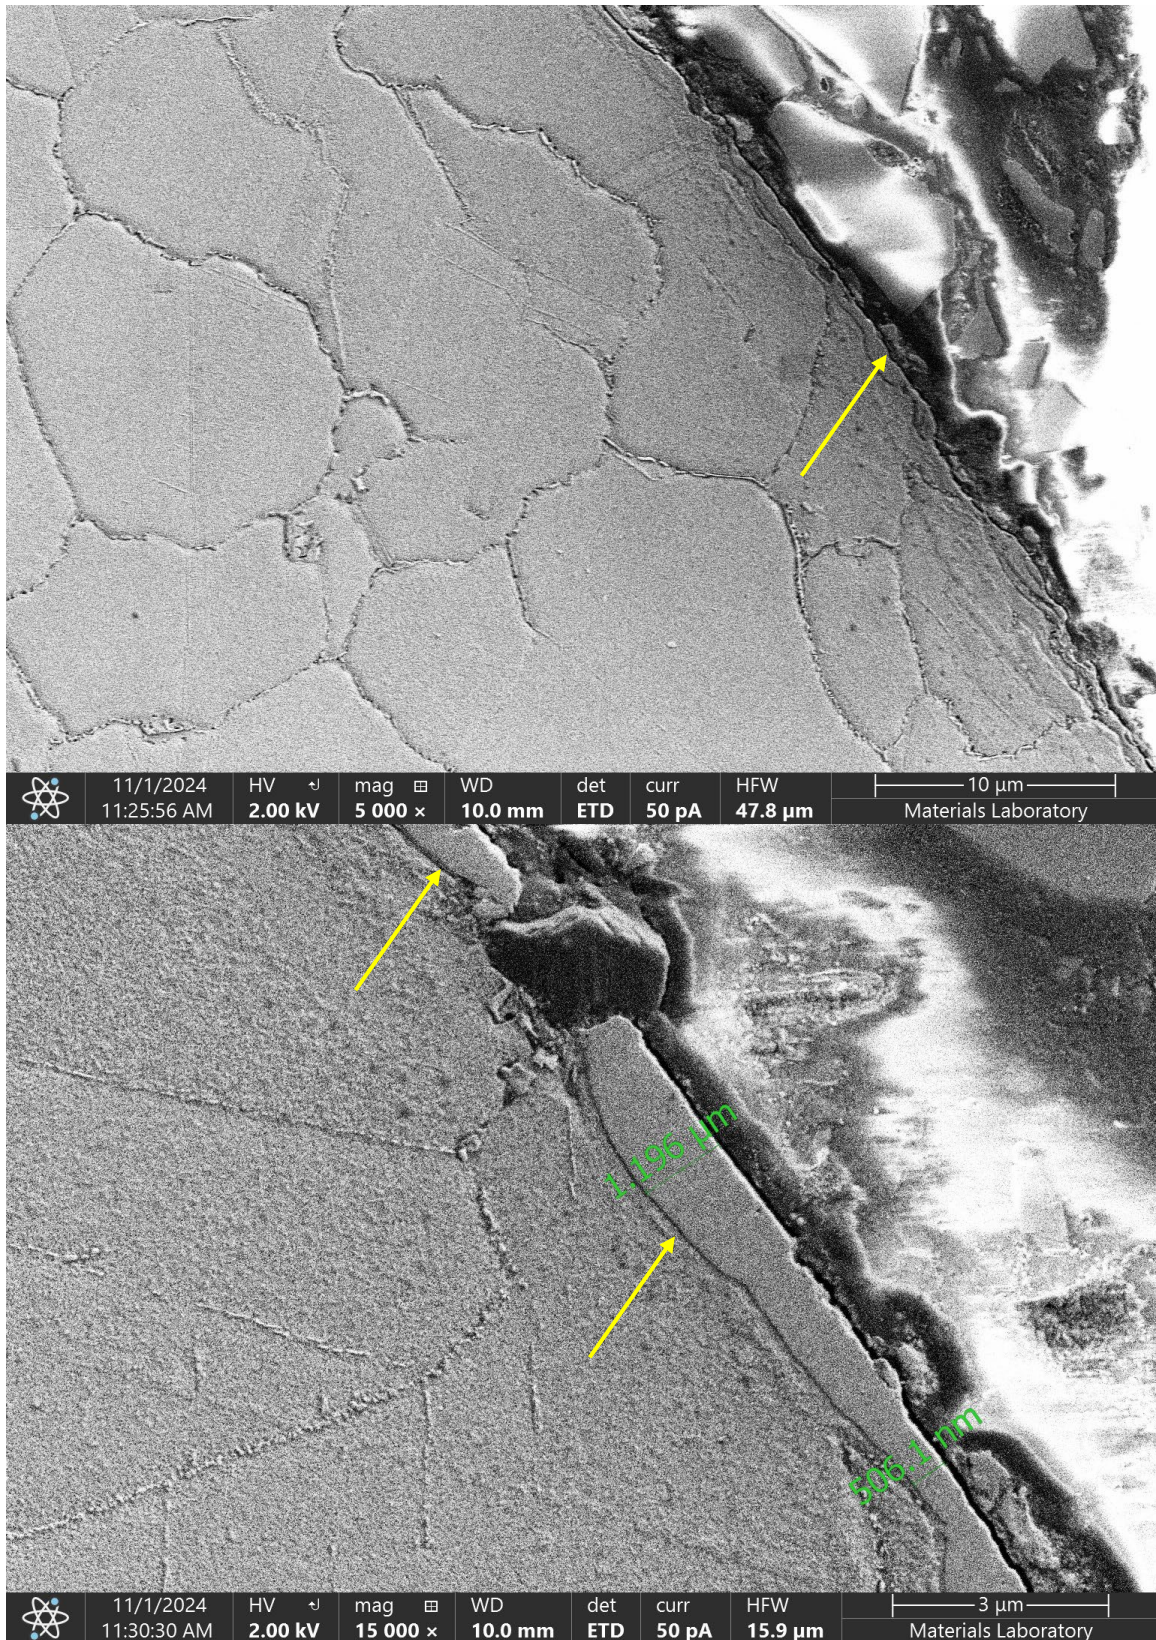
**Figure 12.** SEM images showing the edge coating on the radial cross-sectioned stem at 5000X and 15000X magnification. The yellow arrows point to the chromium coating.

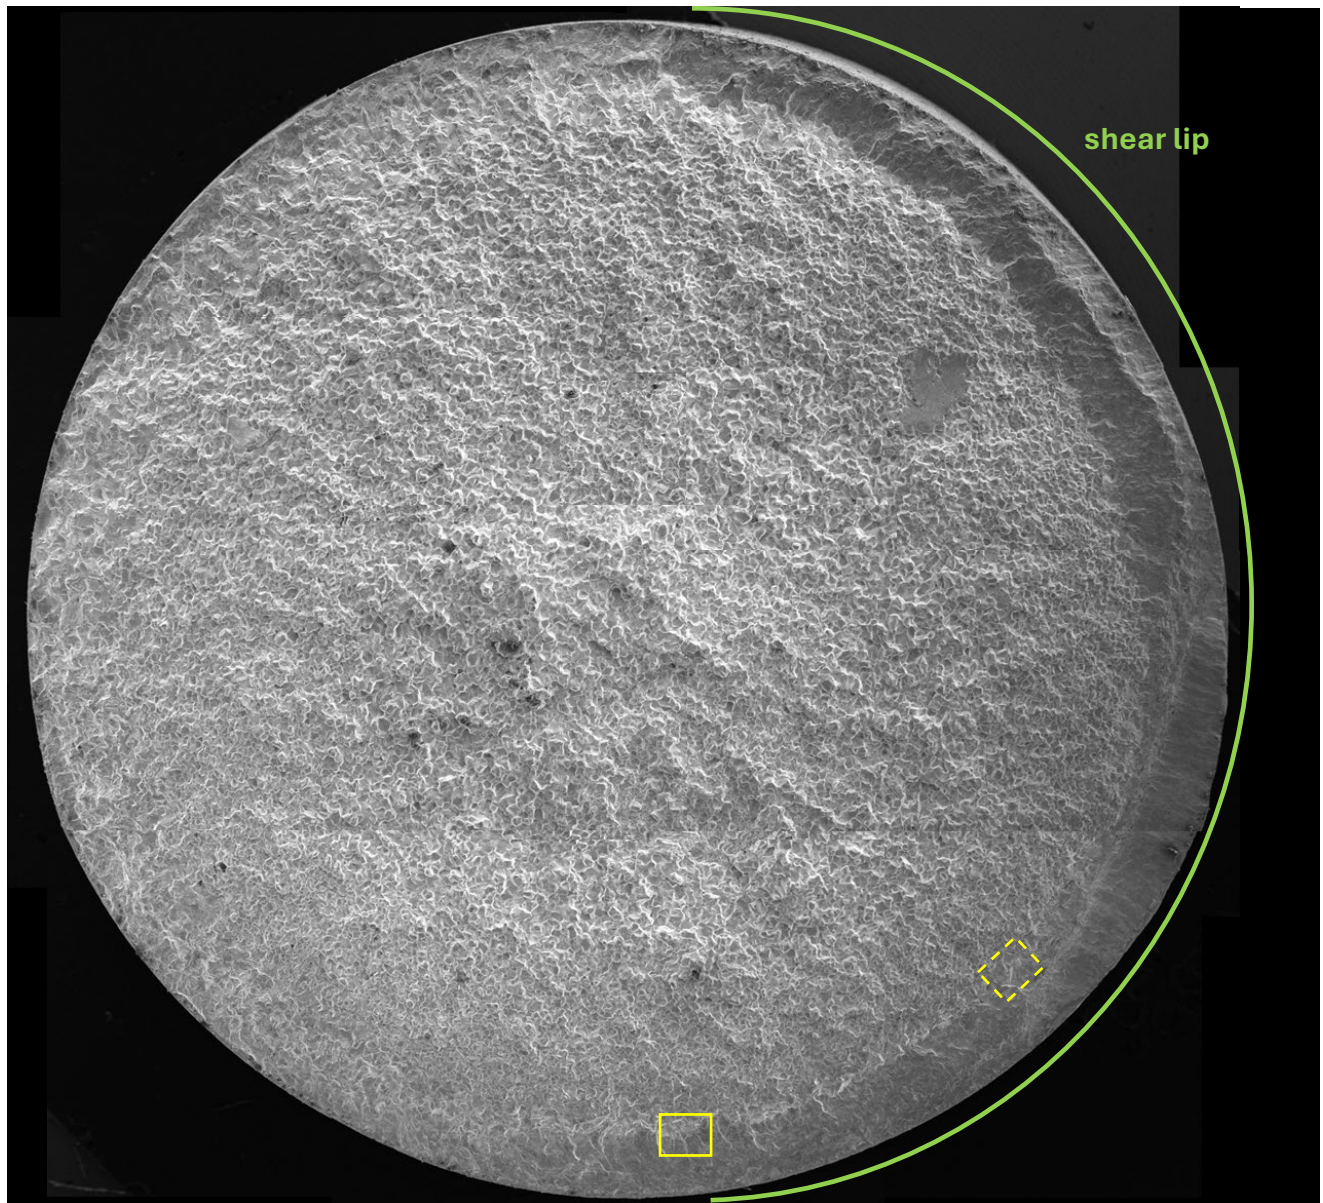
Figure 13 is a montage SEM image of the exhaust valve stem fracture surface from a top view. The green curved line on the right side of the image identifies the shear lip along half of the circumferential edge of the fracture surface. Cyclic overstress features were observed in many areas just inside and along the shear lip. The solid and dashed yellow boxes in the image are two locations where higher magnification images were acquired. These are shown in figures 14 and 15. Figure 14 shows an area where mixed mode fracture features were observed. It is the only area where micro-void coalescence (MVC) or dimple overstress was observed and is identified by the yellow arrows in the image. Cyclic overstress features were observed near or just inside along the shear lip and nowhere else. One such area is pointed out in figure 14 by the yellow arrow. The arrows in figure 15 point to more of these cyclic overstress features. A side view of the fracture surface is shown on the cleaned valve stem in the right image of figure 4. The overall fracture mode is brittle overstress appearing to initiate at the core.

**Figure 13.** Montage SEM image of the exhaust valve stem fracture surface showing the shear lip along half of the circumferential edge of the fracture. The yellow boxes are where higher magnification images are shown in figures 14 and 15.

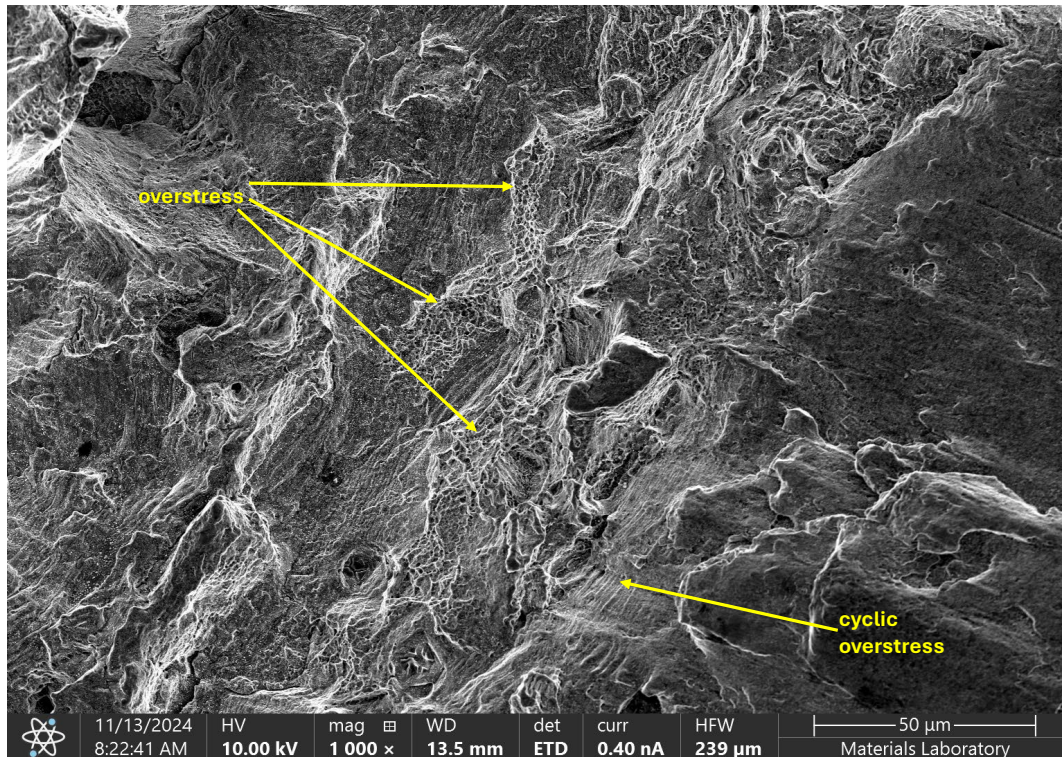
**Figure 14.** Higher magnification SEM image of the yellow dashed box area in figure 13 showing mixed mode fracture just inside the shear lip area.

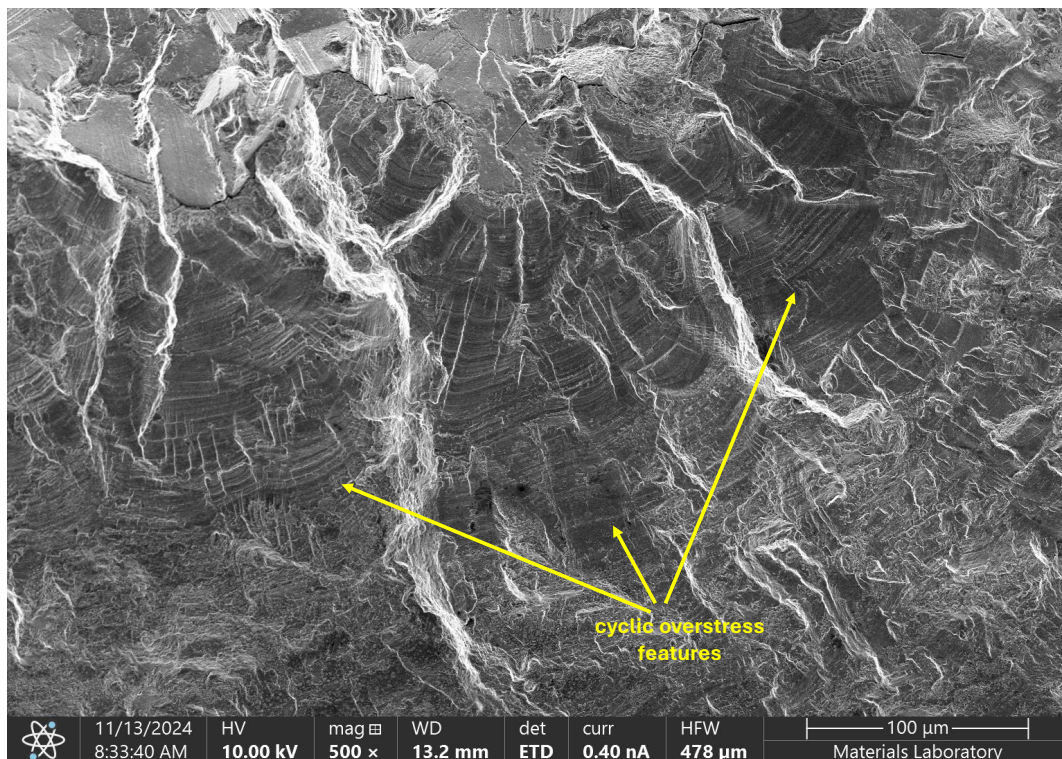
**Figure 15.** Higher magnification SEM image of the yellow box area in figure 13 showing cyclic overstress features found in areas along the inside of the shear lip area.
