WPR23FA258

## INVESTIGATION PHOTOGRAPHS

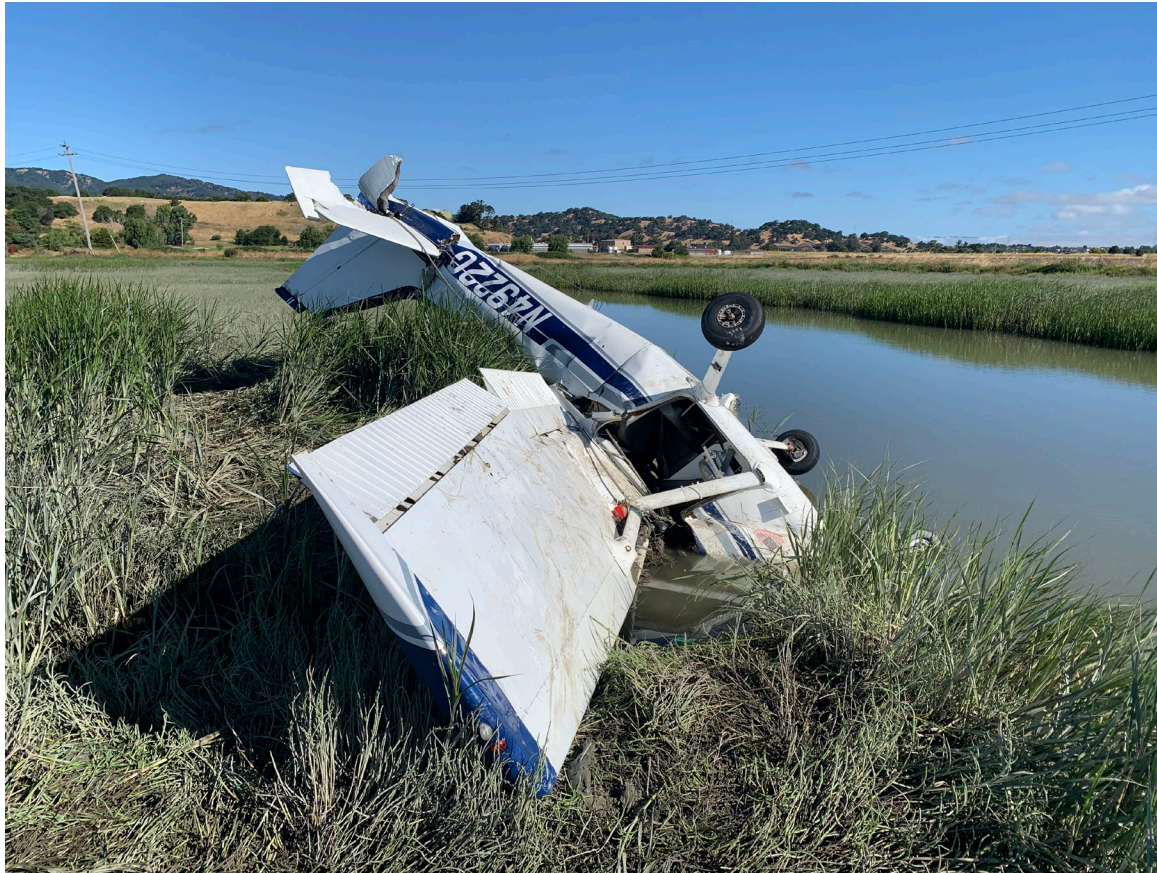
**Photograph 1 - Wreckage - Left Side (Courtesy of NTSB)**

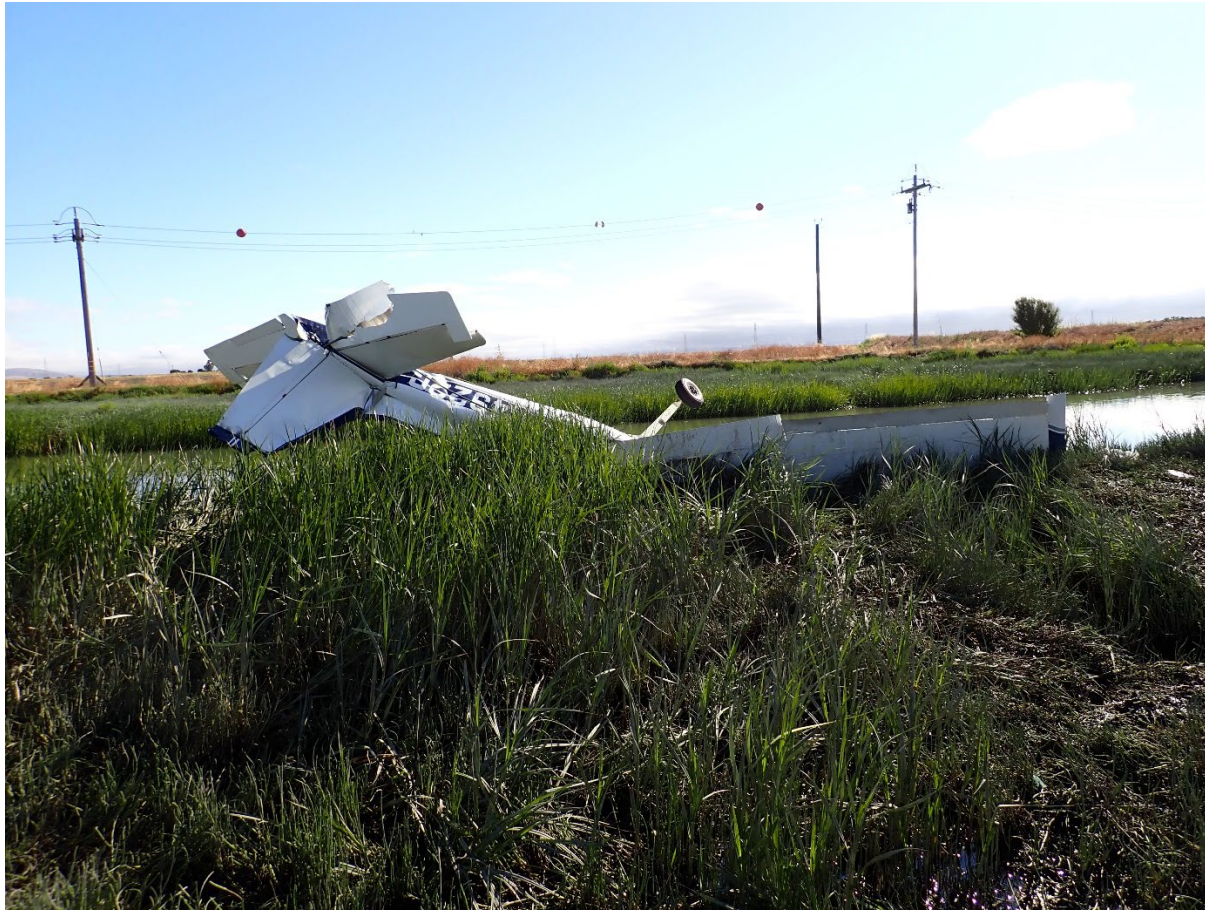
**Photograph 2 - Wreckage and Power Lines (Courtesy of Textron Aviation)**

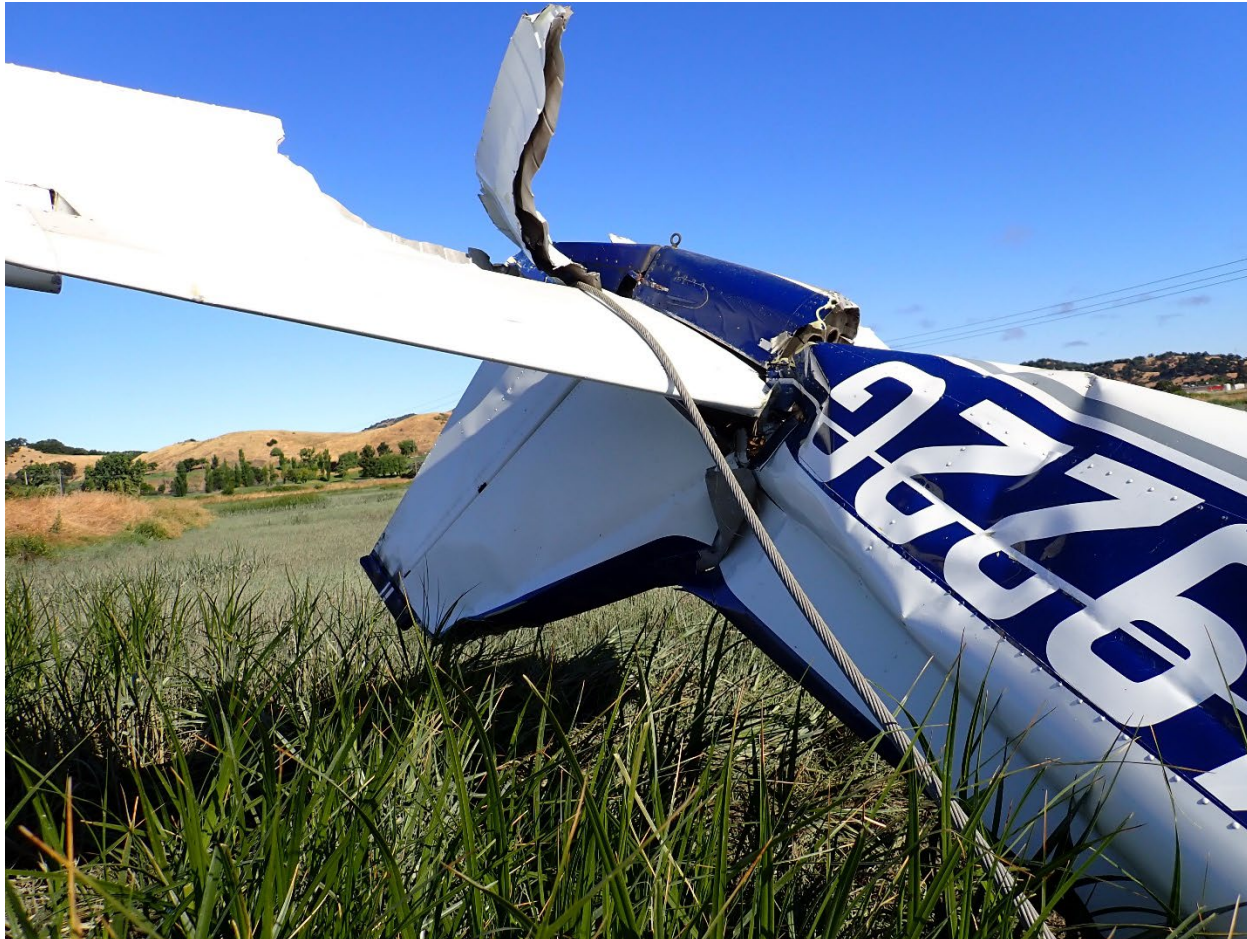
**Photograph 3 - Empennage Wrapped with Power Line (Courtesy of Textron Aviation)**

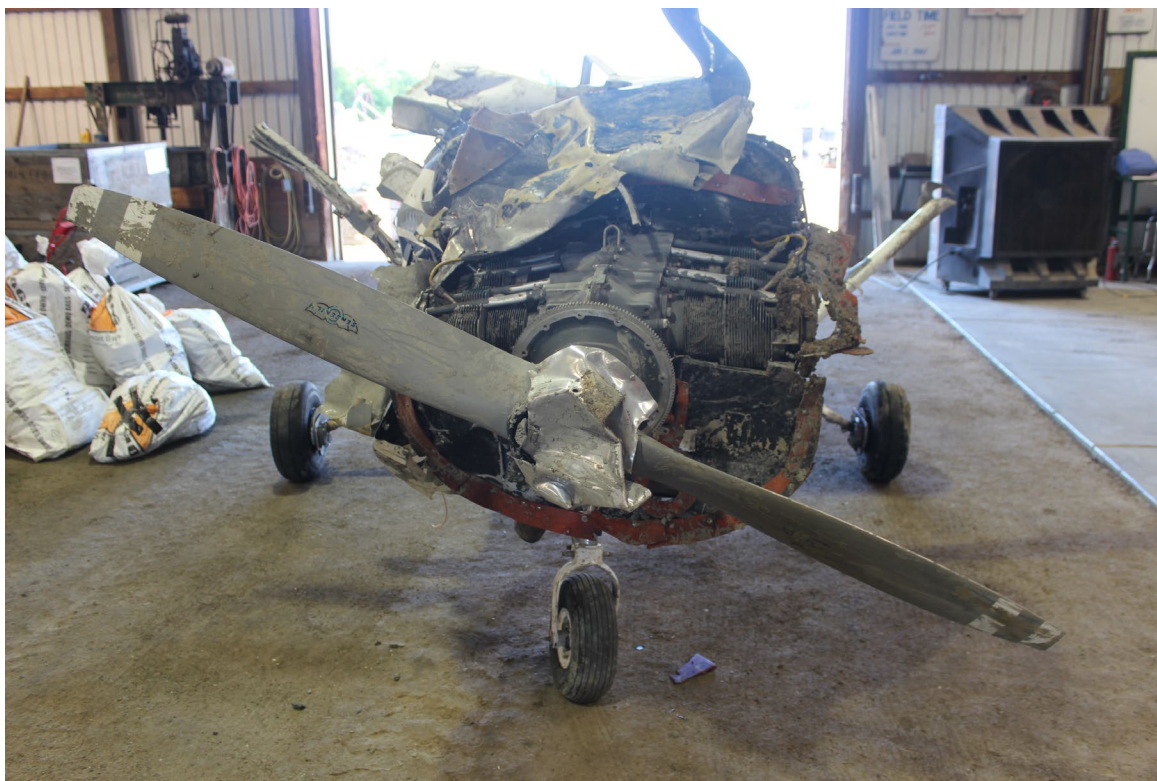
**Photograph 4 - Propeller and Spinner (Courtesy of Lycoming Engines)**
