# National Transportation Safety Board

WPR23FA258

**AIRWORTHINESS**

Location: San Rafael, CA  
Date: July 8, 2023  
Time: 2201 Mountain standard time  
Airplane: N4922G, Cessna C172  
Operator: Kirk Hurford, Co-owner

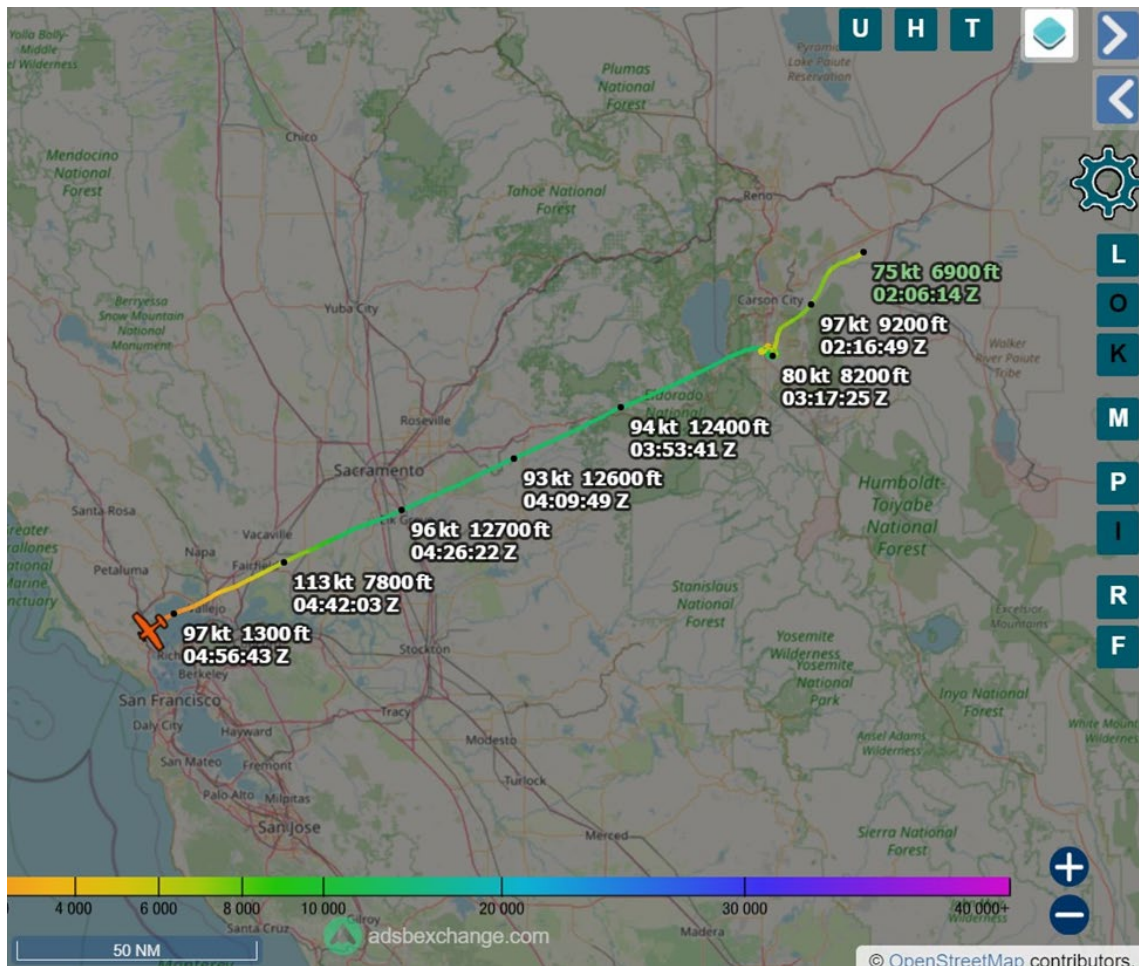
Figure 2 - ADS-B Track (Entire Route)

The airplane departed MEV at 2000, and ADS B data shows the airplane circled over MEV and climbed from about 4,600 ft msl to about 12,500 ft msl before proceeding direct to CA35. The airplane maintained about 12,500 ft until about 65 miles northeast of CA35, where it began an enroute descent. Airplane maintained 90-110 kts during the descent on a heading of about 240° until about 2159. During the remainder of the flight the airplane continue to slow and descend, with the airplane slowing to 43 kts at 500 ft at 2200:17. The airplane continued to descend, and groundspeed increased until the last data return, which indicated 70 kts at 0 ft about 0.4 miles northeast of the approach end of runway 22 at CA35. The accident site was located about 0.2 miles northeast of the approach end of runway 22 at CA35. See Figures 2 - 6

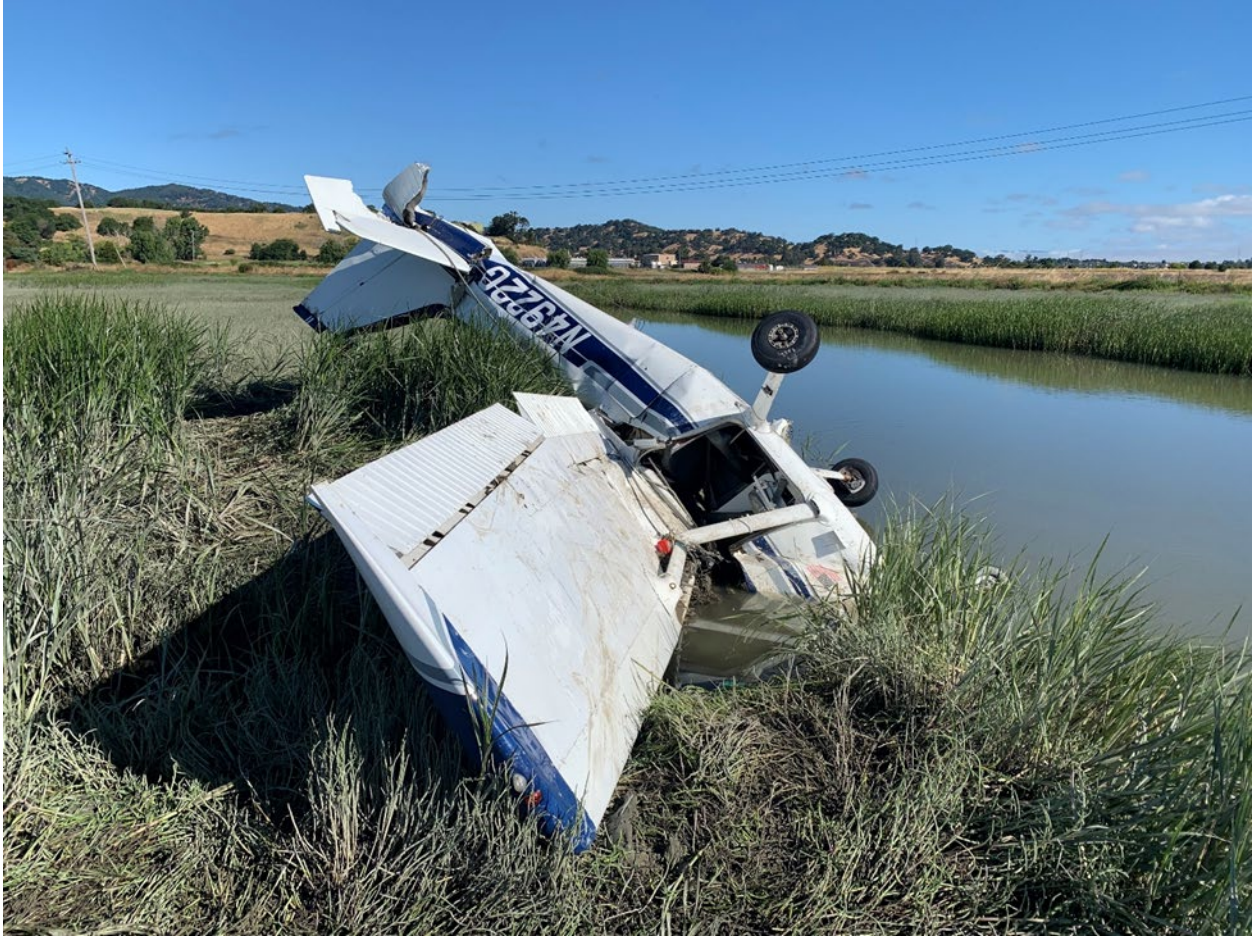
Figure 7 - Airplane Wreckage

All four corners of the aircraft were observed. The aircraft came to rest inverted about 161' from the initial impact on a slight down sloping wet embankment adjacent to a water way in a 58° MH and 952' from the approach end of runway 22 at San Rafael Airport (CA35), San Rafael, CA (figure 7). The aircraft collided with high tension wires which were about 30 ft high while approaching runway 22 at CA35.

The wreckage was partially submerged in water, partially inverted, and oriented with the nose pointed in an easterly direction (figure 6).

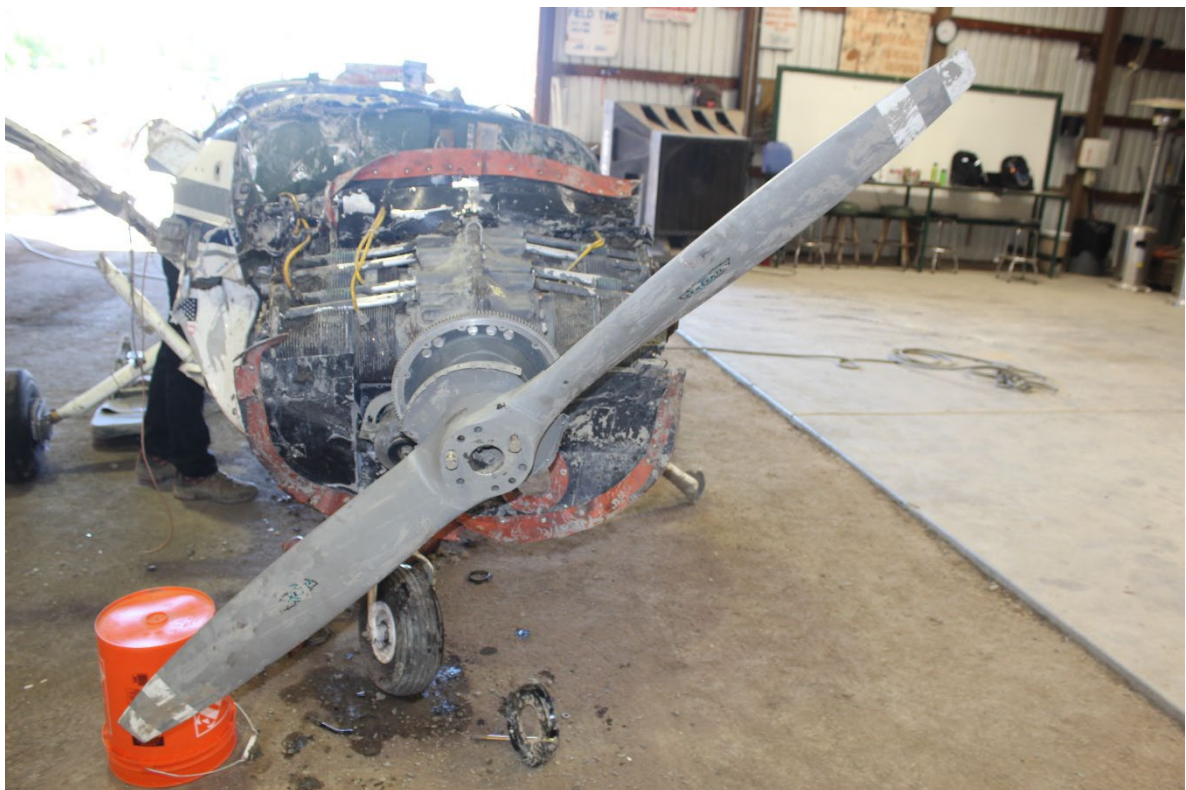
Figure 8 – Propeller Blades (Courtesy of Lycoming Engines)

The metal two bladed fixed pitch propeller remained attached at the crankshaft flange. The impact damaged spinner was attached to the propeller. The propeller blades remained attached to the propeller hub. One propeller blade exhibited witness marks (about midspan) and arching consistent with contacting an energized powerline. The subject propeller blade tip was missing a corner section of material and exhibited arching signatures. Both propeller blades remained straight and essentially undamaged.
