# National Transportation Safety Board

WPR23FA286

## **ENGINE EXAMINATION SUMMARY REPORT**

Location: Glendive, Montana  
Date: 07/28/2023  
Time: 1410 Local  
Airplane: N2442; A VAN NIEROP RISEN 915iS

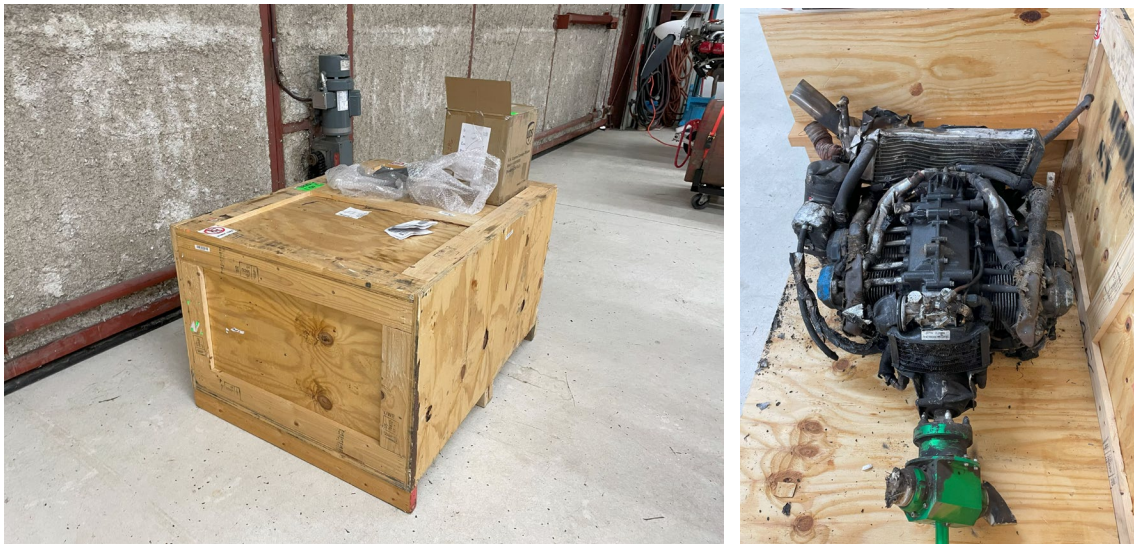
**Figure 1 Crated Engine**

The engine was removed and transported from the accident site by the Glendive airport manager for storage for transport. NTSB international shipping to Canada was lengthy. The engine was shipped to Rotech Motor Ltd, at the Vernon Regional Airport, Vernon, British Columbia, in Canada. The follow-up examination was conducted on March 26, 2025, with the NTSB-IIC and Rotax investigator in attendance. The shipping box was undamaged in Canada.

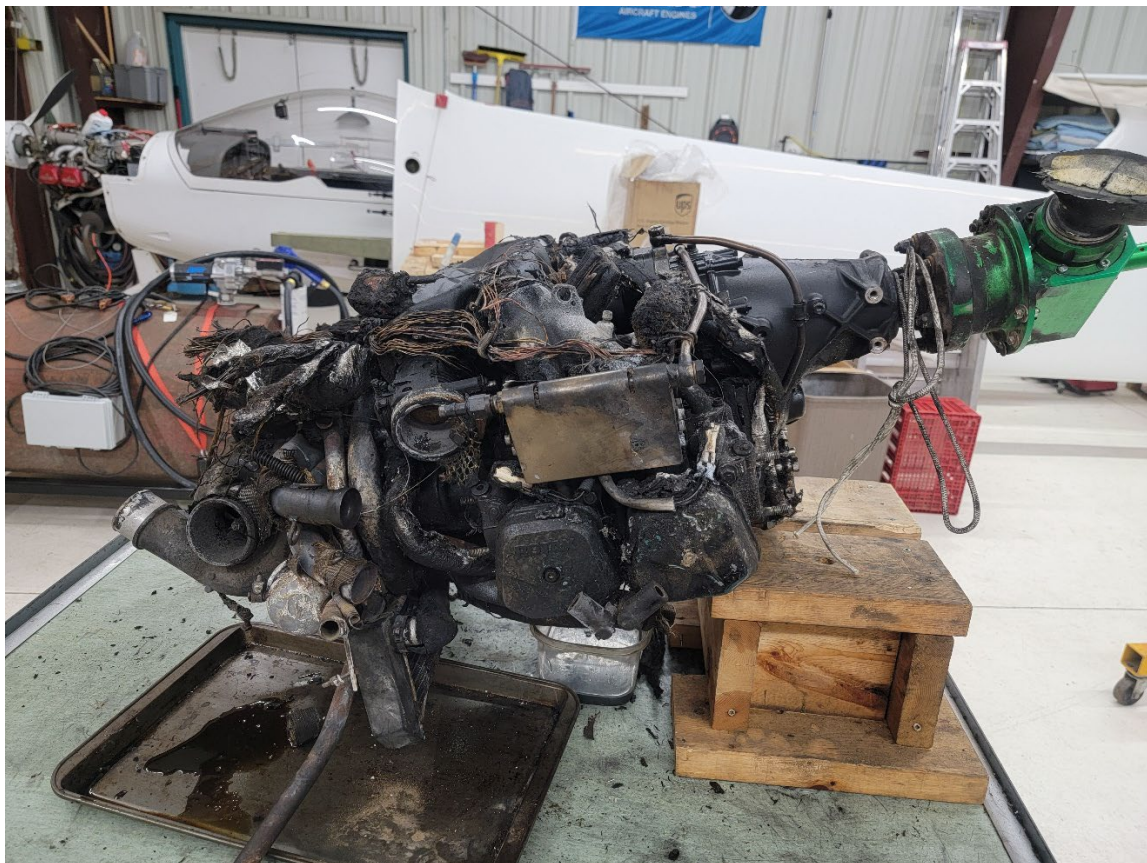
**Figure 2 Engine with reduction gearbox attached**

The propeller assembly remained attached to the crankshaft propeller flange. The reduction gearbox had one of two blades cut off for shipping and the other sheared off from impact damage. The airplane and engine sustained post impact fire which consumed most of the airplane.

The left side of the engine appeared to have been exposed to less heat than the right side of the engine. The non-Rotax radiator had been relocated at the rear of the engine with a turbocharger and remained attached to their mounting points and were fire damaged. The intake system and turbocharger line were consumed by post impact fire. The ignition system was damaged and consumed by post impact fire. A portion of the engine support structure remained attached to the engine mounts.

The reduction gearbox assembly appeared in good condition. The oil filter, oil tank and oil cooler all had impact damage. The oil lines were fire damaged but were connected to their attachment points. Oil was observed dripping from the bottom of the engine. In maneuvering the engine about ¼ quart of oil was collected. The coolant radiator and lines had impact damage but remained attached to their connection points.

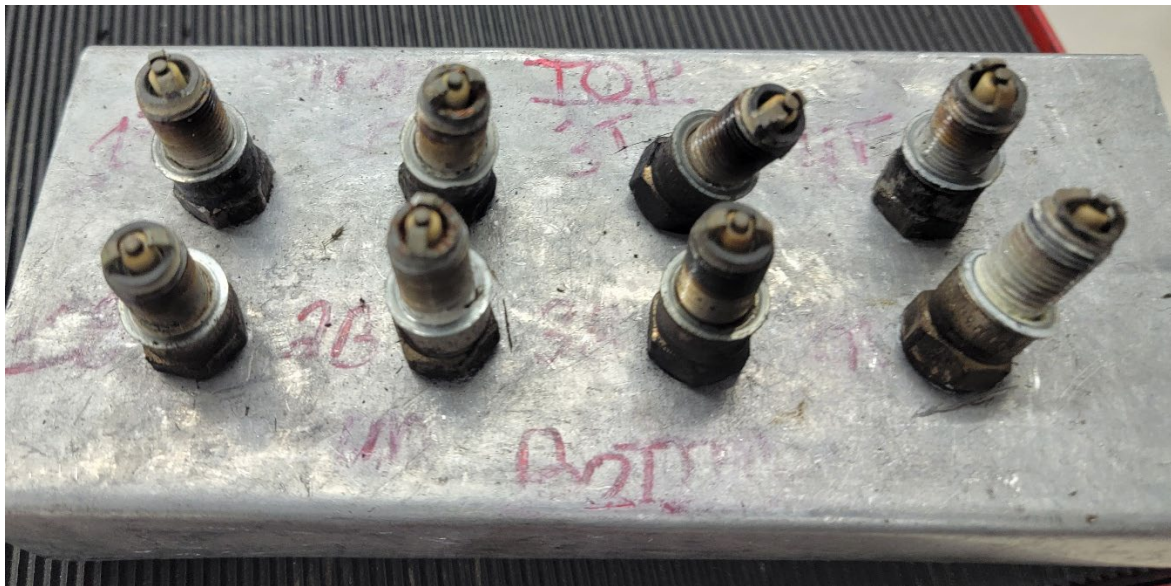
**Figure 3 Cylinder spark plugs**

The spark plugs were removed from each of the cylinders. The spark plug electrode areas had normal amounts of combustion deposits and coloring. The ignition system (ignition modules/coils, wires) was substantially damaged and partially consumed by the post-impact fire.

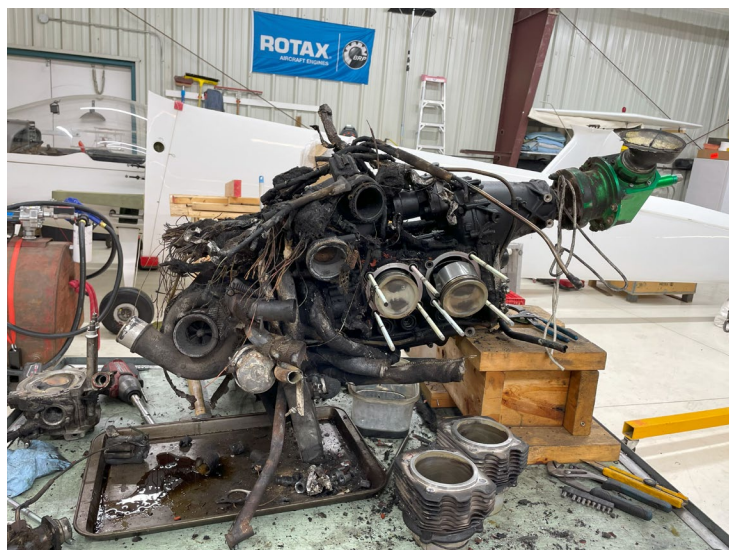
**Figure 3 Cylinder removal**

The cylinder heads were removed from the engine and examined. No anomalies were found with the cylinder heads, as they appeared to be in good physical condition.

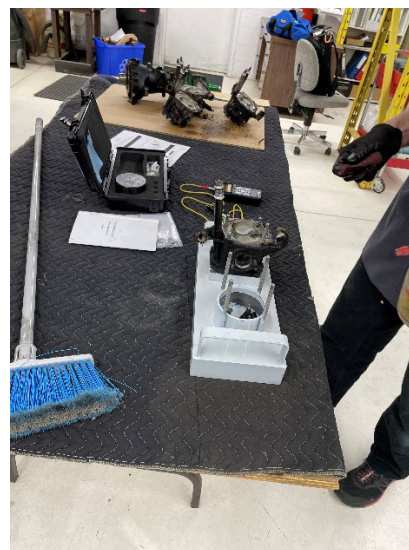
**Figure 4 Hardness Test**

Evidence existed of engine over temp limit issues that the pilot was sorting out with the manufacture. A hardness test was conducted on the cylinder heads. All the cylinders passed the test. The excessive temperatures the engine experienced were as a result of post-impact fire.

The cylinder heads were liquid-cooled and passed the hardness test, indicating that the cooling system was functioning prior to the impact.

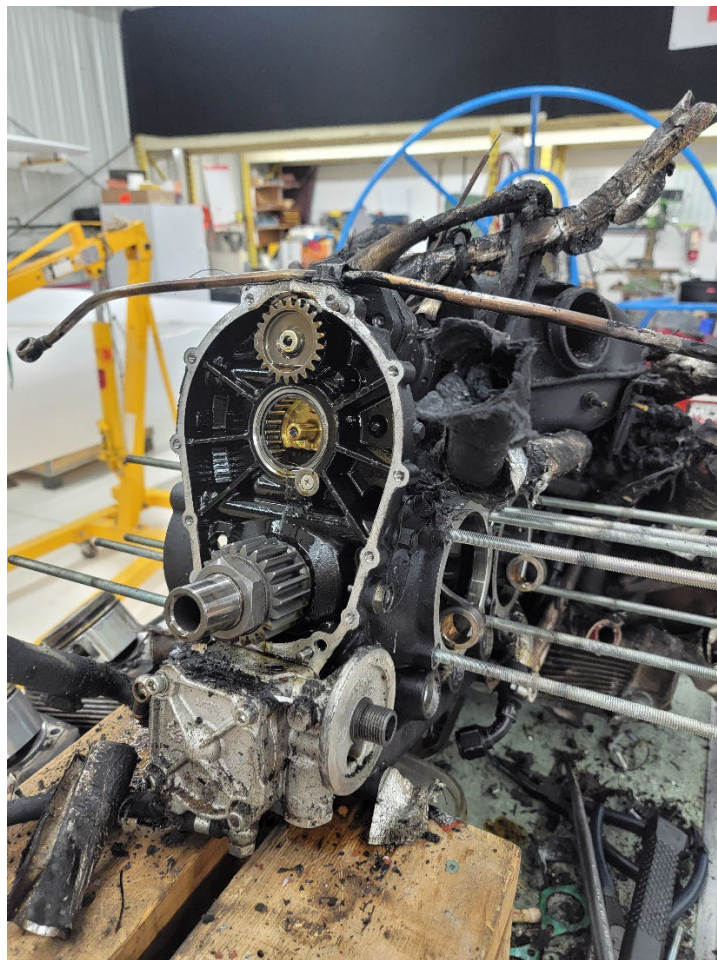
**Figure 5 Engine with reduction gearbox removed**

The reduction gearbox was in good physical condition and rotated easily without binding. The gearbox was removed and inspected. The internal gearset appeared to have been adequately lubricated, and there were no signs of pre-impact mechanical failure.
