# National Transportation Safety Board

WPR23FA286

## **ONSCENE EXAMINATION REPORT**

Location: Glendive, Montana  
Date: July 28, 2023  
Time: 1410 MDT  
2010 UTC  
Airplane: Risen 915 iS (N2442)

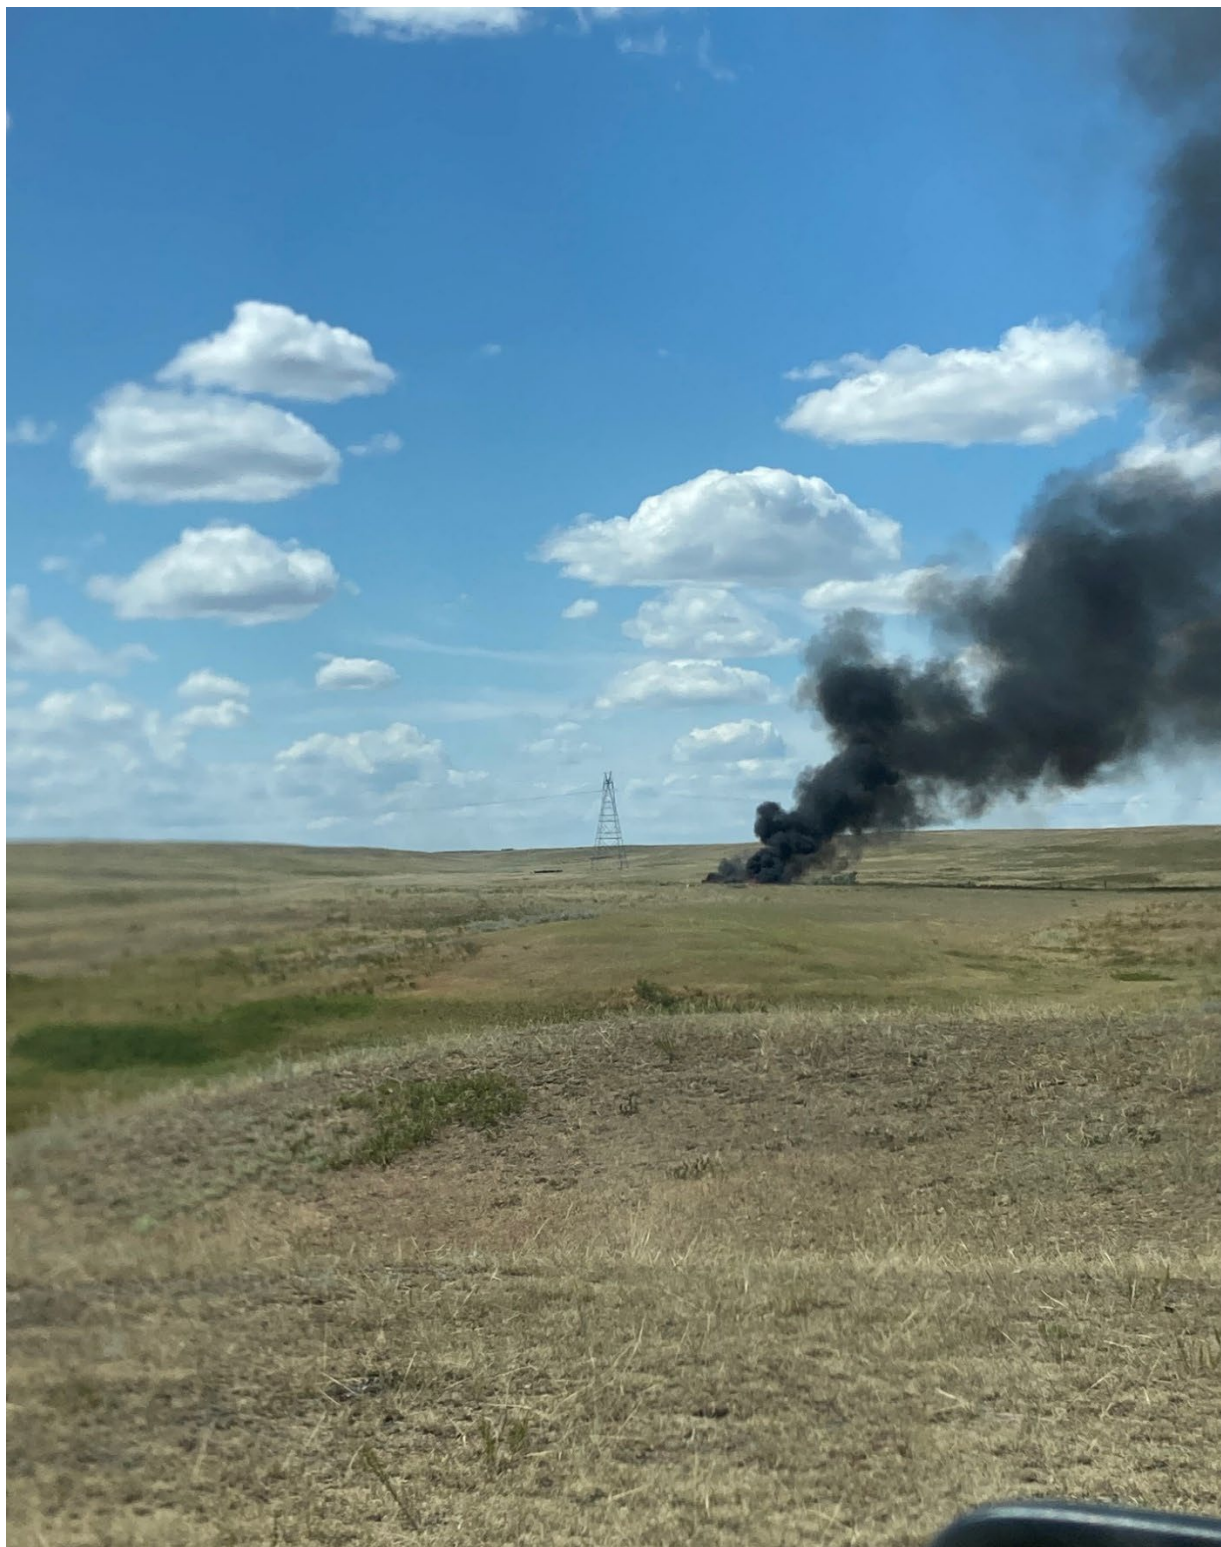
**Figure 1: Accident site. (Courtesy of property owner)**

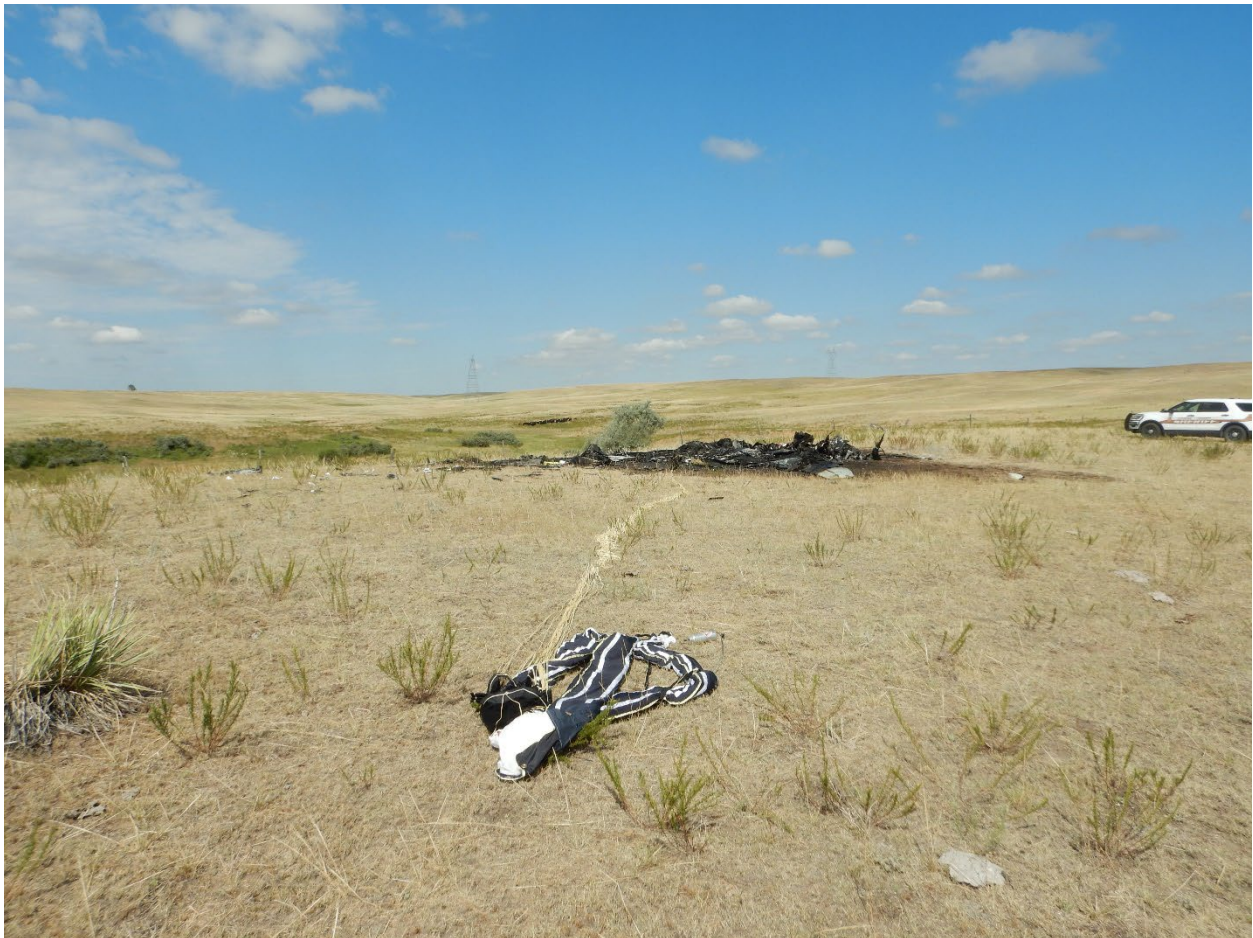
**Photograph 2: North view with deployed airframe ballistic parachute**

Examination of the accident site revealed that the airplane came to rest on a heading of 001°magnetic. The engine forward of the instrument panel was canted to the right about 30°. All of the wreckage excluding the last 2 feet of the right-wing tip was consumed by postcrash fire. All major structural components of the airplane were accounted for at the accident site and no debris path was observed. Windshield fragments were found 30 ft forward of the main wreckage. Various carbon fiber pieces were scattered 30 ft beyond the tail section. The airframe ballistic parachute was found fired, but the parachute had not unfurled.

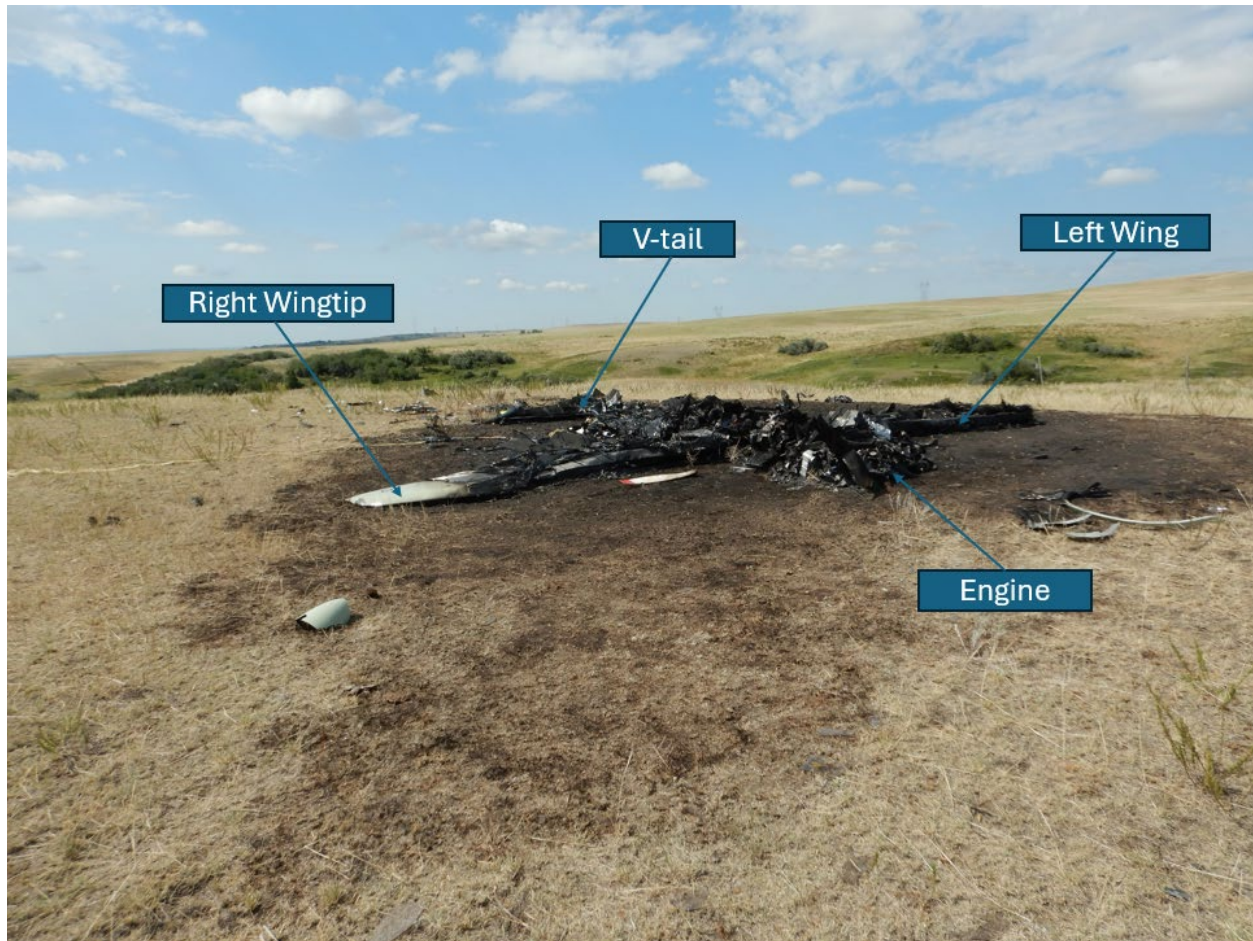
**Photograph 3: South view of the accident site**
