## Air Safety Investigations Aircraft Incident/Accident Technical Report

| Aircraft Incident/<br>Accident Information | Year: 1963 | Make: Beechcraft | Model: P35 |
| | Serial number: D-7217 | | Registration: N8572M |
| Air Safety Investigator: Kurt A. Gibson | | Report #: ASI-23-BV-T | Report date: 10-19-23 |

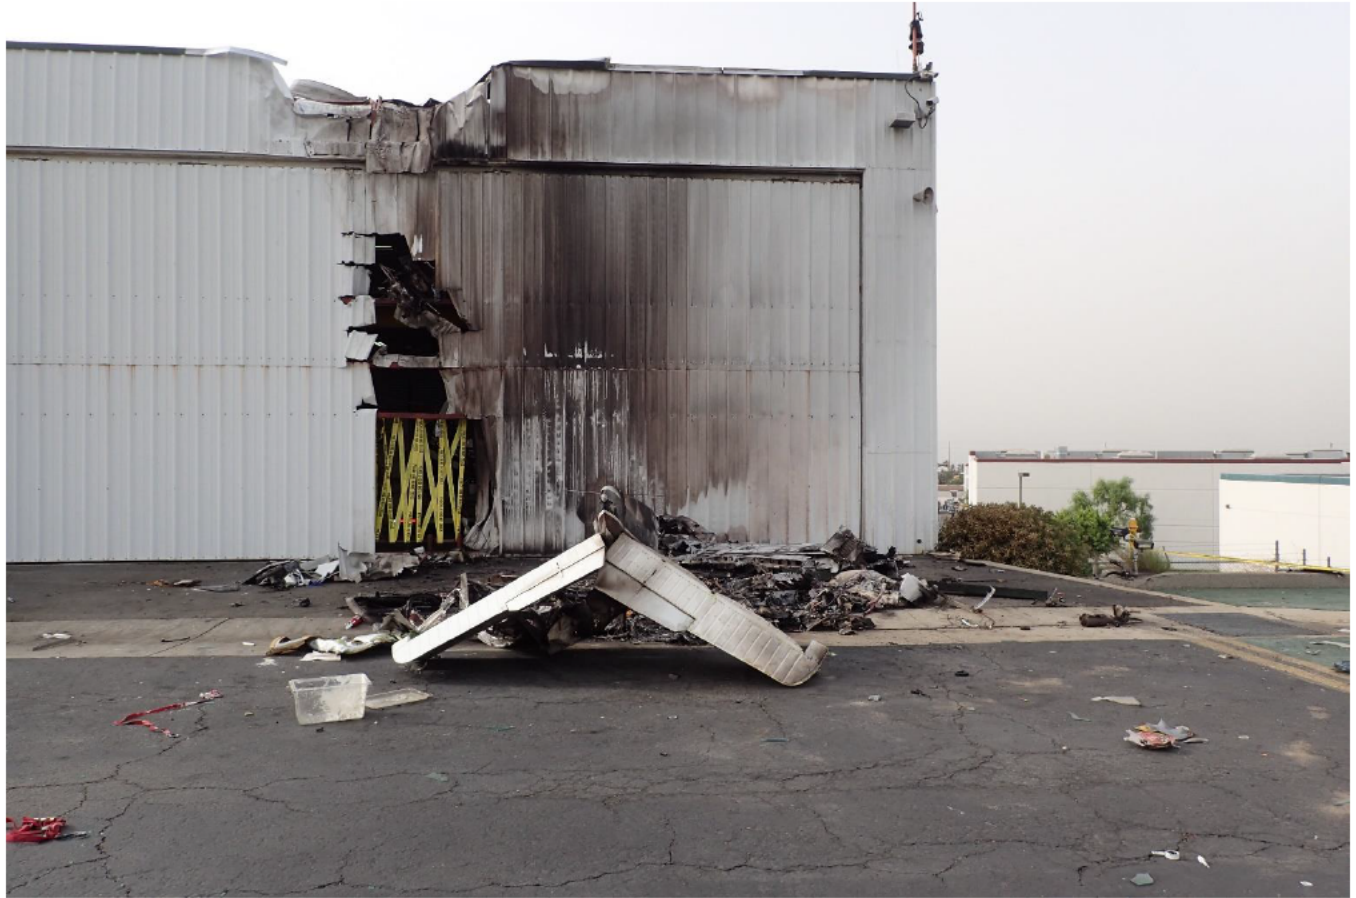
The aircraft impacted a hangar in a near vertical attitude. The left wing impact separated from the rest of the aircraft and remained on the roof of the hangar. A portion of the airframe engine mount structure remained imbedded in the hangar door. The aircraft then impacted the concrete tarmac in front of the hangar in an inverted attitude. A post impact fire ensued and consumed most of the fuselage, the empennage and the right wing also displayed thermal damage signatures.

Wreckage Overview (ASI-23-BV (2).jpg)

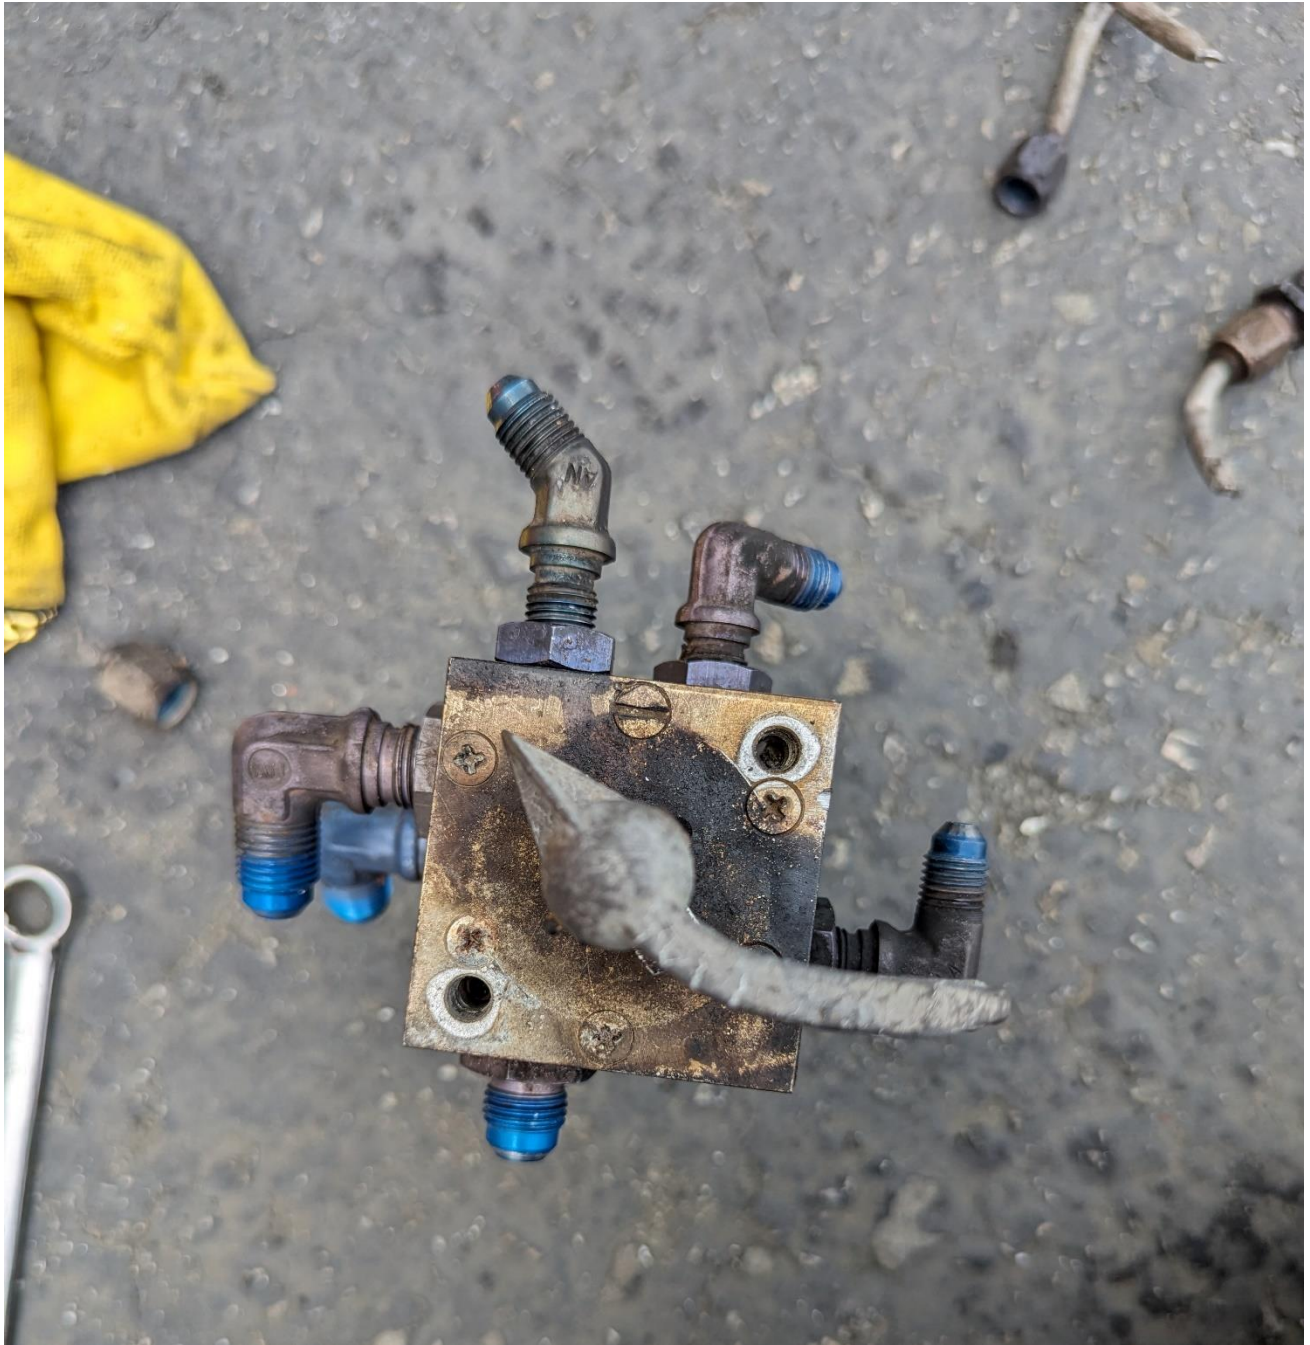
The fuel selector valve cover had impact separated free from the fuel selector and the fuel strainer screen was not observed during the examination. The fuel selector valve was found in the OFF position detent. The fuel selector valve was capable of normal movement and was unobstructed in the LEFT and RIGHT positions.

Fuel Selector Valve (ASI-23-BV (205).jpg)

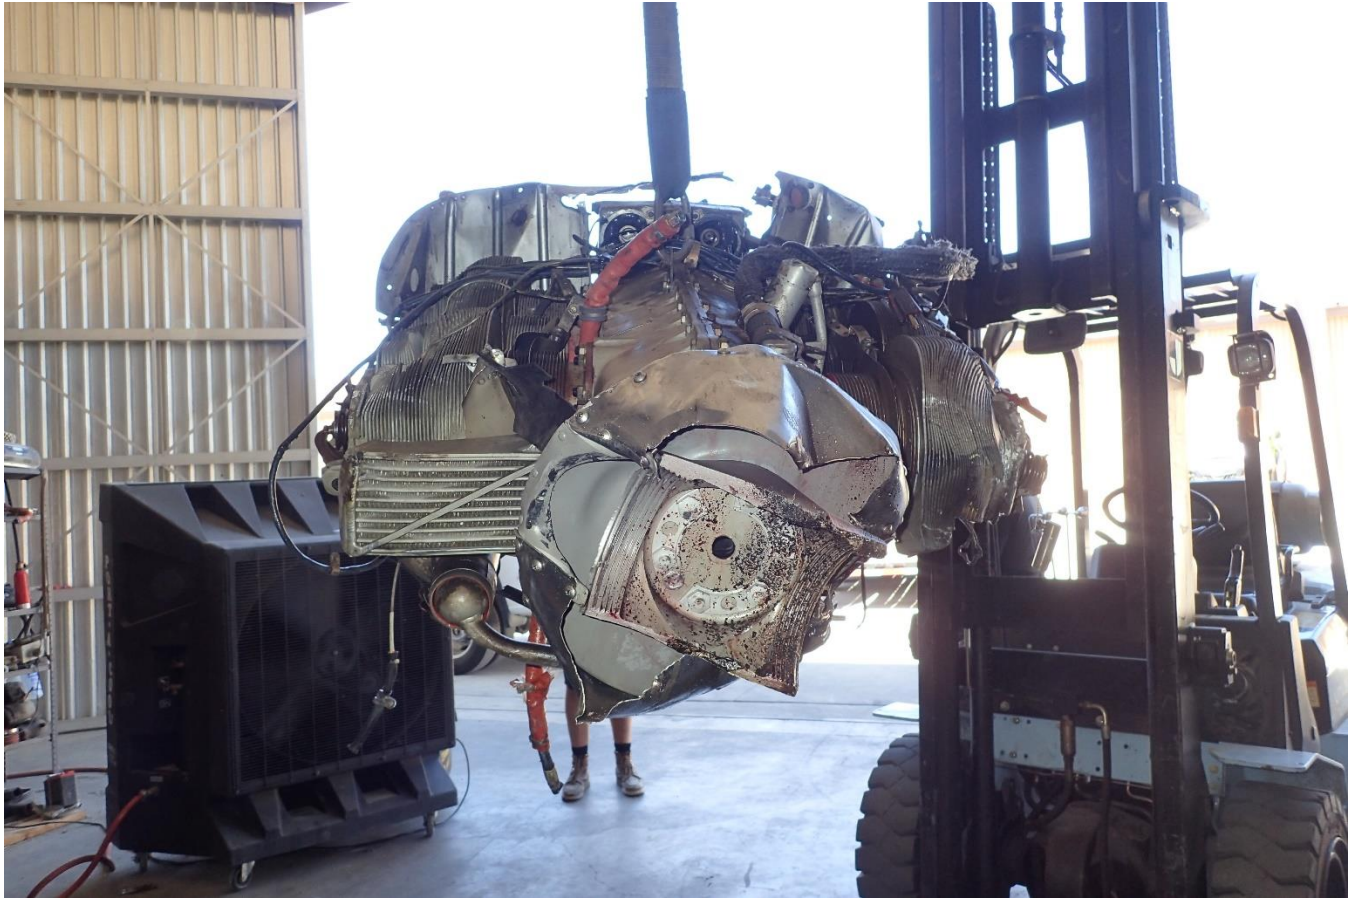
The engine was initially examined by a local Airframe and Powerplant mechanic under the supervision of the NTSB IIC. The mechanic reported that the crankshaft was not capable of rotation despite removal of all of the engine accessories. The oil sump was removed and portions of the crankshaft, connecting rods, and camshaft were visually examined. All the connecting rods remained attached to their journals and there were no signs of lubrication distress or main bearing shift. The throttle and fuel metering inlet screen was removed and was clear of any obstructions. The fuel pump drive shaft remained intact and was capable of rotation.

Engine Overview (ASI-23-BV (226).jpg)

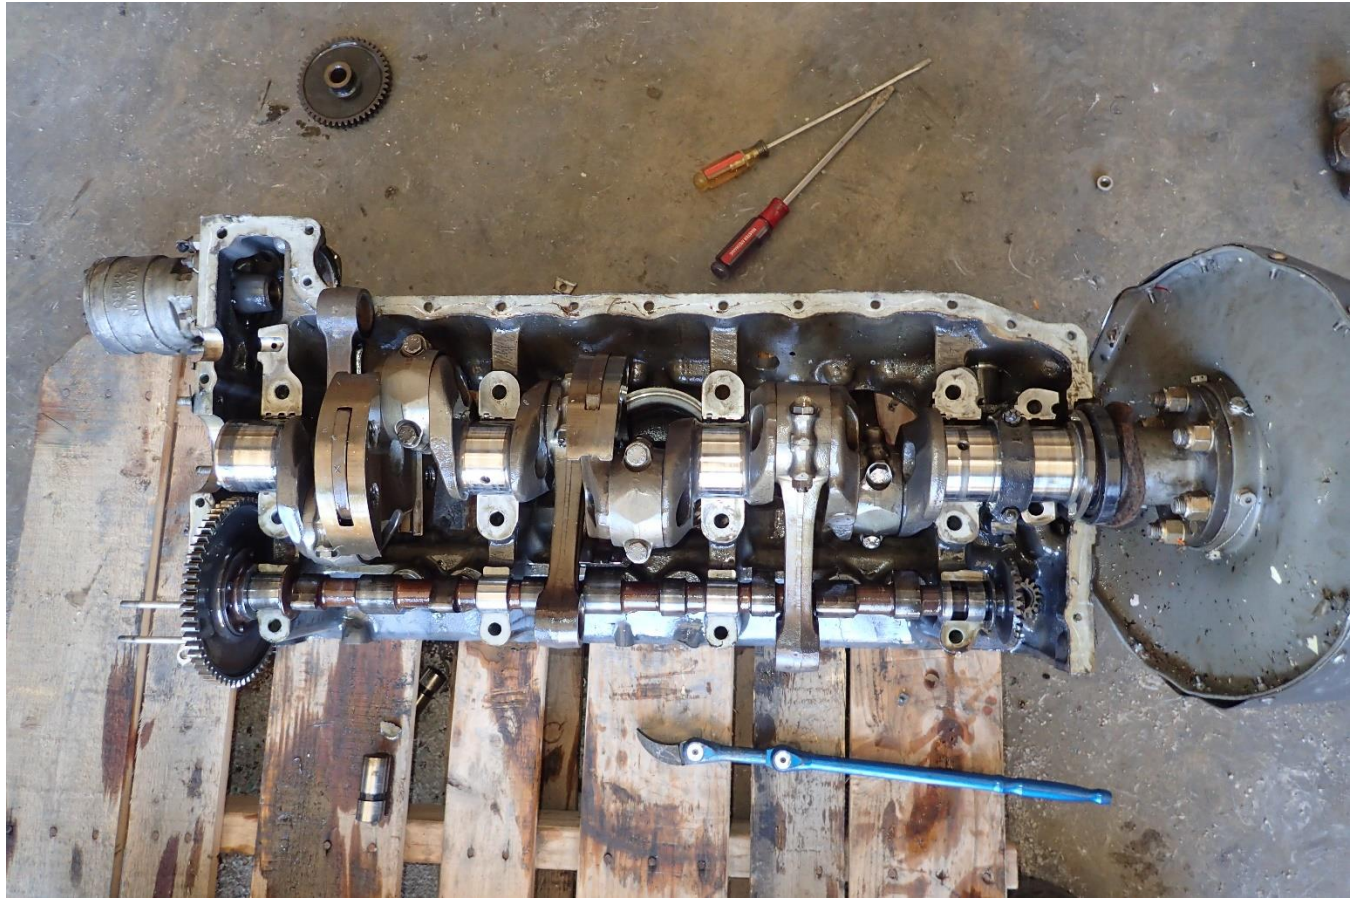
On 08-01-23 the engine was torn down by this investigator under the supervision of the NTSB IIC. The engine bearings all displayed significant wear; however, there were no anomalies noted that would have prevented normal operation. The cylinders, pistons, overhead components, and valve faces displayed normal operating and combustion signatures.

Engine After Disassembly (ASI-23-BV (234).jpg)

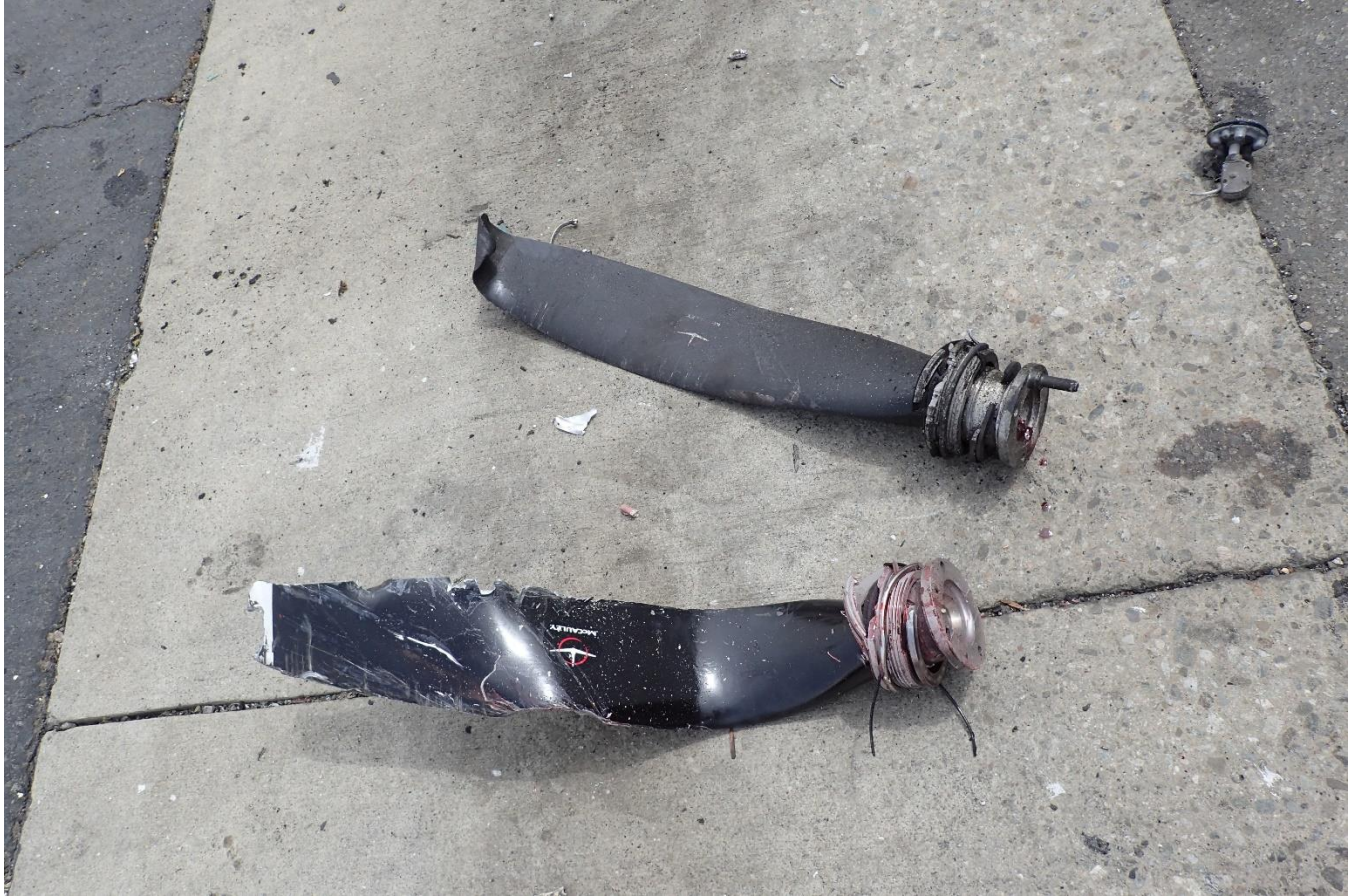
The propeller hub remained attached to the propeller flange and was fractured. Both of the propeller blades had separated from the hub and were found among the wreckage. One of the propeller blades displayed minor forward bending deformation and the tip was curled approximately 90°. The other propeller blade displayed S-bending deformation and had significant gouging on both the leading and trailing edges of the propeller blade. The blade tip had a small portion that had separated and was not located at the time of the examination. The impacted hangar door displayed several slash marks that were consistent with propeller strikes.

Propeller Blades (ASI-23-BV (138).jpg)
