# National Transportation Safety Board

WPR23FA287

## **ENGINE EXAMINATION REPORT**

Location: Upland, California  
Date: July 30, 2023  
Time: 0640 Pacific Daylight Time  
Airplane: Beech P35, N8572M

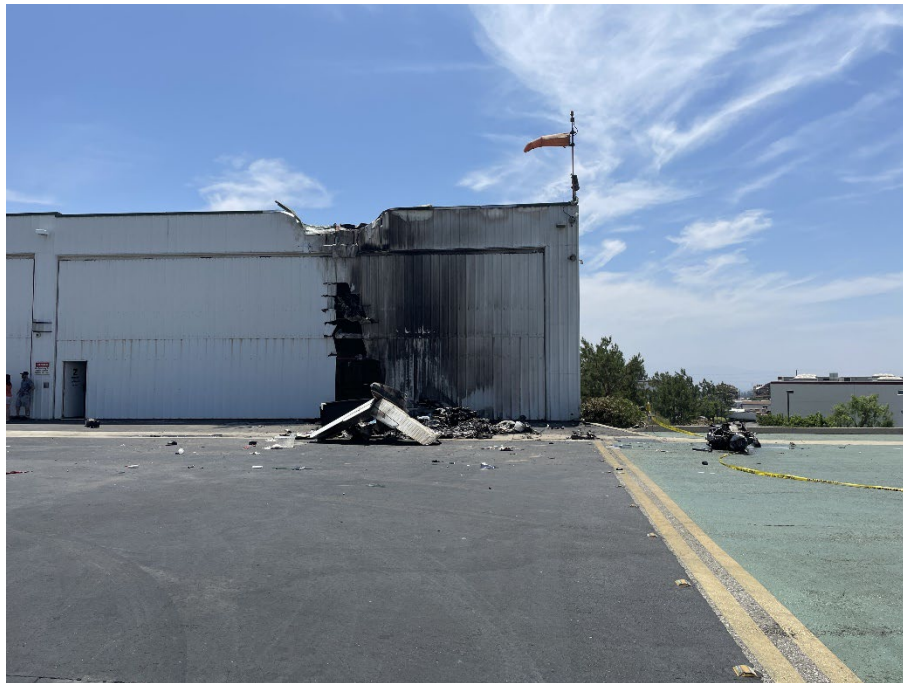
Figure 1. Accident Site Overview

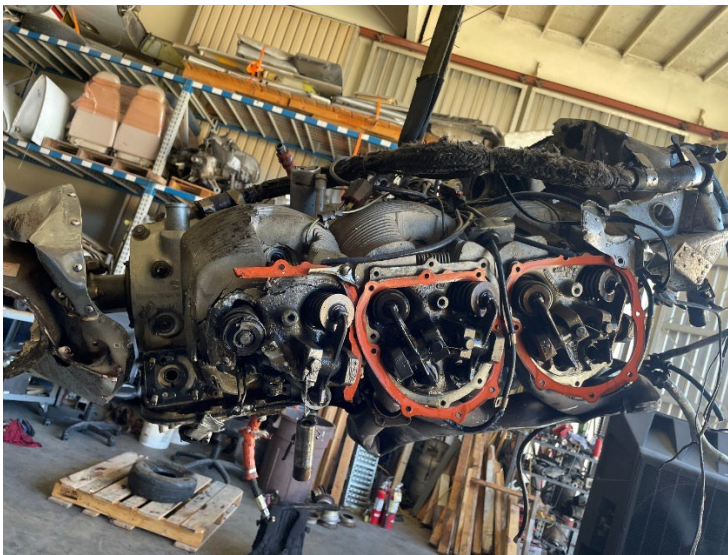
Examination of the recovered engine revealed that the engine had separated from the engine mount. All six cylinders and most engine accessories remained attached to the engine; both magnetos separated from their respective engine mounts. The oil sump pan had fractured open exposing the internal components of the engine.

Figure 2. Left Side View of the Engine

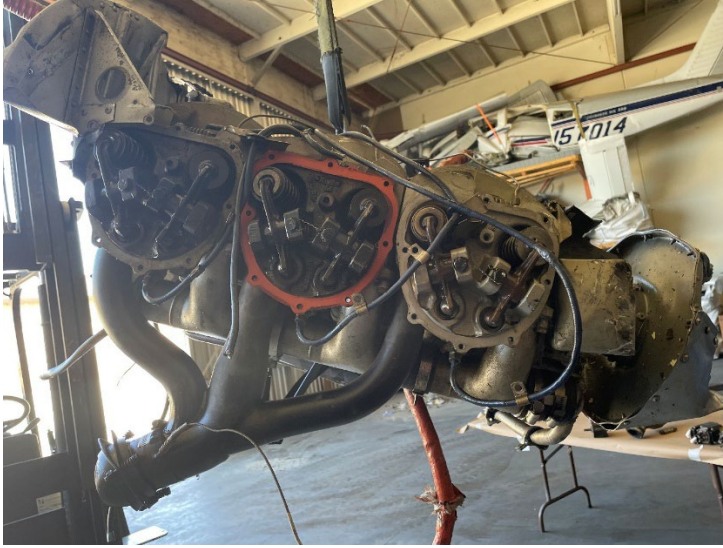
Figure 3. Right Side View of the Engine

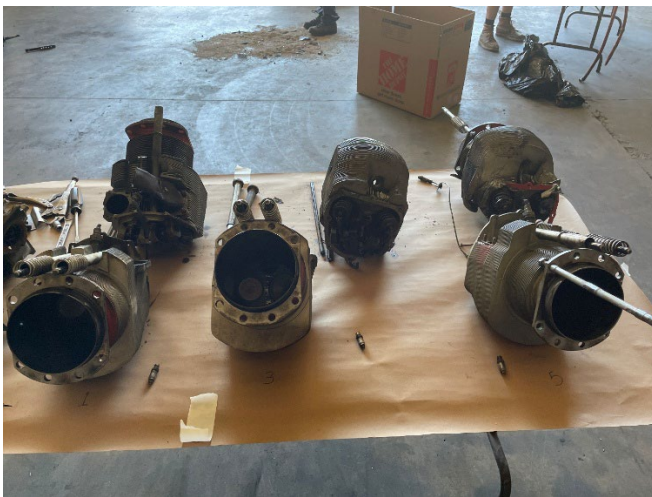
A visual inspection of the cylinders revealed that all the cylinder walls were normal in appearance. Cylinder Nos 1, 2, 3, 4, and 6 valve faces showed normal combustion signatures; the No 5 cylinder had slightly less combustion signatures but was not abnormal in appearance.

All the piston faces had uniform combustion deposits; A copper-color was observed on the sides of the pistons and was consistent with oil coaking.

Figure 4. Nos 1, 3, 5 Cylinders

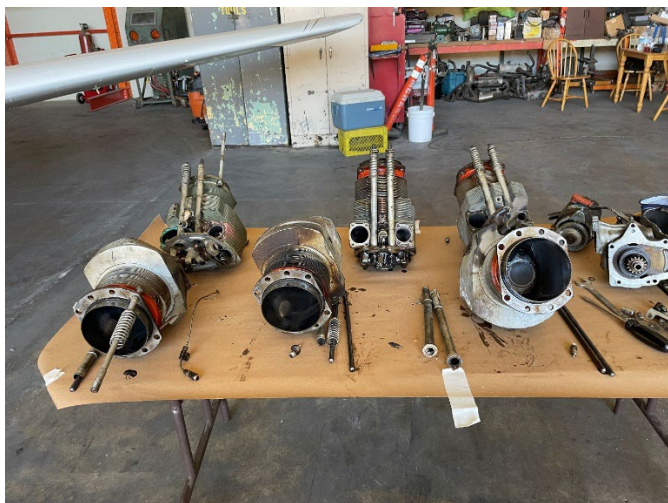
Figure 5. Nos 2, 4, 6 Cylinders

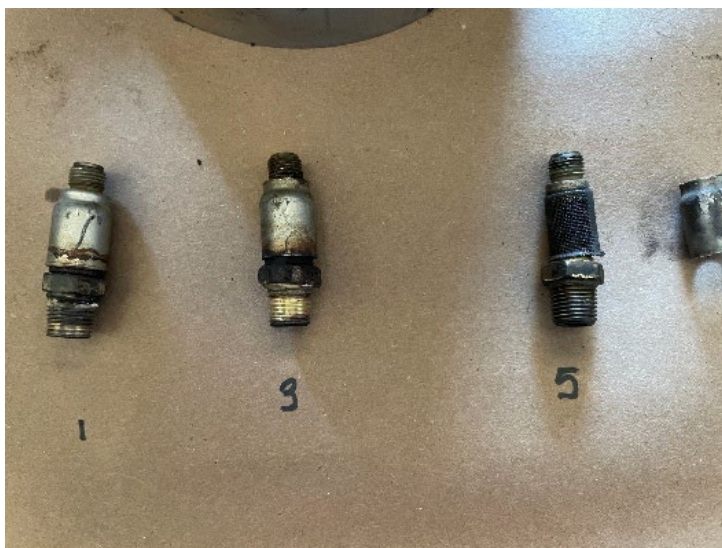
Fuel injector nozzles were removed, Nos 1, 2, 3, 4, and 6 were clear of debris. The No 5 fuel injector nozzle had sustained impact damage and was bent.

Figure 6. Fuel Injector Nozzles Nos 1, 3, 5

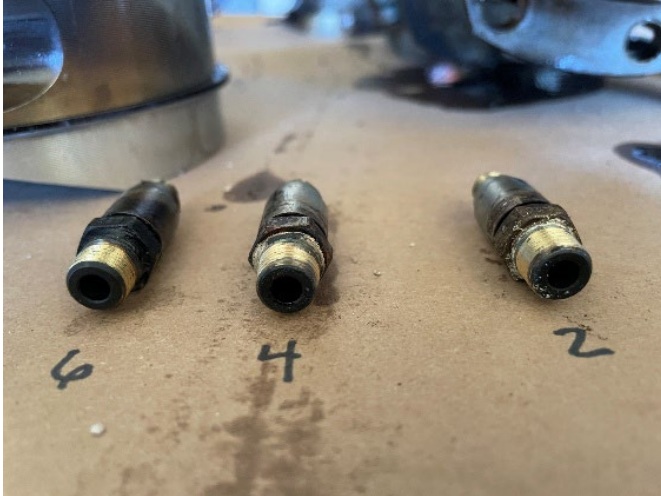
Figure 7. Fuel Injector Nozzles Nos 2, 4, 6

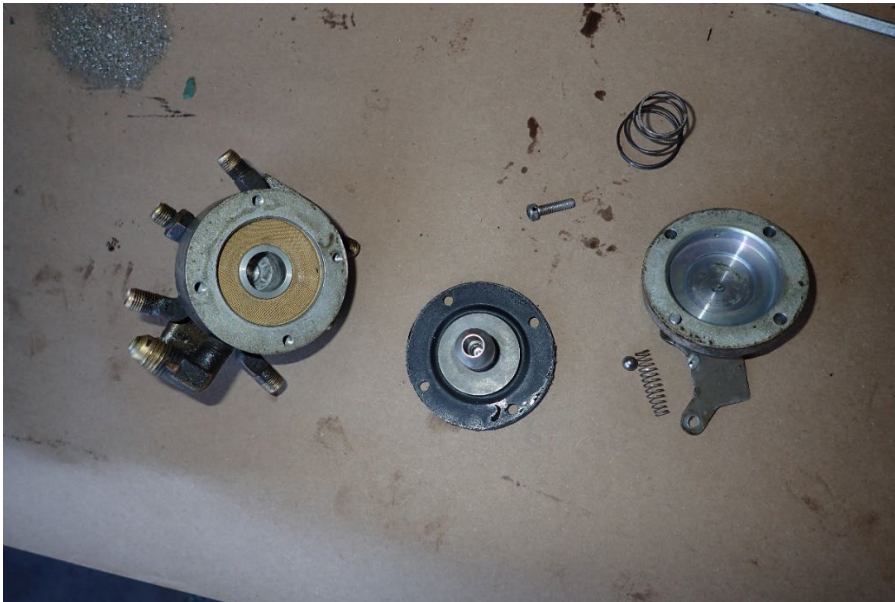
The fuel flow manifold valve was intact, undamaged, removed and disassembled. The screen was clear and free of debris. The spring and diaphragm were intact and undamaged.

Figure 8. Fuel Metering Assembly (Photo Courtesy of Textron Aviation)

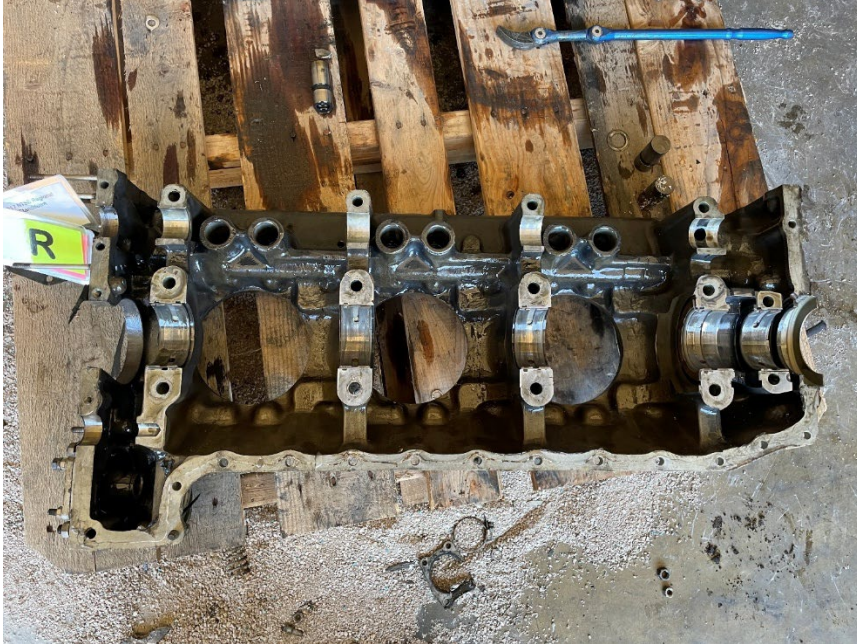
The engine case was further disassembled to access the crankshaft, camshaft, and rotating mass. A visual examination of the main bearings revealed that they were worn and pitted. The No 5 main bearing support on the right side was cracked. No determination could be made as to why the engine would not rotate - likely the cracked No 5 main bearing.

Figure 9. Right Side of Engine Case

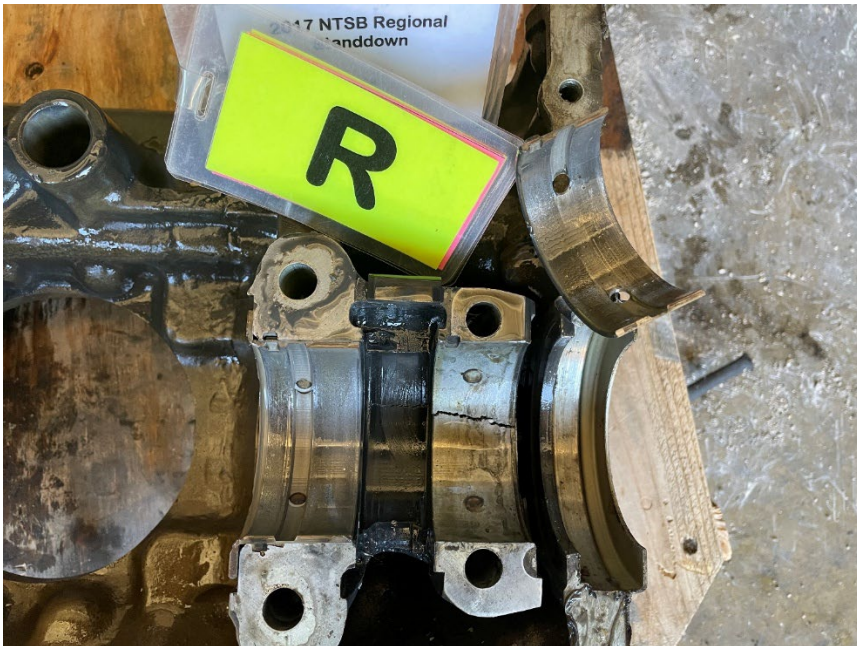
Figure 10. Broken Main Bearing

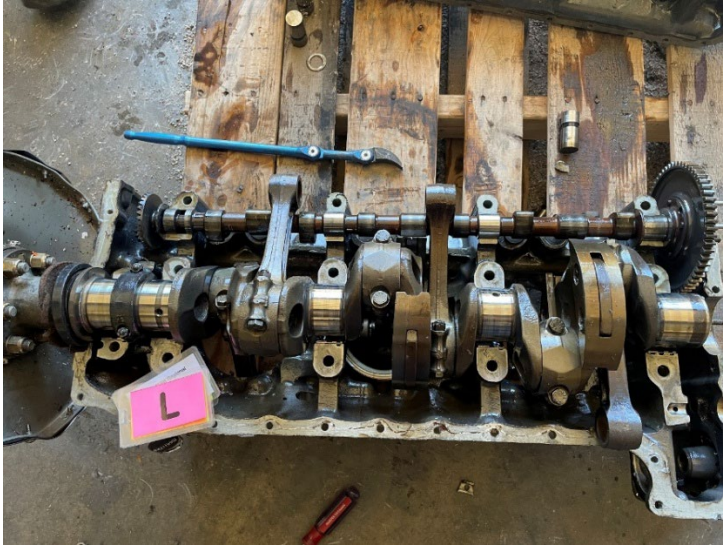
Figure 11. Left Side of Engine Case with Crankshaft and Camshaft

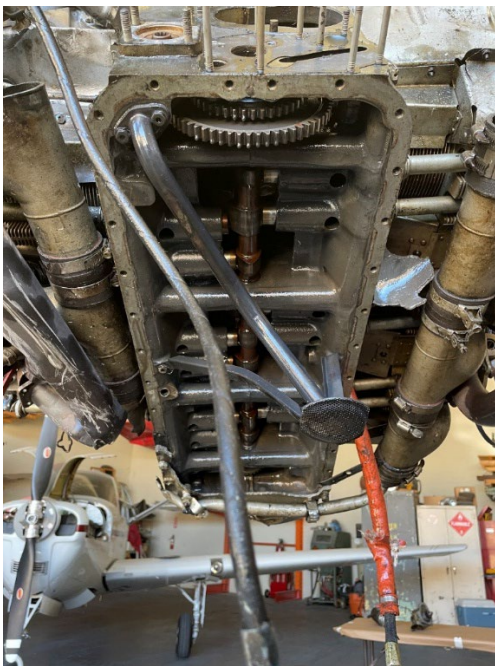
Figure 12. Bottom View of Engine
