# National Transportation Safety Board

WPR23FA287

## **ACCIDENT SITE REPORT**

Location: Upland, California  
Date: July 30, 2023  
Time: 0640 Pacific Daylight Time  
Airplane: Beech P35, N8572M

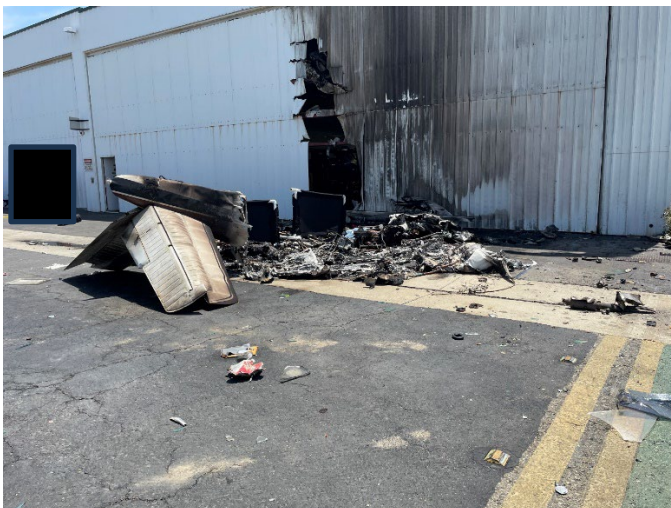
Photo 1 - View of Main Wreckage

On July 30, 2023, at 0640 Pacific Daylight Time, a Beech P35, N8572M, was destroyed in a postcrash fire when it was involved in an accident near Upland, California. The pilot and two passengers were fatally injured. The airplane was operated as a Title 14 *Federal Aviation Regulations Part 91* personal flight.

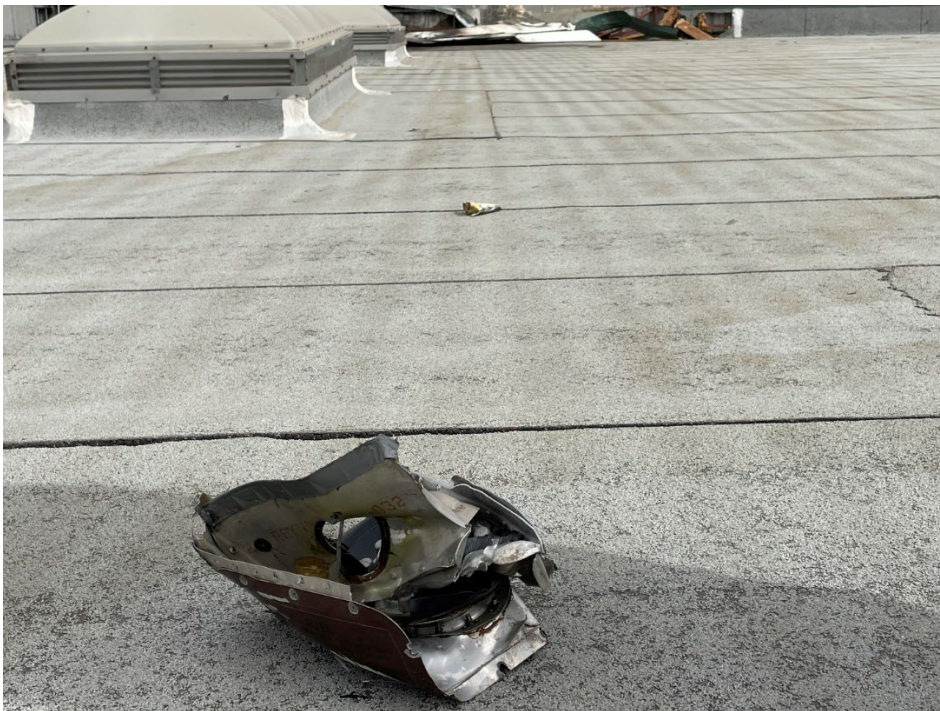
The left wing was found upright on the hangar rooftop near the windsock. The fuel cap assembly was the furthest piece outside also on the hangar rooftop, about 80 ft south of the left wing.

Photo 2 - Rooftop with Fuel Cap Assembly and Left Wing in Background

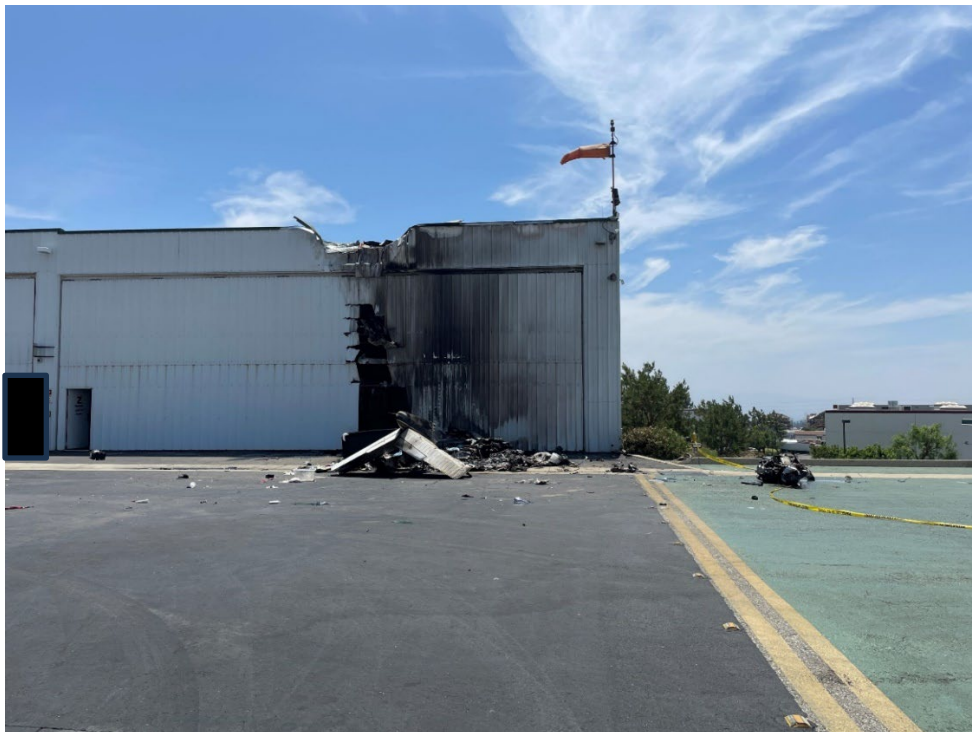
Photo 3 - View of Main Wreckage

The remainder of the airplane came to rest at the base of the hangar on the ramp and was thermally destroyed in the postcrash fire. The right wing with its landing gear separated from the fuselage and came to rest inverted with the wing tip bent adjacent to the hangar door.

The fuselage was thermally destroyed exposing all the flight control cables. All flight control cable separations were consistent with tension overload. Flight control continuity was established from the cockpit to all flight control surfaces.

The tail section was inverted and had thermally separated from the fuselage. The elevator trim actuator was measured and found to be in the neutral position.

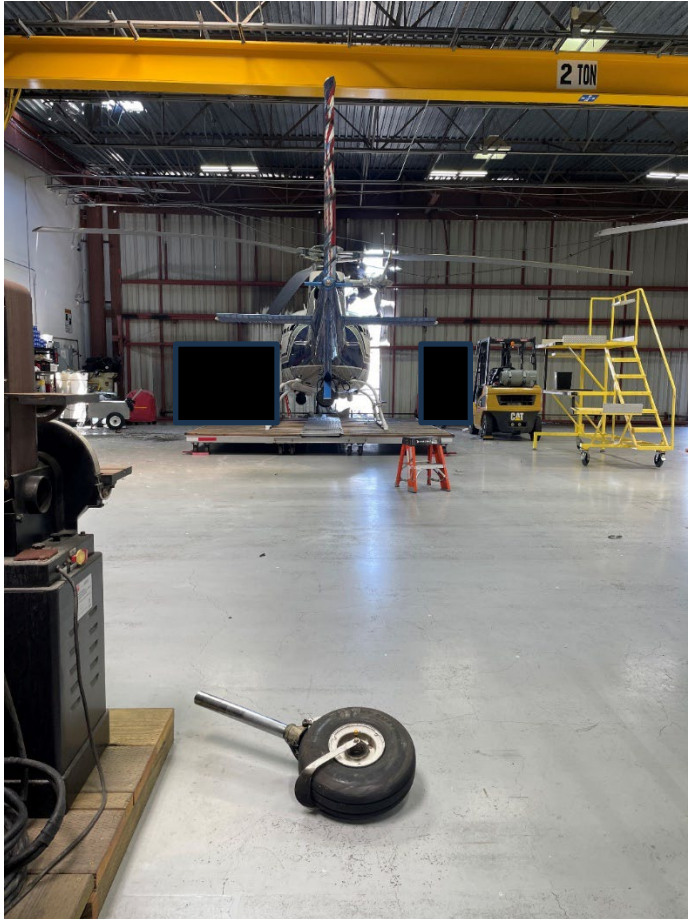
The nose strut with wheel assembly separated and was located inside the hangar. It was about 60 ft behind the helicopter.

Photo 4 - Nose Wheel Strut and Wheel Assembly Inside the Hangar

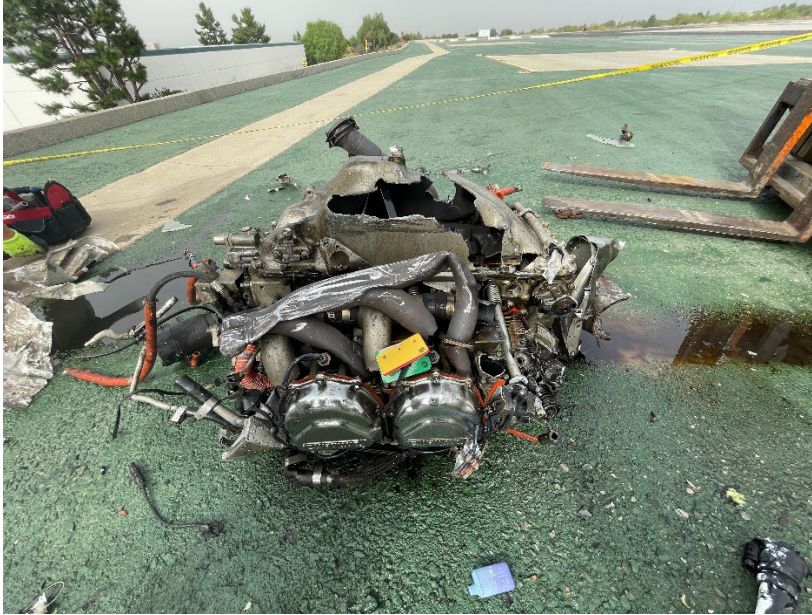
Photograph 5 - View of Engine

The engine separated from the engine mounts and came to rest inverted about 20 ft northwest of the main wreckage. The oil sump was broken exposing the interior of the engine case. The oil sump was removed; the camshaft and crankshaft were intact, and the connecting rods all appeared to be intact. The Nos 5 and 6 cylinders sustained impact damage as did the front of the engine/nose-propeller hub assembly.

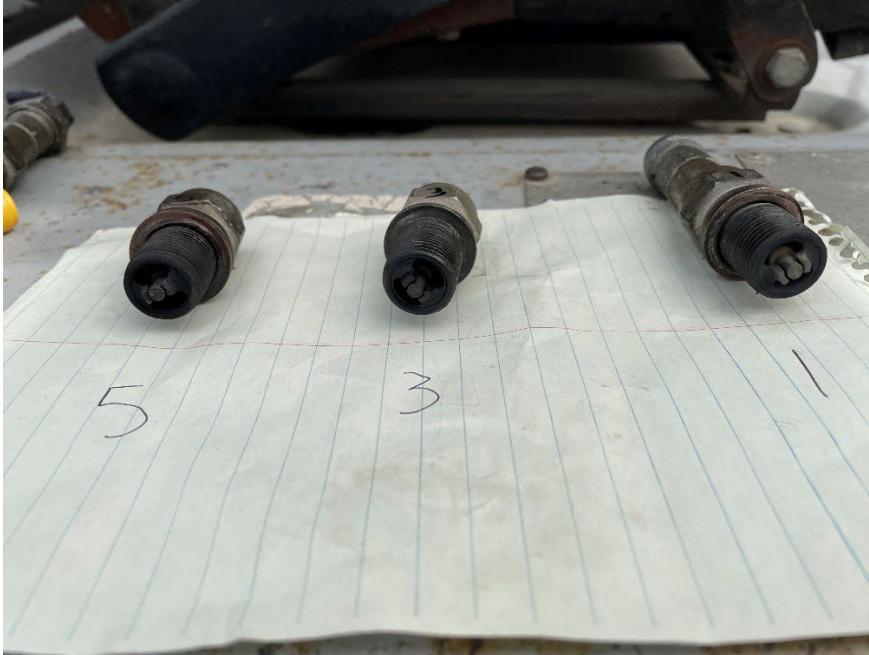
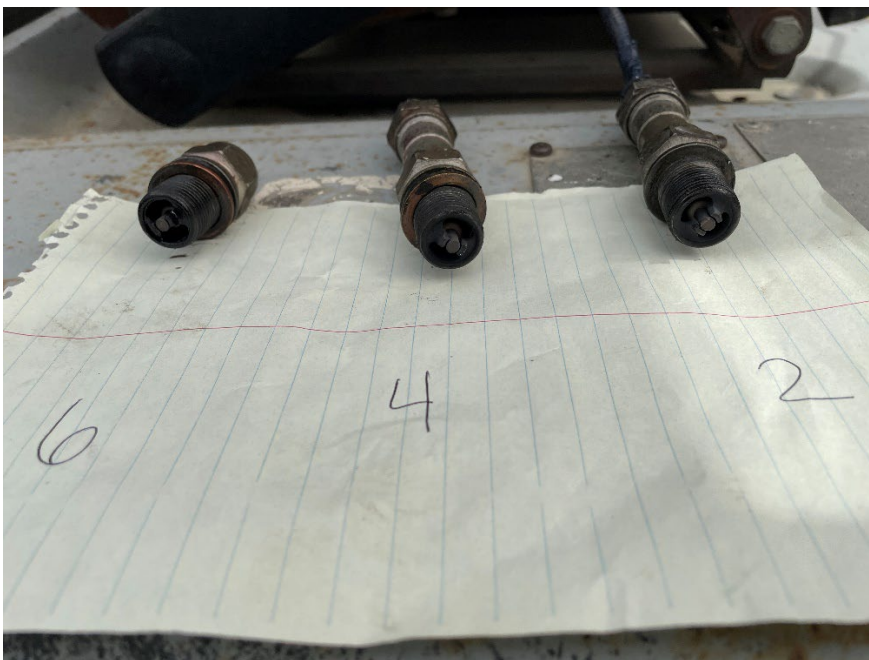
The top spark plugs were removed. They were sooted and appeared to show normal wear and operating signatures when compared to the Champion Aviation Check-A- Plug AV-27 chart. The magnetos separated from their respective mounting pads. The ignition leads were damaged but remained attached to the magnetos.

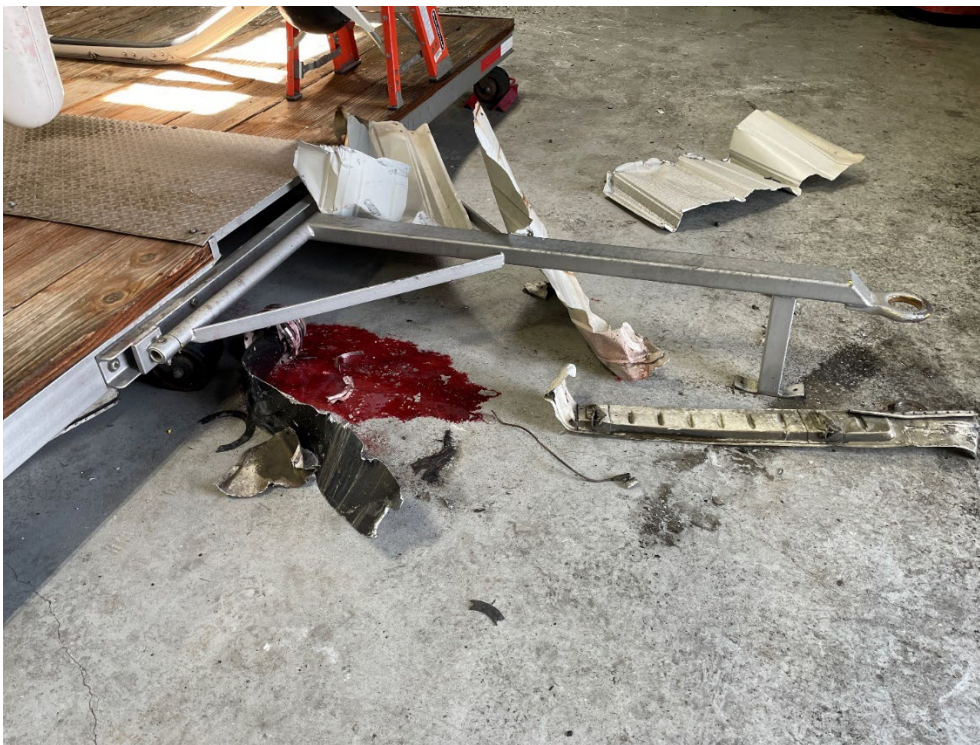
One propeller blade was located inside the hangar on the floor at foot of a movable helicopter platform. The propeller blade had leading and trailing edge nicks and gouges, chordwise scratching, and S-bending.

Photograph 9 - Propeller Blade inside Hangar

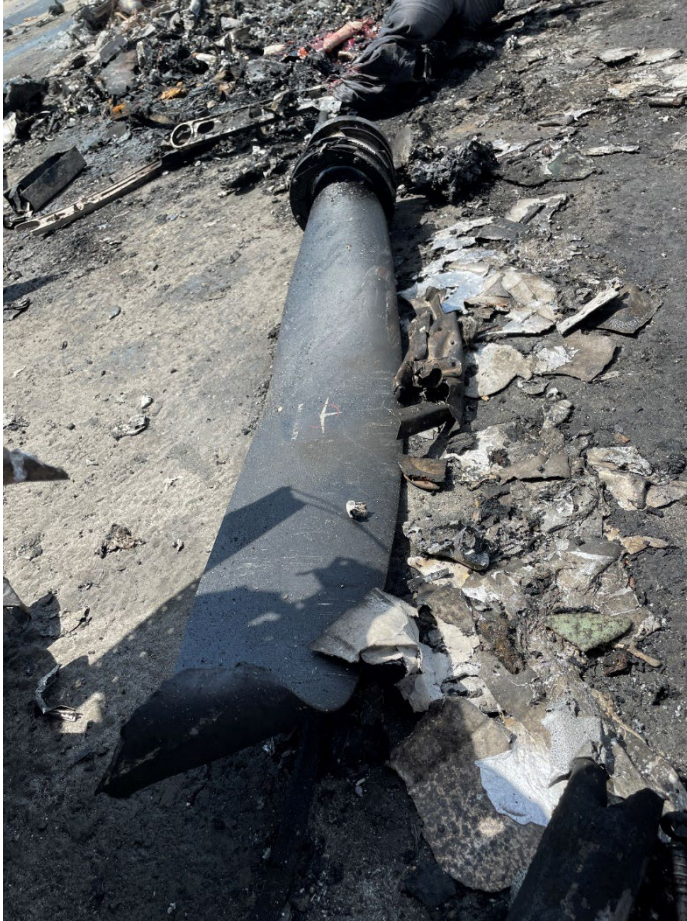
The other propeller blade was in the main wreckage and had sustained fire damage. Leading edge nicks and gouges were identified, and the blade was curled at the tip.

Photograph 10 - Propeller Blade in Main Wreckage

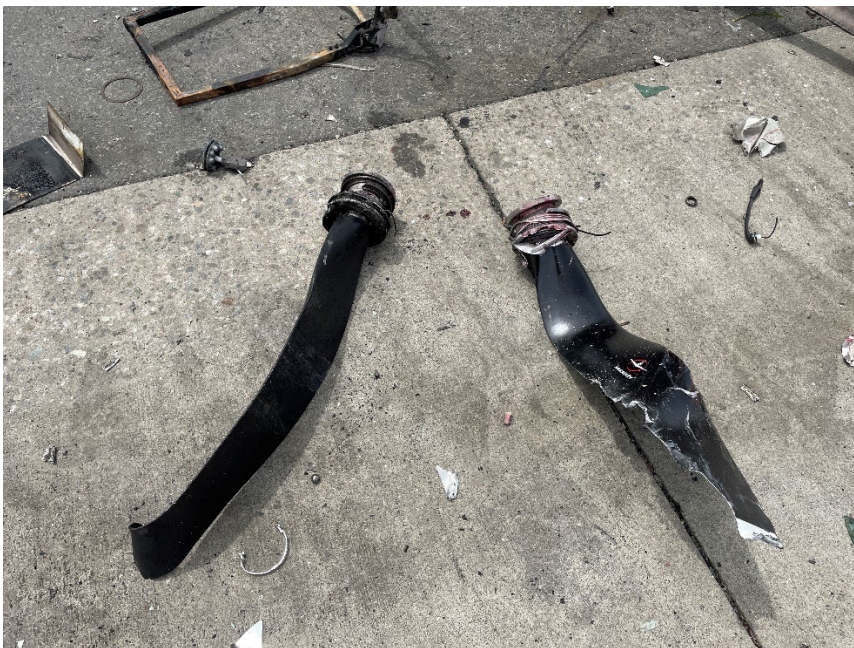
Photograph 11 - Propeller Blades

The airplane was equipped with a two-bladed McCauley propeller. The propeller hub was broken, with a portion of it remaining attached to the crankshaft. Another portion of the propeller hub along with portions of the firewall, engine mount and nose landing gear were embedded in the hangar door. Both propeller blades separated from the propeller hub.
