# National Transportation Safety Board

WPR23FA299

## INVESTIGATION MATERIALS SUPPLEMENT

Location: Van Nuys, California  
Date: 08/02/2023  
Time: 1036 Pacific daylight time  
Airplane: Czech Sportcruiser

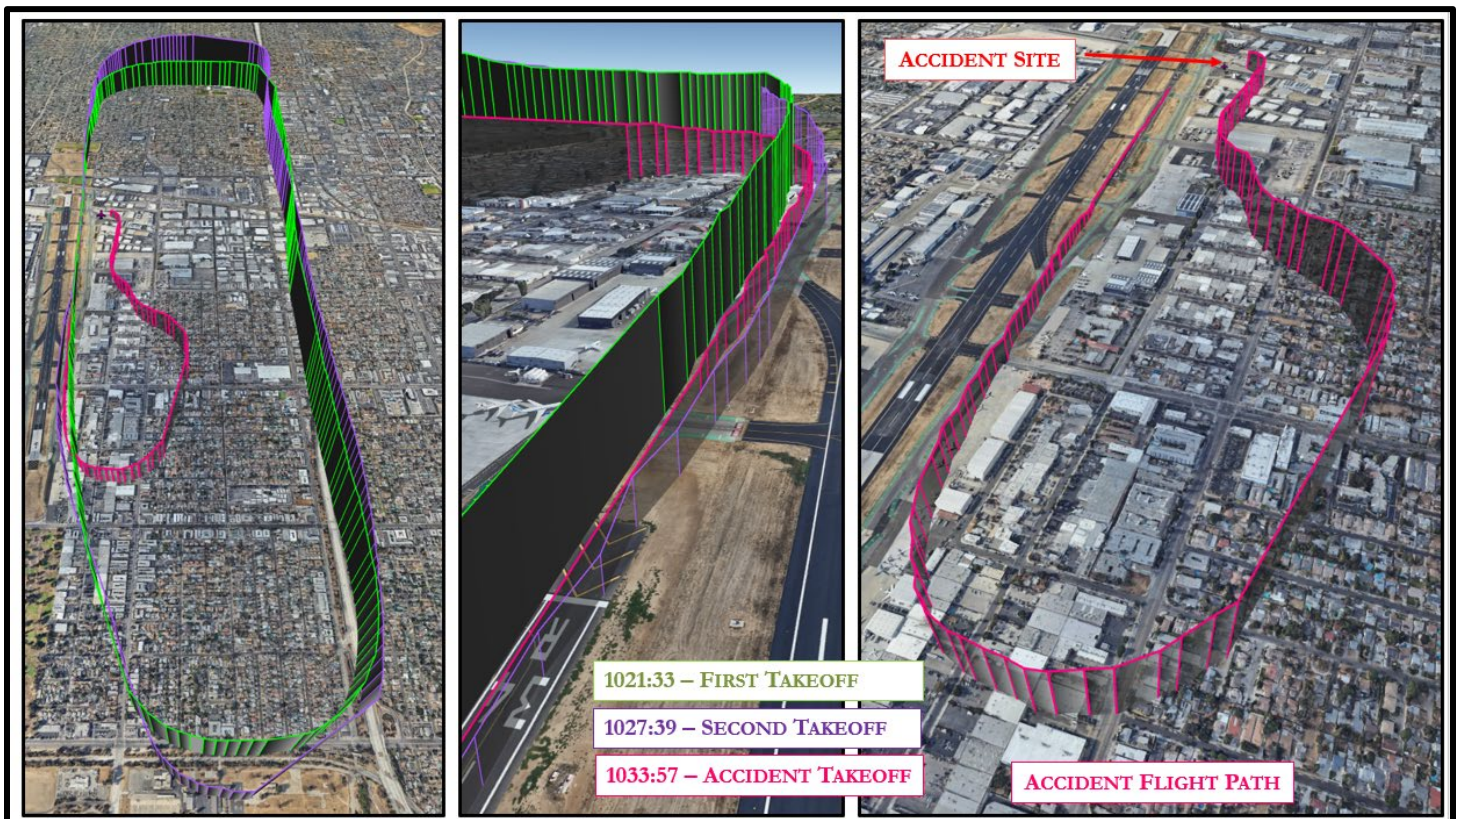
Figure 1: Flight Path

A review of Automatic Dependent Surveillance – Broadcast (ADS-B) flight tracking data revealed that the airplane departed runway 16L about 1021:33. The airplane made a left traffic pattern and performed a touch-and-go practice takeoff and landing at 1027:39. The airplane made another left traffic pattern following a similar flight path as the first path (see Figure 1 below). The airplane touched down about 1033:57 and then became airborne about 1,700 feet down the runway, in nearly place as the previous takeoff. Thereafter there is a gap in data for about 14 seconds and the next hit reappears at taxiway “K,” with a groundspeed reduction from 60 to 50 kts. The flight path continues at that speed and the altitude slowly increases.

At 1035:09 the airplane turns left onto the crosswind leg of the traffic pattern at an altitude of about 315 feet above ground level (agl). The airplane then turns onto the downwind leg and there is a 15 second gap in data, and the hit reappears at 1035:42. At that point, the airplane shows a speed of 71 kts at an altitude of 430 feet agl, the highest the airplane reaches during this segment of the flight. The airplane turned left toward the airport and the altitude continued to decrease. When reaching about 830 feet from runway, at about 1036:12, the airplane banked slightly right to align parallel the runway. About 22 seconds later, when the airplane was abeam the runway numbers 16L, it was at an airspeed of about 55 kts and banked left while at an altitude about 195 feet agl. The last hit was at 1036:39 and located 255 feet east-northeast of the accident site; it showed an altitude of 170 feet agl.

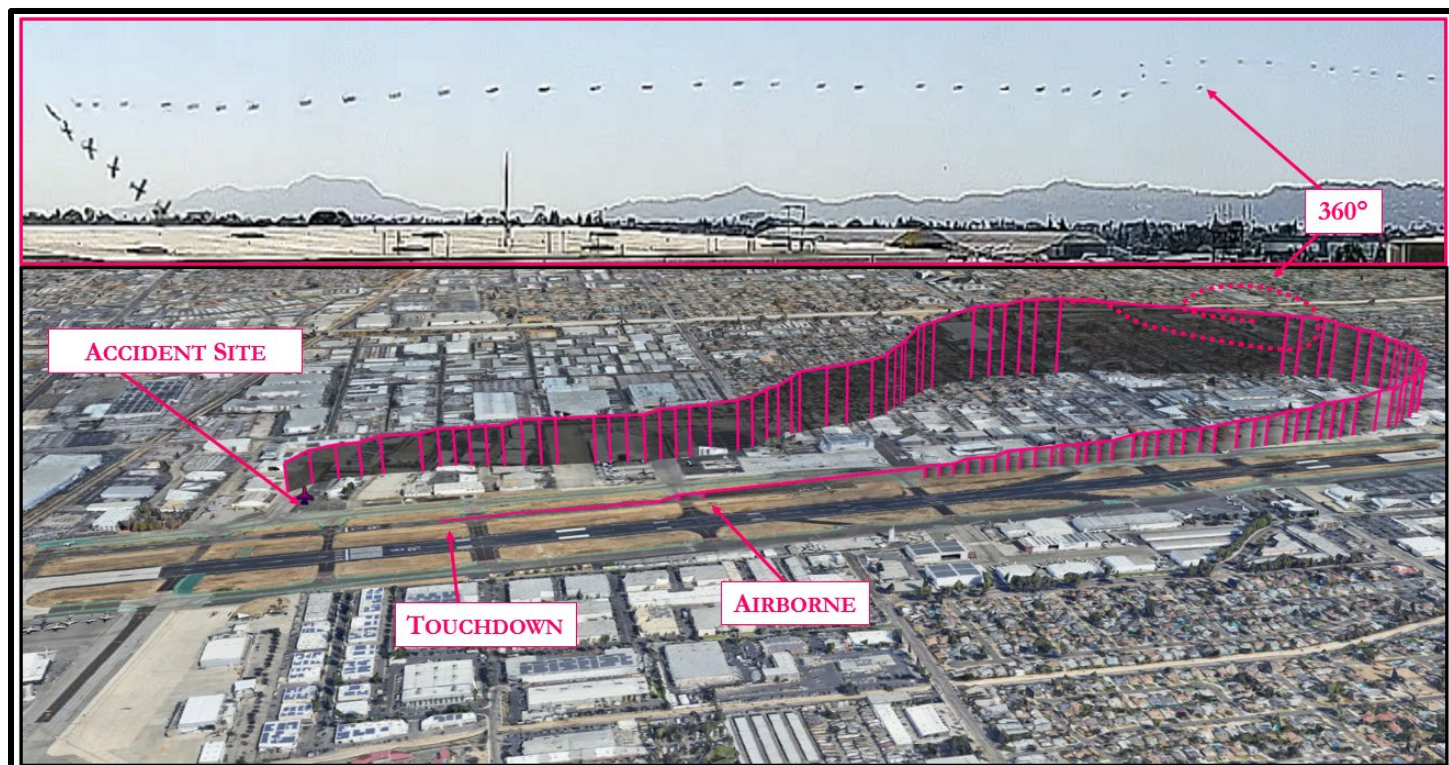
*Figure 2: Flight Path and Composite of Video*

Numerous security cameras captured the airplane prior to impact. A review of the footage revealed that the footage revealed that after the airplane turned onto the downwind leg of the traffic pattern for runway 16L, it continued on a level altitude for about 10 seconds. At approximately 1135:42 the airplane made a 360° turn

during which the altitude fluctuated, climbing at the end. The airplane then monetarily flew toward the runway, dipping in altitude, and continued on to parallel the runway. At 1036:35 the airplane banked to the left which continued to get steeper and the nose dropped lower as the turn steepened. The airplane impacted in a near vertical attitude.

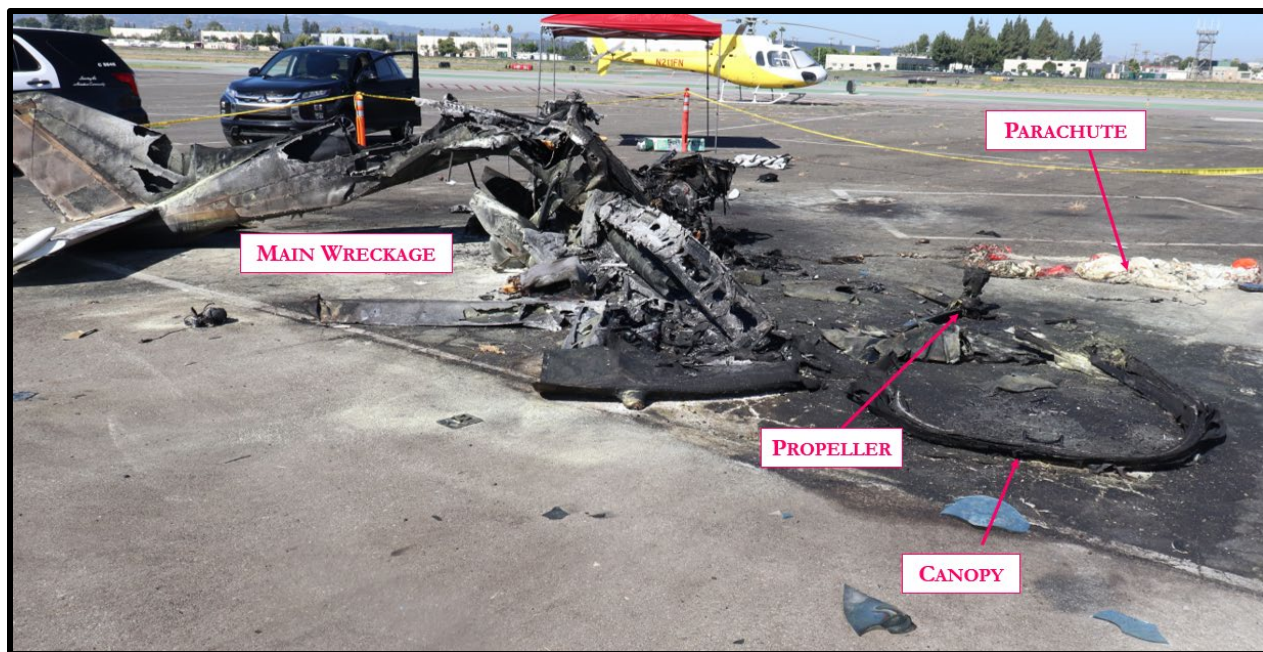
Figure 12: Main Wreckage

The wreckage was consumed by fire. The wings and tail remained attached. The propeller was in front of the wreckage and there was a divot in the concrete pad consist with that being the first impact. The fuselage body was bent down at the empennage (adjacent to the step) with the tail resting on the surface. One propeller blade came loose from the hub and had light scratches on the leading edge. The other two remained attached. The rocket had been deployed and was found ahead of the wreckage.

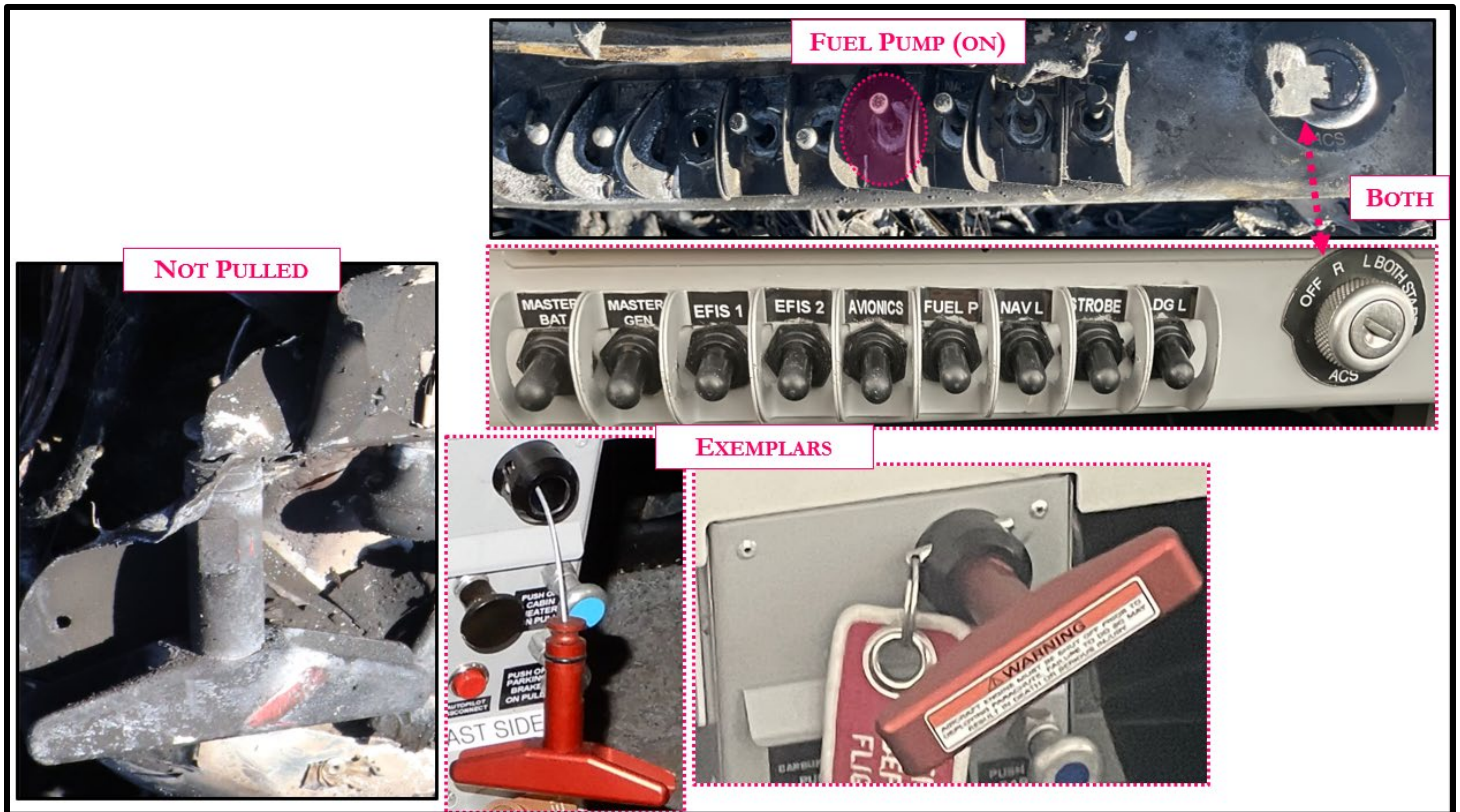
Figure 14: Cockpit Parachute Handle and Fuel Pump Switch

The fuel pump was on.

The throttle was in the full forward “max” position.

The BRS handle base was in the housing.

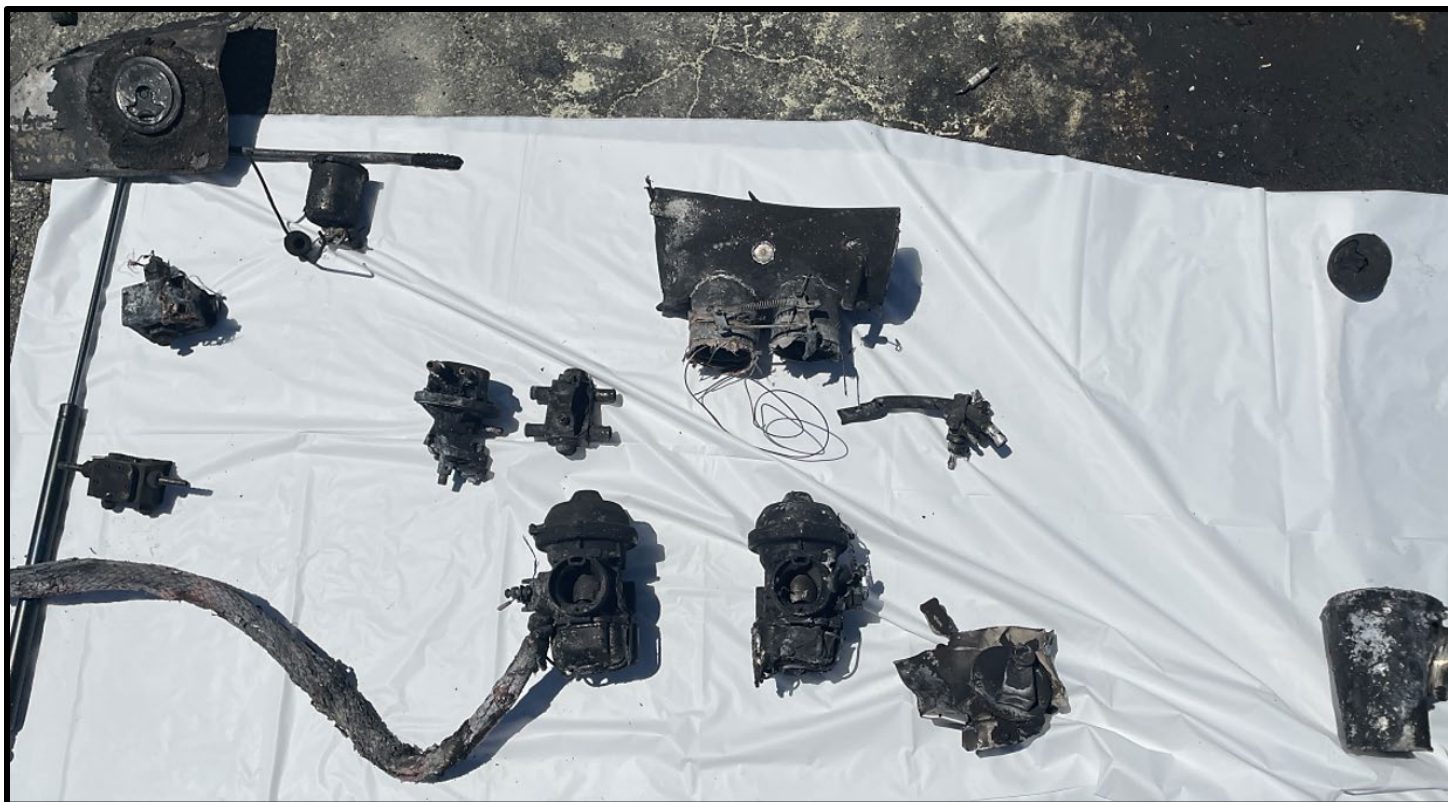
Figure 15: Fuel System Components

The fuel tanks were consumed by fire. The ports on the fuel tanks were visible and the fuel caps remained affixed in their respective filler-necks. There were partially burned fuel lines to the fuel selector. The fuel selector was positioned on the “LEFT” selection. The fuel selector was free to rotate and there was no evidence of mechanical malfunction. The bottom part of the gascolator was located and the burned electric fuel pump. The fuel pump had melted debris in the orifice going through the pump. The transducer was located and the orifice appeared free of debris. The plastic rotor could not be heard moving when air was blown through the inlet, presumably because it had melted.

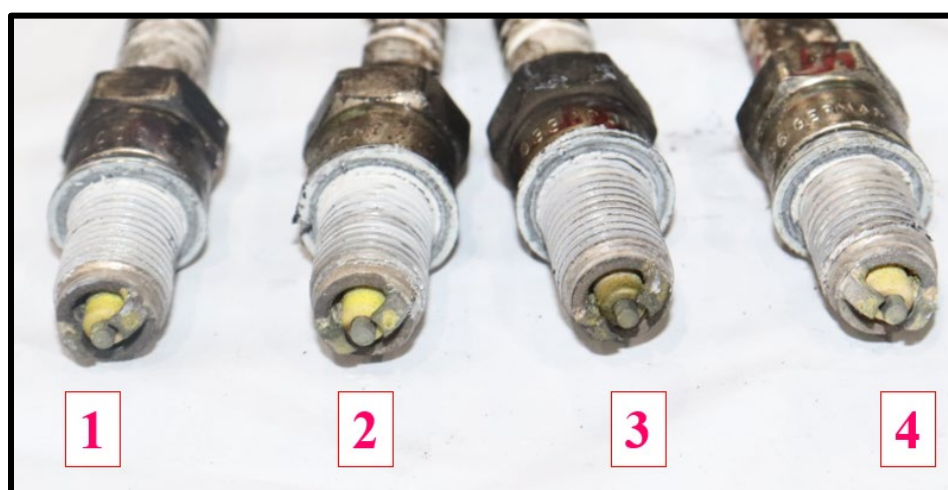
Figure 16: Upper Spark Plugs

Investigators removed and examined the top spark plugs. The spark plug electrodes in normal condition and all appeared similar in shape. The color of the ceramic was yellow, with the Nos. 3 appearing darker than the others. The threads were white.

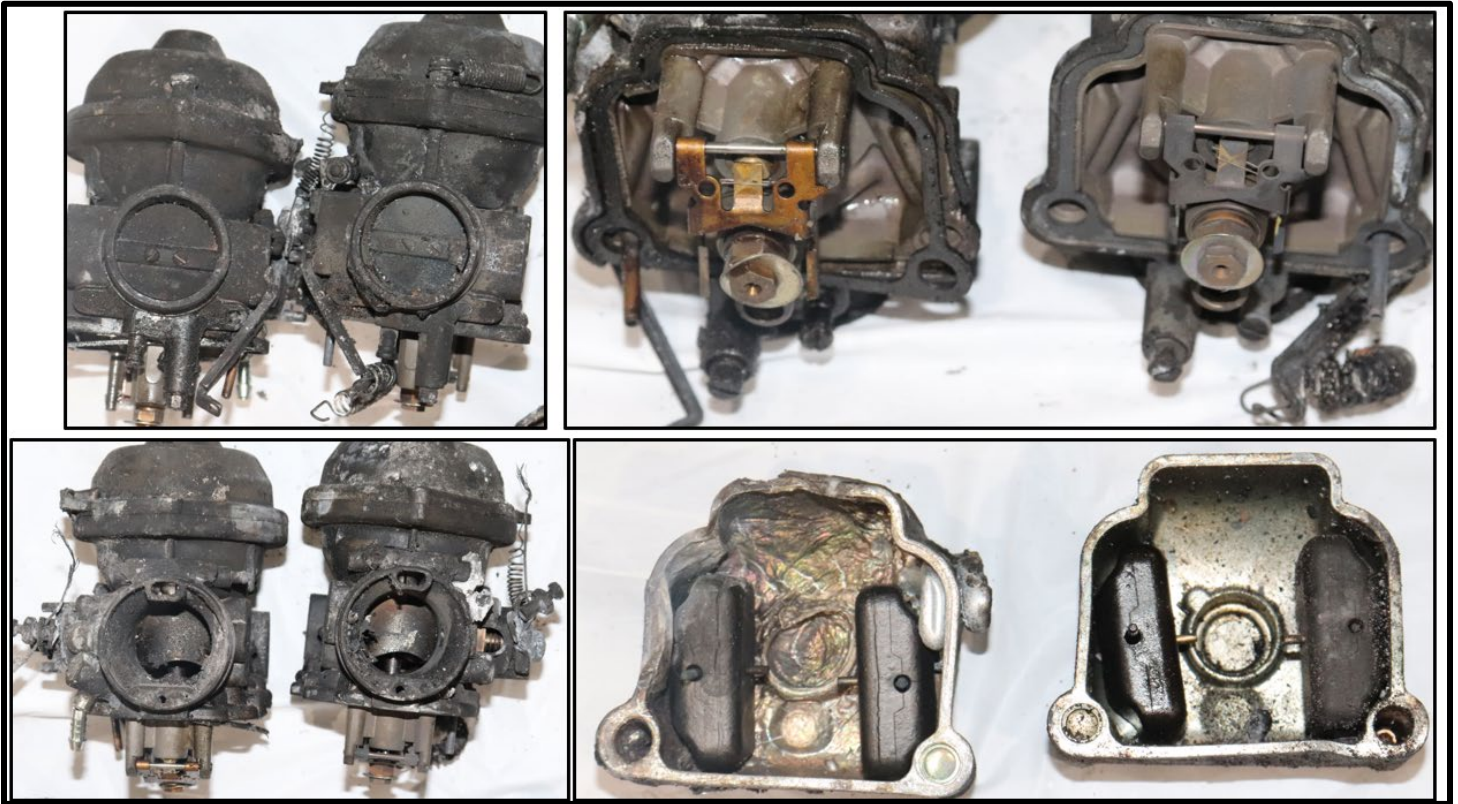
Figure 18: Carburetors

The No. 1/3 carburetor was found with its piston slide misaligned when viewed through the venturi. The half-moon curve at the bottom of the slide was not aligned with the bore of the carburetor.

The No. 2/4 carburetor piston slide was more misalignment than the No. 1/3 when viewed through the venturi. After removal of the carburetor top, the piston slide was extracted. The diaphragm had been consumed in the post-impact fire, preventing confirmation of proper alignment between the index tabs and housing slots. A Rotax representative stated that this type of misalignment likely would have affected engine performance. The main jet was unobstructed.

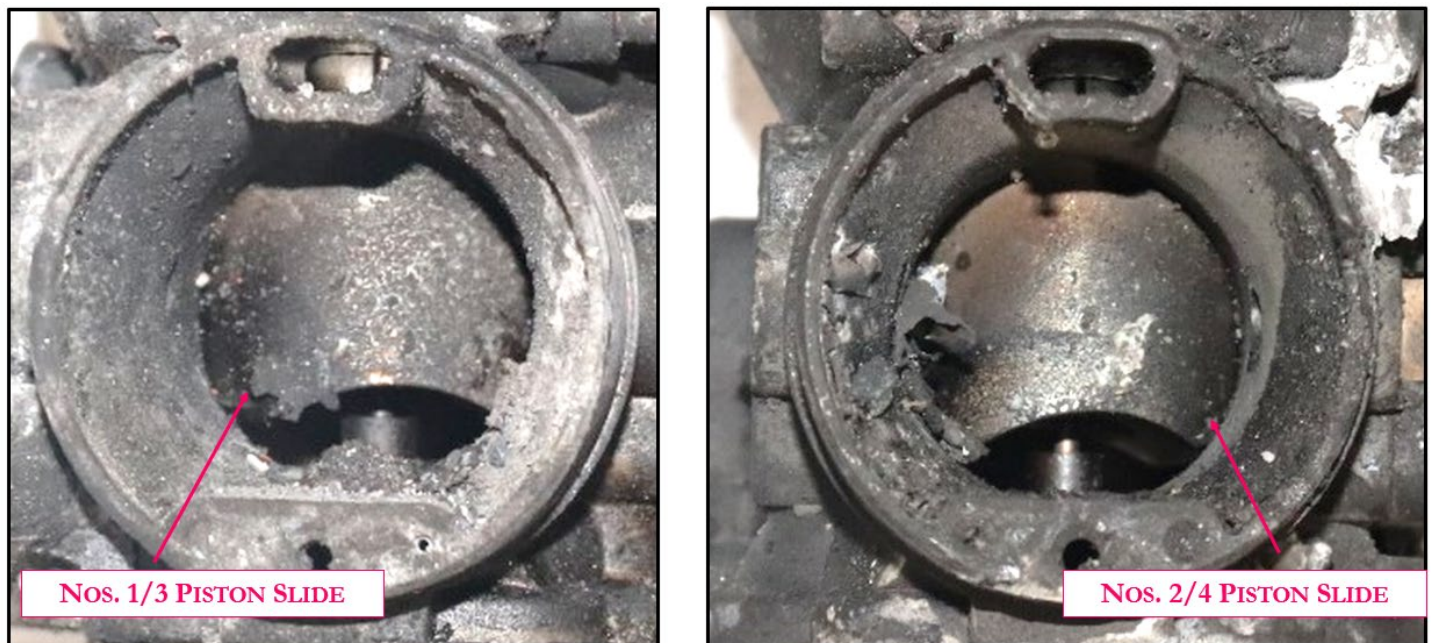
Figure 19: Carburetor Piston Slides

The carburetor top was removed, and the piston slide was extracted from the housing. The diaphragm's index tabs were not aligned with the corresponding slots in the carburetor top, indicating an incorrect assembly. According to a Rotax representative, this misalignment is known to cause vibrations (rough running engine), high magneto drops, and would likely affect the overall performance of the engine. The main jet was unobstructed.
