# National Transportation Safety Board

WPR23FA301

## **AIRFRAME AND ENGINE EXAM REPORT**

Location: Idaho City, Idaho  
Date: August 4, 2023  
Time: 10:10  
Airplane: N617G, Glastar with Superior engine.

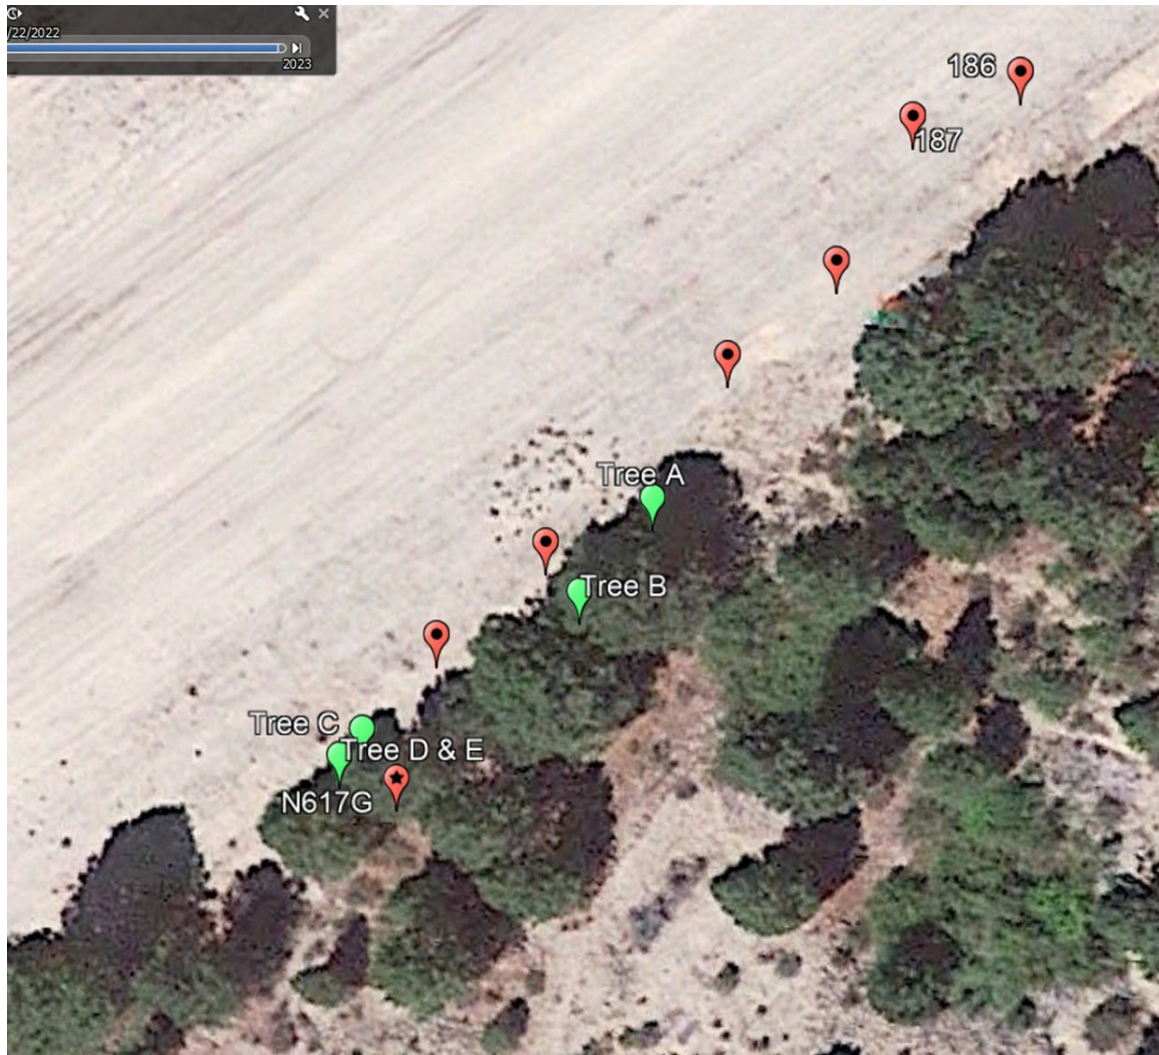
southeastern border of the runway edge. The edge was lined with tall pine trees of about 40 to 50 ft in height. Five trees, identified as tree A, B, C, D, and E, exhibited evidence of recent contact. Tree A and B exhibited small, low hanging branches broken off and deposited at the tree base. Tree C exhibited a large gouge about ten ft above ground level (agl). Tree D and E were located about three ft apart and each exhibited large impact marks and loss of bark about 8 ft agl. Tree E exhibited a deep chop mark, consistent with a cut from a sharp object. The gouges in trees C, D, and E were indicative of a left wing high, right wing low impact. See figure 1 and 2.

**Figure 1. Google Earth image of the accident location and the tree locations.**

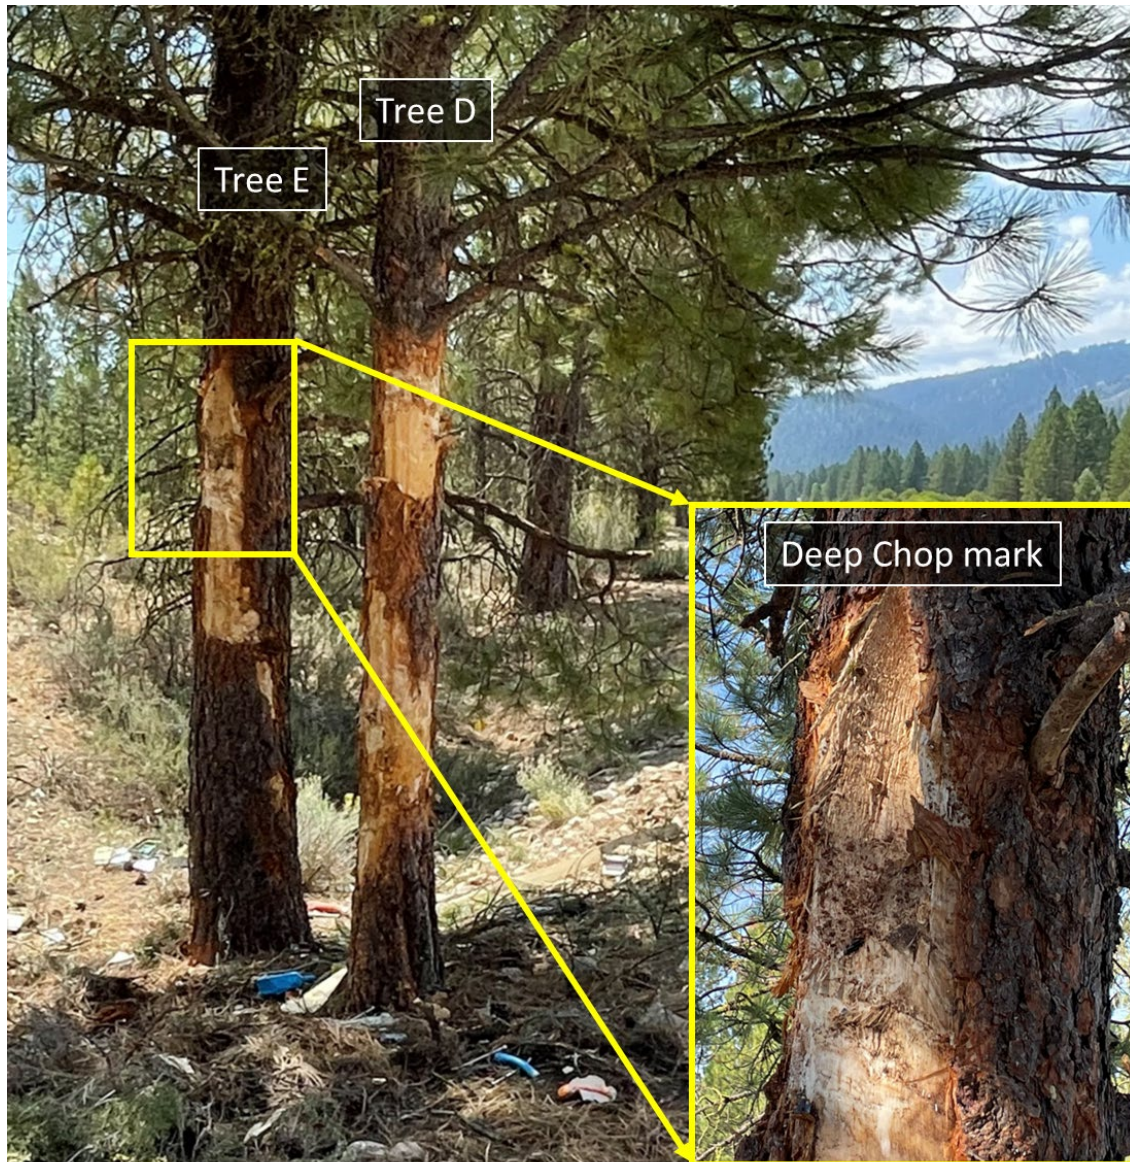
**Figure 2. Tree D and E, showing gouges and chop marks.**

The fuselage came to rest near tree D and E. The fuselage exhibited an impact fracture near the right door that extended to the empennage with the two-part composite fuselage separating at the longitudinal seam. Tree D was located at the end of the separation. This damage is consistent with tree D entering the fuselage as the airplane entered the tree line and splitting the fuselage along the longitudinal seam.

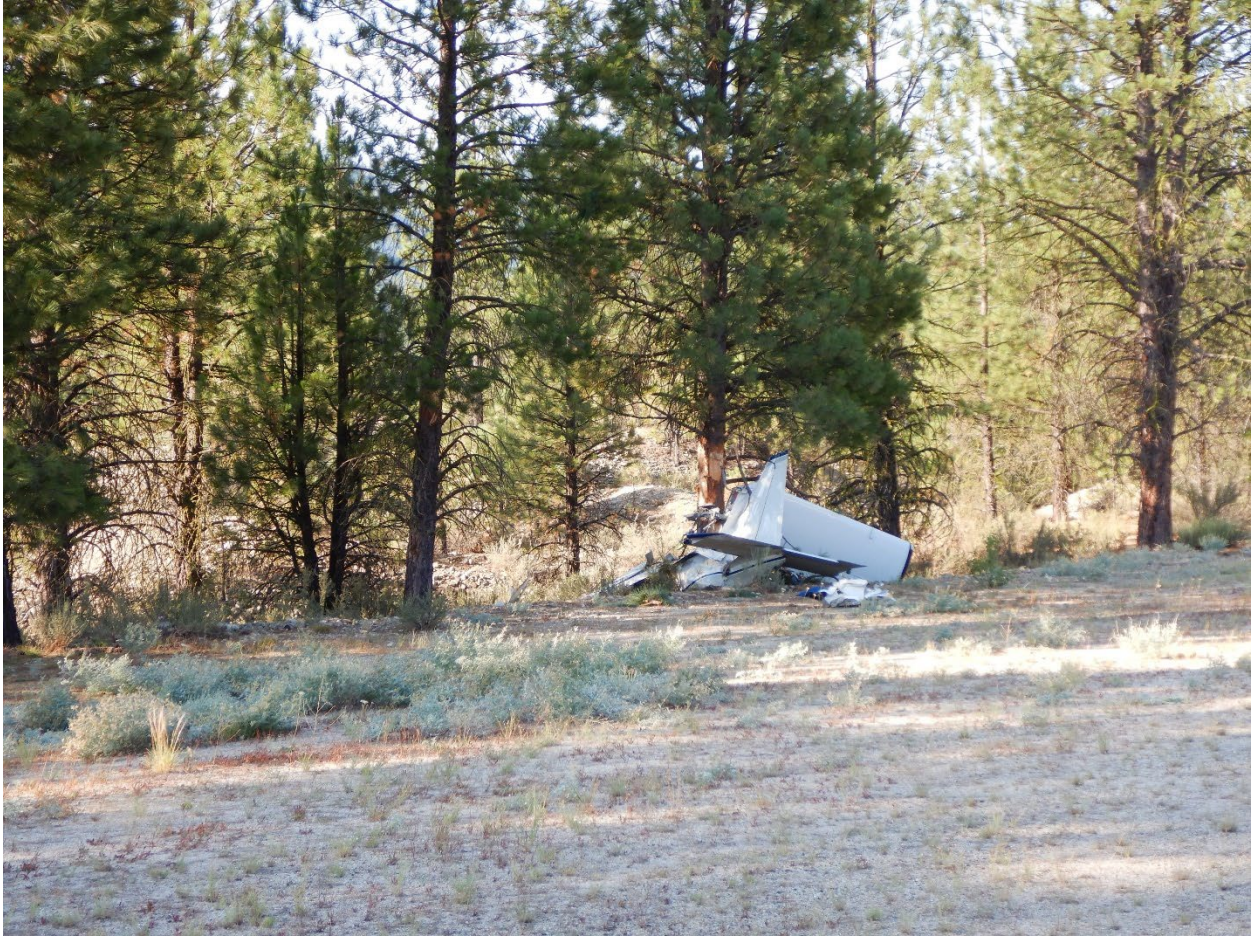
The airplane came to rest, upright, about 100 ft southeast of the centerline of the gravel runway, on a magnetic heading of about 144° and an elevation of 3,890 ft above mean sea level (msl). All major components remained near the wreckage. Both wings fractured and separated from the fuselage. Fuel remained in both wing tanks, but the quantity could not be determined. The fuselage was breached from the right side, just aft of the firewall to the empennage. The first point of probable impact was a gouge in a pine tree, about ten ft above the ground. The left wing exhibited large circumferential dents to the leading edge.

**Figure 4. N617G at accident site, looking about 145° magnetic.**

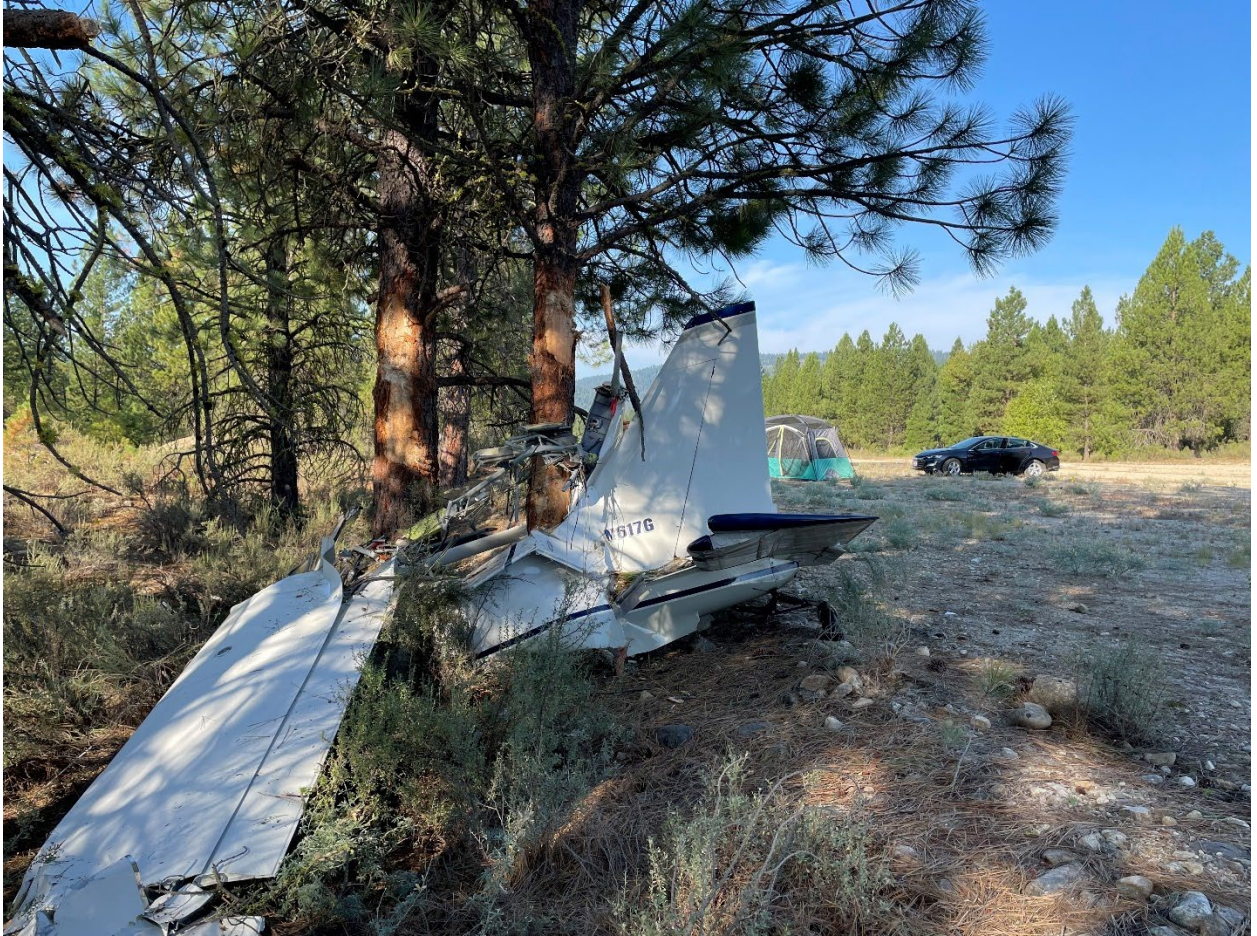
The fuselage was breached on the right side. Tree D exhibited evidence of entering the fuselage at the right door location and ending at the beginning of the empennage. The left half of the fuselage remained on one side of the tree and the right half of the fuselage remained on the other side of the tree. The fuselage split along the seam of the two-piece composite fuselage.

**Figure 5. Fuselage left side**

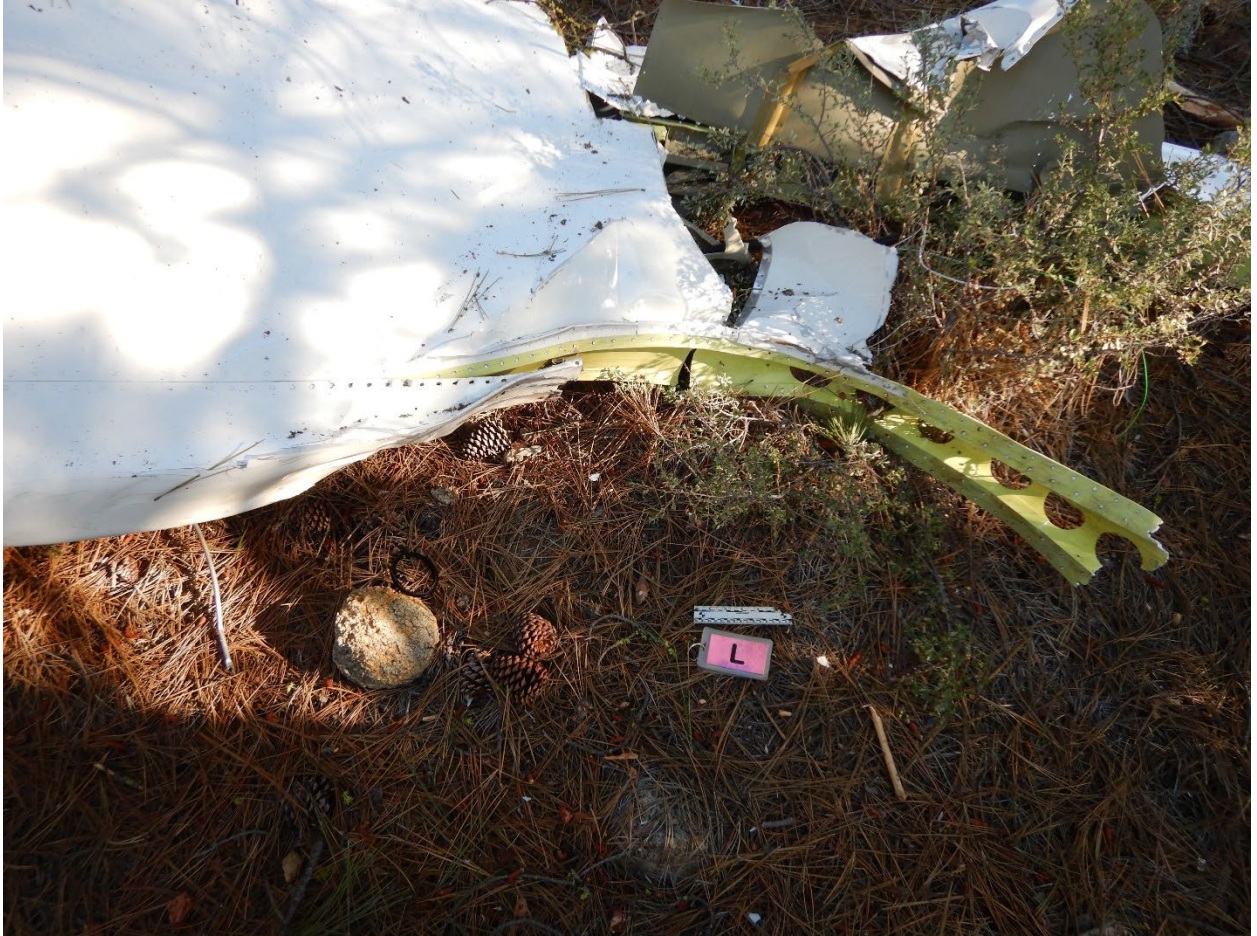
Both wings fractured and separated from the top of the fuselage. The left wing exhibited a circular indentation that started about 3 ft inboard of the wing tip and progressed outboard. The wing tip and about 1 ft of the wing fractured and separated from the wing. The left-wing fuel tank remained secured and contained an undetermined amount of fuel. The quantity of fuel was easily observed in the tank and indicated an abundant amount of fuel. The left-wing aileron remained attached to the wing and exhibited spanwise damage. The left-wing flap remained attached to the wing and exhibited minor damage. The flap indicated zero degrees flaps set. The lift strut had separated from the fuselage.

**Figure 8. Left wing leading edge near outboard tip.**

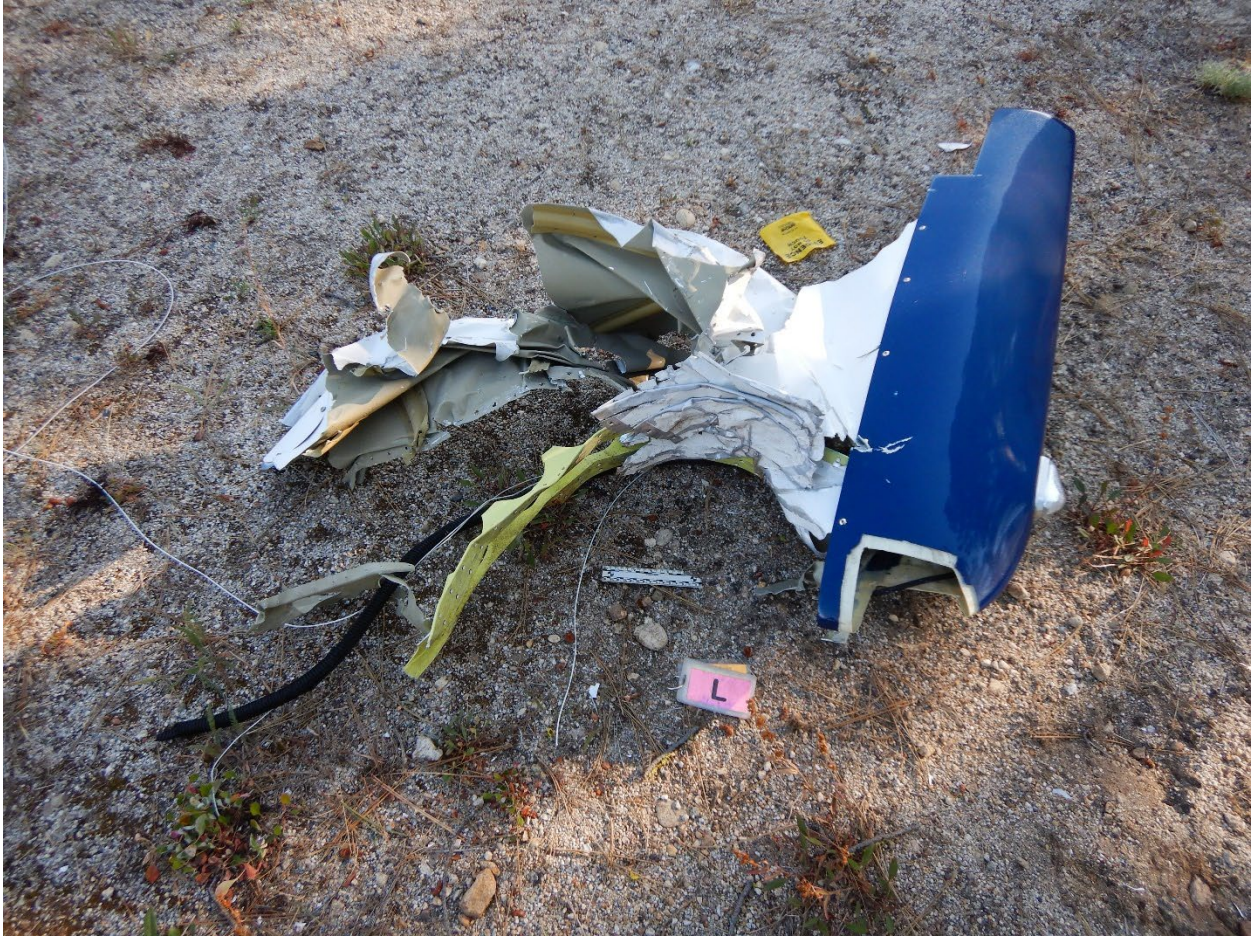
**Figure 9. Left wing tip.**

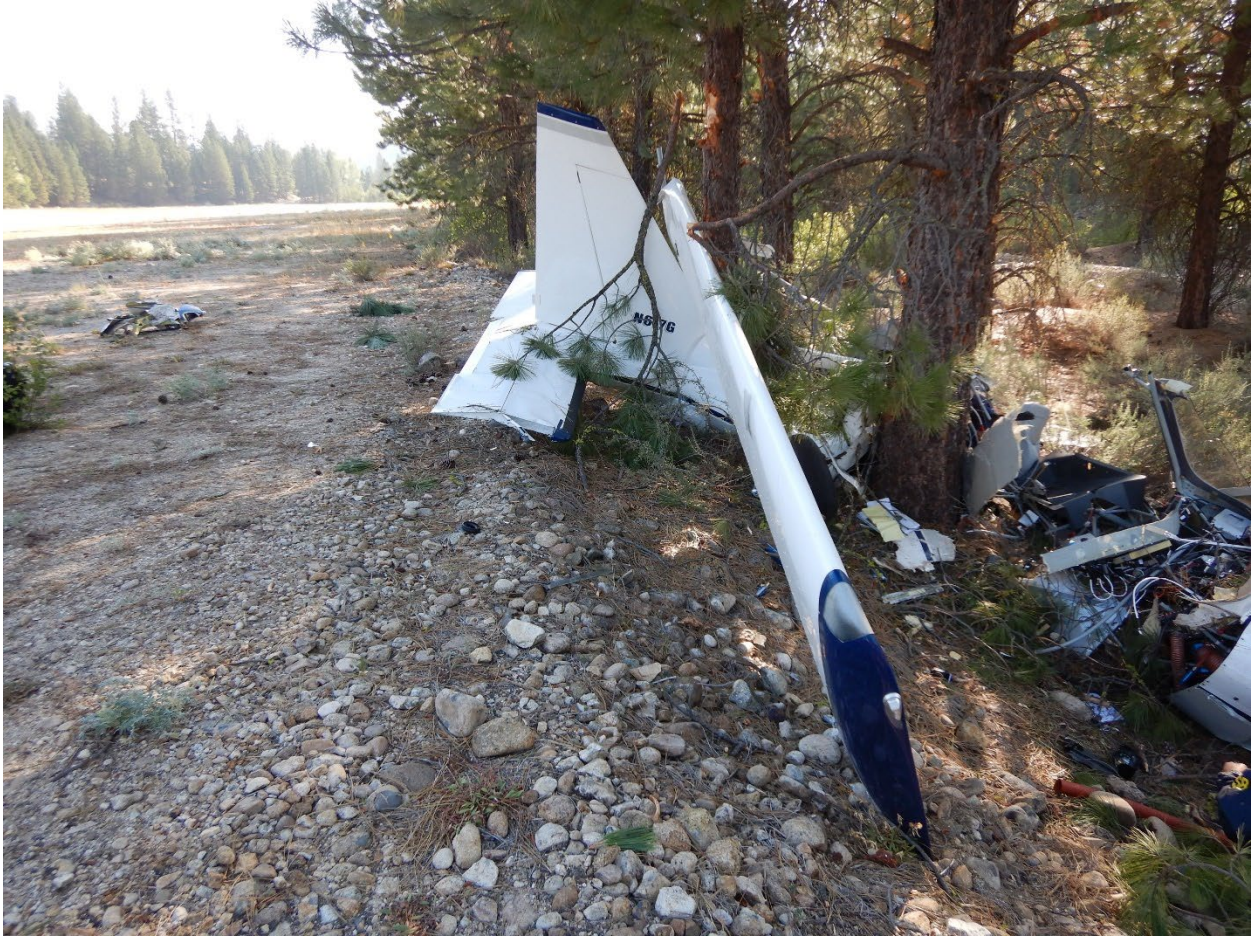
The right wing fractured and separated from the top of the fuselage. The wing came to rest between the wreckage and tree D. There was a circular indentation at the root of the leading edge that was adjacent to tree D. The right-wing aileron remained attached to the wing and exhibited minor damage. The right-wing flap remained attached to the wing and exhibited minor damage. An abundant amount of fuel remained in the right-wing tank. The lift strut separated from the fuselage.

**Figure 10. Right wing.**

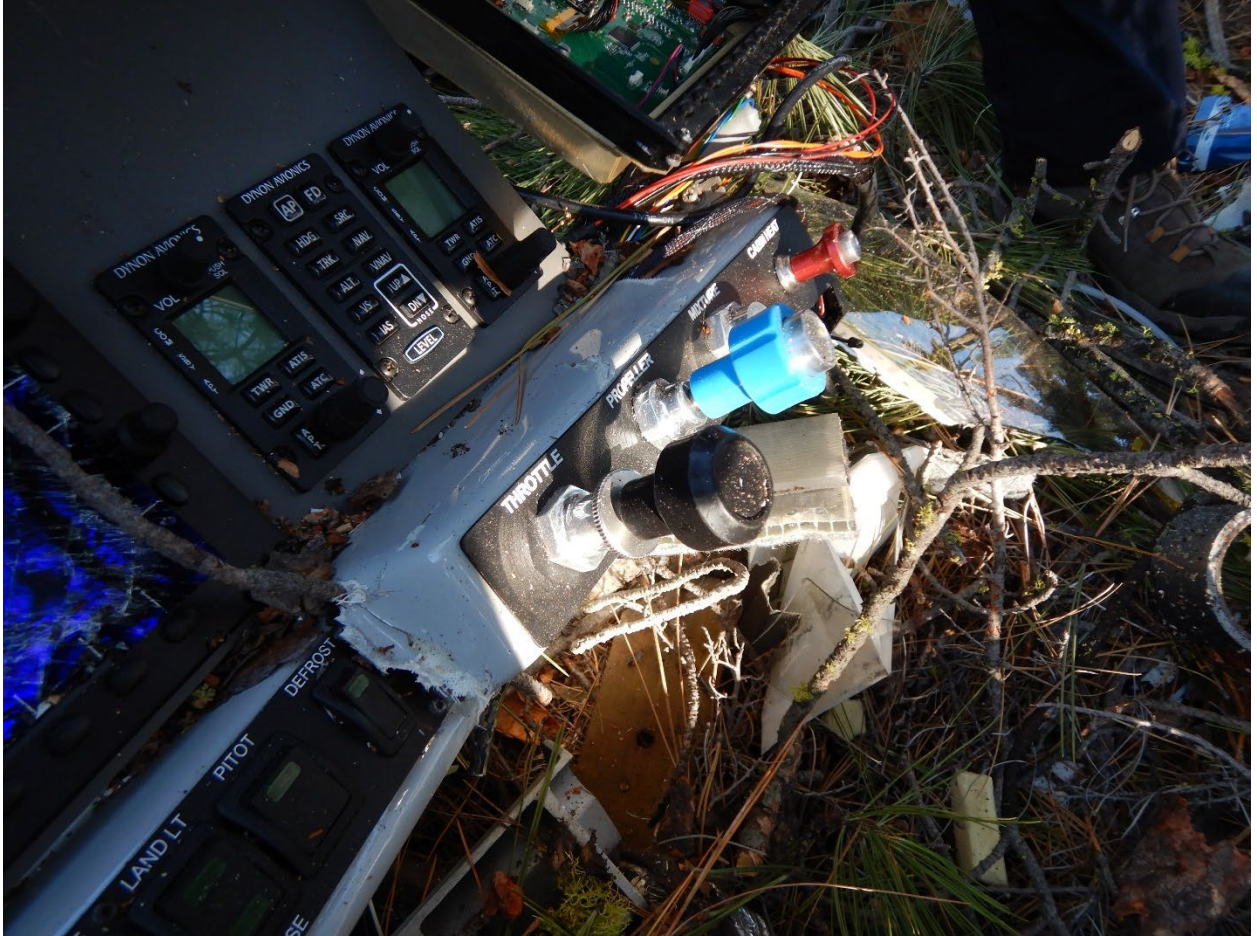
The throttle was positioned in the full forward position (full power). The propeller handle was positioned in the full forward position (high RPM). The mixture lever was separated from the throttle quadrant and found in the debris.

**Figure 15. Throttle quadrant**

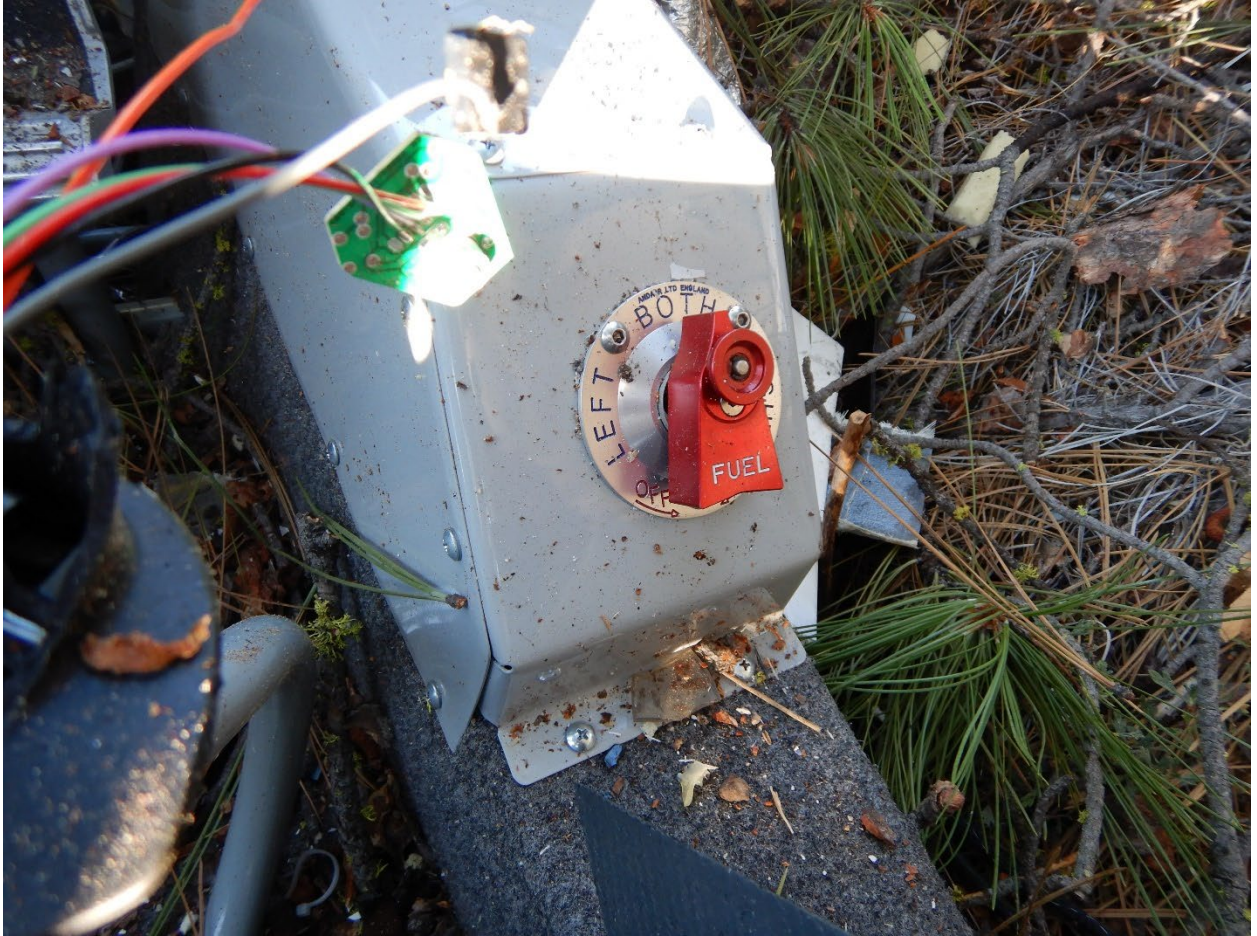
The fuel selector switch was found in the BOTH position.

**Figure 16. Fuel selector handle**

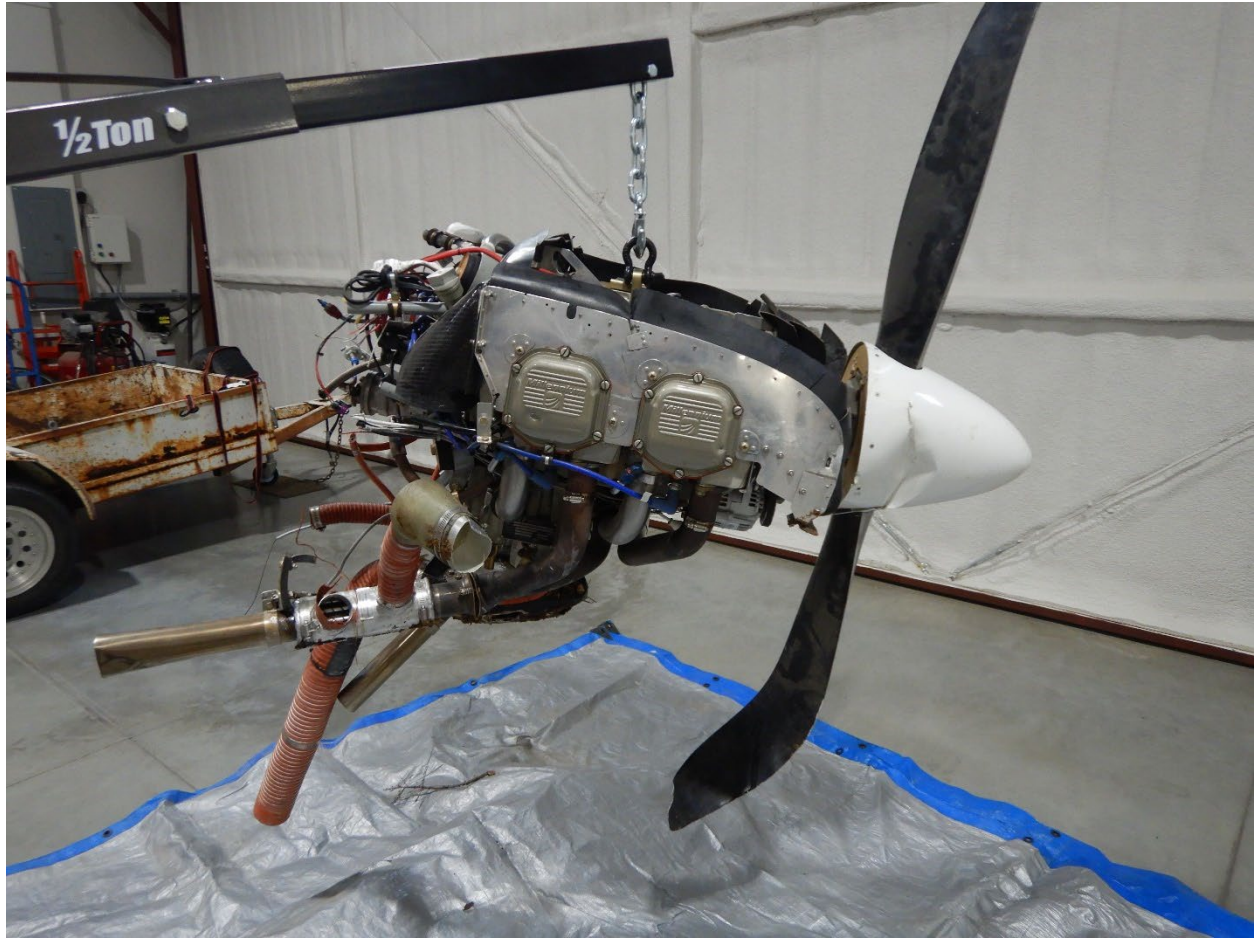
February 7, 2024. Engine examination performed. The engine was located at a hangar at the Nampa Airport (MAN), Nampa, Idaho. The engine did not exhibit signs of heavy impact damage and exhibited only minor damage to external components. The intake tubes and the exhaust tubes, located at the bottom of the engine were not crushed. The fuel servo, located at the bottom of the engine exhibited minor impact damage. The air filter attached to the fuel servo exhibited upward crush damage.

**Figure 19. Engine at follow up examination.**

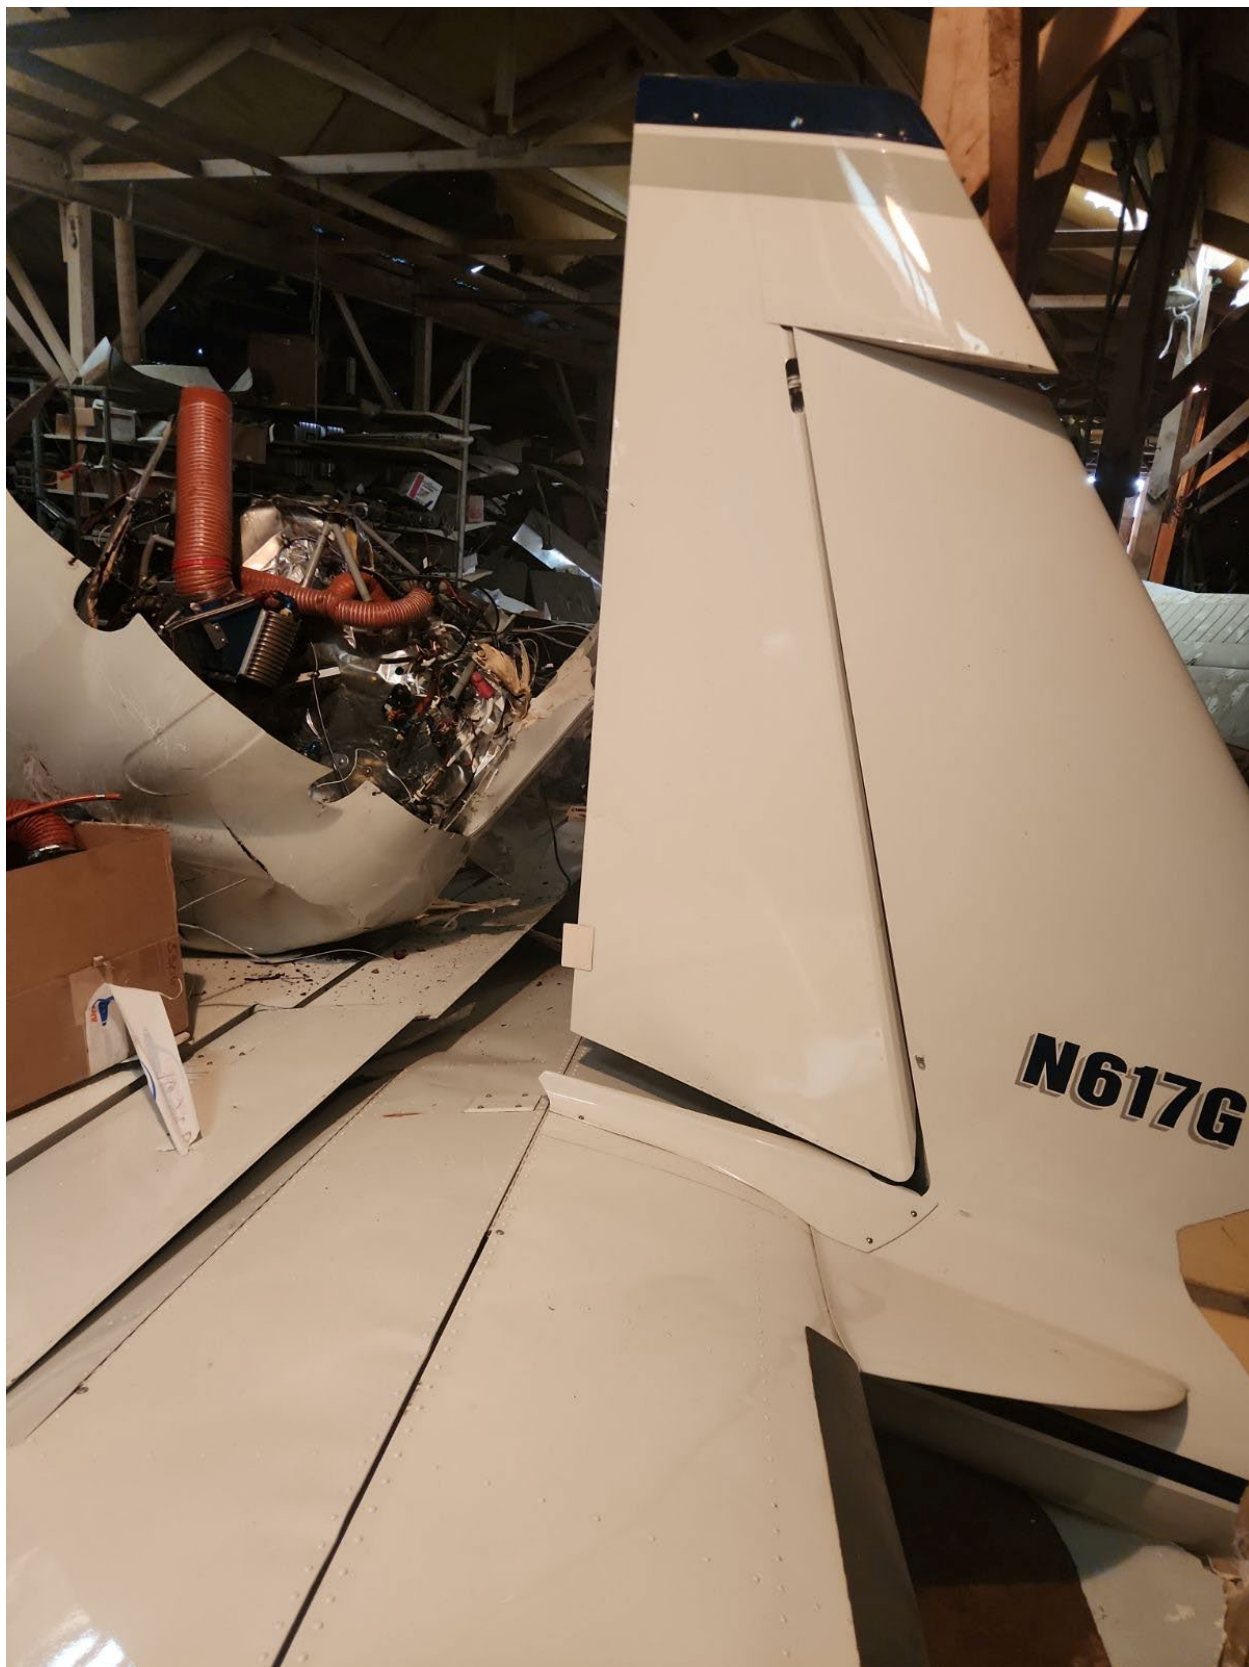
The rudder was examined during the follow up travel conducted on February 7, 2024. The rudder remained attached to the vertical stabilizer. The two rudder control cables were cut during recovery. The two rudder control cables remained attached to the rudder horns and extended to the cuts made by the recovery agents. The rudder control cables then continued to the mid-section of the fuselage. Rudder control continuity was established from the rudder pedals to the mid-section of the fuselage. Due to the damage and inaccessibility, the continuity of the flight controls in the mid-section of the heavily damaged fuselage could not be determined.

**Figure 20. Rudder.**

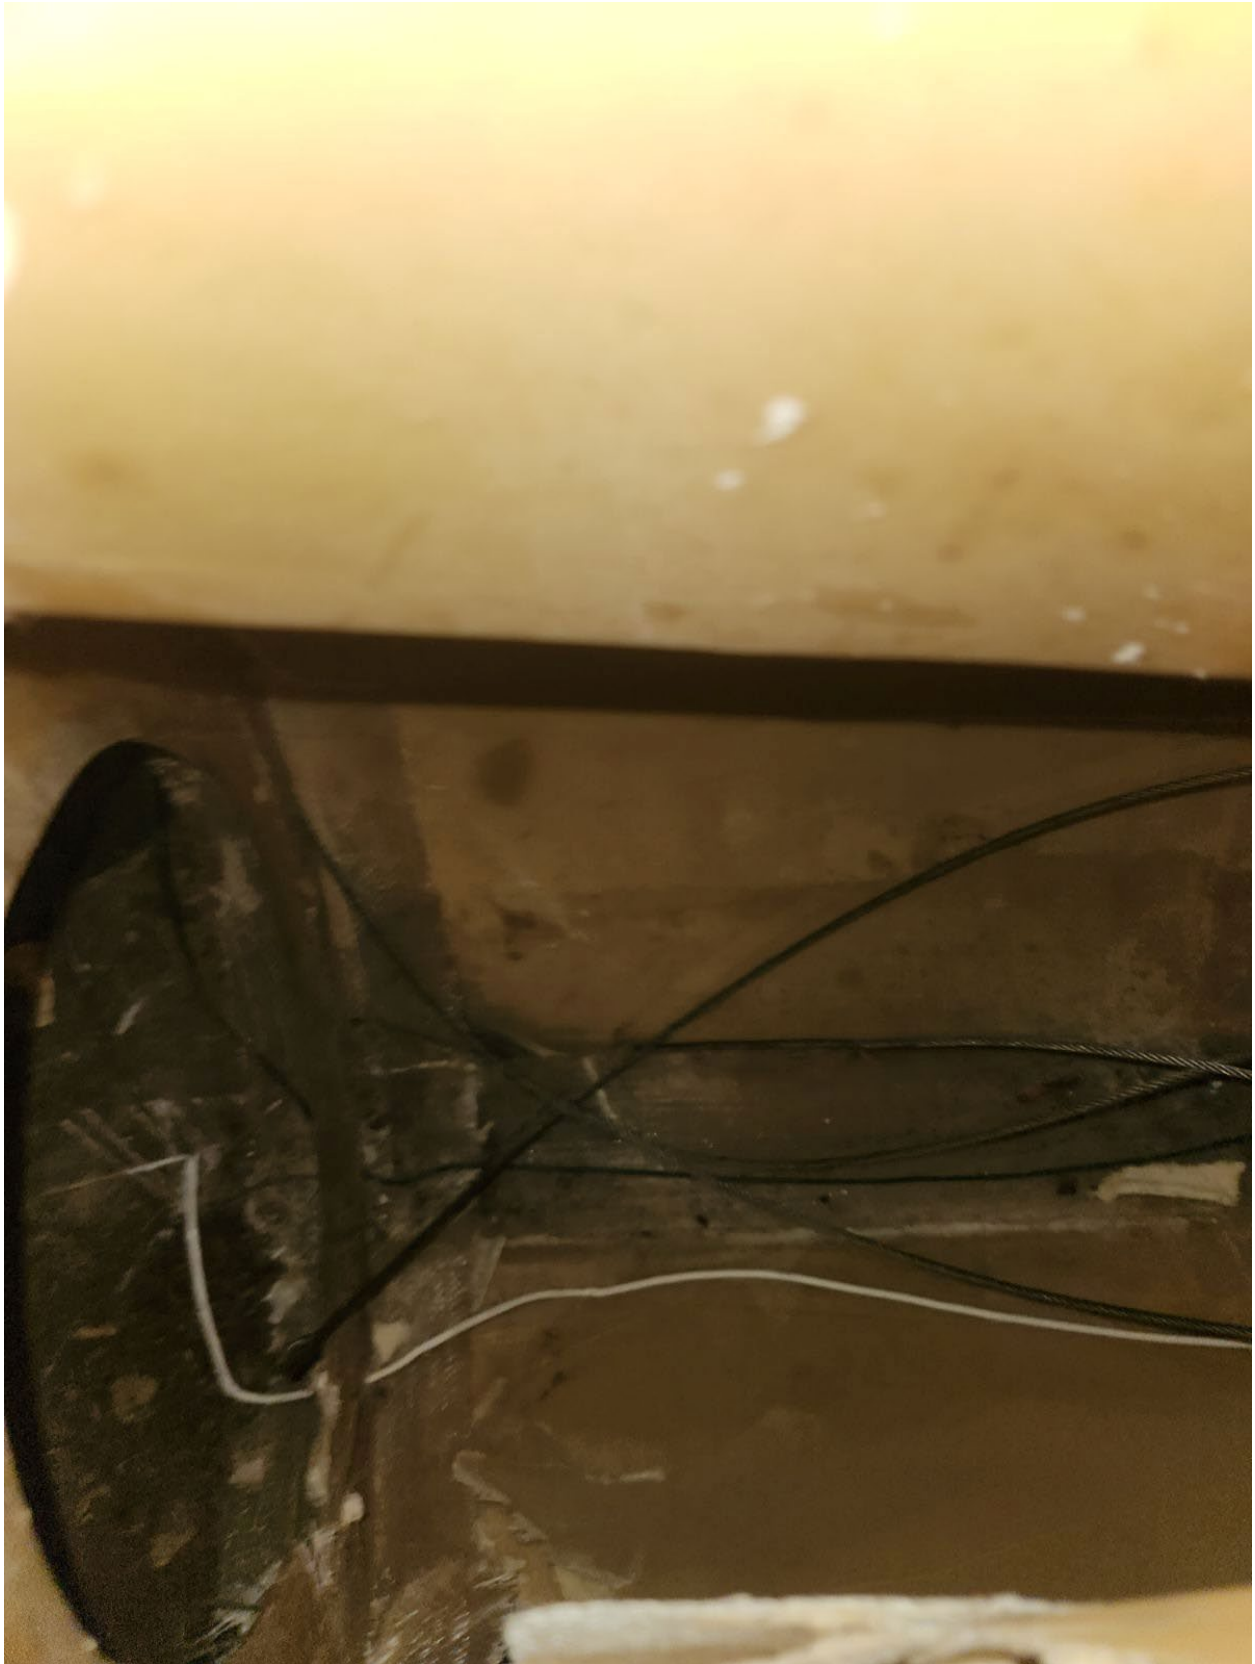
**Figure 21. Rudder control cables.**
