# National Transportation Safety Board

WPR23FA323

Factual Report 24-064

Location: West Jordan, Utah  
Date: August 23, 2023  
Vehicle: Hensler Howard Cassutt, N6291N  
Investigator: Stephen Stein (AS-WPR)

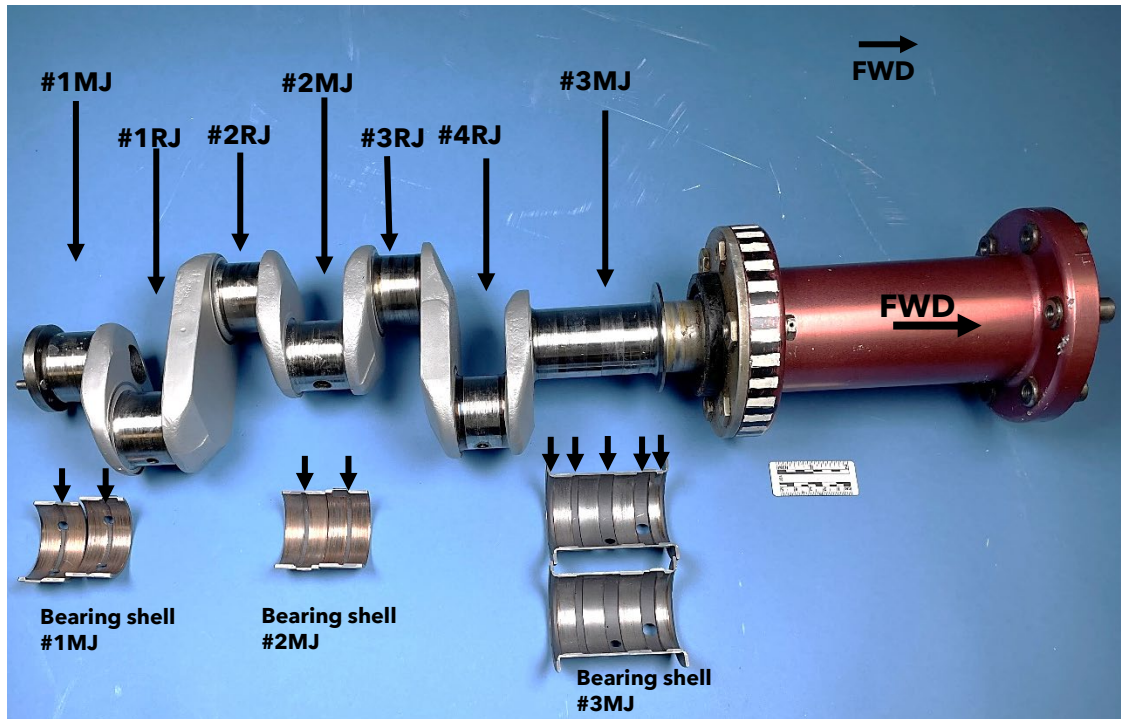
The crankshaft contained a propeller flange at the forward end. The outer edge of the propeller flange was marked: "M010M/020P" indicating the main journals were grinded 0.01 inch undersize and the rod (pin) journals were grinded 0.02 inch undersize<sup>2</sup>; "RN" indicating the crankshaft received a nitride treatment after grinding; "24IIII32" which are marks used for timing of the engine; and "S238646-1" indicating a work order number from "Aircraft Specialty Services". According to the work order records from Aircraft Specialty Services, the crankshaft was overhauled in 1976, which included work to grind the main and rod journals undersize by the amount indicated earlier.<sup>3</sup> The aft face of the crankshaft cheek between #1RJ and #2RJ was stamp marked "42428".

**Figure 1.** As-received crankshaft and bearing halves from the #1MJ, #2MJ, and #3MJ. The crankshaft is numbered from aft to forward, starting with the #1 main journal (#1MJ) and #1 rod journal (#1RJ) at the aft end, and ending with the #3 main journal (#3MJ) at the forward end. Unmarked arrows point to positions on the inner surface of the bearing shells that contain circumferential recessed grooves (for oil passage).

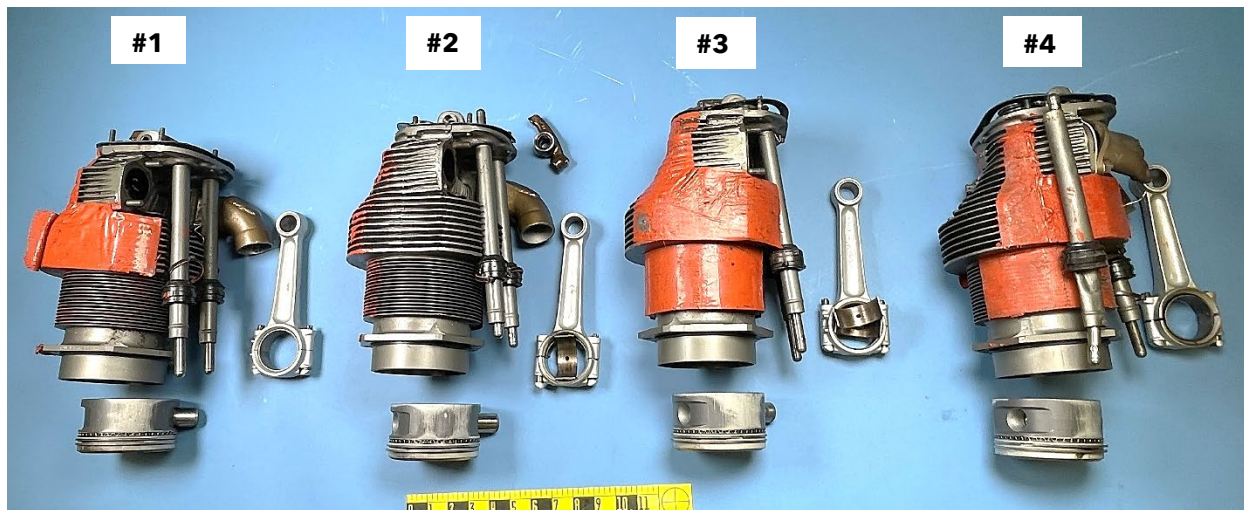
**Figure 2.** As-received cylinders, connecting rod arms with bearing shells, and pistons with corresponding wrist pins, numbered #1 through #4 (left to right).

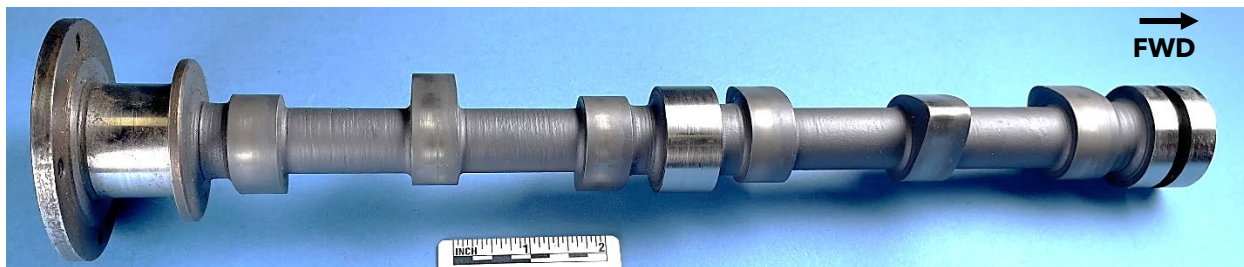
The camshaft was intact and showed no evidence of a crack. The body of the camshaft contained a stamp mark "626608-X".

**Figure 3.** As-received camshaft.

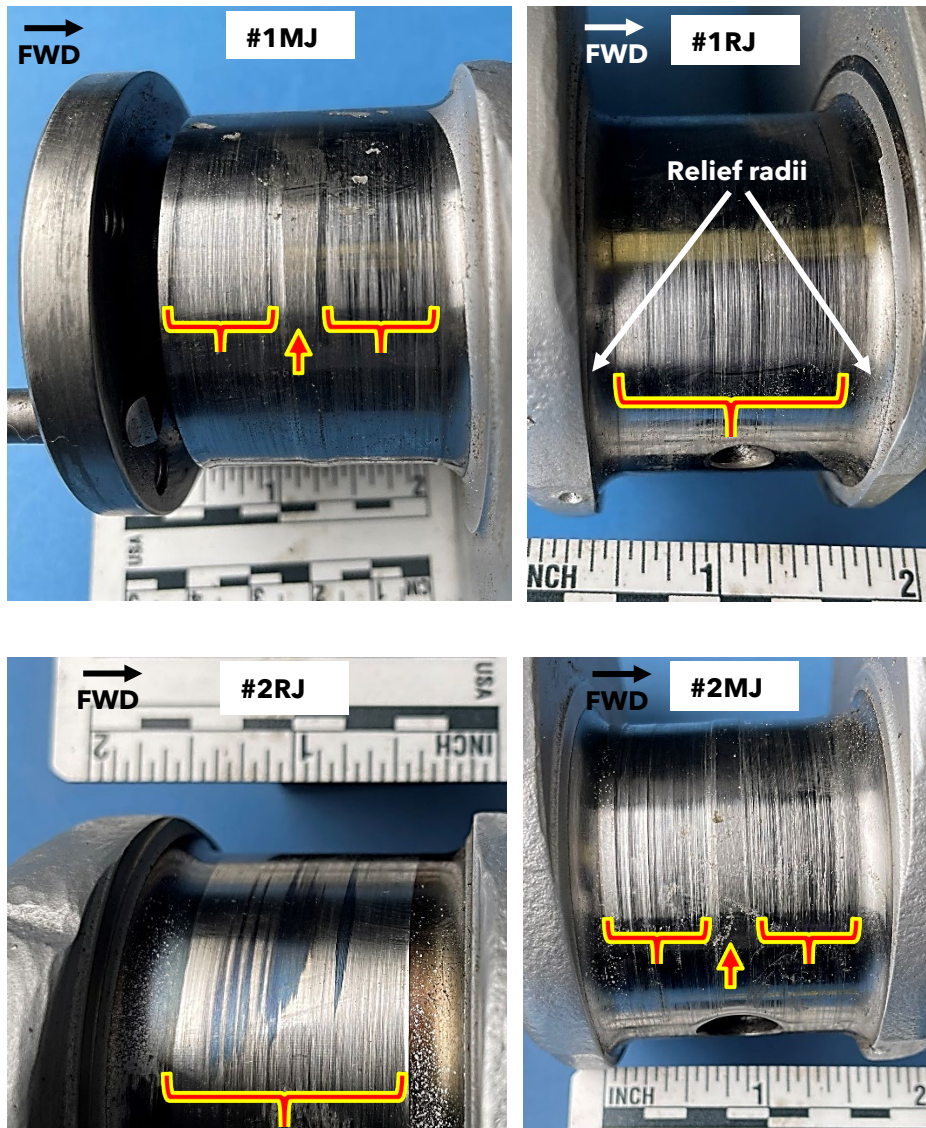
The crankshaft was intact (no evidence of a fracture). The crank cheek portions of the crankshaft exhibited a dull silver-like tint. The surface of the main and rod journals contained evidence of a wear pattern, indicated by brackets in figure 4, at locations that corresponded to the contact areas on the bearing shell. The wear pattern extended all around each journal. Stereo microscope examination of all the journal surfaces revealed the relief radii contained no evidence of circumferential scoring marks<sup>4</sup> or a crack. The #2RJ and #3RJ showed evidence of blue-purple heat tint at several locations, whereas the remaining main and rod journals showed no evidence of heat tinting. The oil passages on the crankshaft were inspected for debris and obstruction. A long and round wood stick at the end of a cotton swab applicator was inserted into each oil passage. The wood stick was inserted into each oil passage with no resistance. No evidence of debris was found at the end of the wood stick when the wood stick was removed from the oil passages.

The diameter of the main and rod journals were measured with a digital micrometer and the results are shown in tables 1 and 2. The measured diameter of the main journals were less than that for an "010" undersize main journal designation marked on the propeller flange of the crankshaft. The measured diameter of the rod journals were less than that for an "020" undersize rod journal designation marked on the propeller flange of the crankshaft.

**Figure 4.** Close-up of the main and rod journals. Brackets indicate location of wear pattern. Unmarked arrows point to positions on the journals that exhibited evidence of metal deformation/lip that extended above the worn surface (these areas correspond to circumferential recessed grooves on inner surface of each bearing shell).

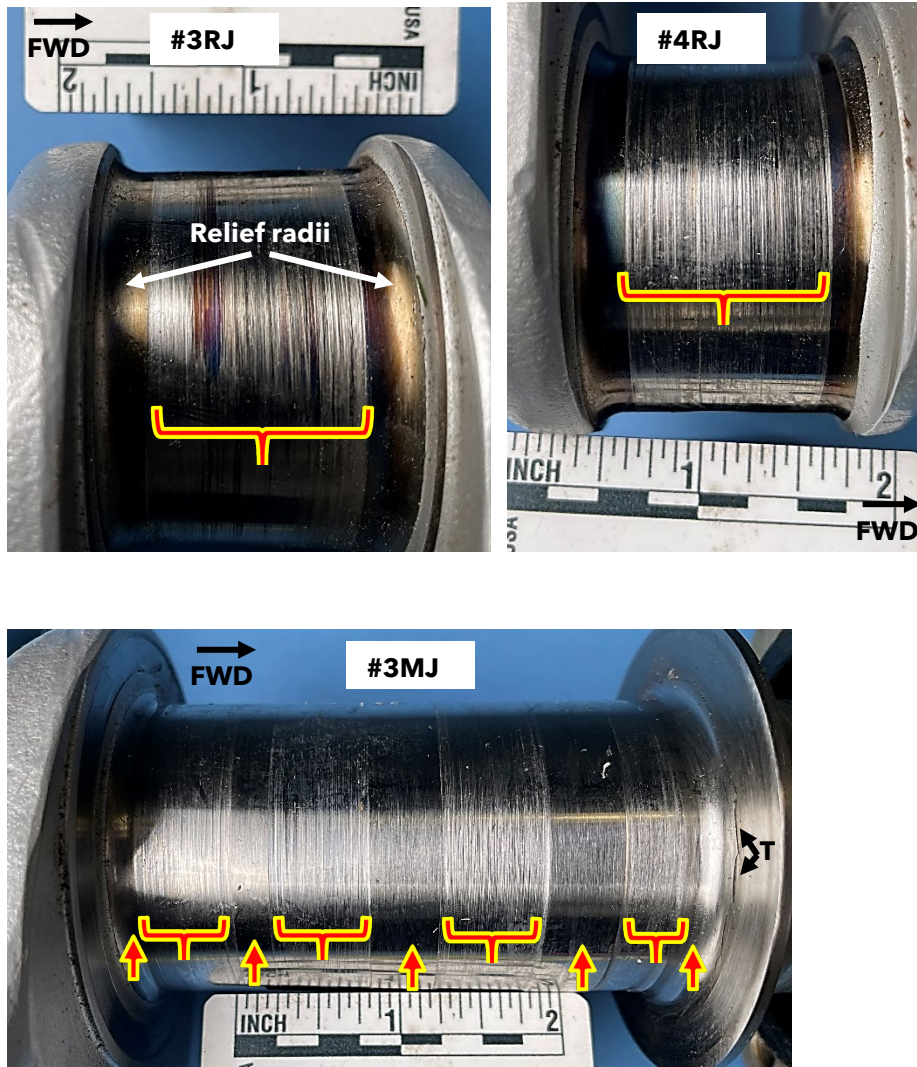
**Figure 4 (continued).** Close-up of main journals and rod journals. Brackets indicate location of wear pattern that extended all around the circumference of the journal. Unmarked arrows point to positions on the journals that correspond to circumferential recessed grooves on inner surface of each bearing shell. The area outside of the relief radius, in the general area indicated by arrows "T", contained many circumferential-like cracks that extended all around the flange.

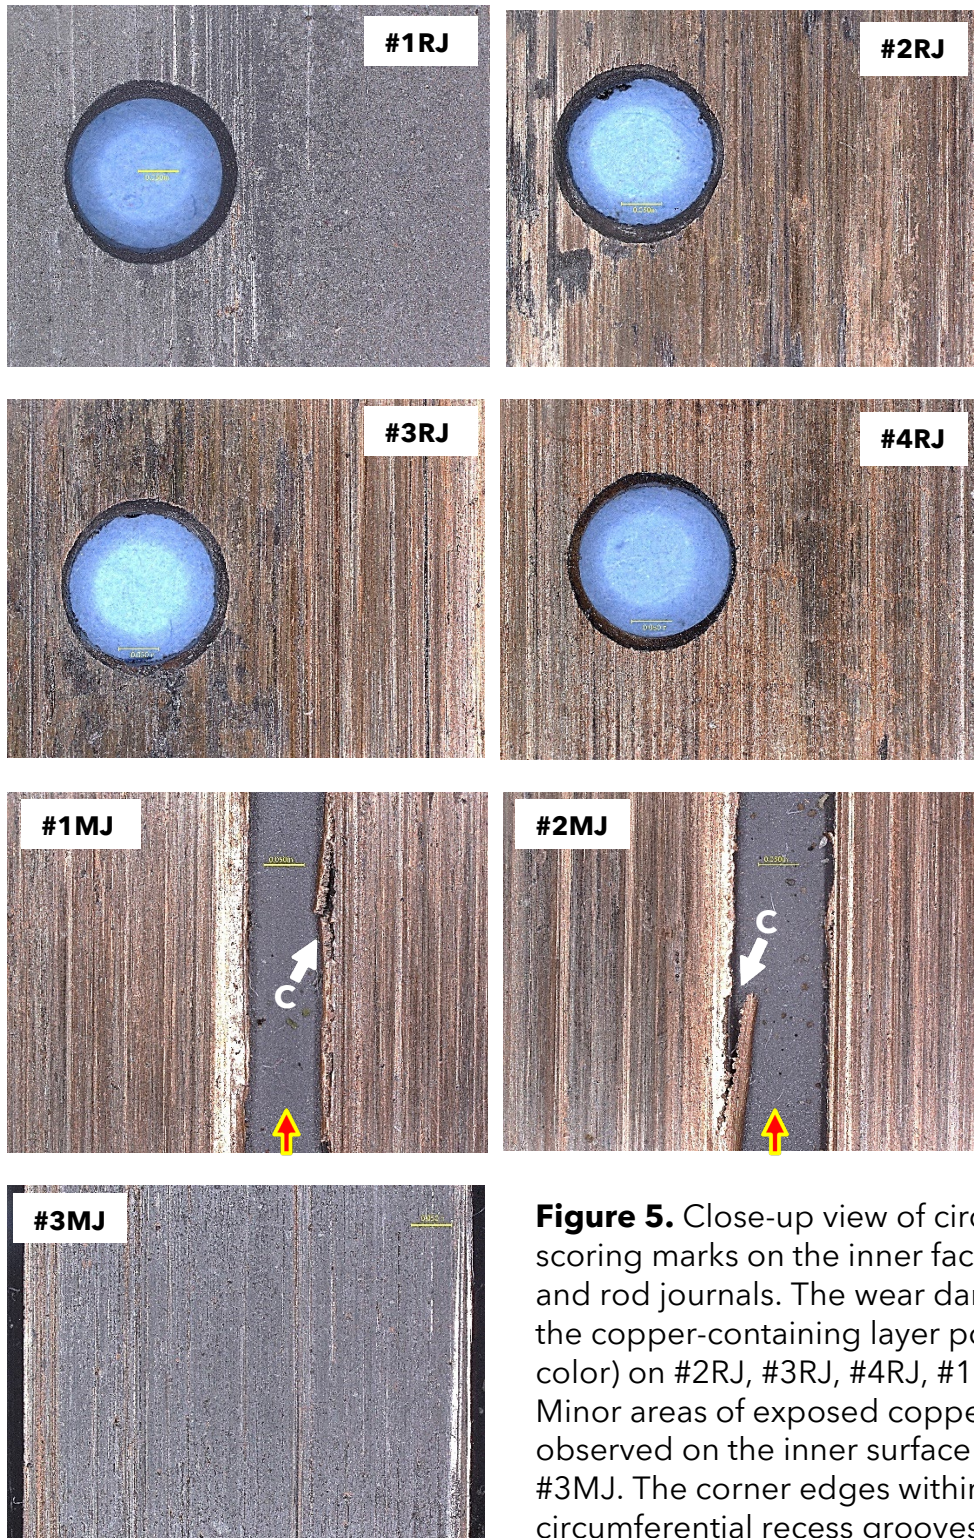
The inner surface of the bearing shells for the #1MJ and #2MJ each contained a circumferential recessed groove at the center portion whereas those on the #3MJ contained five circumferential recessed grooves (locations indicated by unmarked arrows in figures 1 and 5).<sup>6</sup> The inner surface of the bearing shells for the #1RJ through the #3RJ did not contain circumferential recessed grooves. The inner (inboard) surface of the #2RJ, #3RJ, #4RJ, #1MJ, and #2MJ contained severe wear damage that exposed the copper-containing layer portion (red color). The inner (inboard) surface of the #1RJ and #3MJ contained wear damage that exposed isolated areas of the copper-containing layer portion (red color).

**Figure 5.** Close-up view of circumferential scoring marks on the inner face of the main and rod journals. The wear damage exposed the copper-containing layer portion (red color) on #2RJ, #3RJ, #4RJ, #1MJ, and #2MJ. Minor areas of exposed copper were observed on the inner surface of the #1RJ and #3MJ. The corner edges within the circumferential recess grooves of the #1MJ and #2MJ exhibited evidence of a crack and compression damage in the areas indicated by arrows "C".

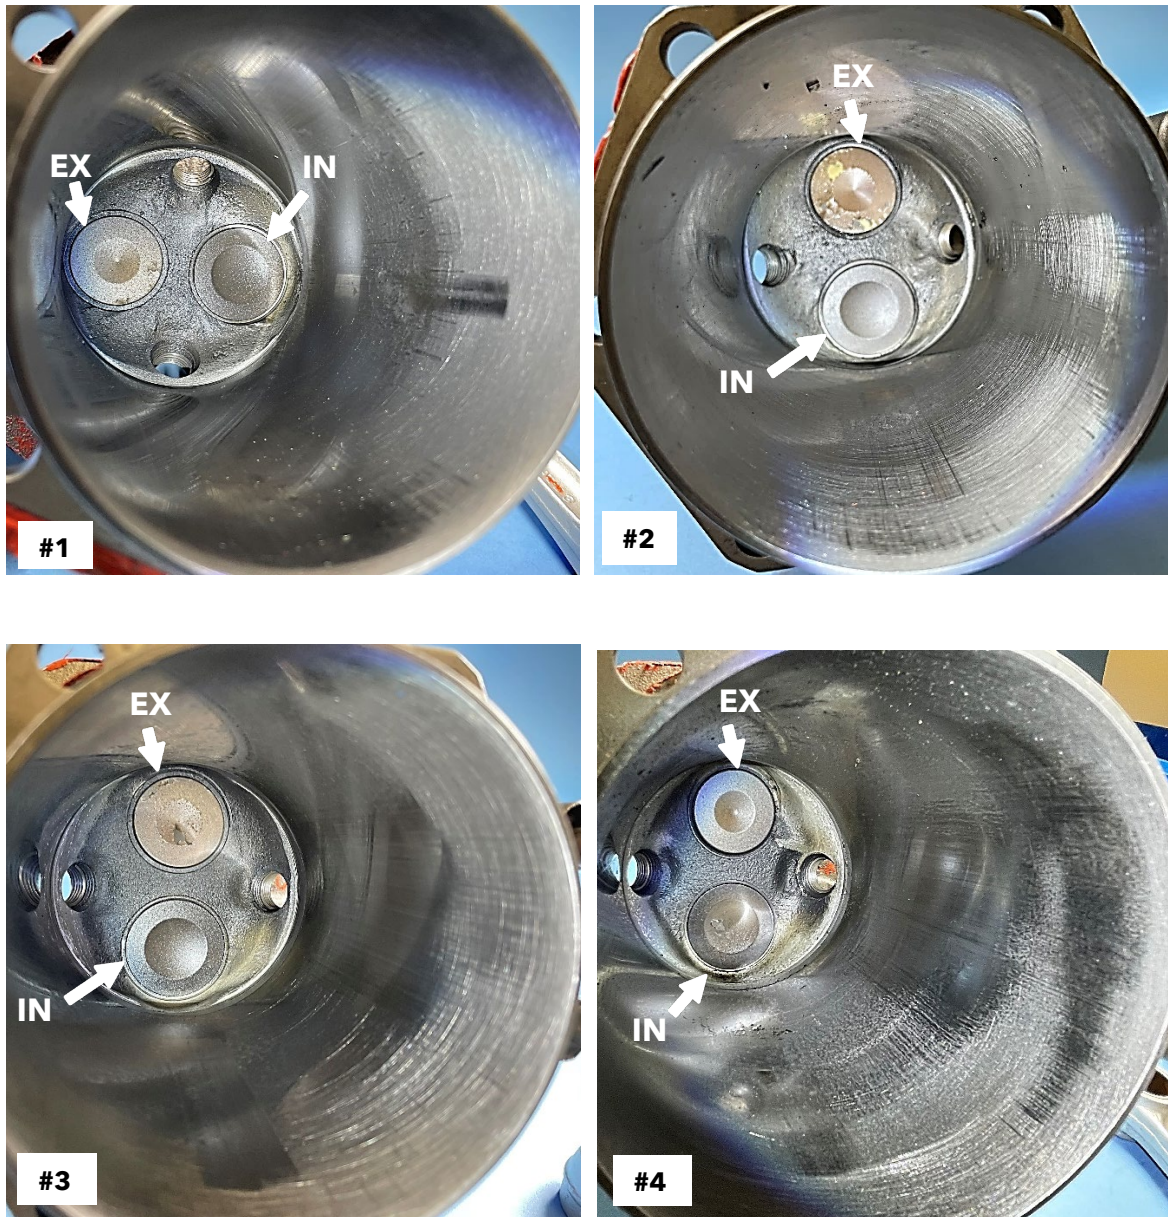
The combustion chamber of the #1 through #4 cylinders showed evidence of scoring marks. The scoring marks were oriented parallel to the length of the combustion chambers (see figure 6). Coating (film layer) was peeling from the combustion face of all exhaust ("EX") valves with the exception of that from the #4 exhaust valve. Coating (film layer) was peeling from the combustion face of the intake ("IN") valve of the #4 cylinder but were not peeling from those of the remaining three intake valves.

**Figure 6.** View looking into the combustion chamber of the cylinders. Coating (film layer) was peeling from the combustion face of all exhaust ("EX") valves with the exception of that from the #4 exhaust valve. Coating (film layer) was peeling from the combustion face of the intake ("IN") valve of the #4 cylinder but were not peeling from those of the remaining three intake valves. The diameter of the head portion from the exhaust piston was smaller compared to that of the intake piston.

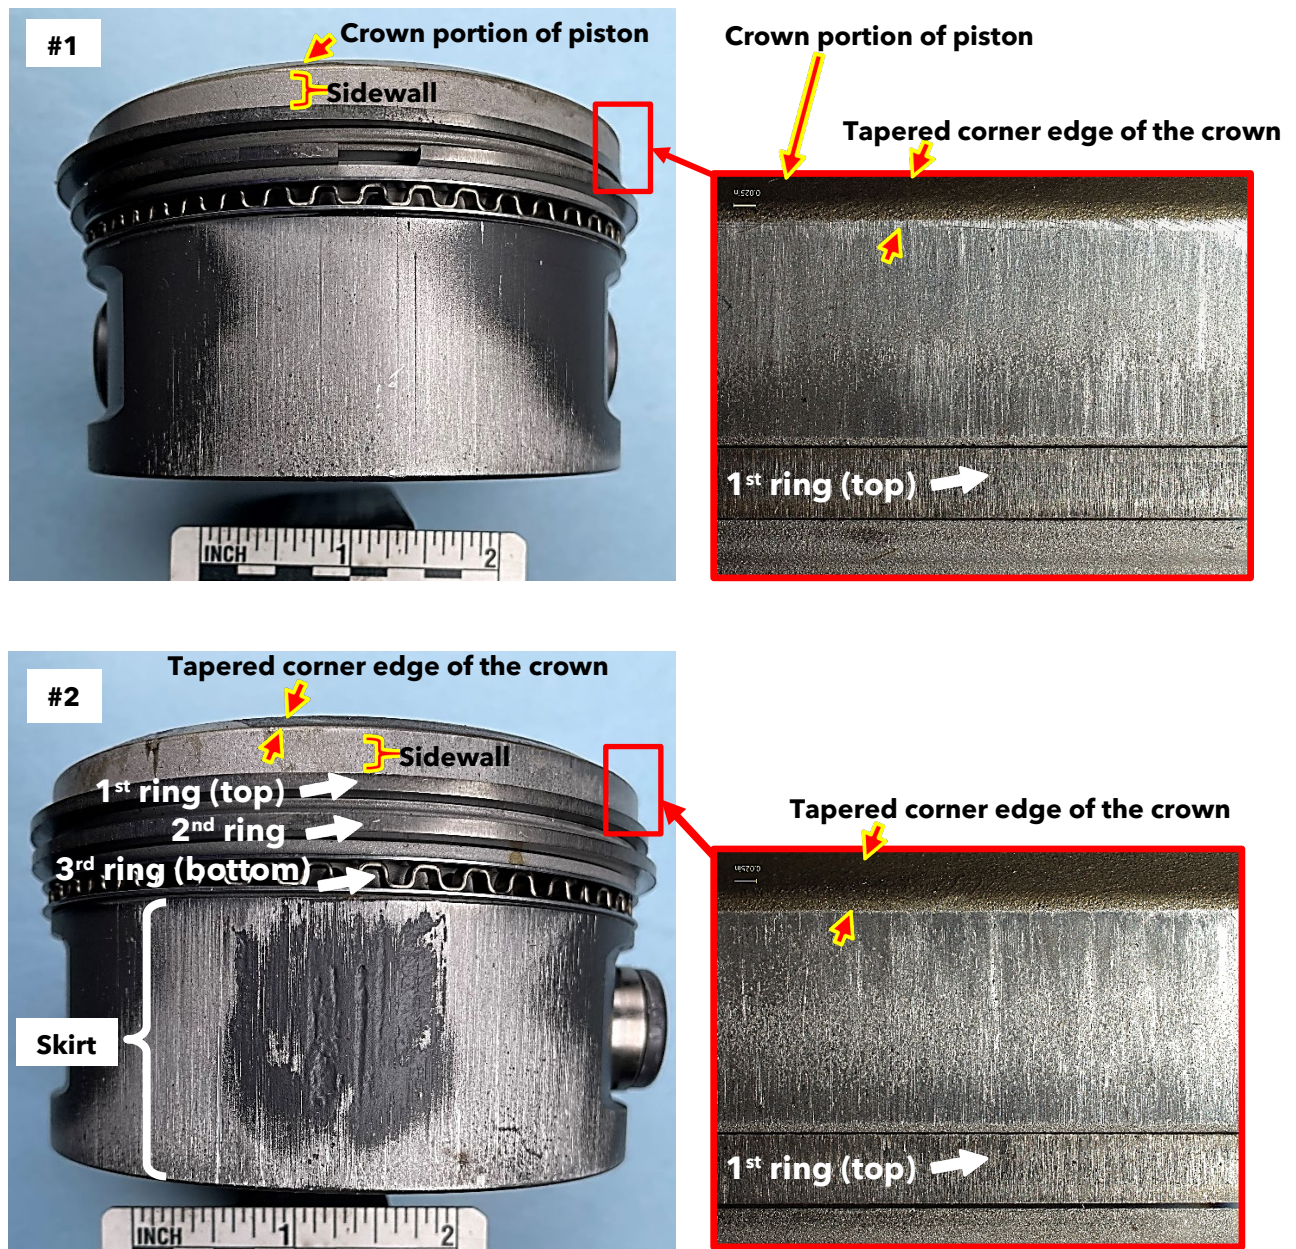
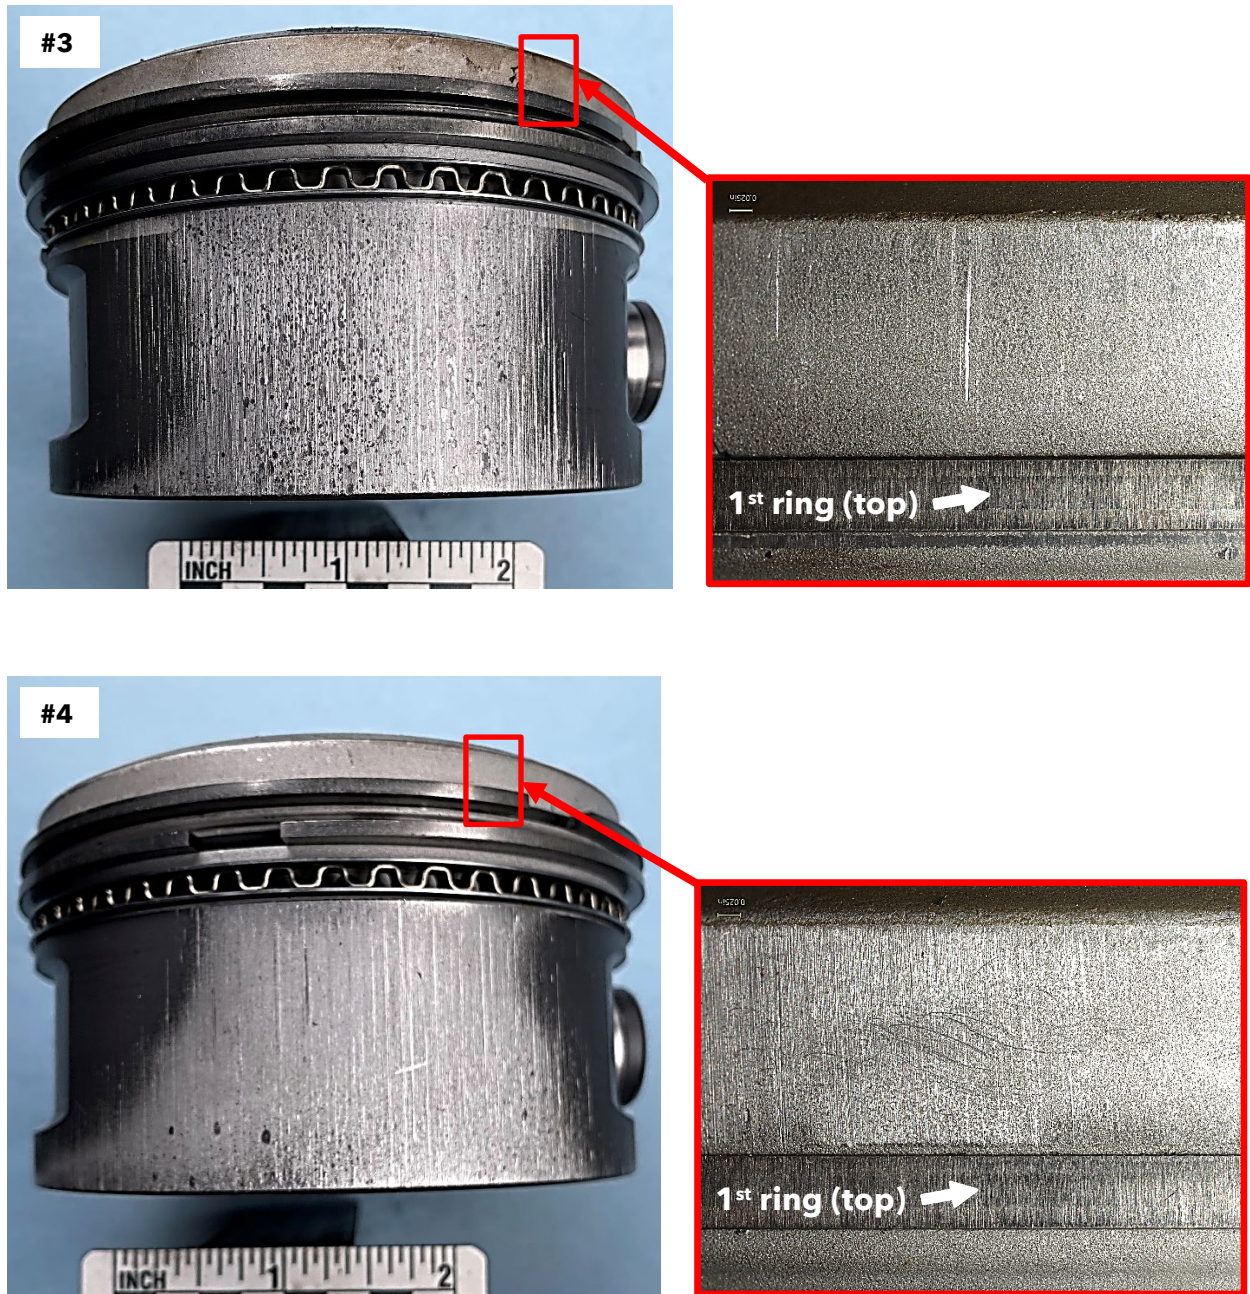
The crown portion of all the pistons contained a beveled (tapered) corner edge, see figure 7. The crown portion of each piston and the tapered edges exhibited an olive-like tint that showed no evidence of erosion or cracking. The sidewall of the piston in the area that extended between the tapered corner edge and the first groove for a ring contained longitudinal scoring marks.

The piston contained three rings (first and second ring are the compression rings and the third ring is the oil ring). The three piston rings were intact. The outer wall of the rings showed evidence of scoring marks (oriented parallel to the longitudinal axis of the cylinder).

The skirt portion of the piston (below the three rings) contained longitudinal scoring marks. The portions of the skirt that showed no evidence of scoring marks exhibited a black-dark gray tint.

**Figure 7.** Side view of the pistons showing scoring marks in the skirt area and sidewall in the area above the top piston rings.

**Figure 7 (continued).** Side view of the pistons showing scoring marks in the skirt area and sidewall in the area above the top piston rings.
