# National Transportation Safety Board

WPR23FA323

## **NTSB ONSCENE AND WRECKAGE EXAMINATION REPORT**

Location: West Jordan, Utah  
Date: August 23, 2023  
Time: 1200 mountain daylight time  
1800 UTC  
Airplane: Experimental Amateur Built Cassutt III

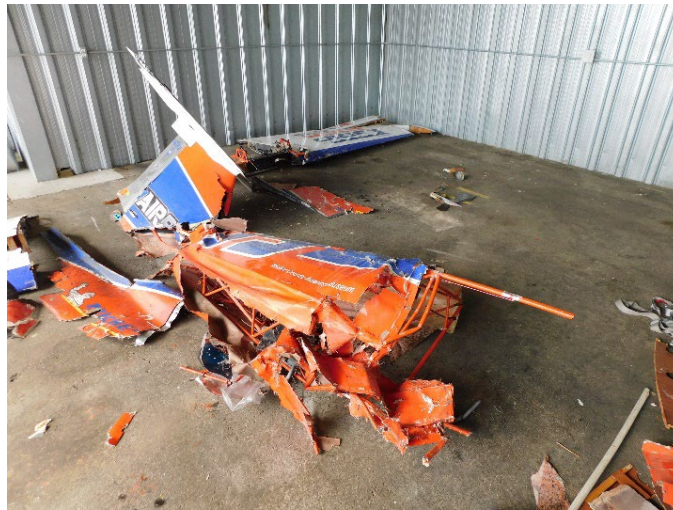
The airframe was substantially damaged. The fuselage consisted of welded tube metal covered in fabric. The fuselage fractured and partially separated from the fire wall. The cabin area was breached, and the fuselage aft of the cabin area was partially separated. Only one control cable to the rudder held the aft fuselage to the cabin area.

**Photograph 1: Fuselage (midsection) and empennage**

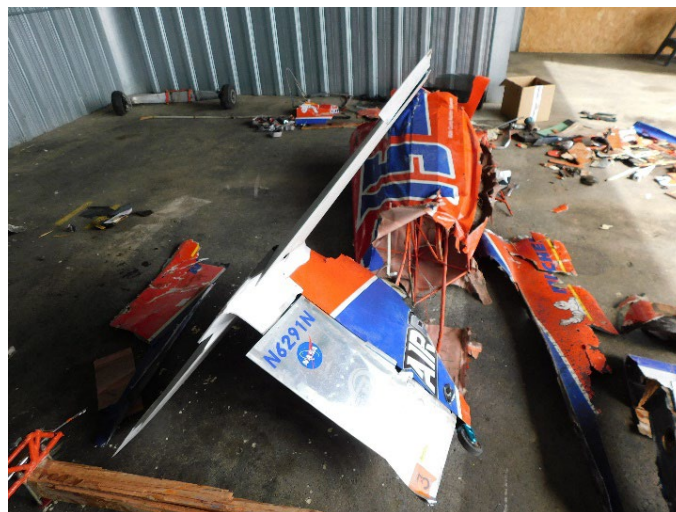
**Photograph 2: Empennage and fuselage from rear**

The empennage was separated from the aft fuselage. The elevators remained attached to the horizontal stabilizer at the T-Tail. Control continuity was established from the elevator to the control yoke through the bell crank at the empennage and the push pull tube control linkage. The horizontal stabilizer remained attached to the vertical stabilizer. Rudder control continuity was established from the rudder to the right pedal through the right rudder control cable. The left rudder control cable was fractured and separated approximately six inches from the left rudder pedal, but the cable was continuous to the rudder. The left rudder cable separation exhibited broomstrawing, consistent with overload separation.

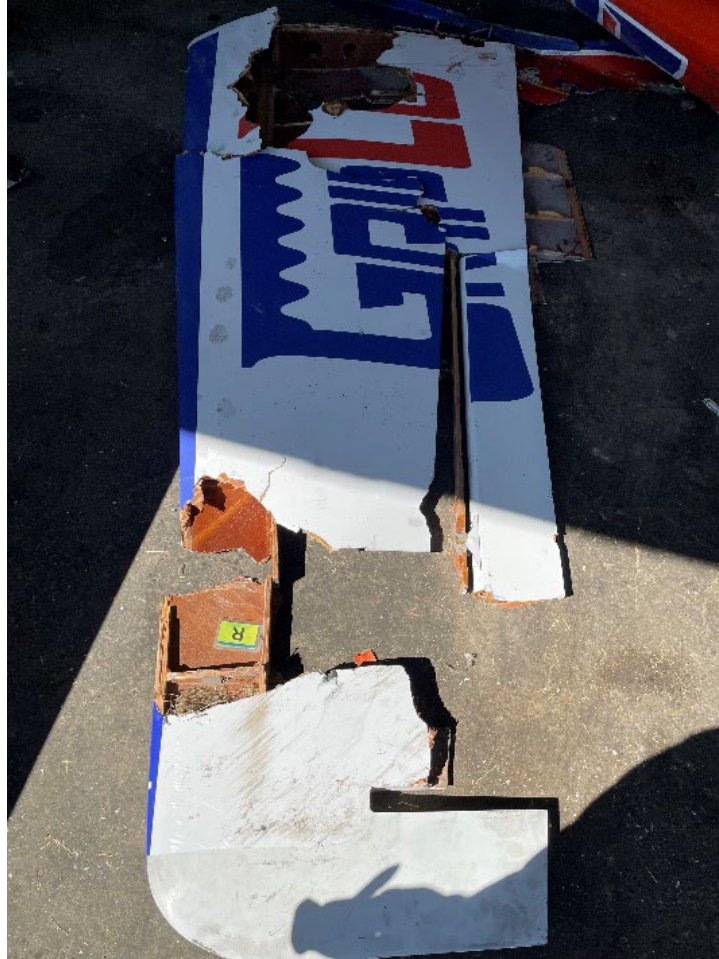
The right wing separated from the spar at the wing root. The right wing fractured into three large pieces; wing tip, mid-section, and inboard section. The right aileron remained attached at the hinges and the aileron torque tube remained attached to the aileron at the rod end bearing. The right side aileron push rod was separated at the wing root and exhibited fracture signatures consistent with overload separation at the rod end bearing. The rod end bearing at the fuselage was attached at the bellcrank and was continuous to the control yolk at the cockpit.

**Photograph 3: Right wing**

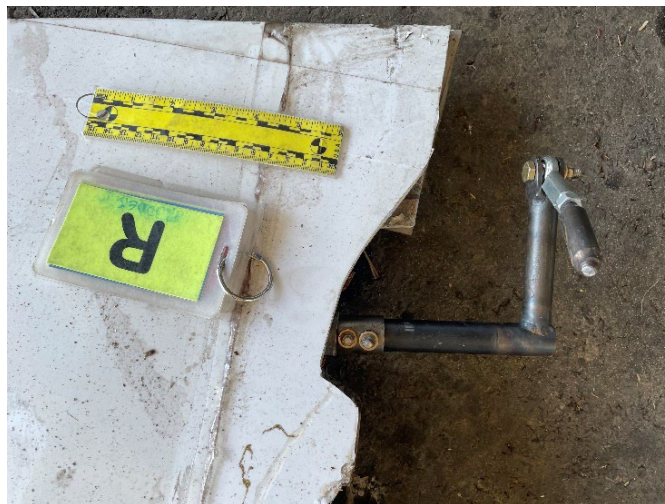
**Photograph 4: Right wing rod end bearing at wing root**

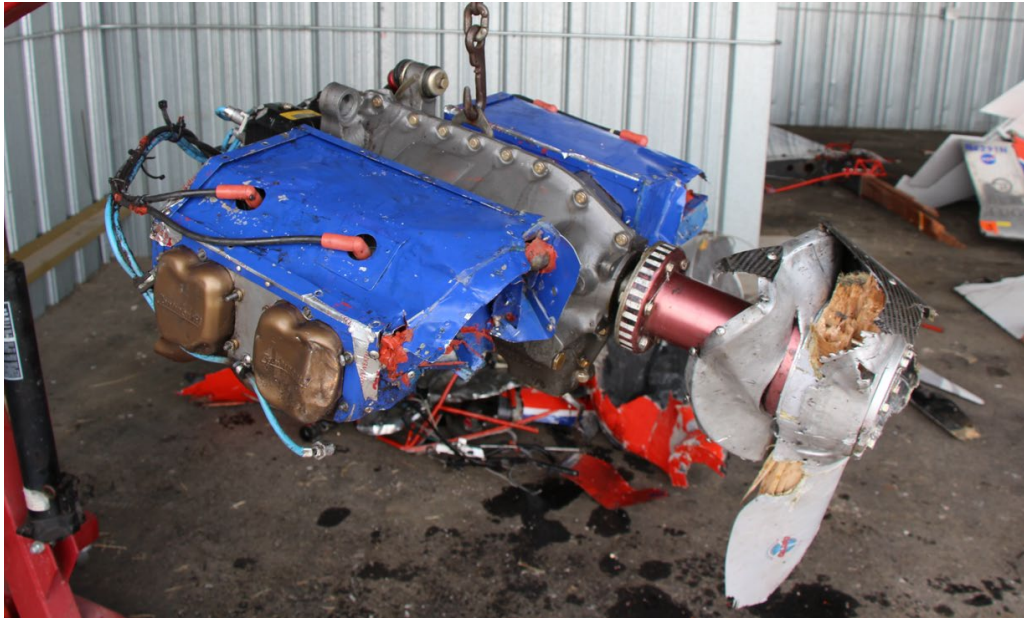
The airplane was originally registered on December 31, 2001 with a Continental Engines O-200, a 100 hp, horizontally opposed, air cooled, normally aspirated, reciprocating engine. However, the engine make/model that was installed could not be confirmed as the original engine data plate had been removed or covered. The engine was equipped with two plenums that had been installed over the cooling fins for cooling efficiency. Both plenums remained attached and had sustained some damage near cylinders. Each of the four engine mounts were bent, but remained attached to the engine firewall and engine.

**Photograph 5: Engine prior to examination**

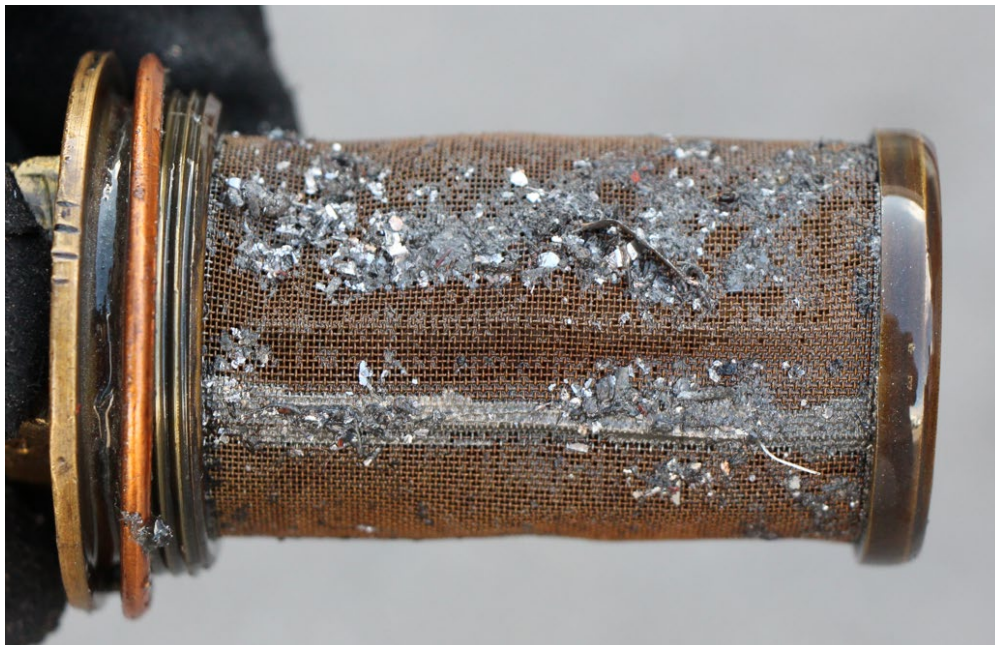
The oil in the engine case and at the oil sump was purple in color. Two near empty containers of Lucas synthetic SAE 20W-50 racing engine oil were found in the pilot's hangar; however, the contents were yellow in color. Metallic debris was found along the outer circumference of the oil screen. The engine was not equipped with an oil filter. The oil pump exhibited some resistance when actuated by hand at the drive. Some foreign debris was observed within the pump housing. The oil cooler plenum was partially damaged, but remained attached to the oil cooler. No obstructions within the oil cooler were observed as water passed through the unit without resistance.

**Photograph 6: Oil screen**

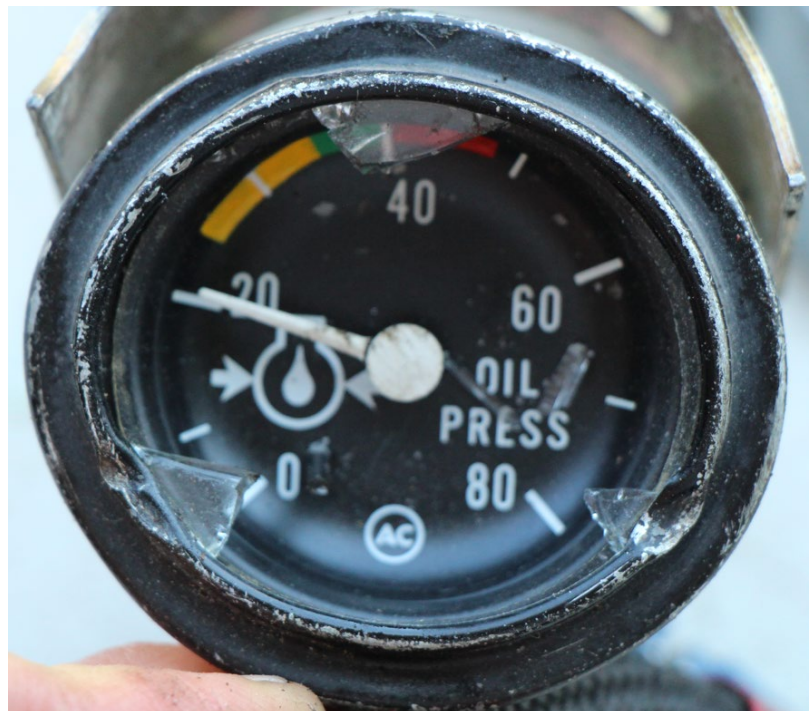
The oil pressure gauge needle could not be manipulated by hand and indicated about 21 psi. A mechanic, who was scheduled to race the accident airplane at the upcoming Reno Air Races reported that he observed the oil pressure gauge at 10 psi prior to the accident flight.

**Photograph 8: Oil pressure gauge**

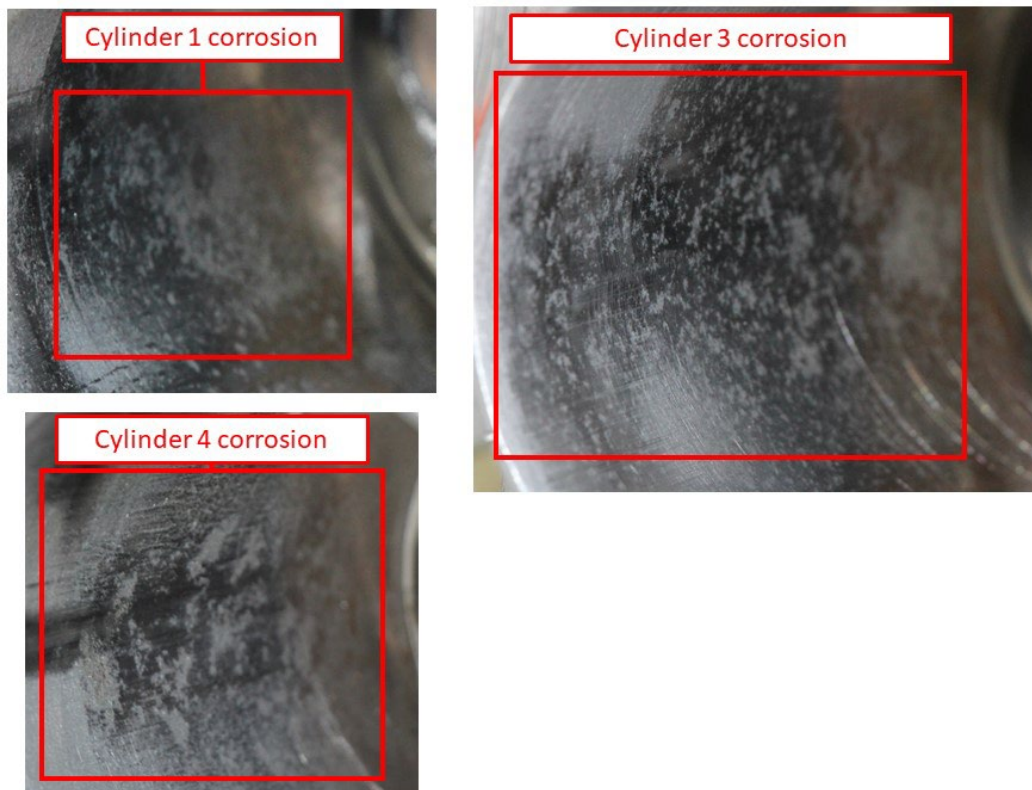
The cylinders were removed from the engine case along with the pistons, connecting rods and bearings. Corrosion and pitting was observed along the walls of each cylinder. In addition the walls exhibited longitudinal scoring and lateral scoring. Some of the lateral scoring marks were deep with a defined groove. The automotive piston rings remained installed at each piston and were unremarkable.

**Figure 1: Corrosion on cylinders walls**

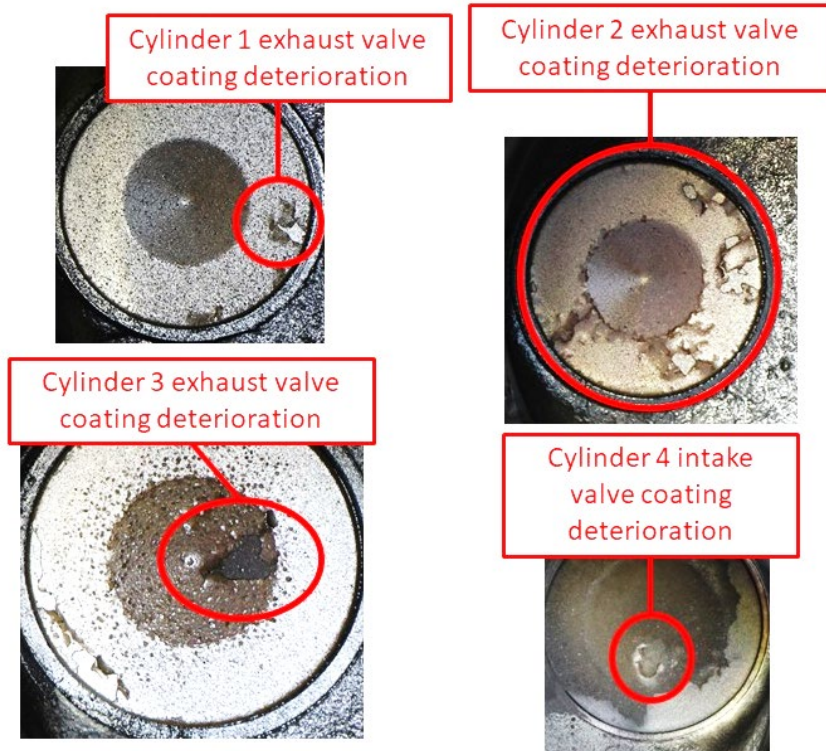
Mechanical continuity was established throughout the rotating group, valve train and accessory section as the crankshaft was manually rotated at the propeller by hand. Thumb compression was achieved at all four cylinders in the proper firing order and most of the valves displayed normal lift when the crankshaft was rotated. The cylinder 4 intake pushrod was bent, which inhibited compression and valve movement. After the push rod was straightened cylinder 4 exhibited normal compression and valve lift. Examination of the cylinders combustion chamber interior components using a lighted borescope revealed corrosion along the cylinders walls at each of the four cylinders, pitting, and longitudinal scoring. Each cylinder displayed normal piston face and valve signatures, and no indications of catastrophic engine failure. The valves were intact and did not display any eyebrow marks on the piston tops; however, some deterioration of the plated exhaust valves was observed.

**Figure 2: Valve coating deterioration**

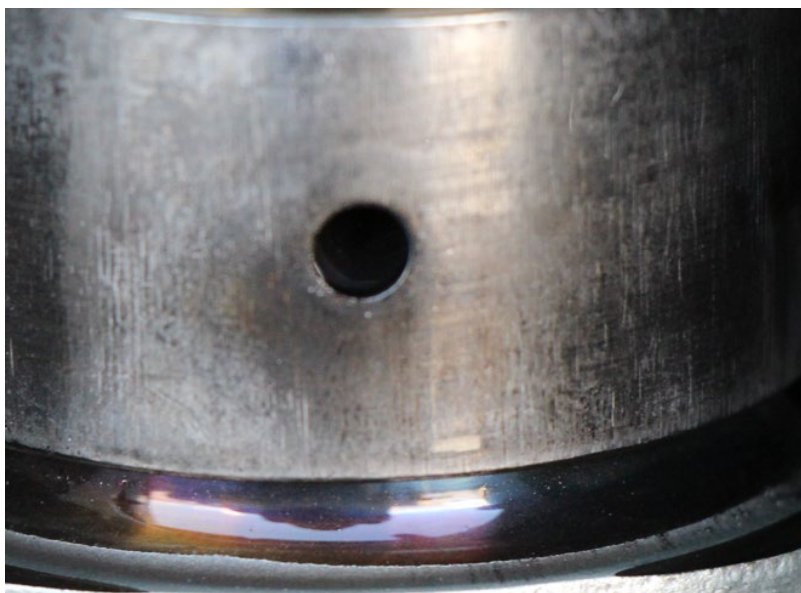
The connecting rods all remained attached to the crankshaft at their respective journals; however, each of the four rods displayed about 1mm of play. Each crankshaft was otherwise unremarkable. The oil at the some of the connecting rod journals exhibited a blue hue.

**Photograph 9: Cylinder 3 bearings at connecting rod journal**

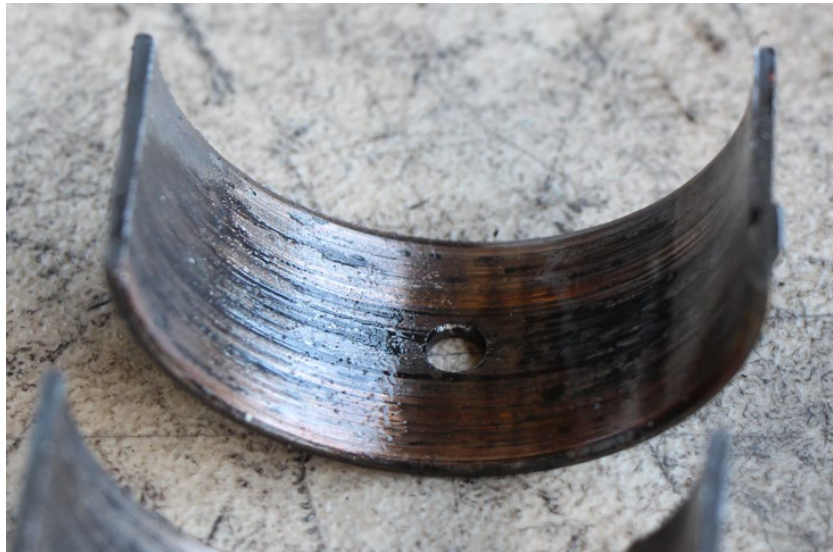
Each of the connecting rod bearings exhibited circumferential scoring and some wear was noted along the bearing races.

**Photograph 10: Cylinder 3 connecting rod bearing**

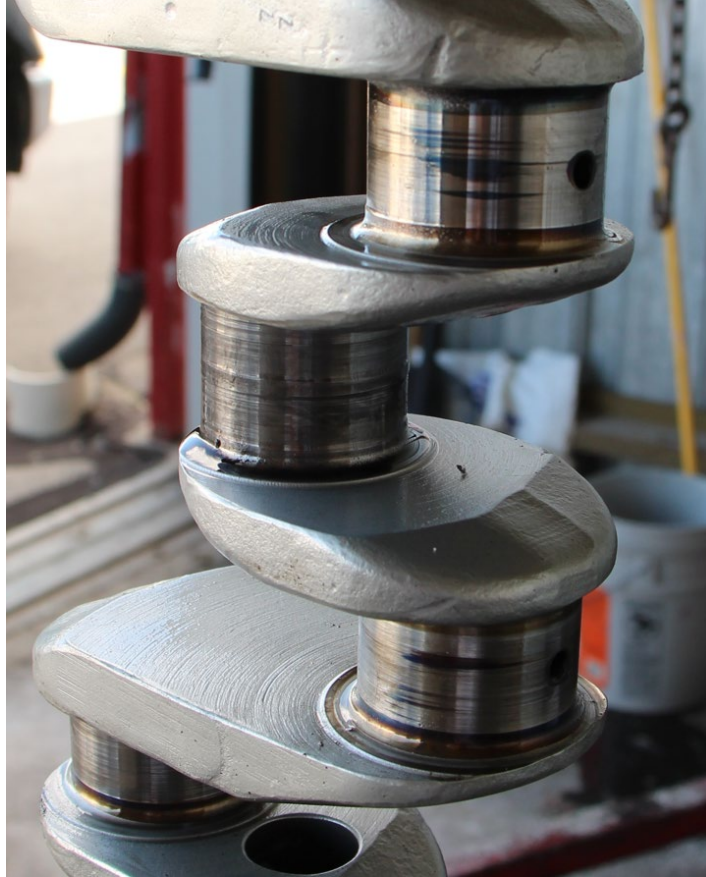
The camshaft lobes and valve lifters were undamaged; the lobes were not worn and the lifters were not spalled or pitted. Each of the connecting rod journals exhibited scoring along the circumference.

**Photograph 11: Crankshaft journals**
