# National Transportation Safety Board

WPR23FA344

## **WRECKAGE EXAMINATION SUMMARY REPORT**

Location: Lake Sammamish, Washington  
Date: 9/15/2023  
Time: 1058 Local  
Airplane: Seawind 3000 (N57TJ)

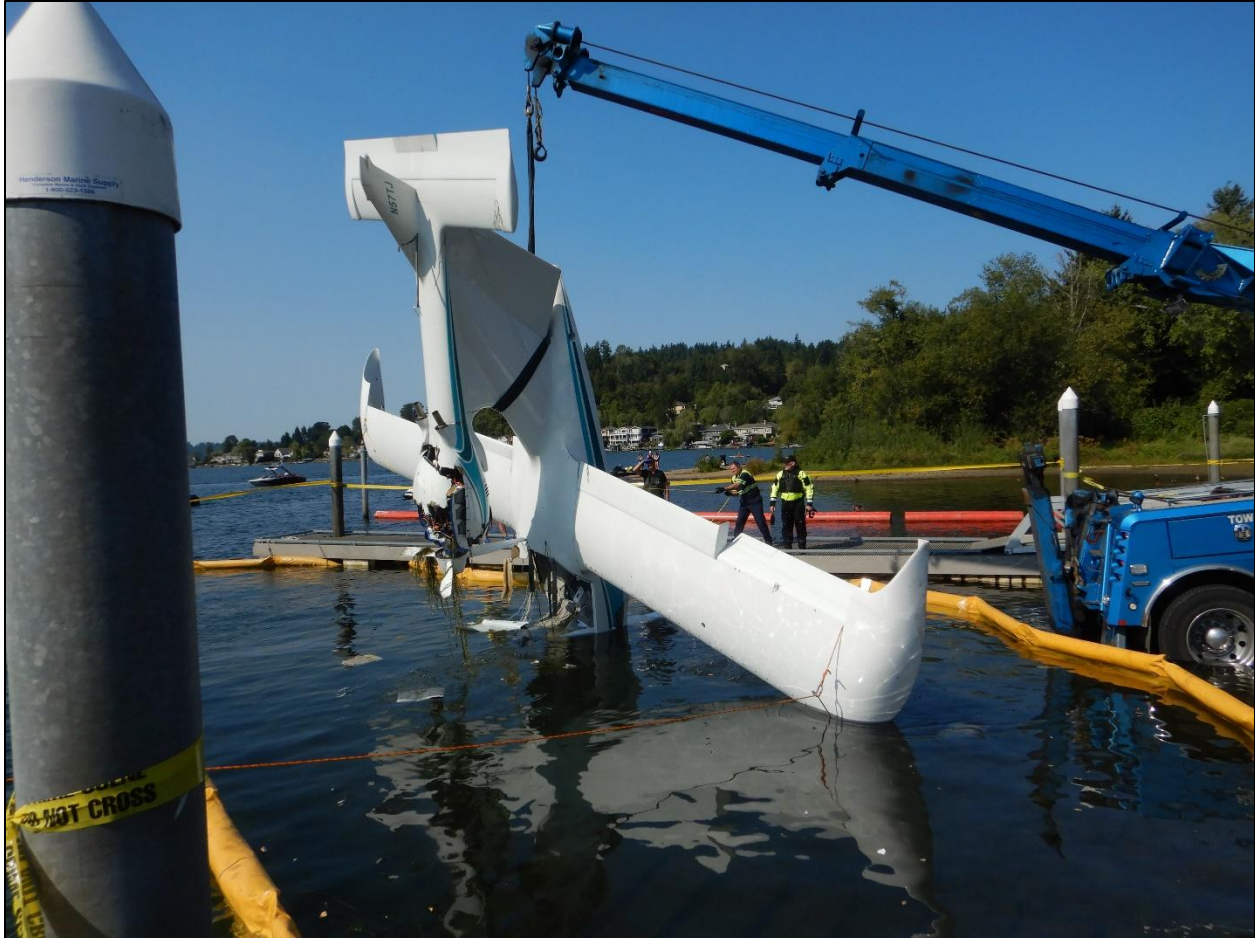
The accident site is located near the pilot's residence on the west cost of Lake Sammamish. Aerial photos from the local media shows the airplane inverted in the water and a debris field about 100 ft in diameter floating on the water. Soon after the accident, the local law enforcement gathered floating debris and towed the airplane to the Lake Sammamish State Park Boat Launch at Jensen's Cove, on the southeast side of the lake, about a 3-1/2 mile distance. The next day a salvage company was hired by the pilot's family to recover the airplane from the water to the pilot's residence. The forward fuselage structure including the canopy was missing. The right aileron separated from the airplane, was found in two sections and was found with in the floating debris. The wings and elevator and horizontal stabilizer were separated by the recovery company for transportation of the wreckage.

**Figure 1. Main wreckage recovery from the water.**

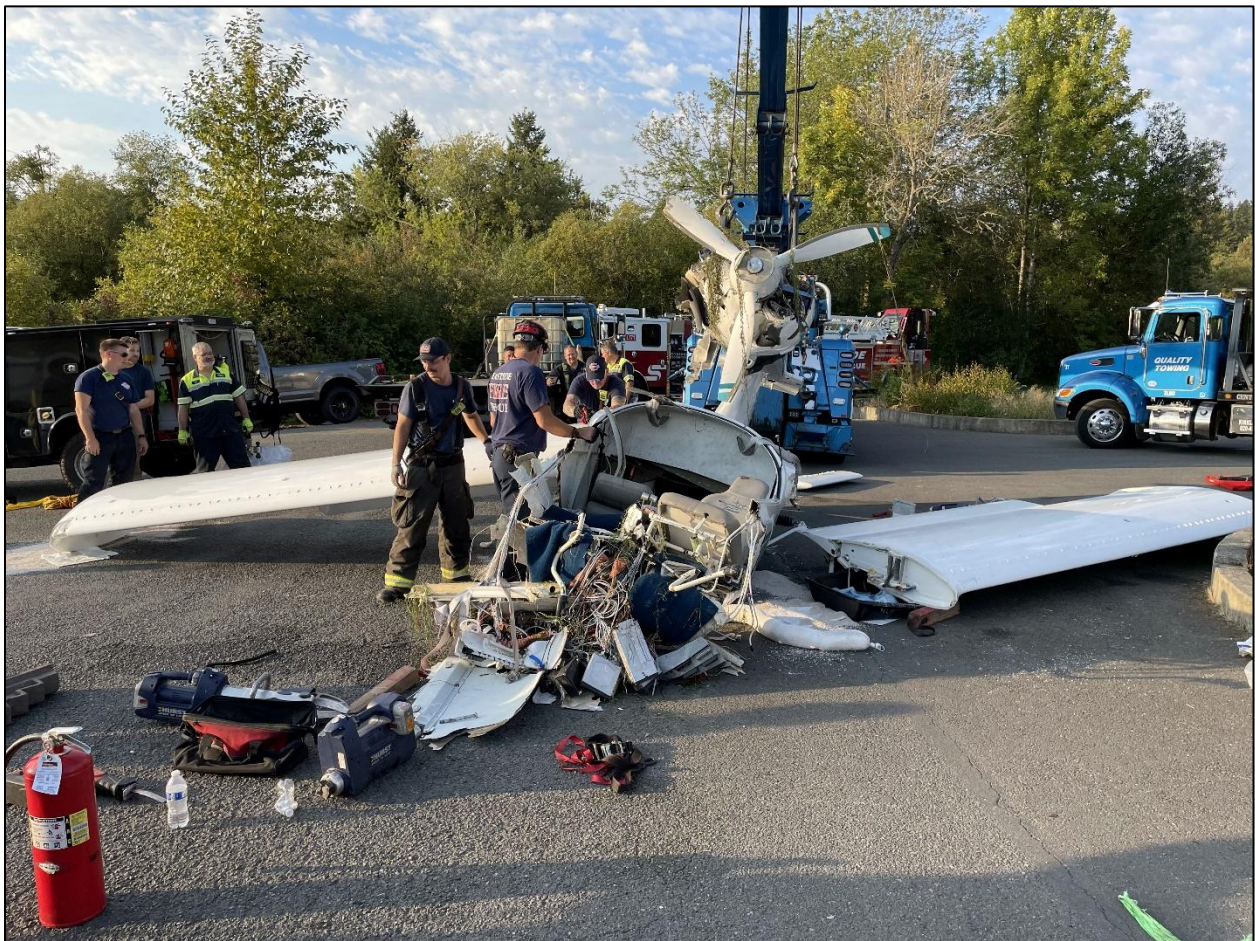
**Figure 2. Recovery process.**

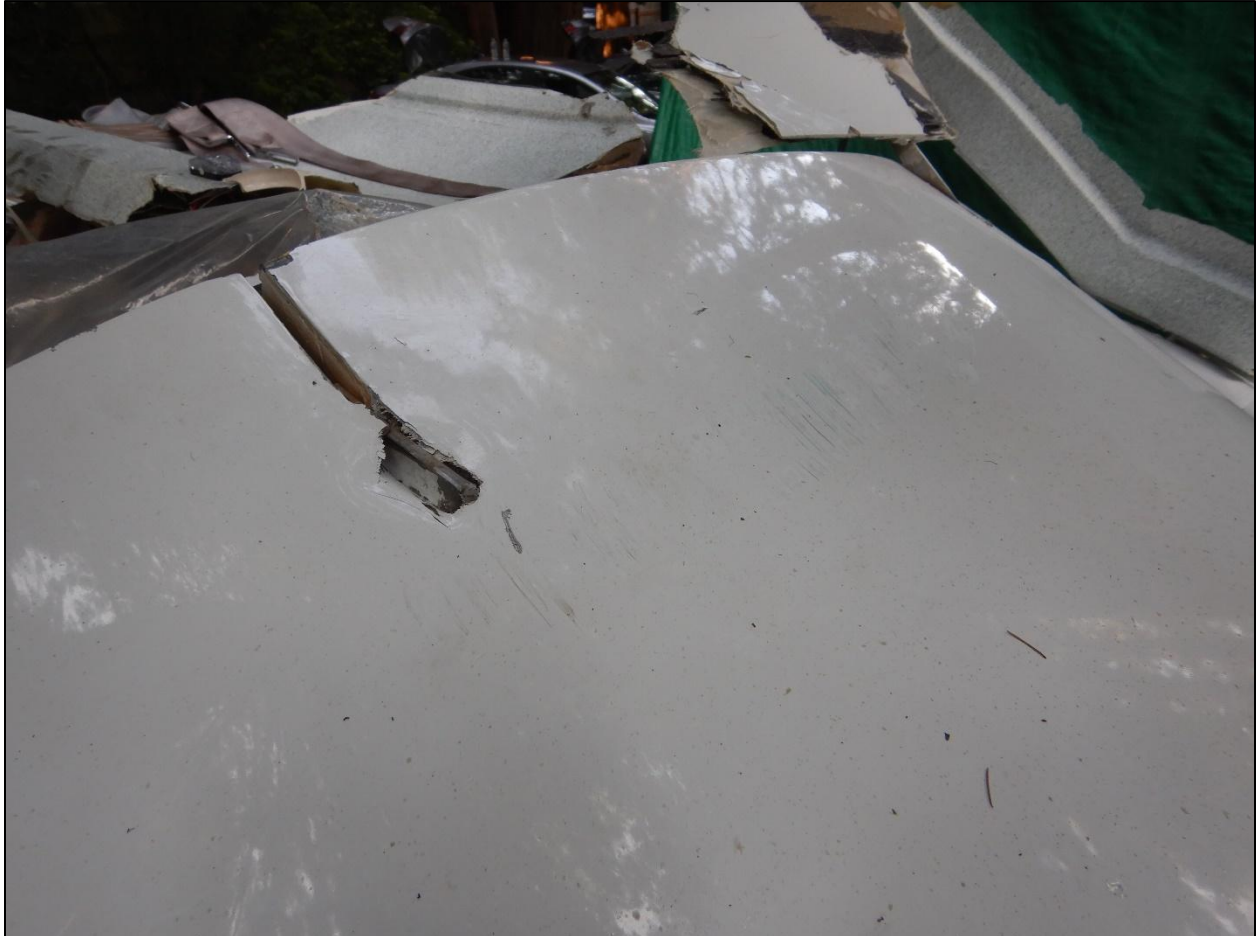
The canopy left hinge support separated from the canopy and was found imbedded in the fuselage. The right canopy hinge support remained attached to a portion of the canopy. Scuff marks were found on the fuselage between the hinge supports.

**Figure 3. Canopy hinges.**

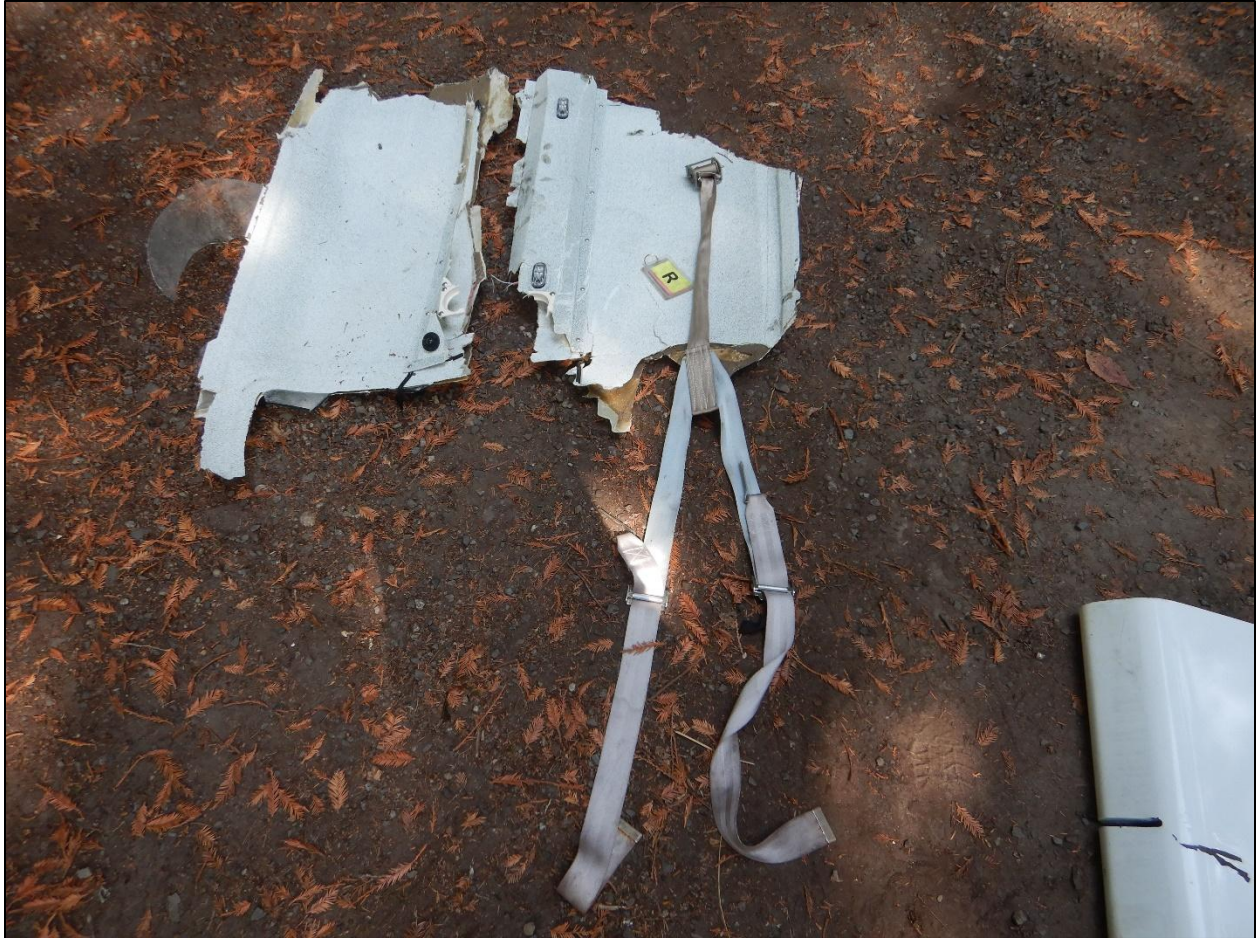
The forward seat lap belts remained attached to the airframe structure and were unlatched and undamaged. The right forward seat shoulder harness was undamaged and remained attached to the right section of the canopy ceiling panel with a castellated nut and bolt. The inertia reel spring separated from the inertia reel and was found unwound underneath the pilot's seat. The inertia reel was damaged and pulled to the left side. The left forward shoulder harness inertia reel and webbing were not found during the examination. The shoulder harness canopy mounting bolt remained attached to the left section of the canopy ceiling. The bolt threads near the tip on its forward-facing side were damaged and had embedded green colored material. Circular wear marks were identified on the ceiling panel near the bolt.

**Figure 4. Canopy ceiling portions and shoulder harness.**

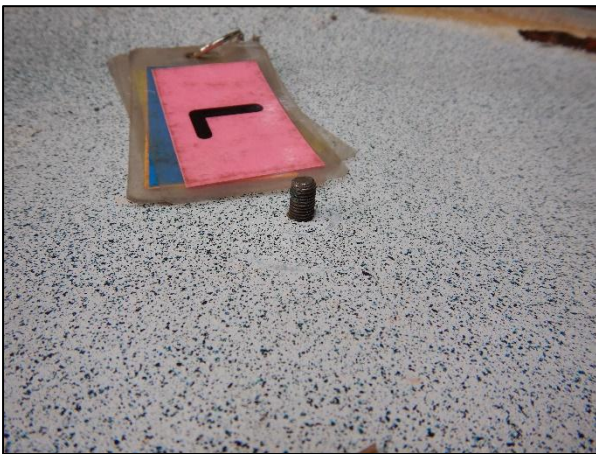
**Figure 5. Left forward seat shoulder harness canopy mounting bolt.**

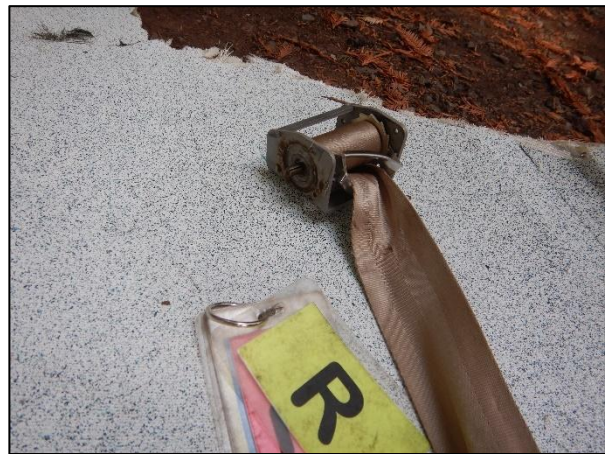
**Figure 6. Right forward seat shoulder harness inertia reel.**

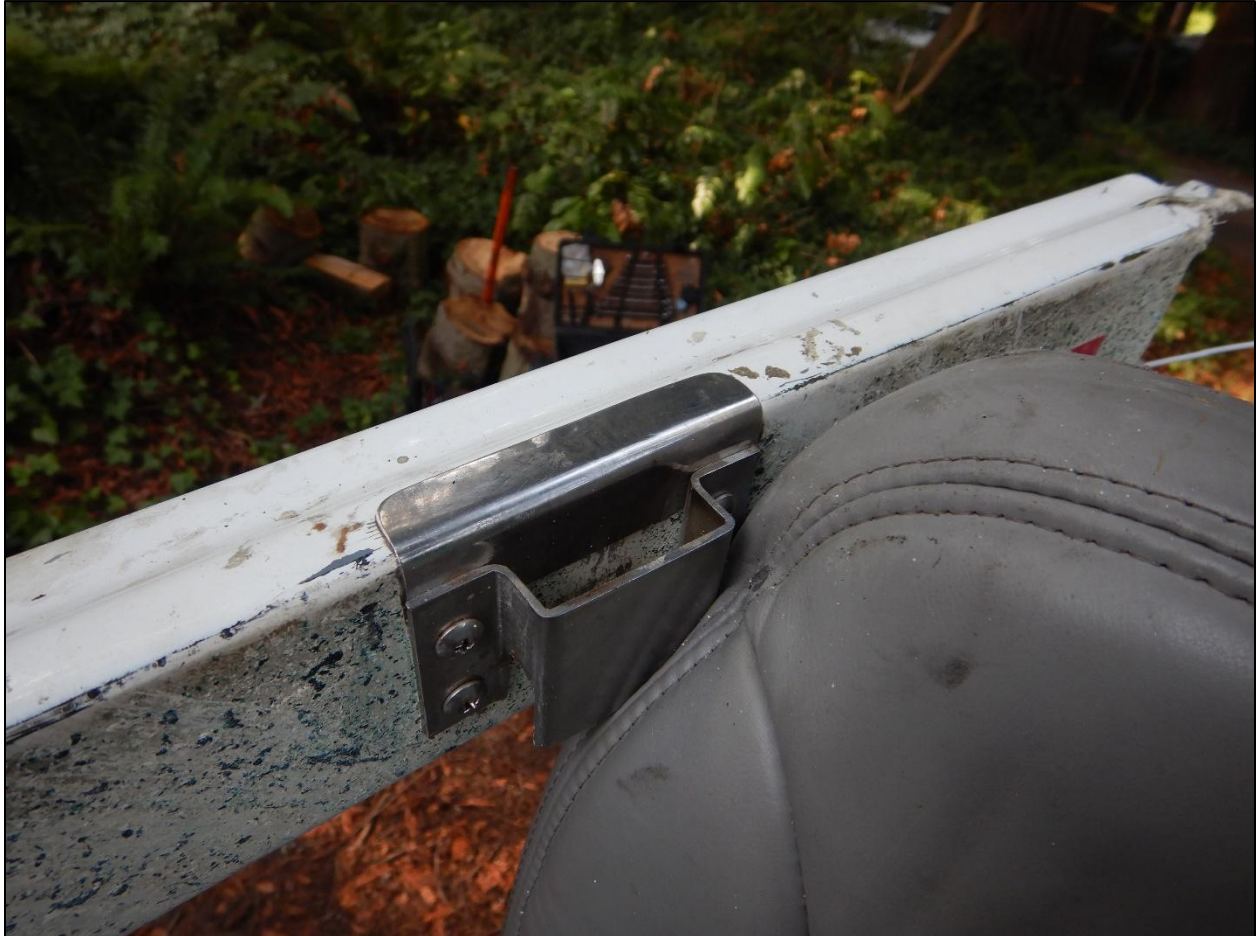
The canopy left latch pocket remained attached and was undamaged. The right canopy latch and receiver were not found during the examination. Both of the forward canopy side-locking mechanisms or the receiving ends were not found during the examination.

**Figure 7. Left canopy latch receiver location.**

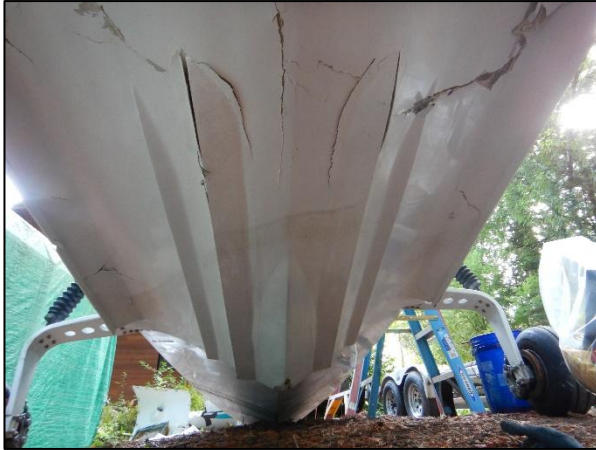
The forward section of the hull was not found during the examination. The forward section of the recovered hull had delamination damage on the hull stem and strakes forward ends. The attached portions of the spray rail were damaged during the recovery process. The several spray rail portions were found in the debris.

**Figure 8. Airplane hull aft view.**

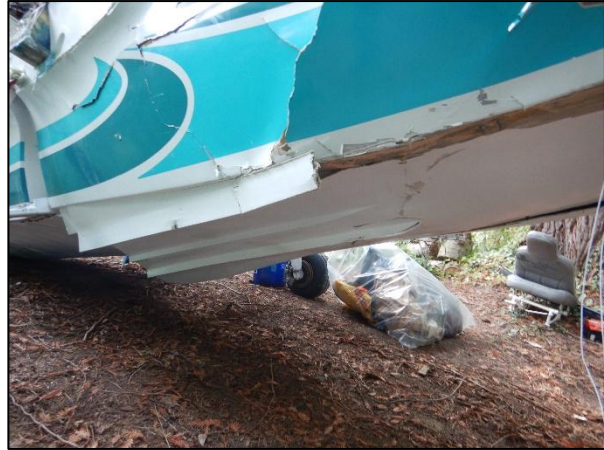
**Figure 9. Airplane hull side view.**

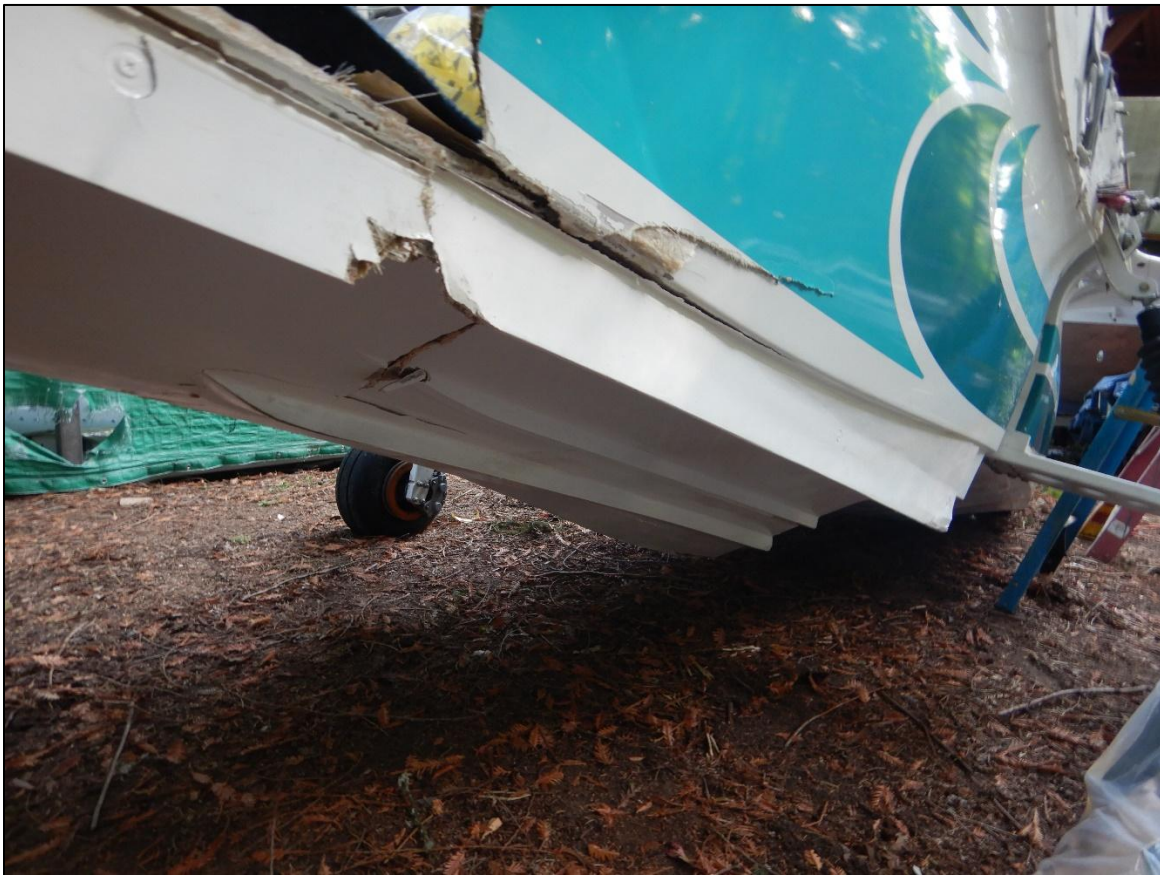
**Figure 10. Airplane hull left side view.**

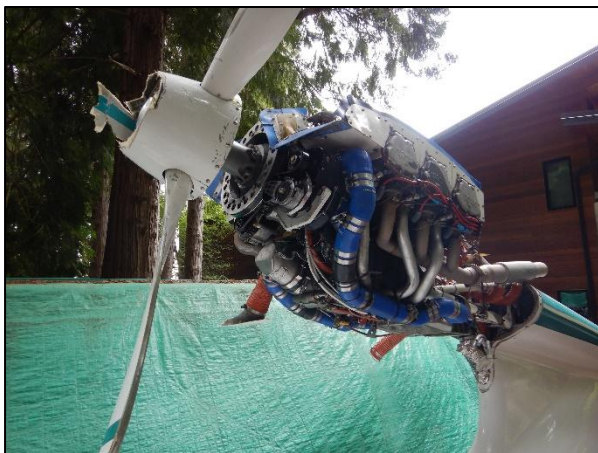
The spark plugs were removed from the Lycoming AEIO-540-L1B5 supercharged (serial number L-25114-48) engine. The automotive spark plug electrode areas had light amounts of combustion residue. The electrodes showed a normal wear condition. The cylinder rocker covers were removed, and the cylinder valve train components were lubricated and undamaged. The single TCM magneto was removed and had water in its housing. The water was removed and spark was obtained from the unit. The electronic ignition and automotive spark plug ignition leads were undamaged. The induction air inlet did not have a filter screen. Engine control linkage moved from stop to stop. The oil was drained and the oil pickup screen was clear of debris. The oil filter was removed and disassembled. No metal particles were identified. The crankshaft was rotated freely by hand and engine gear and valve train continuity was obtained. Compression was felt at all cylinders. The cylinders were examined with a lighted boroscope and no anomalies were noted.

**Figure 11. Lower left view of the engine and propeller.**

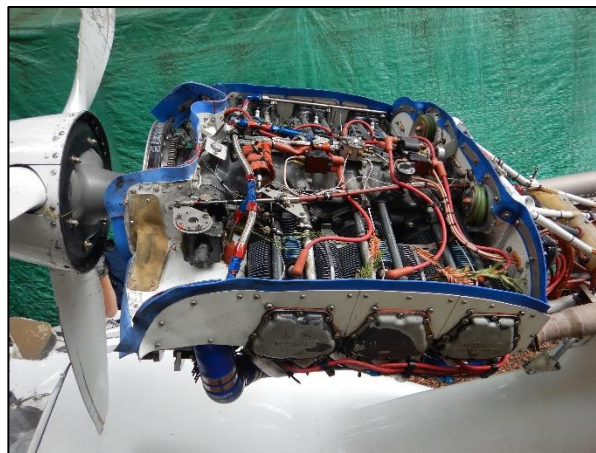
**Figure 12. Upper left view of the engine.**

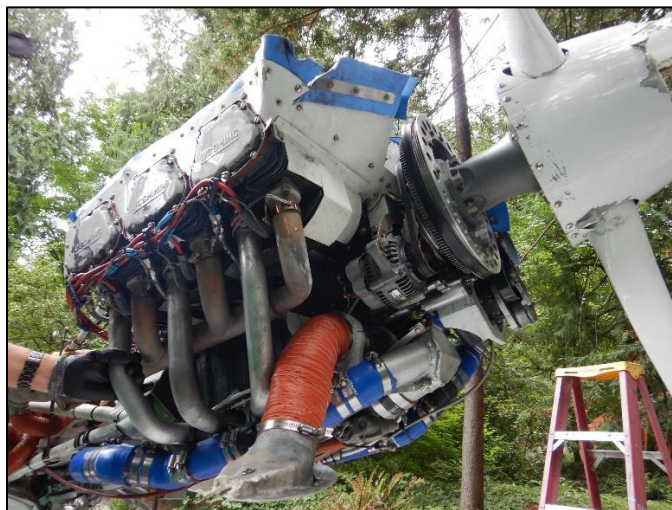
**Figure 13. Lower right view of the engine.**

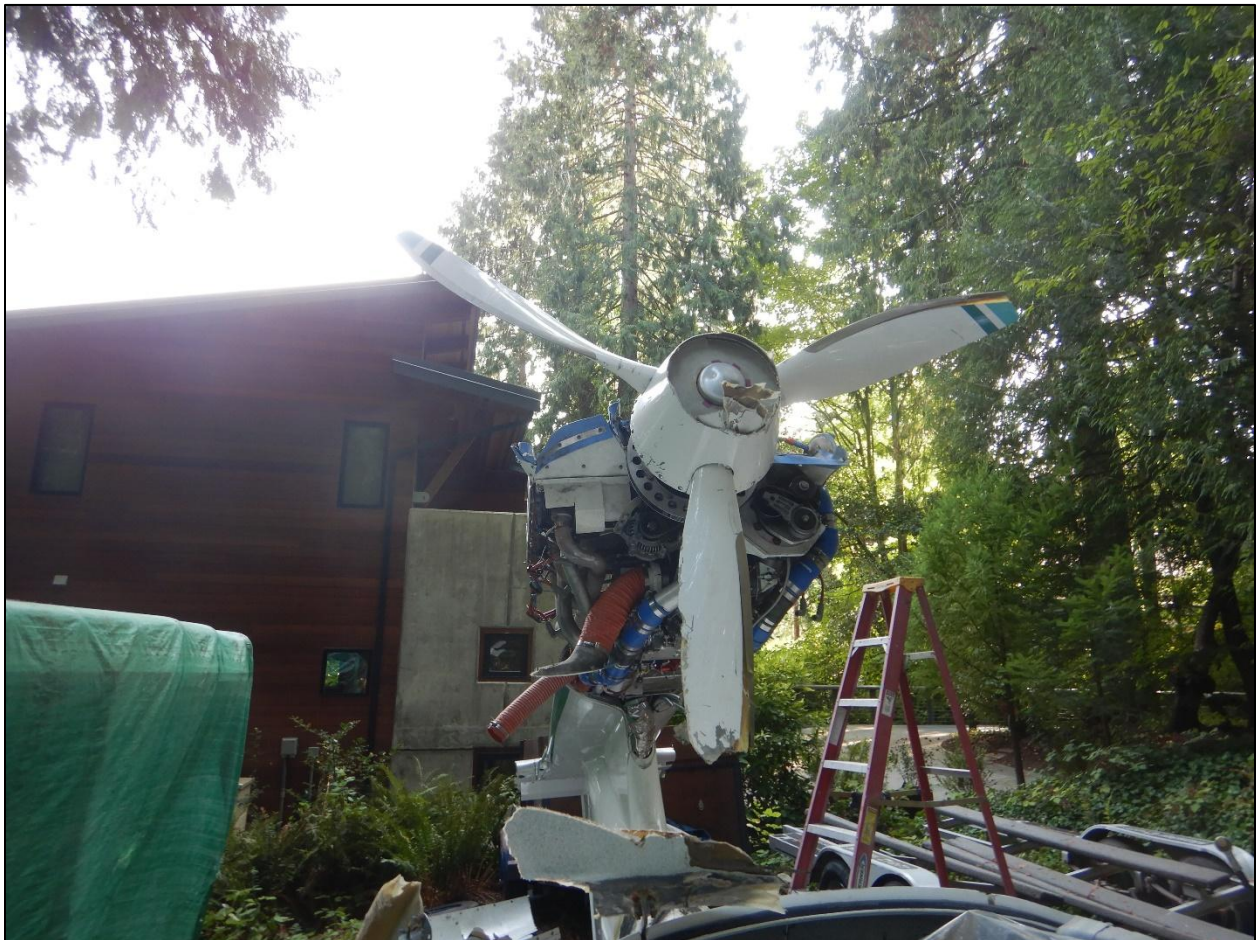
The propeller remained attached to the engine crankshaft flange. The spinner tip was missing, and painted fiberglass material was found wedged in the remaining attached spinner. It was later determined that the painted fiberglass section was from the forward fuselage. One blade was loose in the hub and was missing about 3 inches of the tip. The blade had multidirectional scoring on both sides of the blade. Another blade had delaminated near the tip and had nicks and scoring on both sides of the blade. The last blade had the least amount of nicks and scoring on both side of the blade.

**Figure 14. Engine and propeller assembly.**
