# National Transportation Safety Board

WPR23LA351

## **WRECKAGE EXAMINATION REPORT**

Location: Arlington, Washington  
Date: September 22, 2023  
Time: 1446 Pacific daylight time  
Airplane: Golden Circle Tbird II, Unregistered

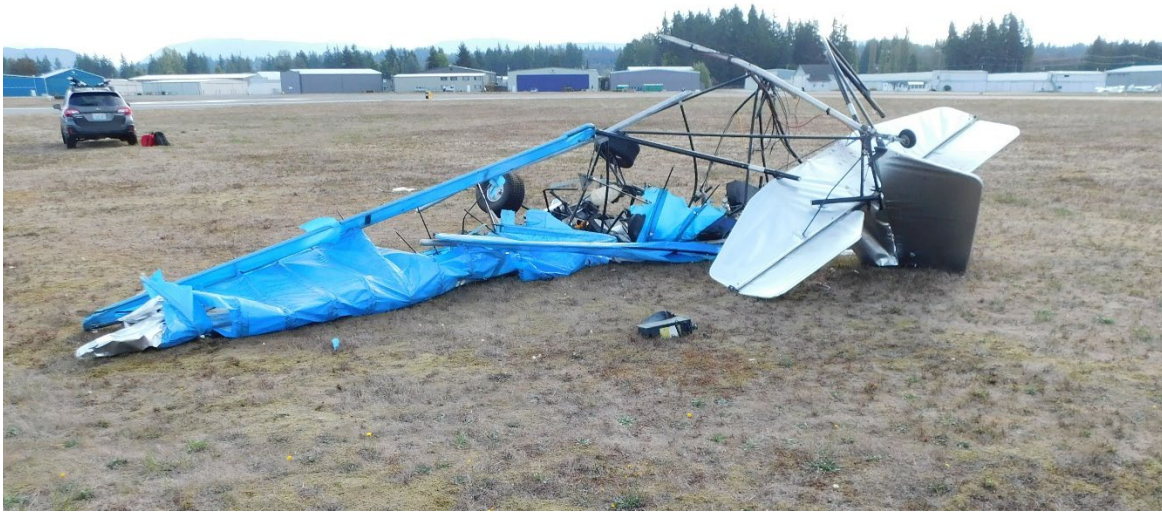
The airplane came to rest inverted in a grass area about 275 ft west of the runway 16 numbers. Several structural tubes were positioned between the main wreckage and separated left wing, which came to rest about 400 ft northeast of the main wreckage. Propeller blade fragments were located around the left wing. The right wing cloth was torn and the wing structural tubes were all bent. The vertical stabilizer was crushed while rudder, horizontal stabilizer, and elevator remained undamaged. The engine remained attached to the fuselage and the propeller blades were attached to the crankshaft through the propeller hub.

**Figure 1: Main wreckage**
