# National Transportation Safety Board

WPR23LA002

## **AIRFRAME & ENGINE EXAM**

Location: Clovis, New Mexico  
Date: October 2, 2022  
Time: 1600 mountain daylight time  
Airplane: Piper PA-46-350P, N987PS

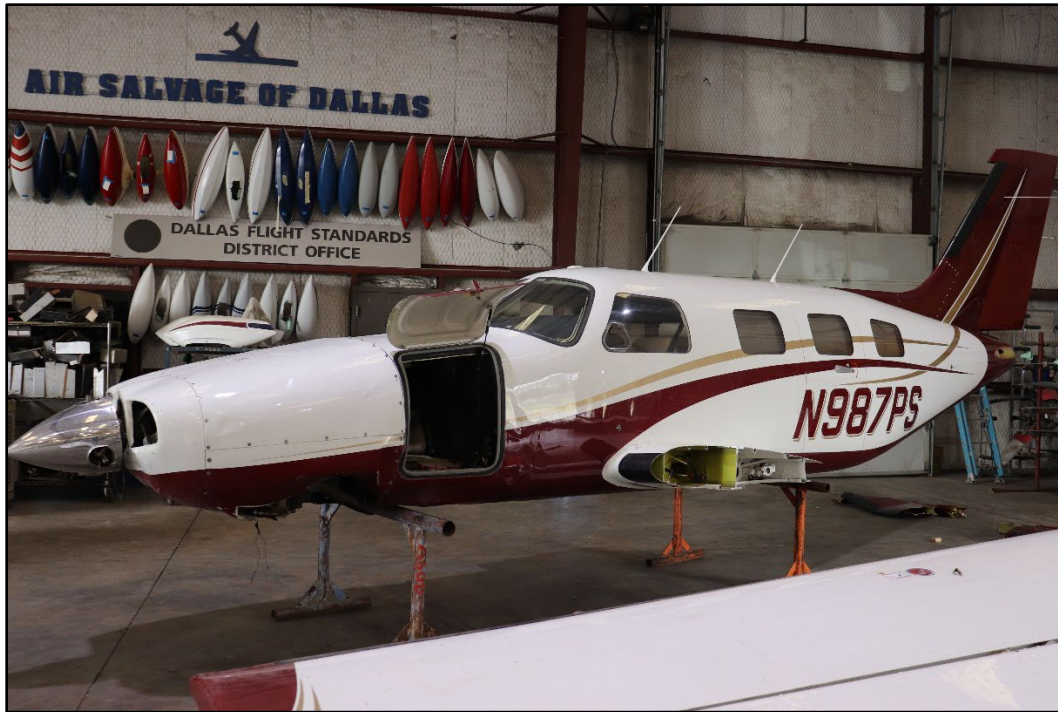
Examination of the recovered airframe revealed that the recovery organization had cut both wings chordwise about 18" outboard of the fuselage, and removed both horizontal stabilizers and elevators for transport. The forward section of the fuselage, near the cockpit was impact and thermal damaged. The observed hobbs meter time was 2936.8 hours.

**Figure 1: View of airplane during examination.**

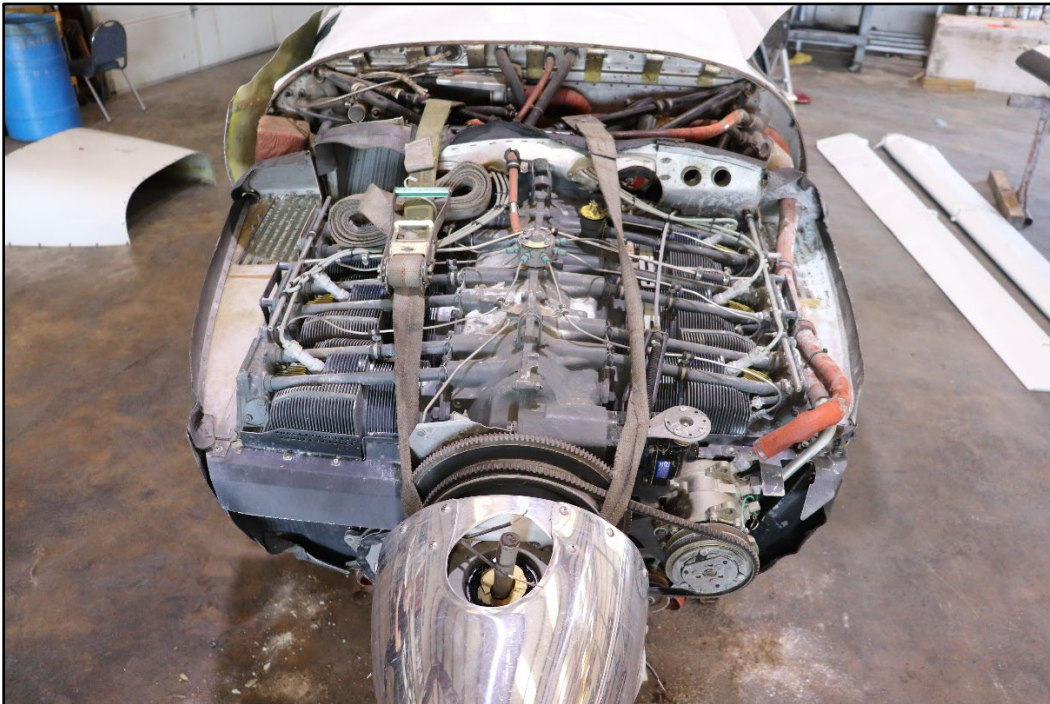
Examination of the recovered engine revealed that the two upper engine mounts had fracture separated. All six cylinders remained attached with no damage noted. All fuel and oil lines that were removed were tight. No evidence of any mechanical damage was observed to the engine crankcase.

**Figure 2: View of airplane engine during examination.**

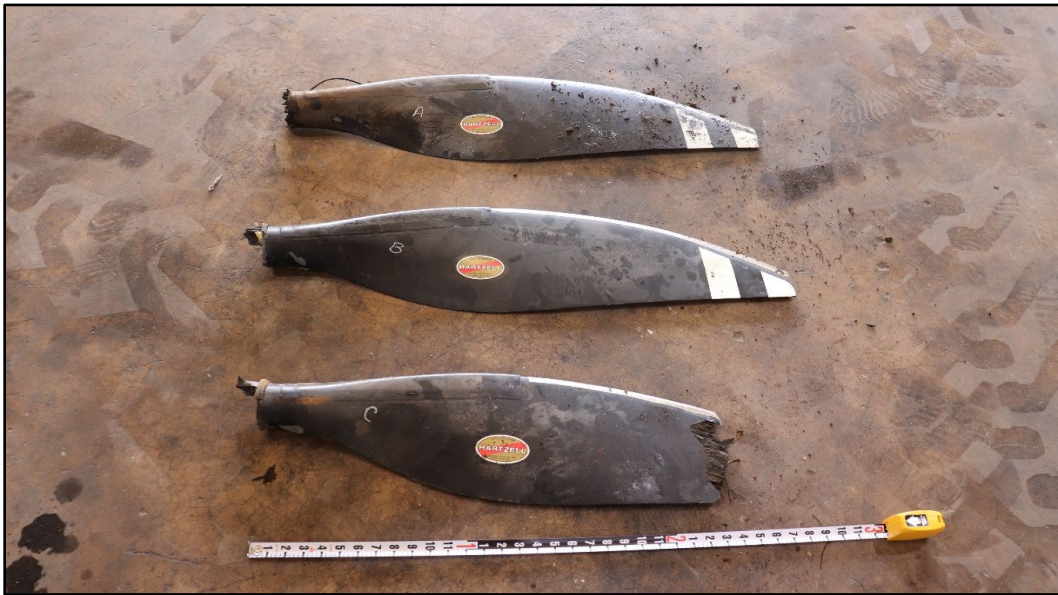
The airplane was equipped with a 3 blade, constant speed propeller. The propeller blades separated near the propeller hub. For the purposes of this examination, the propeller blades where labeled A, B, and C.

Propeller blade A exhibited a crack from the leading edge to the trailing edge, near the tip with polishing of the blade face along with chordwise striations on the cambered side of the blade. Propeller blade B exhibited polishing of the blade face along with unidirectional striations on the cambered side of the blade. Propeller blade C exhibited a separation near the propeller tip with polishing of the blade face along with chordwise striations on the cambered side of the blade.

**Figure 3: View of propeller blades during examination.**
