# National Transportation Safety Board

## **MATERIALS LABORATORY**

Factual Report 23-081

Location: Fresno, California  
Date: October 1, 2022  
Vehicle: Bell 206B, N284CA  
Investigator: Joshua Cawthra

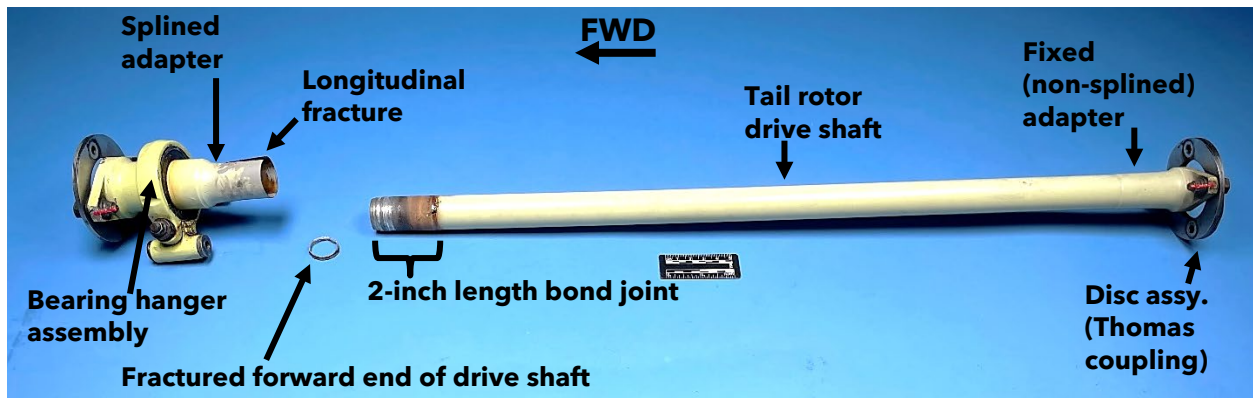
Figure 1 shows a photograph of the as-received tail rotor drive shaft assembly. This assembly was the 4th drive shaft segment from the forward end. At the time of manufacture, the forward end of the tail rotor drive shaft is inserted approximately 2 inches into the bore of the splined adapter and the two pieces are permanently joined by an adhesive. The splined adapter separated from the drive shaft at the adhesive bond joint (along the entire length of the bond joint). The aft end of the tail rotor drive shaft was bonded to a fixed (non-splined) adapter. The bonded joint at the fixed adapter remained intact.

**Figure 1.** As-received tail rotor drive shaft assembly. The tail rotor drive shaft splined adapter separated from the forward end of the shaft at the bond joint.

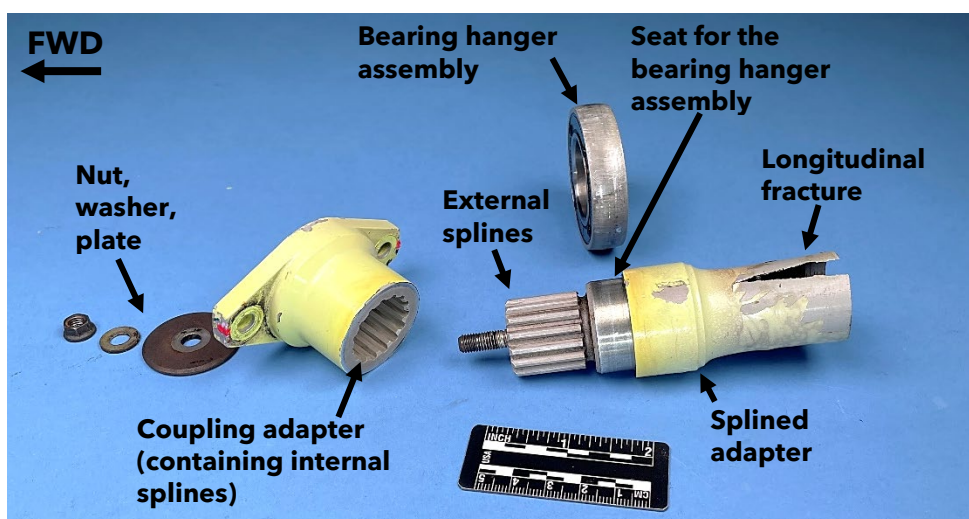
The tail rotor drive shaft and bearing hanger assembly were disassembled. The bearing assembly rotated freely. The nut, washer, and plate (disk with hole in the middle) were disassembled from the aft end of the coupling adapter, after which the coupling adapter (containing internal splines) was removed from the external spline (see figure 2). The exposed splines contained contact marks, typical of normal contact between mating parts, with no evidence of mechanical damage.

**Figure 2.** Disassembled coupling adapter and exposed splines.

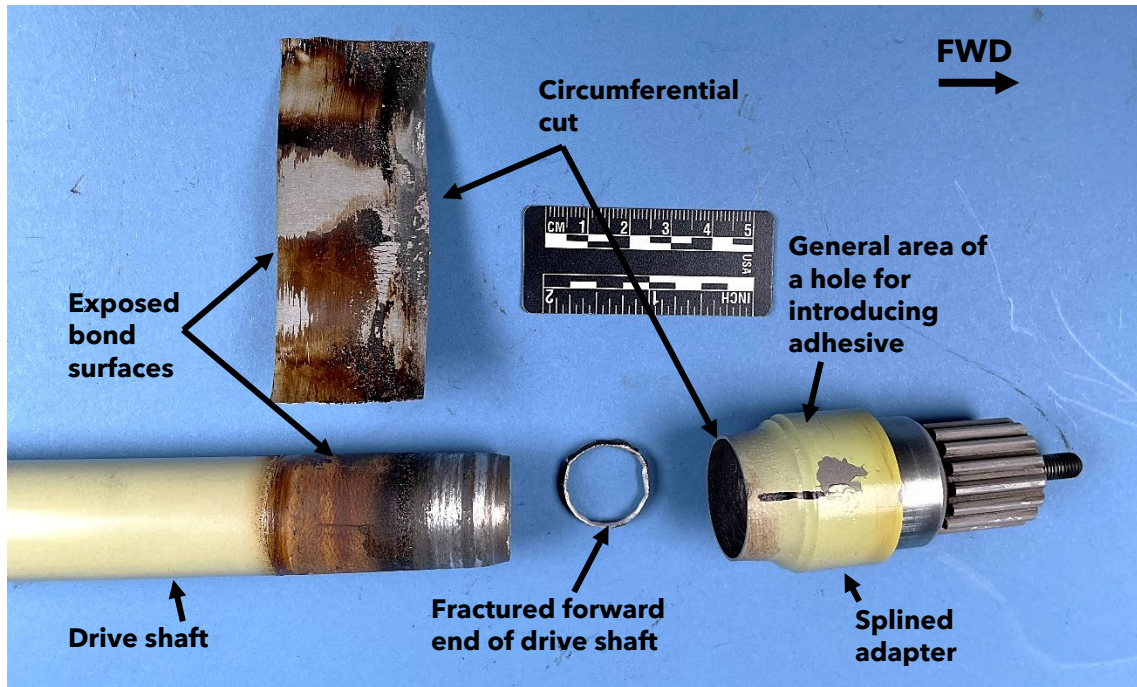
The splined adapter at the aft end contained a longitudinal crack. The length of the longitudinal crack measured approximately 1.5 inches. A circumferential cut was made through the splined adapter that intersected the forward end of the 1.5 inch portion of the crack. The cut portion was unrolled and flatted by hand into a flat sheet to expose the inner bonded surface (see figure 3). Bench binocular microscope examination of the flattened inner surface revealed mixed adhesive and bare metal areas that contained evidence of rotational mechanical damage (rotation between drive shaft and mating adapter). The adhesive material showed evidence of heating and re-solidification. Appendix 2 shows the surface finish on the inner surface in an isolated area of exposed bare metal containing no rotational mechanical damage. The mating bonded surface (on the shaft) showed evidence of adhesive material that extended all around the bond zone with extensive rotational mechanical damage.

**Figure 3.** The aft end of splined adapter was cut (circumferentially) in the area indicated by arrows to expose the bonding surfaces. At time of manufacture, the drive shaft is inserted into the bore of the splined adapter, and adhesive is introduced into the bond joint through a hole in the splined adapter. The hole is sealed by the adhesive.

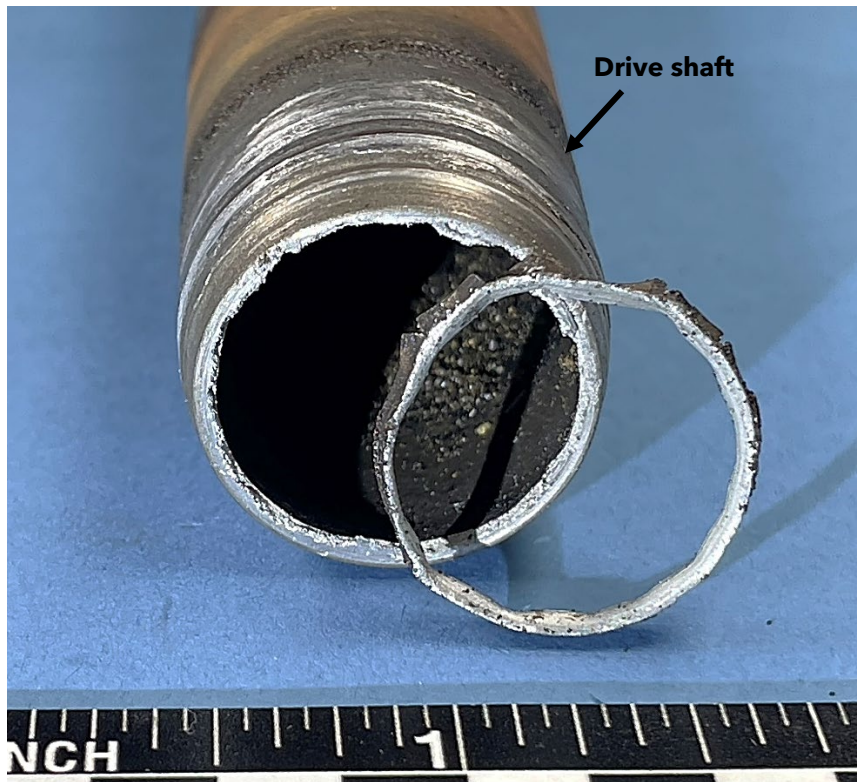
As indicated earlier, a 0.1 inch long portion of the drive shaft fractured circumferentially from the forward end of the drive shaft (see figure 4). Bench binocular microscope examination of the 0.1-inch long separated portion revealed it had turned inside-out. The original black inner surface was facing out and the rotational damaged outer surface was facing in. The manufactured aft end which remained flat (perpendicular to the length of the drive shaft). The aft end of the drive shaft contained a total of 13 axial cracks. The axial cracks were randomly distributed around the drive shaft portion. The fracture faces showed evidence of micro-void coalescent features typical of overstress separation.

**Figure 4.** View of the forward end of the drive shaft showing a 0.1 inch length portion that fractured circumferentially from the forward end.

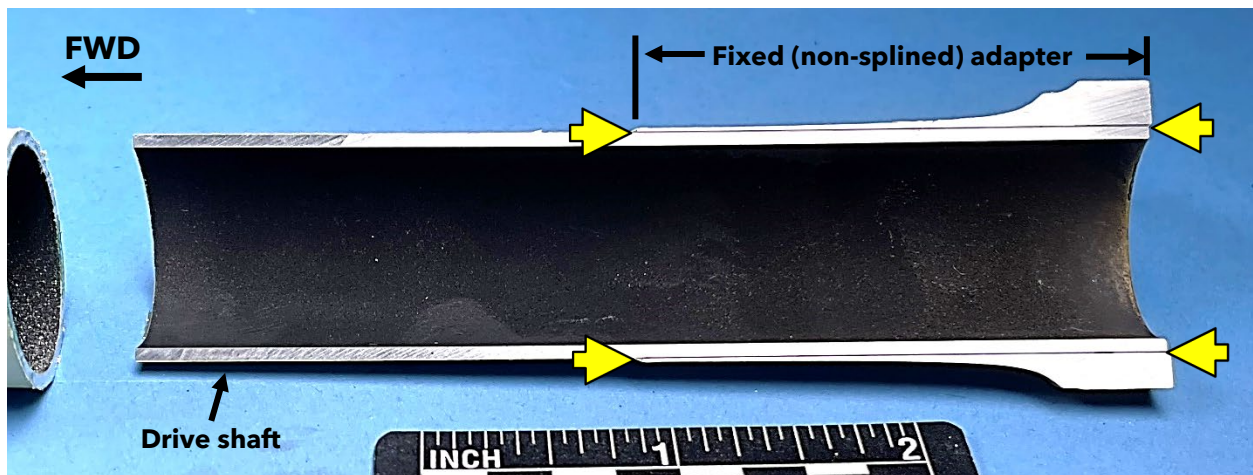
A circumferential saw cut was made on the drive shaft at an area that was located approximately 4 inches from the aft end of the fixed adapter, resulting in a 4-inch length portion that contained the fixed adapter and drive shaft. The 4-inch length portion was longitudinally sectioned in half (see figure 5). One half of the longitudinal section was dipped in a stainless steel tank that was filled with liquid nitrogen, to aid in separating the fixed adapter from the drive shaft portion. After soaking for several minutes, the drive shaft portion was forcibly separated from its mating fixed adapter half. The same procedure was repeated for the mating longitudinal half of the section. Bench binocular microscope examination of the exposed bond surfaces showed mixed bare metal and adhesive material, with no evidence of discoloration or degradation of adhesive material, and no evidence of porosity that exceed the manufacture drawing requirements (see figure 6). Appendix 2 shows the surface finish on the inner surface in an isolated area of exposed bare metal containing no rotational mechanical damage, both on the drive shaft and fixed adapter side.

**Figure 5.** Longitudinal cross section that was made through the fixed adapter showing the adhesive bonded interfaces (bond lines) located between unmarked arrows.

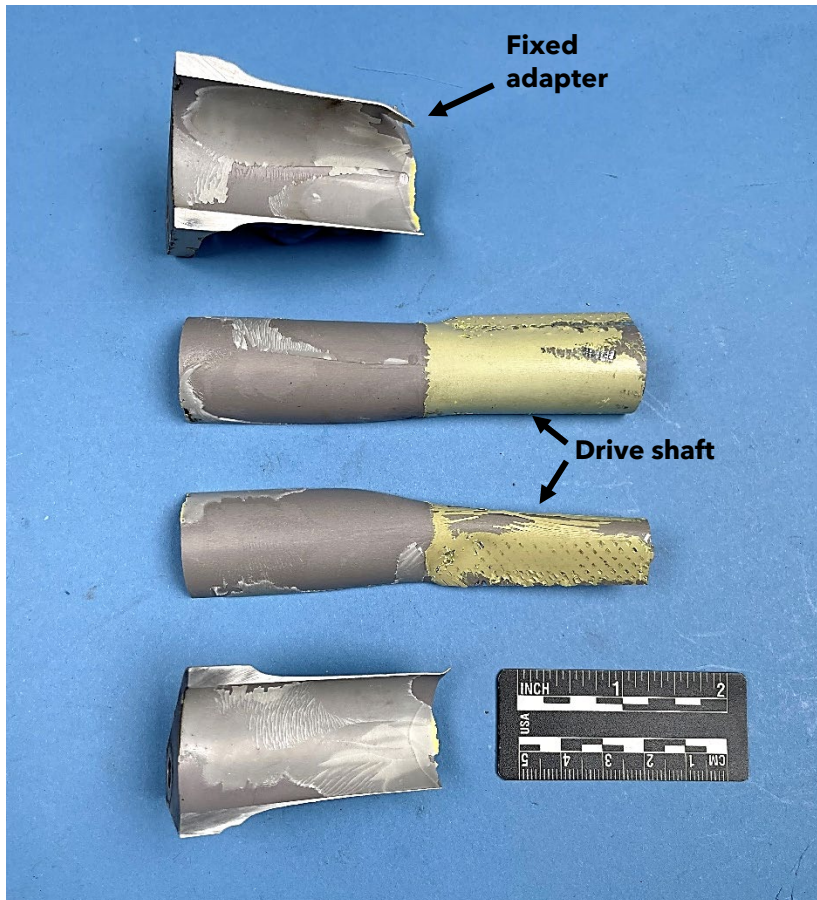
**Figure 6.** Exposed bond surfaces shown after separating the drive shaft from the fixed adapter, post dipping parts in liquid nitrogen.

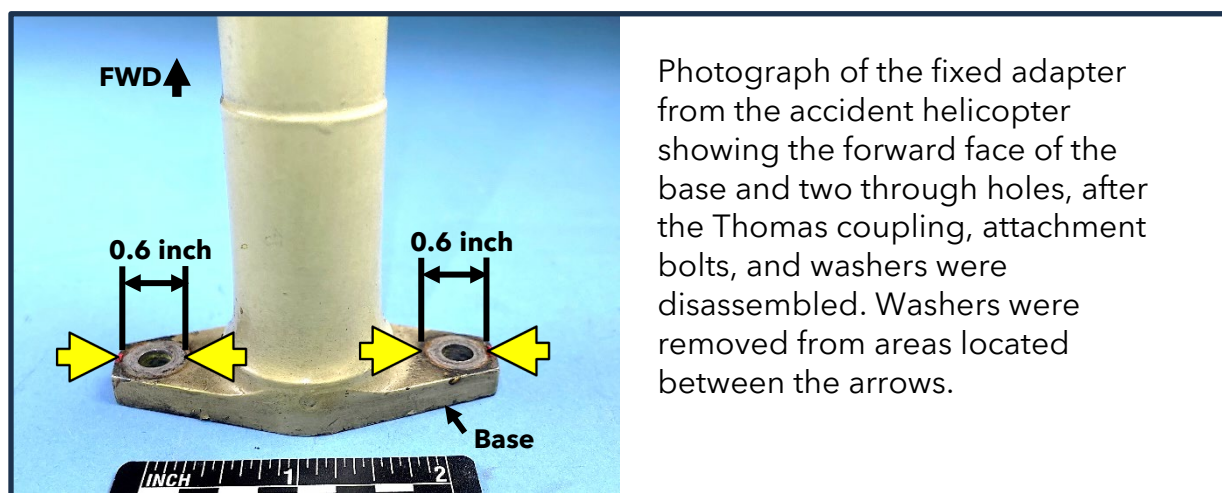
The base of the fixed adapter was attached to a Thomas coupling assembly (see figure 1) by two attachment bolts and washers. The figure below shows a photograph of the base for the fixed coupling after the bolts and washers were removed. The forward side of the base contained impressions of the washers. Based on the treatment and coatings at the base of the fixed adapter, the assembly was consistent with a -101 drive shaft assembly as opposed to the -9 assembly.

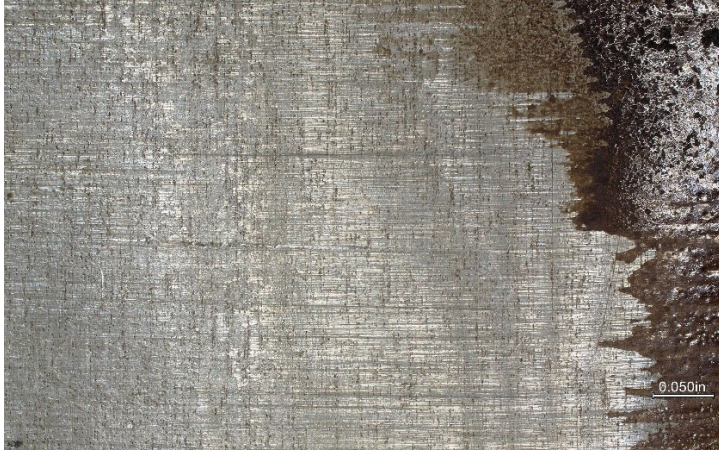
Splined adapter inner surface showing uniform circumferential surface finish scratch pattern.

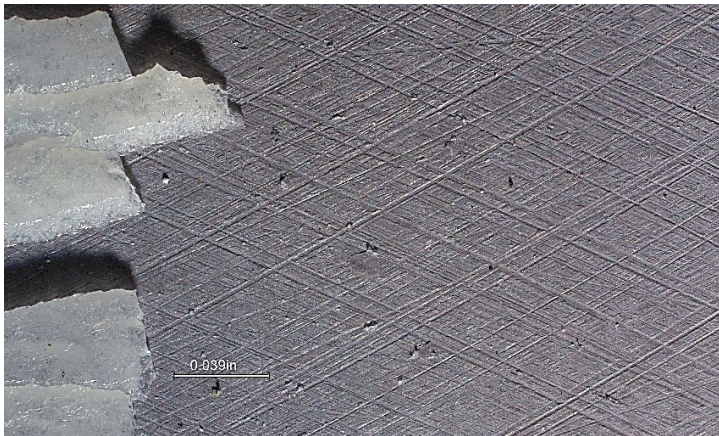
Fixed adapter inner surface showing criss-cross<sup>1</sup> surface finish scratch pattern, similar to an "X" pattern.

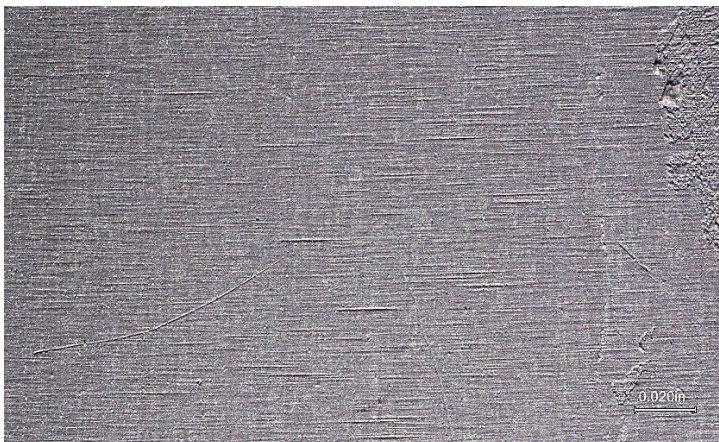
Drive shaft inner surface at the fixed adapter end showing uniform circumferential surface finish scratch pattern.
