WPR23LA004

## INVESTIGATION PHOTOGRAPHS

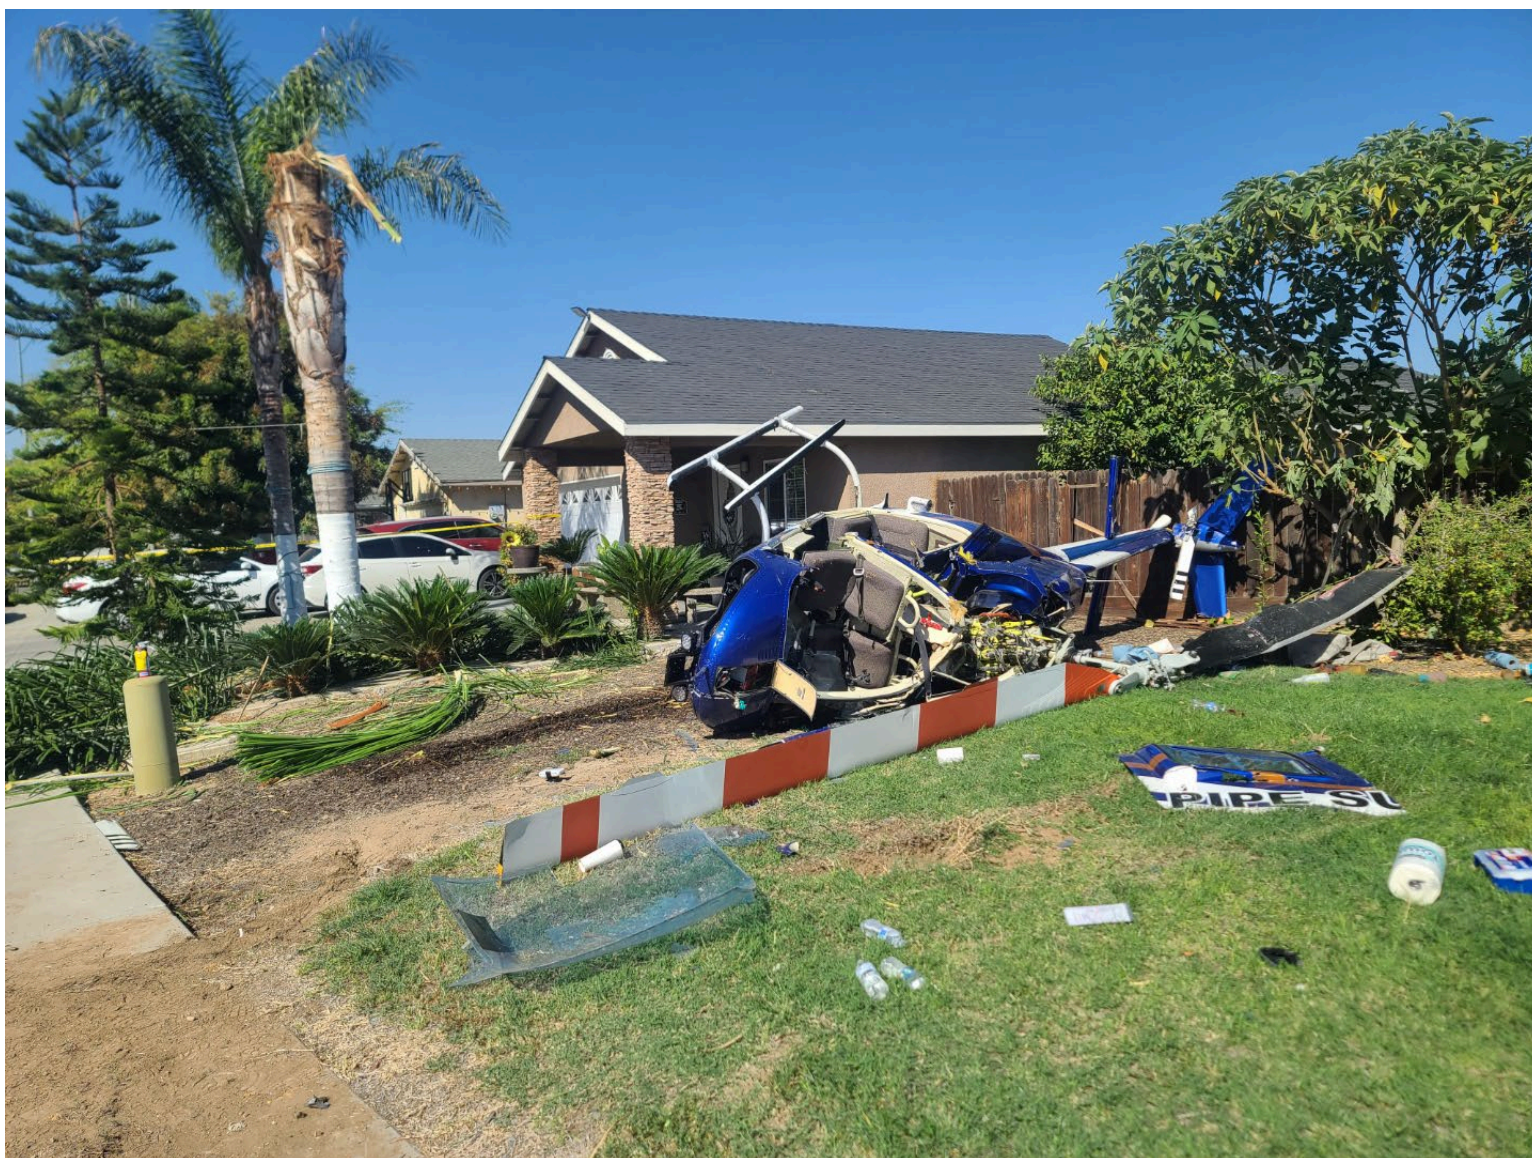
**Photograph 1 - View of the accident site (Courtesy of the FAA)**

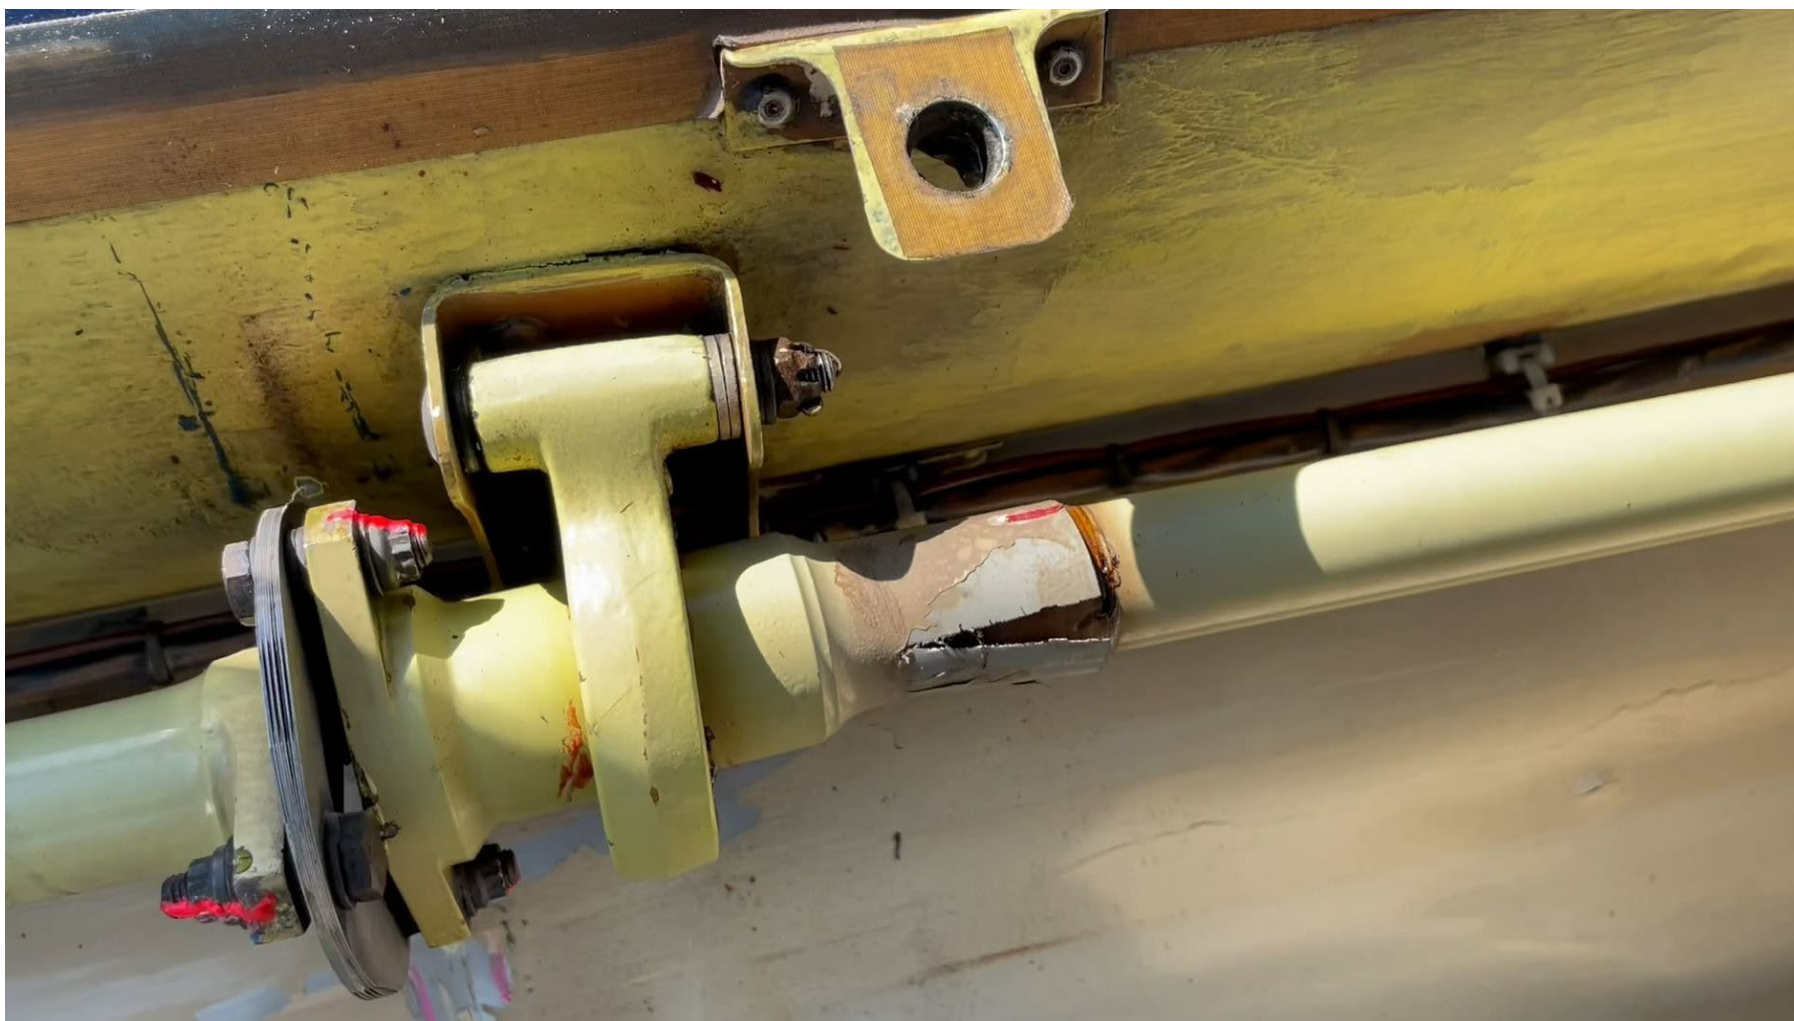
**Photograph 2 - View of the tail rotor driveshaft (Courtesy of the FAA)**
