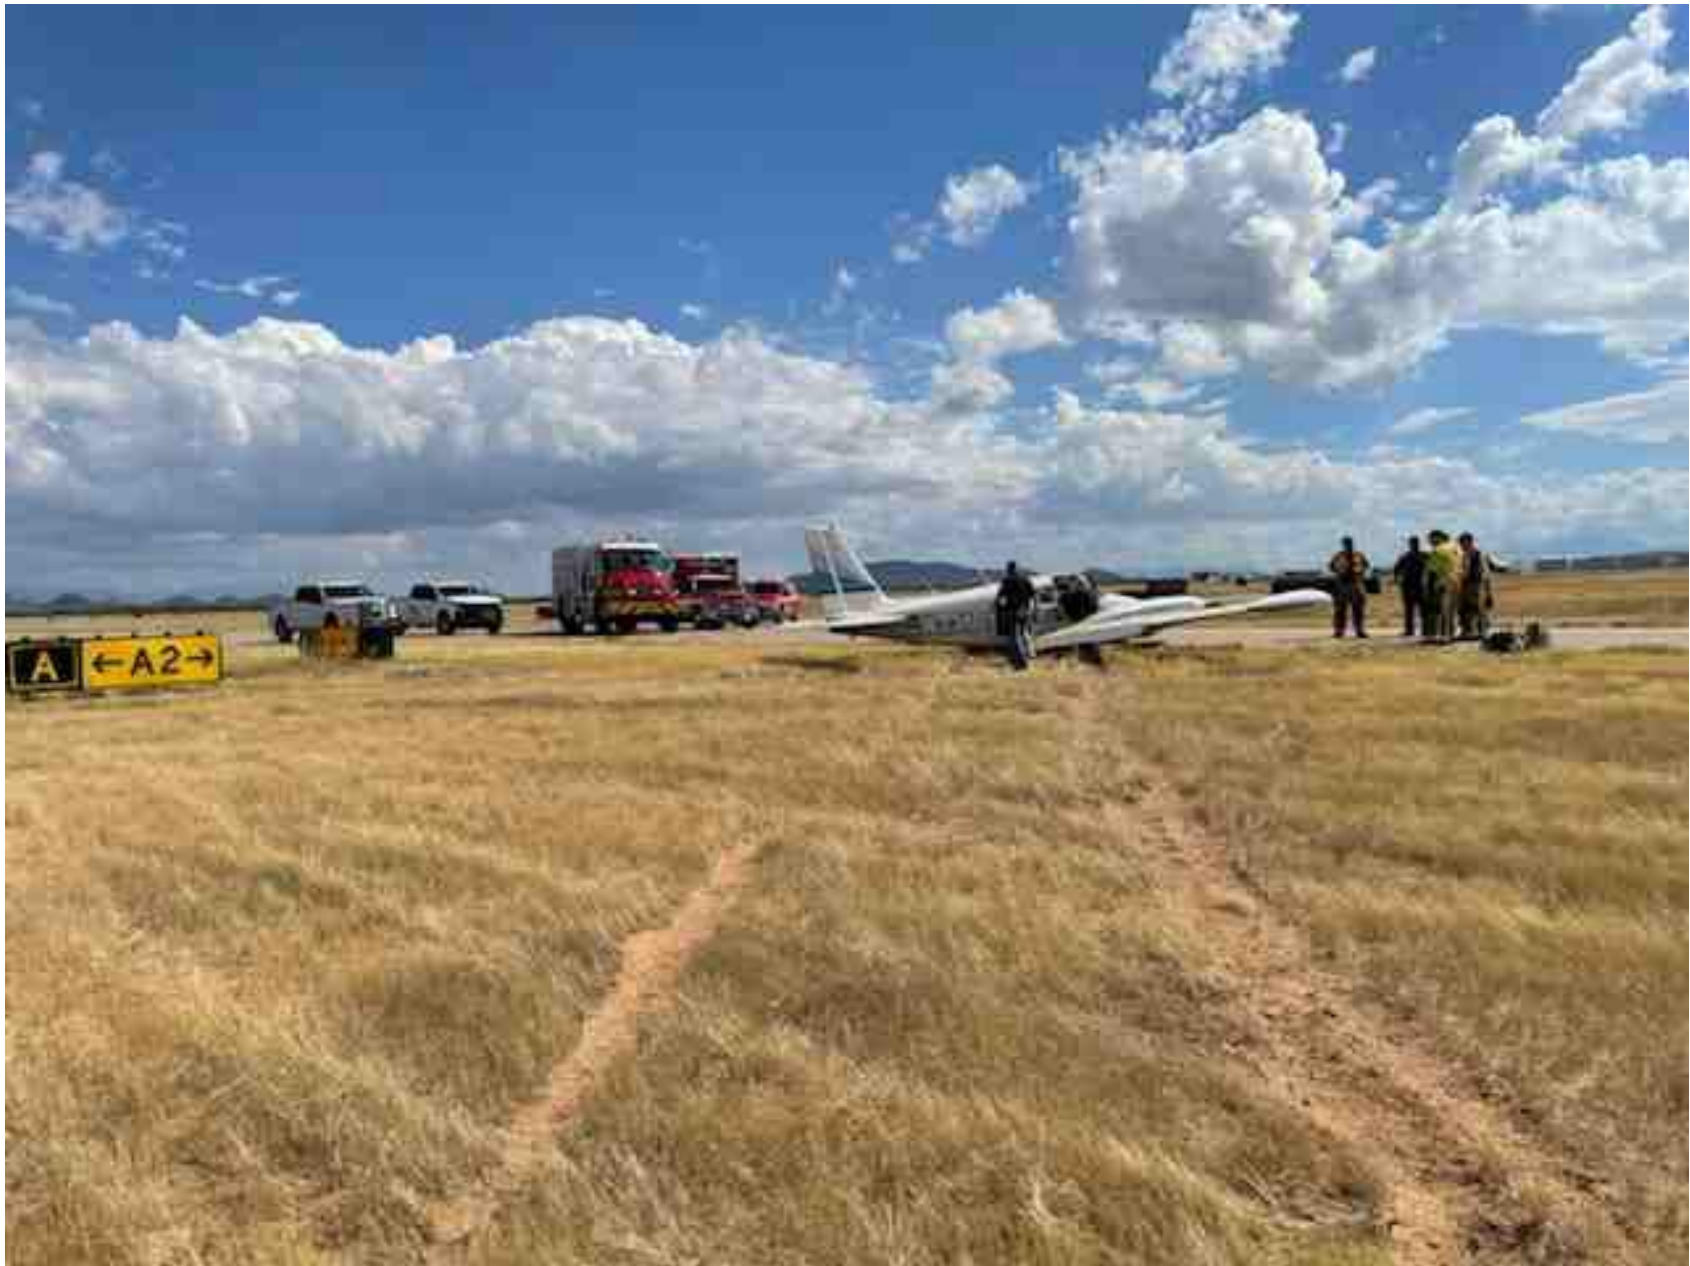
**Photo 1 – Accident Site (AZ Aerotech Photo)**

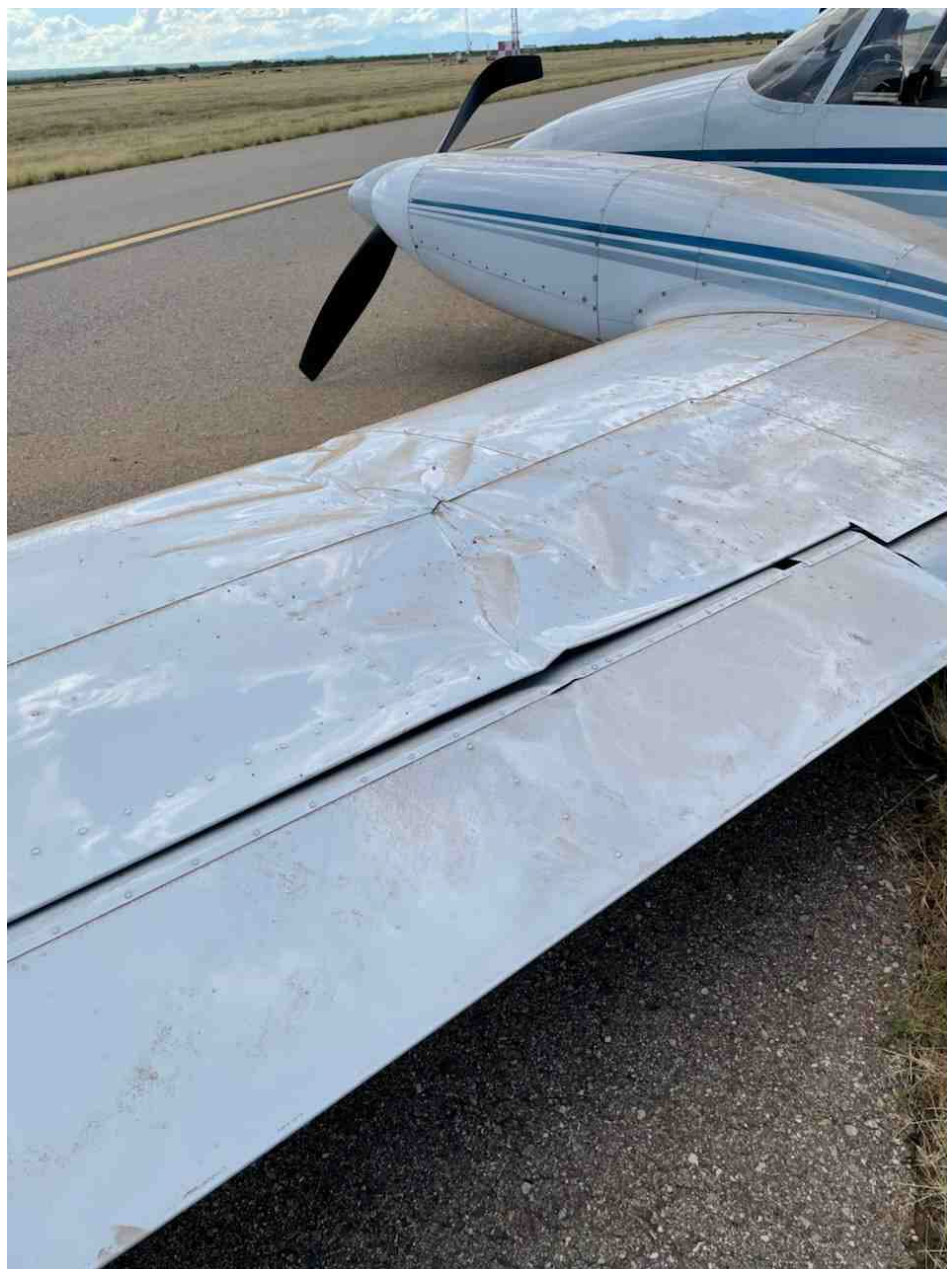
**Photo 2 – Left Wing Damage (AZ Aerotech Photo)**
