# National Transportation Safety Board

WPR23LA016

## **AIRFRAME AND ENGINE EXAMINATION**

Location: Laramie, Wyoming  
Date: October 14, 2022  
Time: 1443  
2043Z  
Airplane: Quickie II, Canadian Registration: C-GDHK

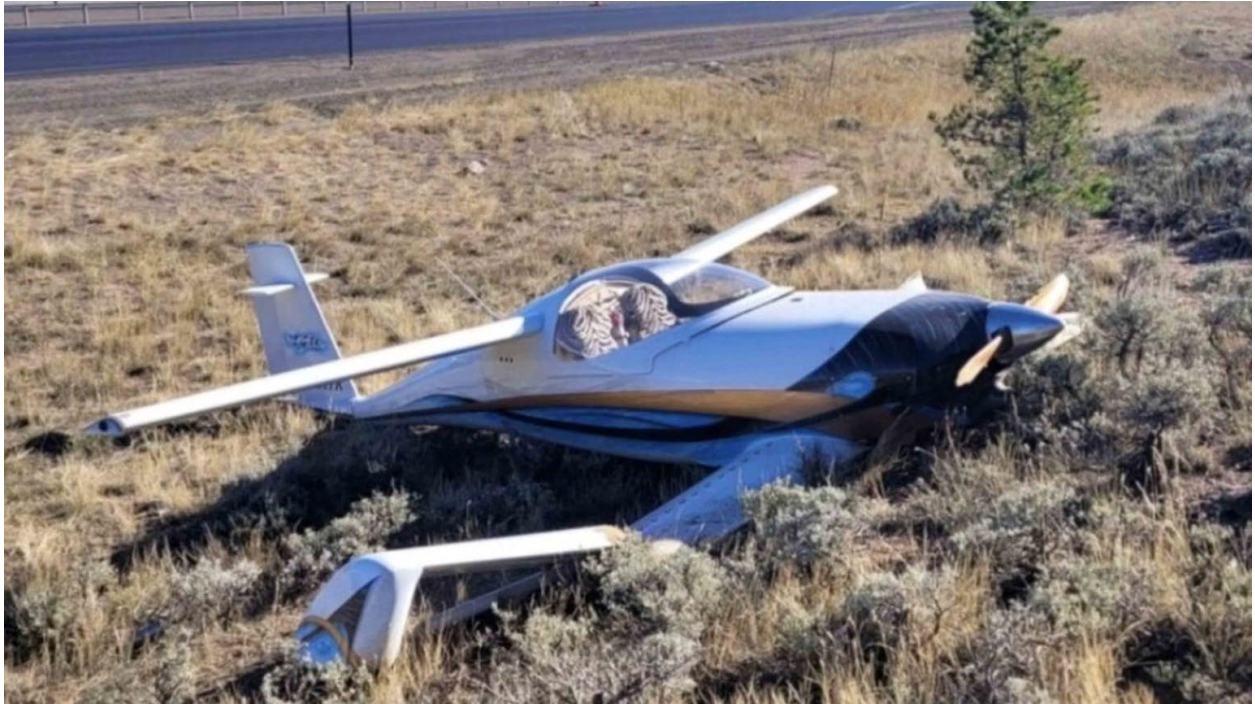
Figure 1. C-GDHK at the accident site. Photo pilot.

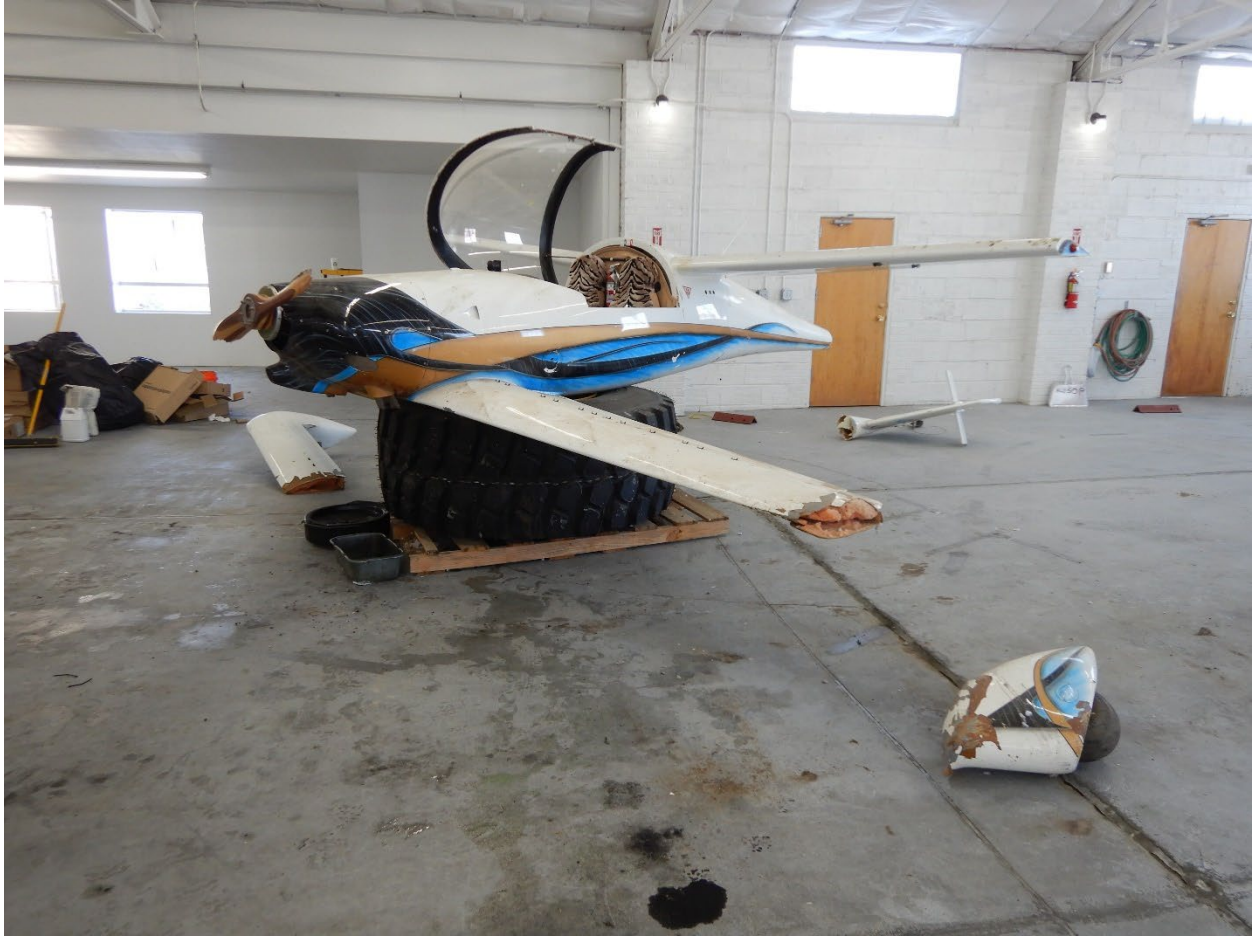
The fuselage was intact except for the right-front canard, the empennage, and the two main landing gear wheels. There were numerous cracks in the composite fuselage.

Figure 2. C-GDHK at the recovery site, prior to the engine and airframe examination.

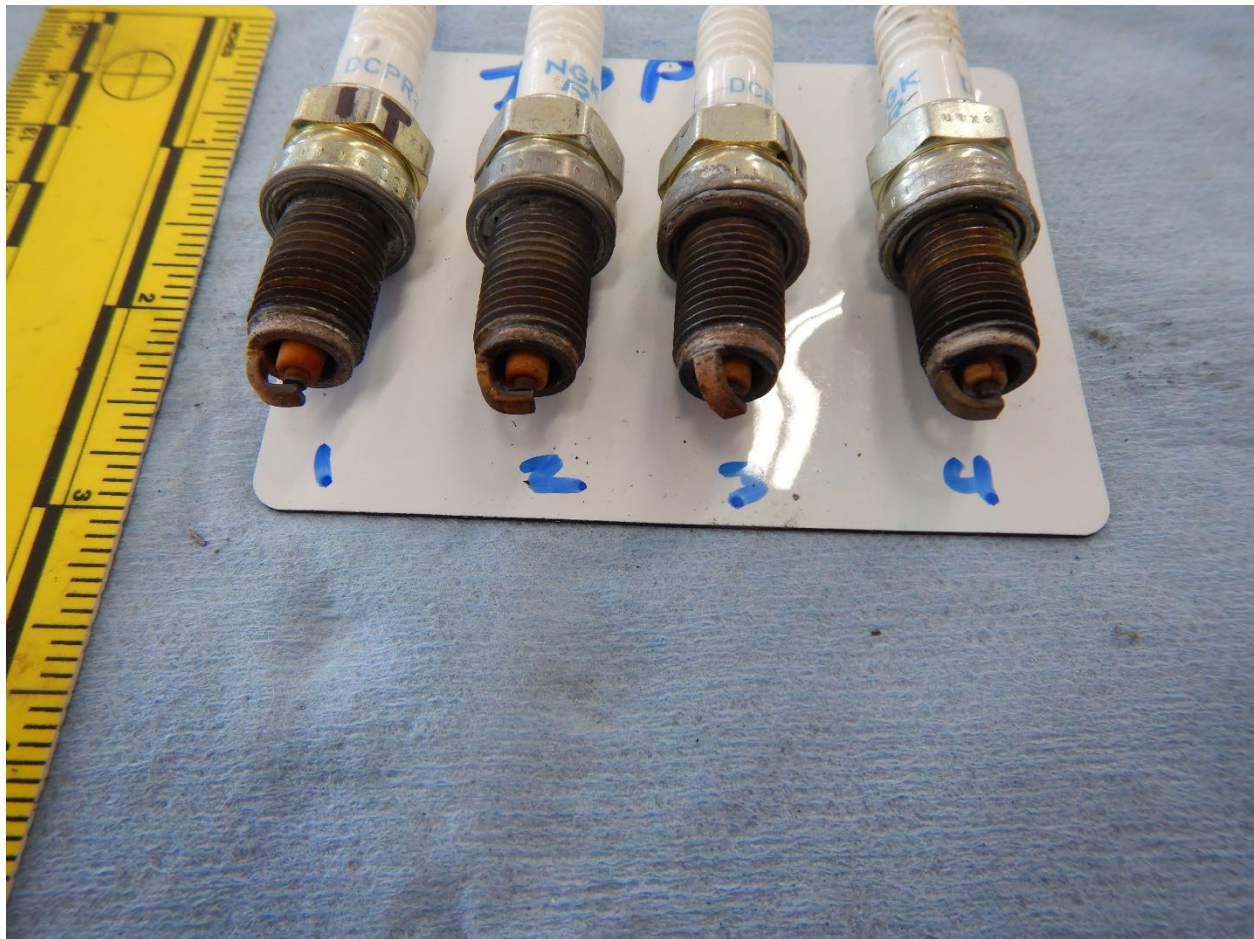
The engine, a Revmaster, R-2100D, remained installed to the fuselage. The top spark plugs were removed and examined. The four top plugs exhibited a dark tan color. The electrode gaps varied from .021 inch to .016 inch. The number four, top spark plug exhibited a bend of the plug to about 10° and a cracked insulator. The leads all exhibited black "electricians' tape" around the lead near the spark plug.

Figure 5. Top spark plugs

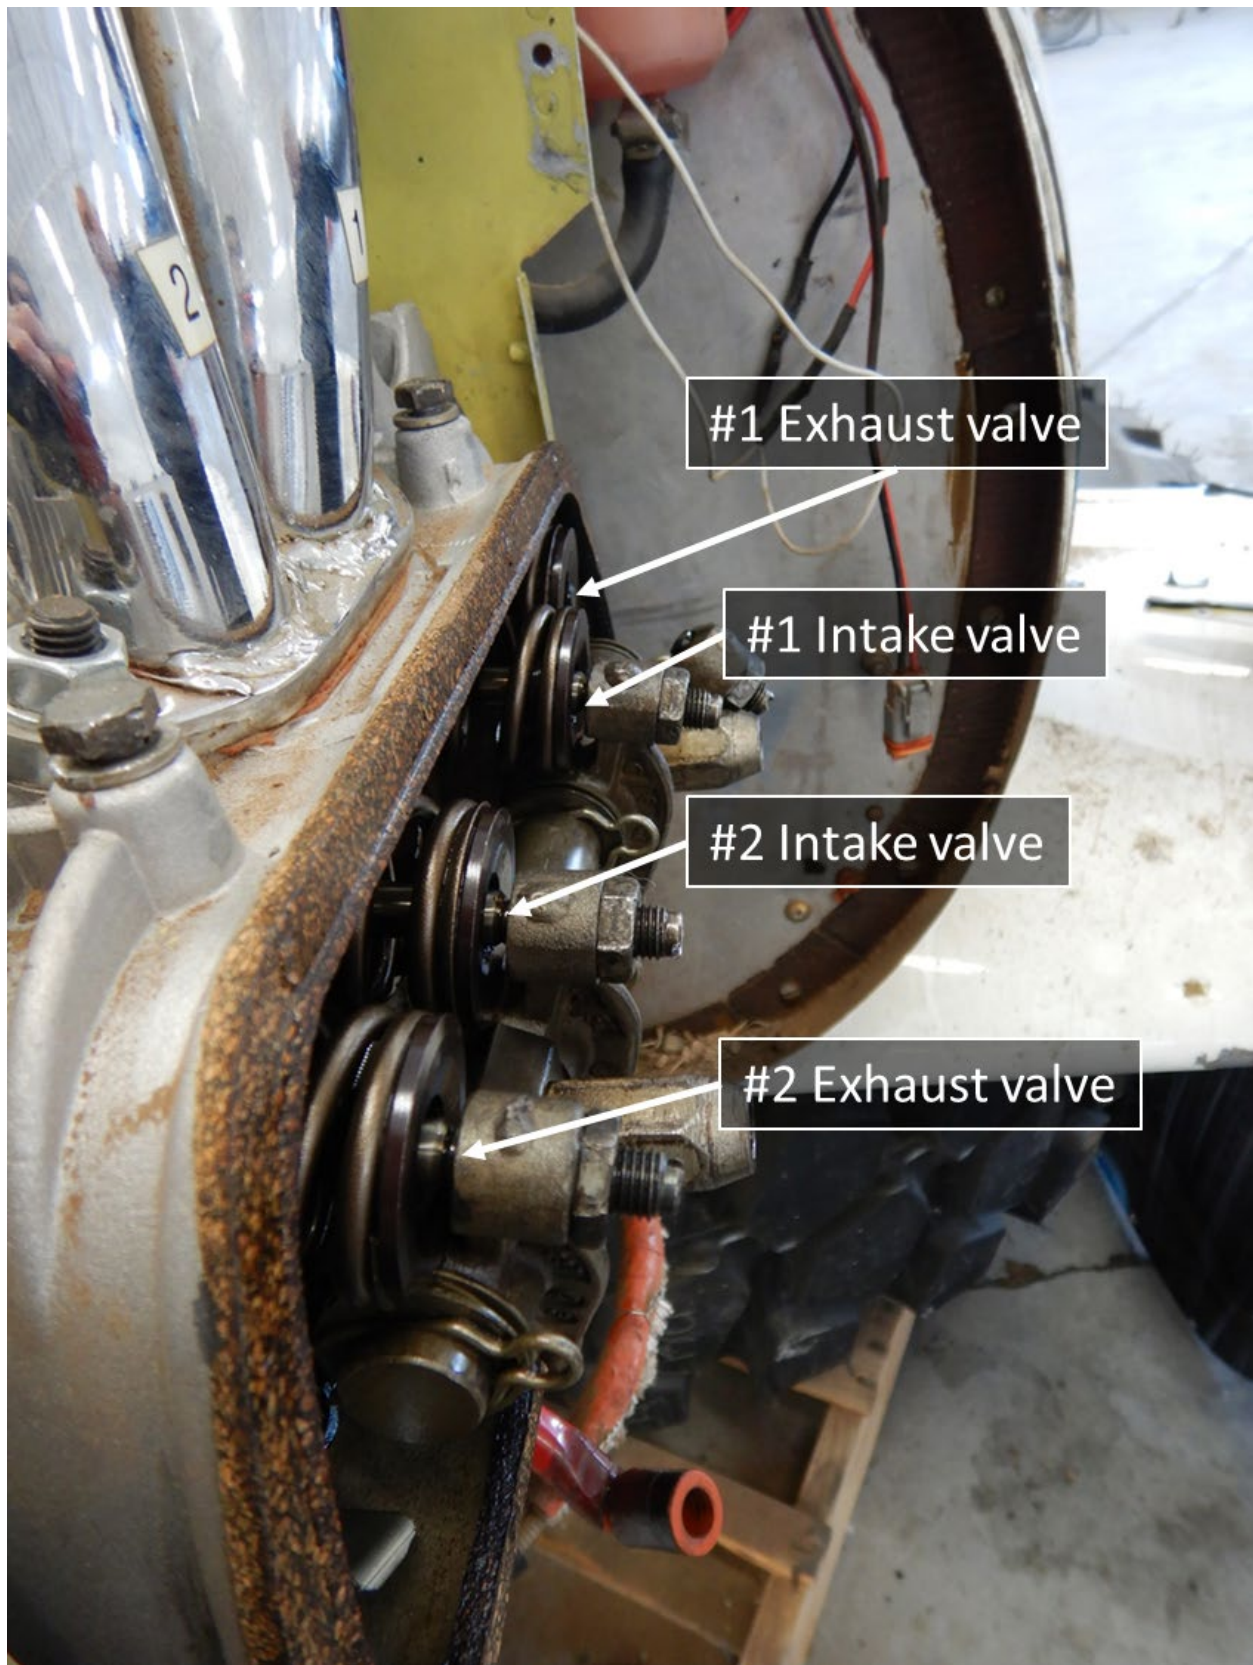
On January 30, 2023, the IIC and an NTSB engine specialist travelled to Laramie, Wyoming to prepare for the examinations. On January 31, 2023, the engine examination revealed the number 1-cylinder exhaust valve was found lodged open and would not reseat, despite the use of moderate force.

The valve train was normal but exhibited one anomaly. The number one-cylinder exhaust valve was lodged open and would not return to its seat despite the use of moderate force. When removed, with the assistance of a mallet, the number one-cylinder exhaust valve exhibited discoloration on the stem and a slight bend. The discoloration had the appearance of a black substance buildup, consistent with carbon buildup. All other valve train components exhibited normal characteristics. The cam lobes appeared to move normally and evenly. The rocker arms all moved about the same distance, except for the number 1-cylinder exhaust valve, rocker arm. The valve train system rotated smoothly.

Figure 6. Number 1- and 2-cylinder valve train. The number 1 (back) exhaust valve is lodged in the open position.

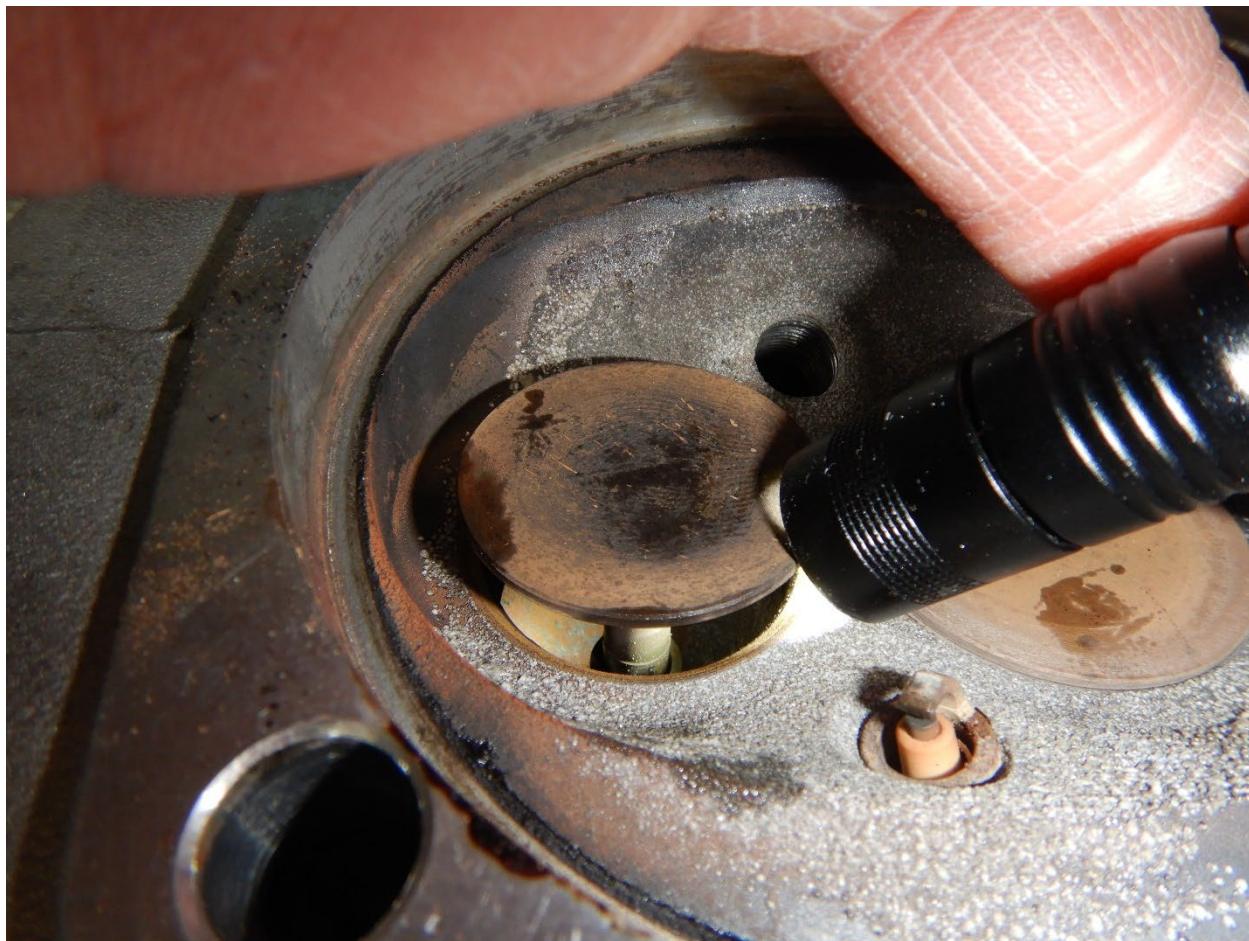
Figure 7. Number 1-cylinder exhaust valve.

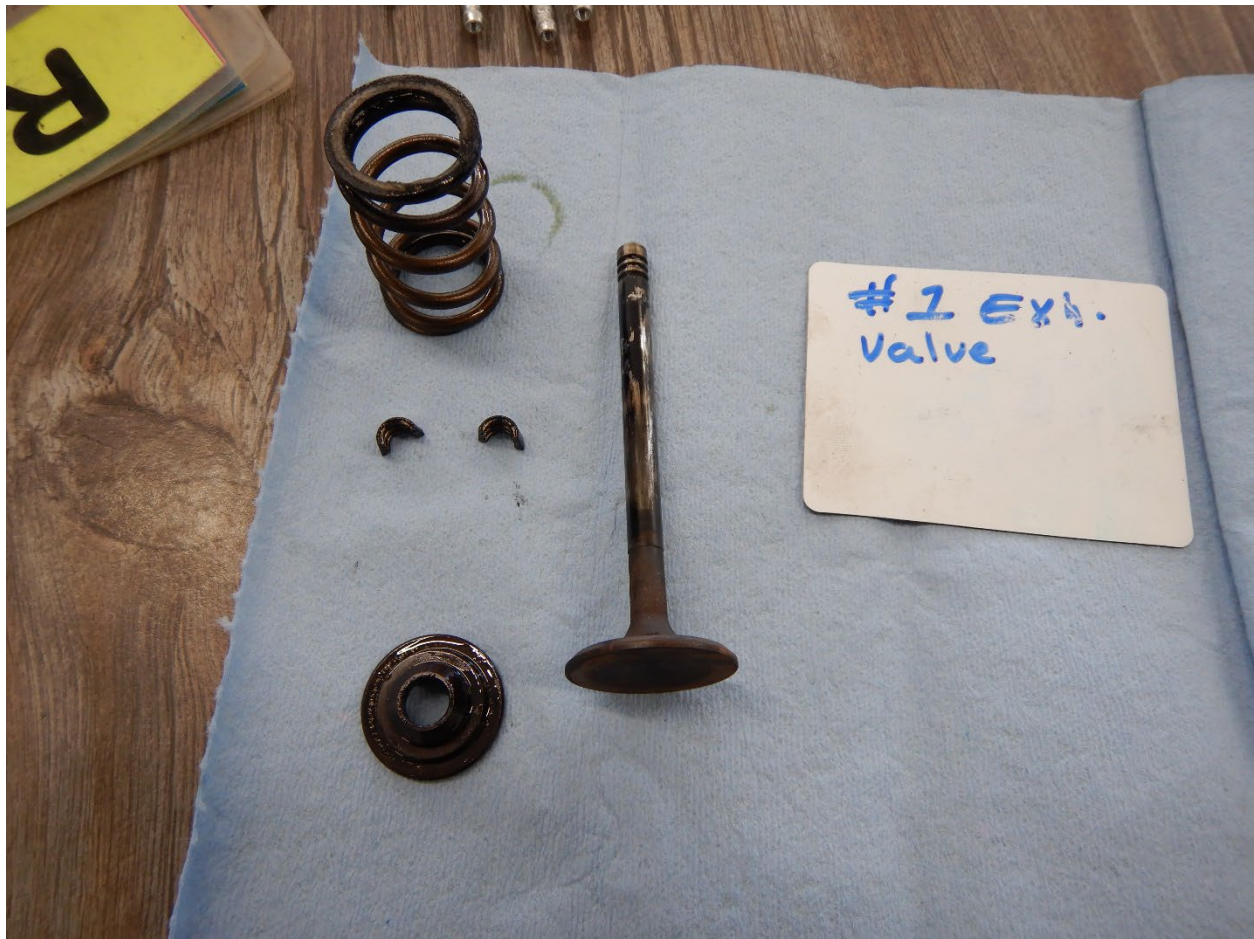
Figure 8. Number 1-cylinder exhaust valve removed from the valve guide.
