# National Transportation Safety Board

WPR23LA017

## **ENGINE EXAM ATTENDEES**

Location: Mesa, AZ  
Date: 10/18/2022  
Time: 0740 Mountain standard time  
Airplane: N747ML, Cessna 177R

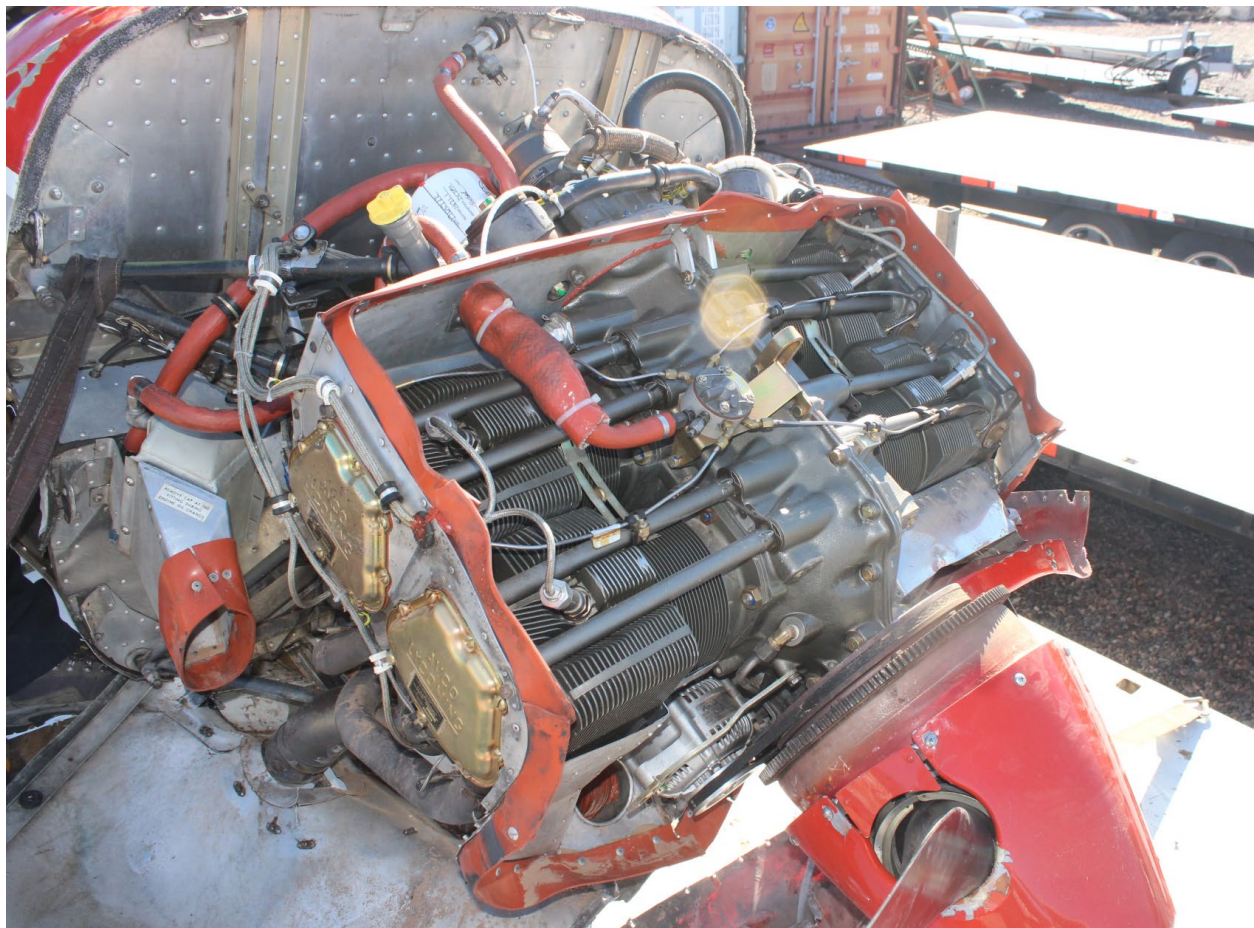
The engine remained attached to the airframe by the engine mount. The engine had sustained no significant impact energy damage (figure 2). The engine mount tubing was deformed. Visual examination of the engine revealed no evidence of pre-impact catastrophic mechanical malfunction or fire.

**Figure 2. View of accident engine**

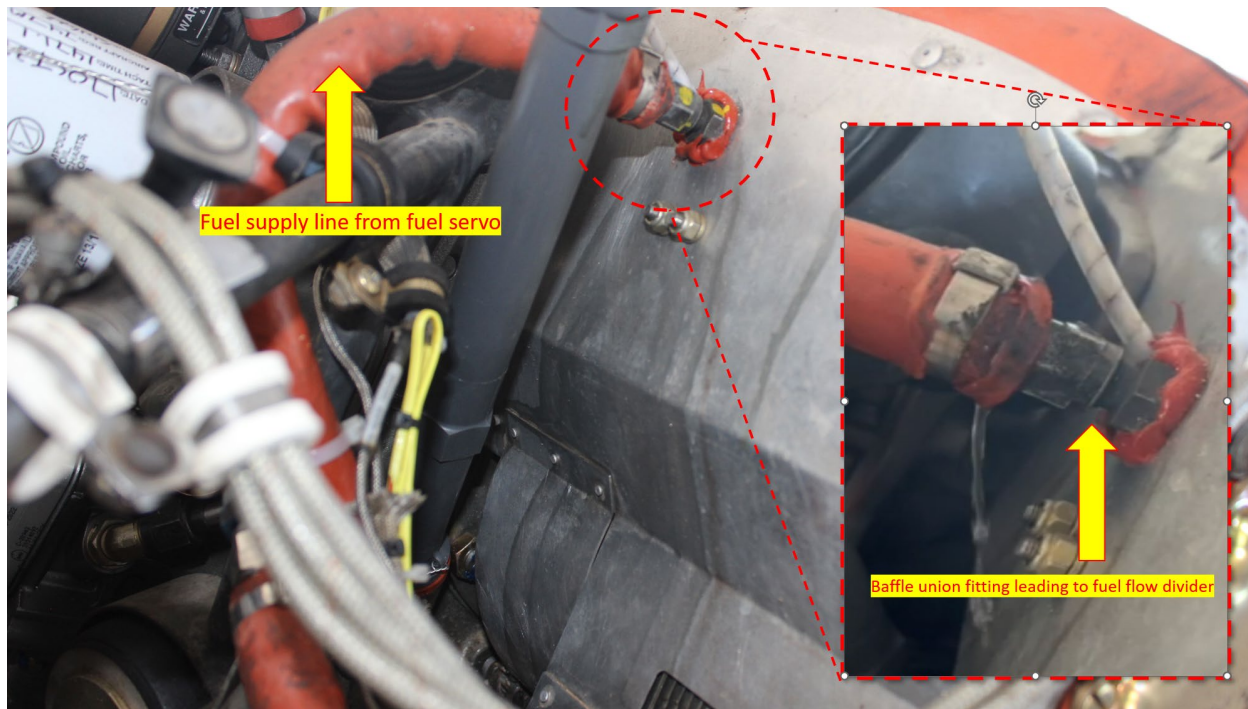
During the hand rotation of the propeller (actuation of the engine driven fuel pump) investigators noted fuel leaking to the ground. Further examination found the fuel line from the fuel injection servo to the flow divider was leaking at the baffle union fitting (figure 3). The fitting would leak fuel during propeller rotation and operational pulses of the engine driven fuel pump, thus indicating the subject pump was functioning. (See video attached in the docket)

Examination found the B-Nut fitting could be hand rotated ½ turn till seated by hand. There was no physical damage to the fitting or evidence of any accident-related impact energy within the surrounding area of the fitting. Fuel staining could be observed on the baffle surface as pictured below. The remaining fuel lines remained secure at each of the respective fuel system components.

**Figure 3. View of fuel supply line from fuel servo with overlaid close-up view of baffle union fitting connection (photo courtesy of engine manufacturer)**

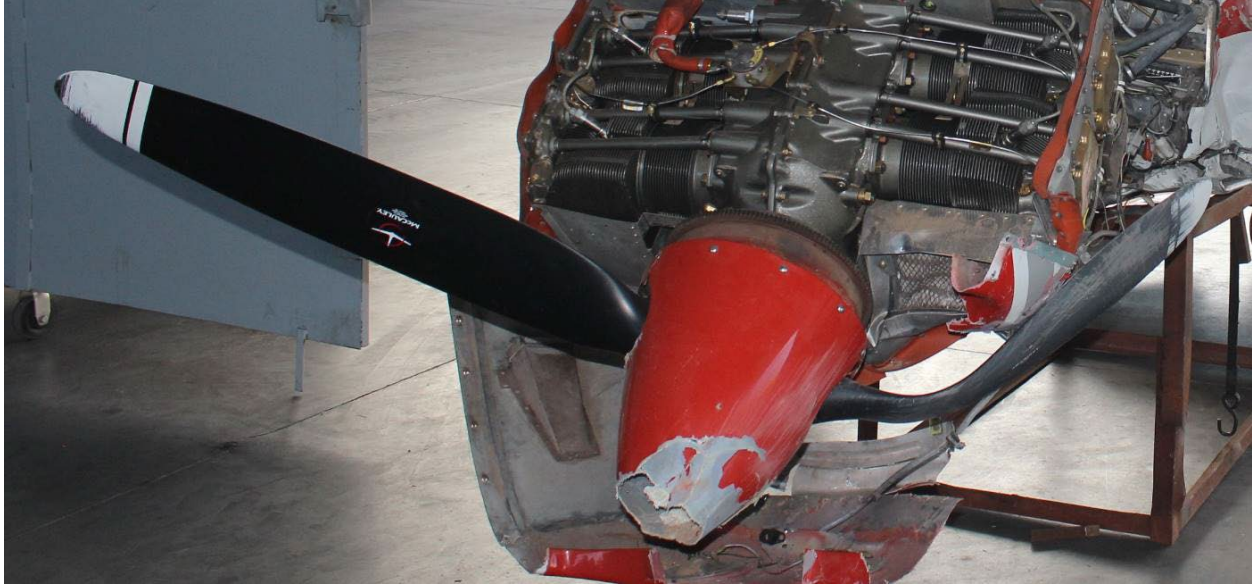
The two bladed constant speed propeller remained securely attached at the crankshaft flange (figure 4). The fiberglass spinner was attached to the propeller. The propeller blades remained attached to the propeller hub. One propeller blade was partially displaced from the hub socket and was bent aft about 45 degrees near the hub. The opposing blade exhibited very localized chordwise striations across the tip.

**Figure 4. View of damaged propeller (photo courtesy of engine manufacturer)**
