# National Transportation Safety Board

WPR23LA022

## **ENGINE EXAMINATION**

Airplane: N50JM

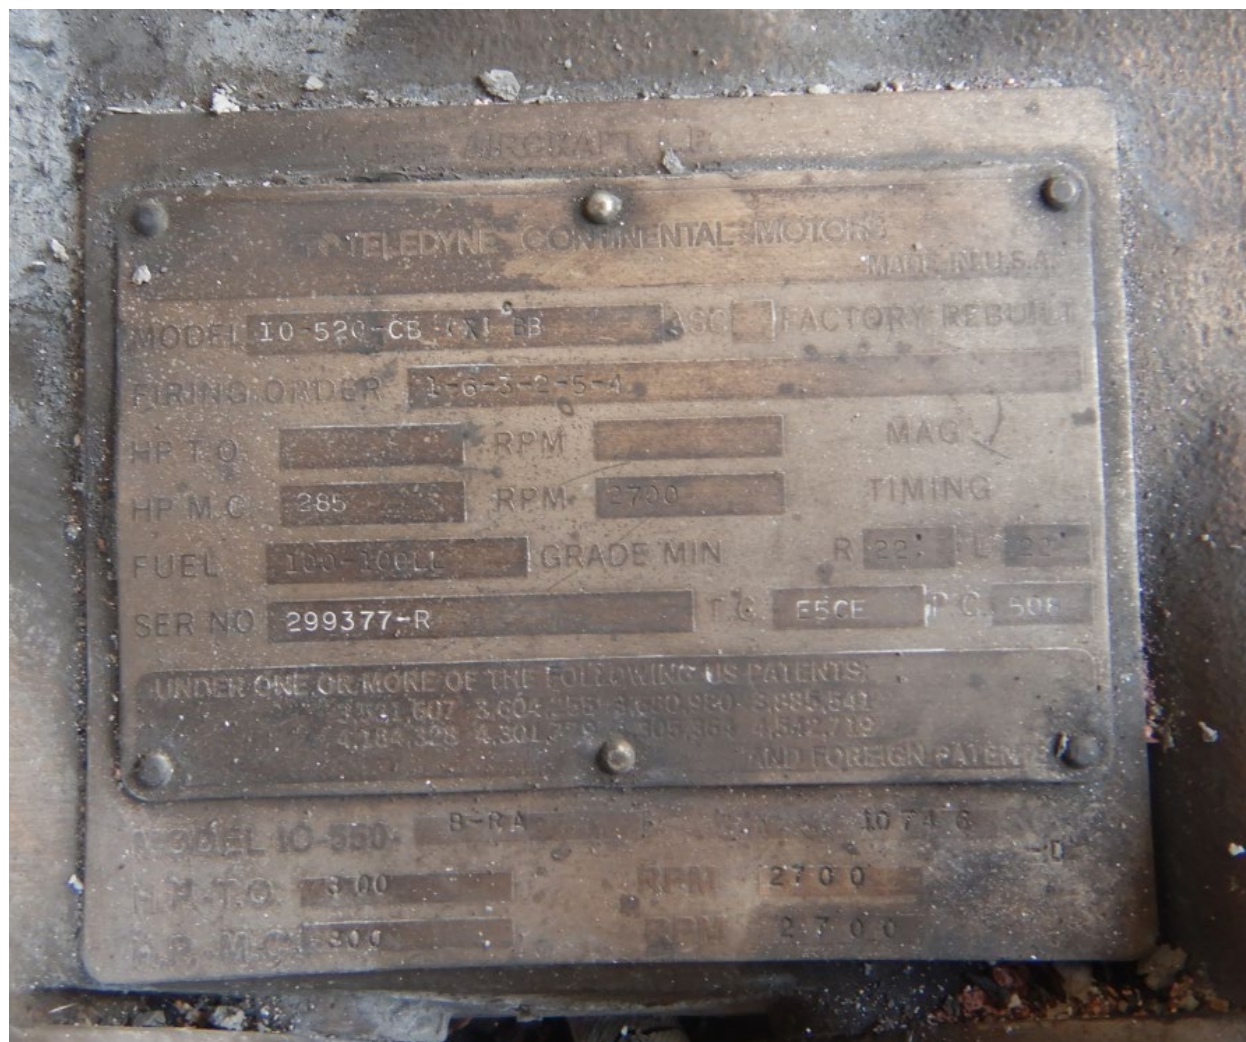
The examination of a Continental IO-520-CB, serial no. 299377-R, took place on July 18, 2023, at Air Transport in Phoenix, AZ. The powerplant is a six-cylinder, air-cooled, direct drive, horizontally opposed, normally aspirated (fuel injected), internal combustion engine rated at 285 hp @ 2700 rpm.

Figure 1. View of data plate of accident engine

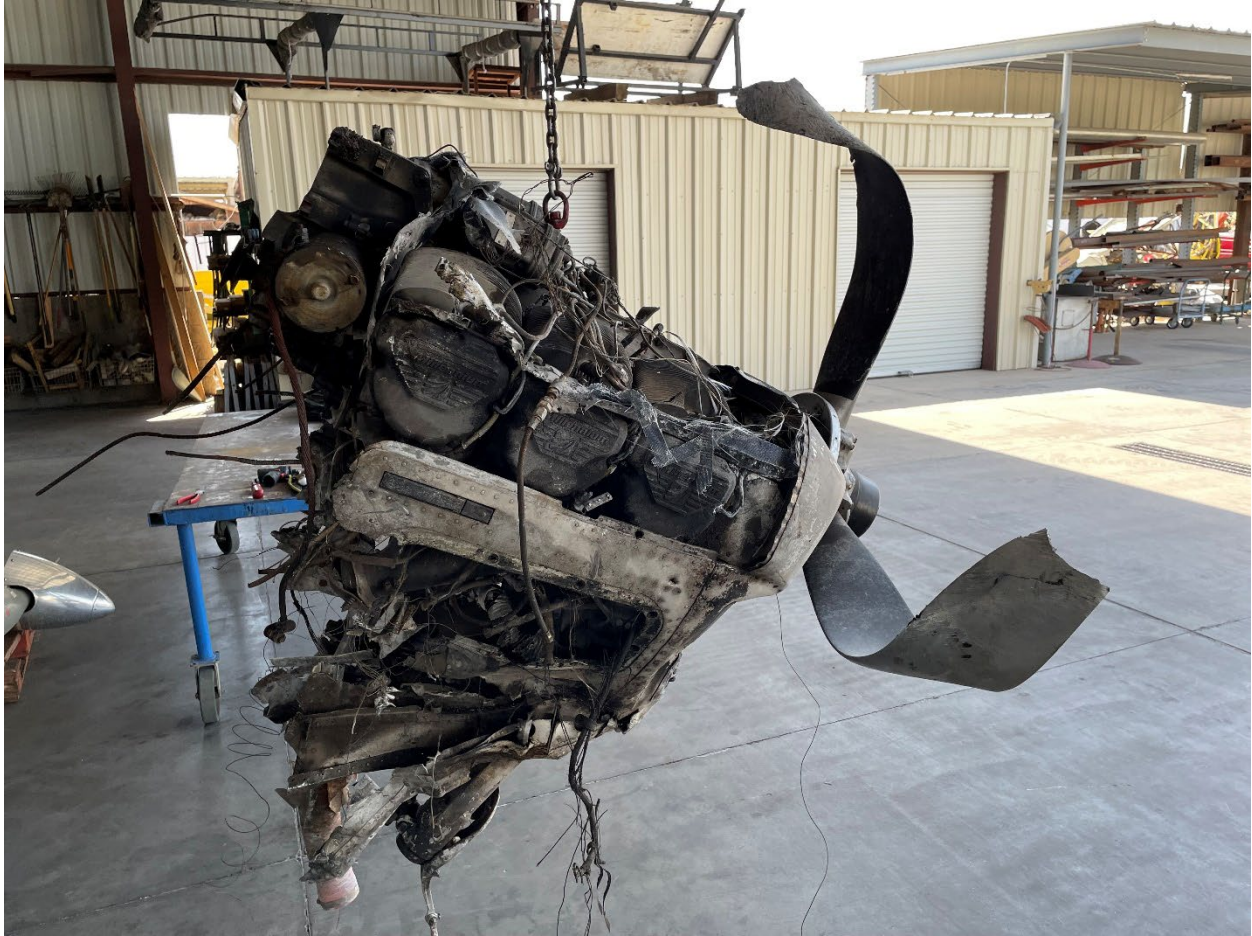
Visual inspection of the engine revealed that the engine sustained thermal damage. The engine examined separate of the airframe due to impact damage and the retrieval process. The engine mounts and engine truss sustained impact and thermal damage. The magnetos, fuel injection servo, vacuum pump, starter remained secured on its respective mounting pad, each sustained thermal damage.

**Figure 2. Overall view of accident engine**

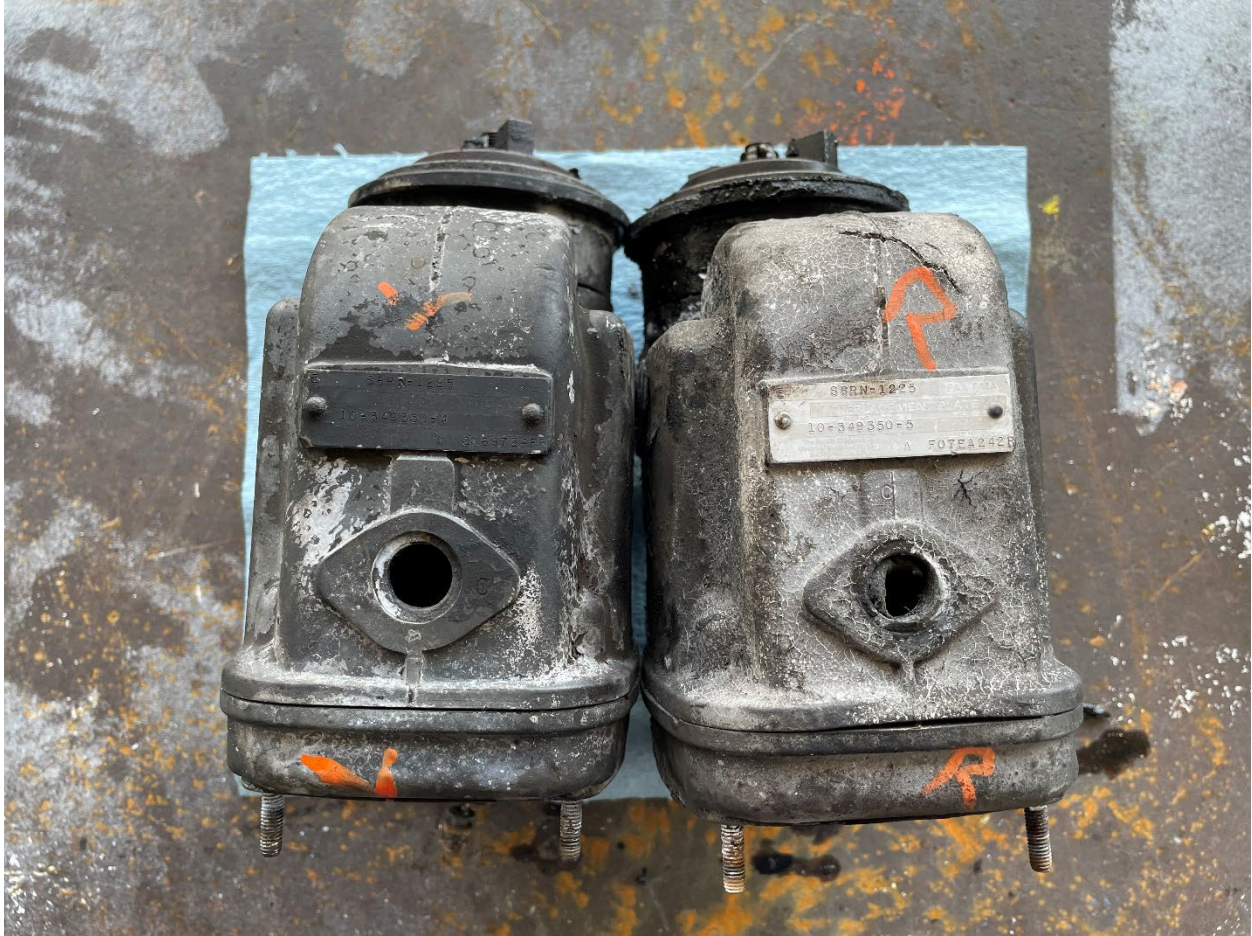
Both magnetos sustained thermal damage and normal operation could not be confirmed. The vacuum pump shaft was not sheared and appeared operational.

**Figure 3. View of thermal damaged left and right magnetos**

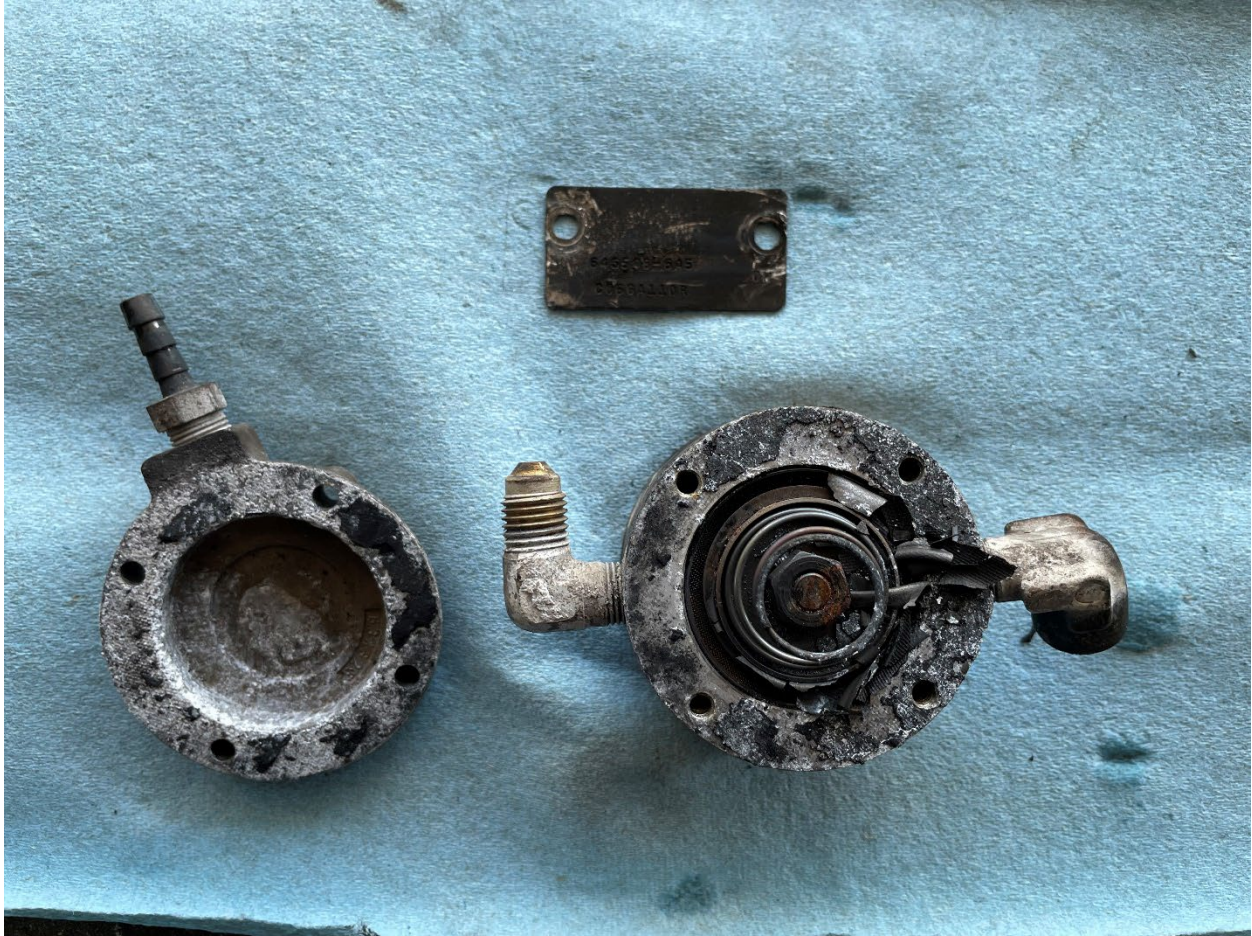
The thermal damaged fuel flow divider remained secured at the mounting bracket situation at the top of the engine. The thermal damaged fuel injection lines remained secured at each flow divider and fuel injector at each cylinder. The flow divider was disassembled and revealed that the diaphragm was brittle, consistent with thermal damage.

**Figure 4. Close-up view of thermal damaged fuel flow divider**

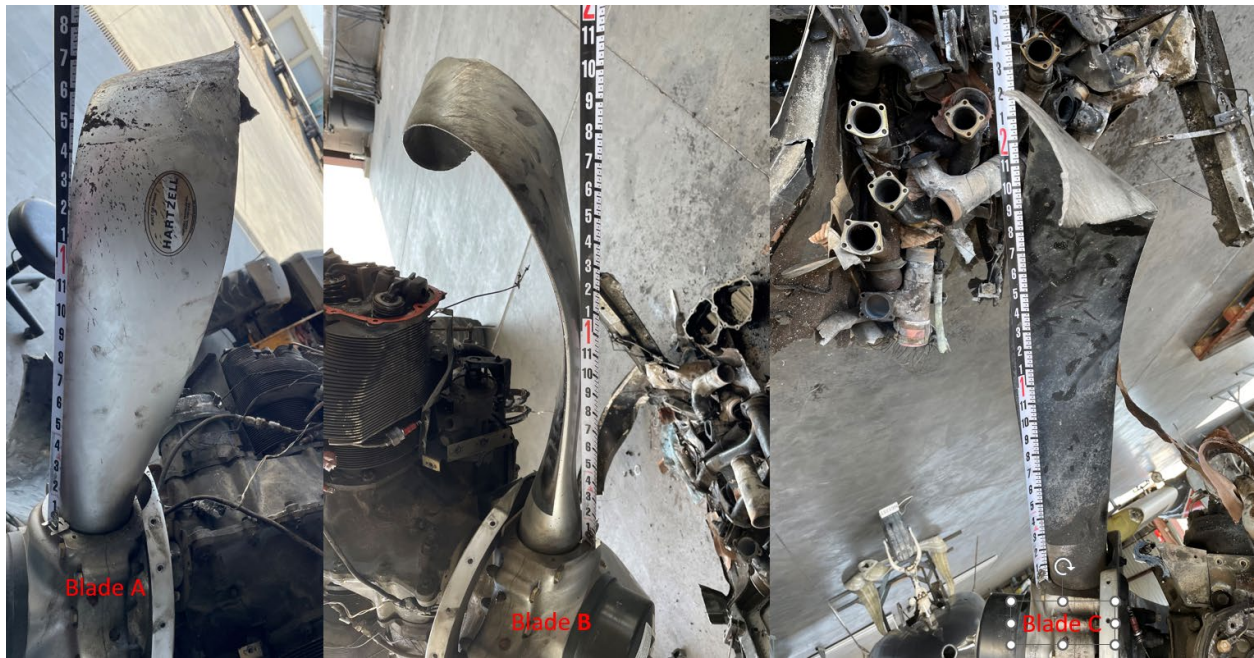
The propeller hub and blade assembly remained secured to the engine' crankshaft flange. Each blade displayed deformation about 20 inches from its blade root, consistent with damage under engine power. The propeller governor remained secured at its respective mounting pad. The governor control mechanism was free to move.

**Figure 5. View of damaged propeller blades**
