**NATIONAL TRANSPORTATION SAFETY BOARD**  
Office of Aviation Safety

**Wreckage Examination Report**

**A. ACCIDENT      WPR23LA022**

Location:            Nogales, New Mexico  
Date:                October 20, 2022  
Time:                1258 MST  
Operator:           Private  
Aircraft:            Beech V35B  
Registration:       N50JM

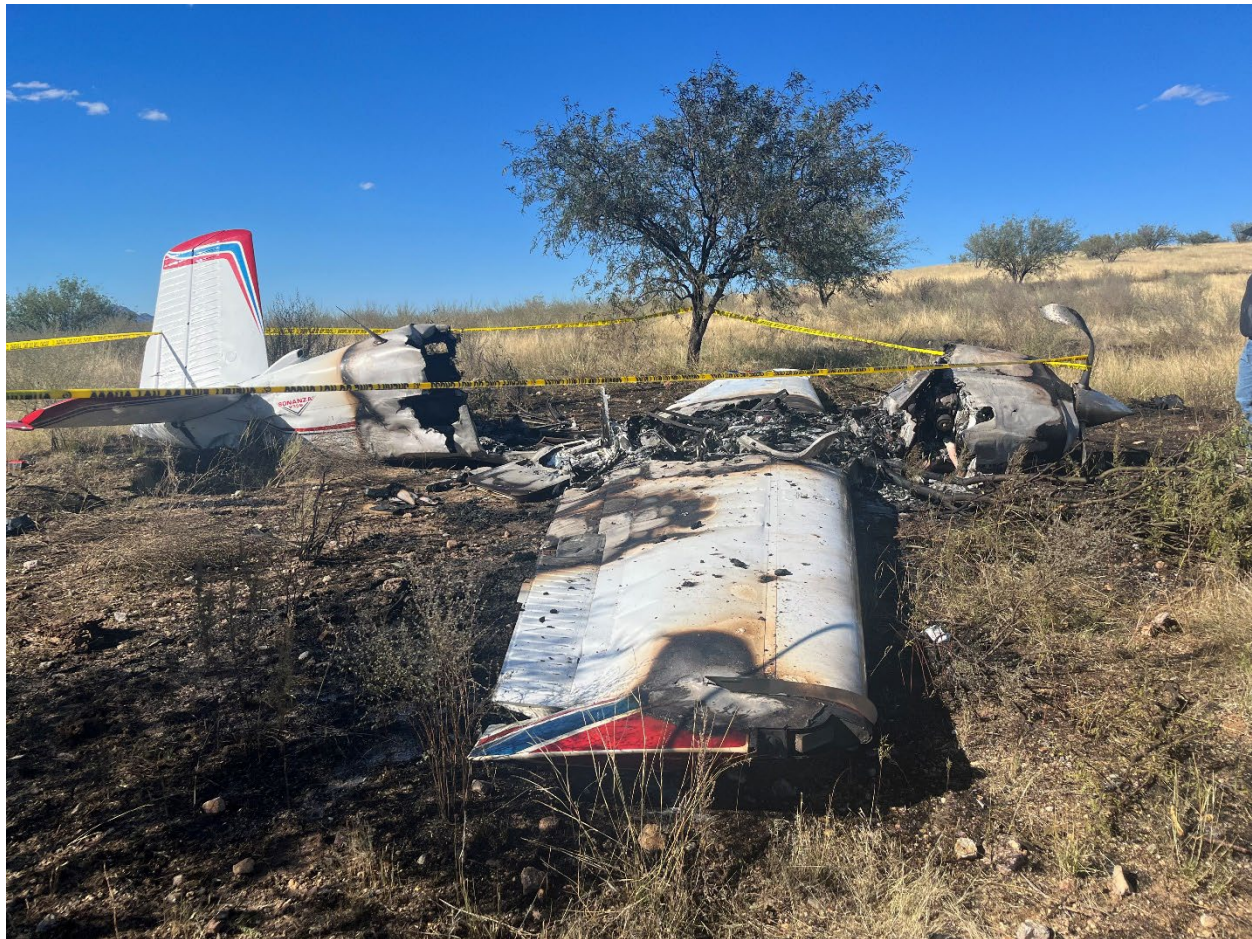
*Photograph 1: Accident airplane prior to examination*

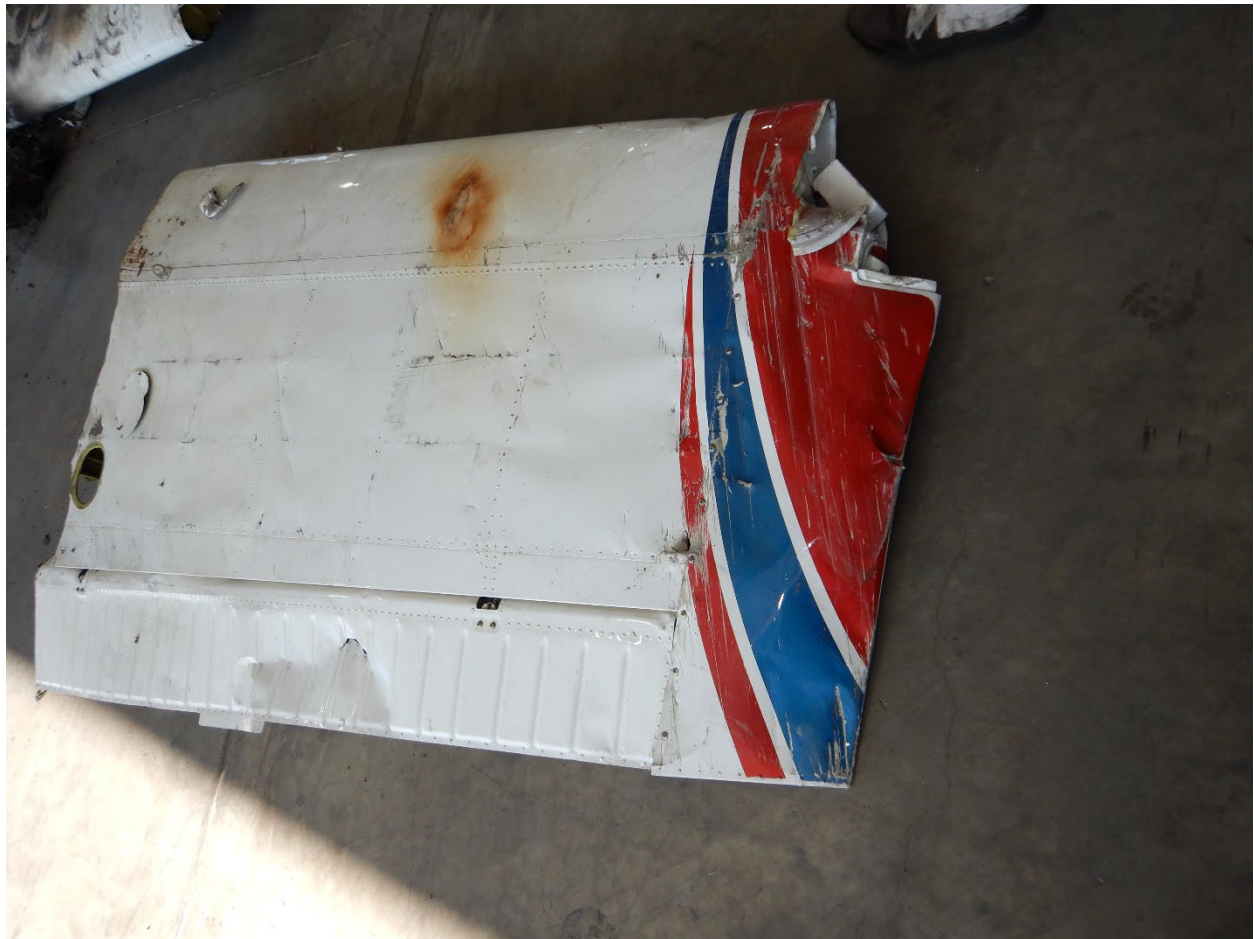
The inboard left wing had separated from fuselage at the wing attach fittings and the outboard portion of the wing was separated by recovery personnel about midspan. The right wing remained attached to the fuselage. Both ailerons and flaps remained attached to the trailing edges of their respective wings. The right wing flap and aileron were damaged by postcrash fire. The left outboard underside of the left wing and wing cap exhibited scratching from ground contact.

*Photograph 3: Underside of left-wing tip that scraped asphalt*

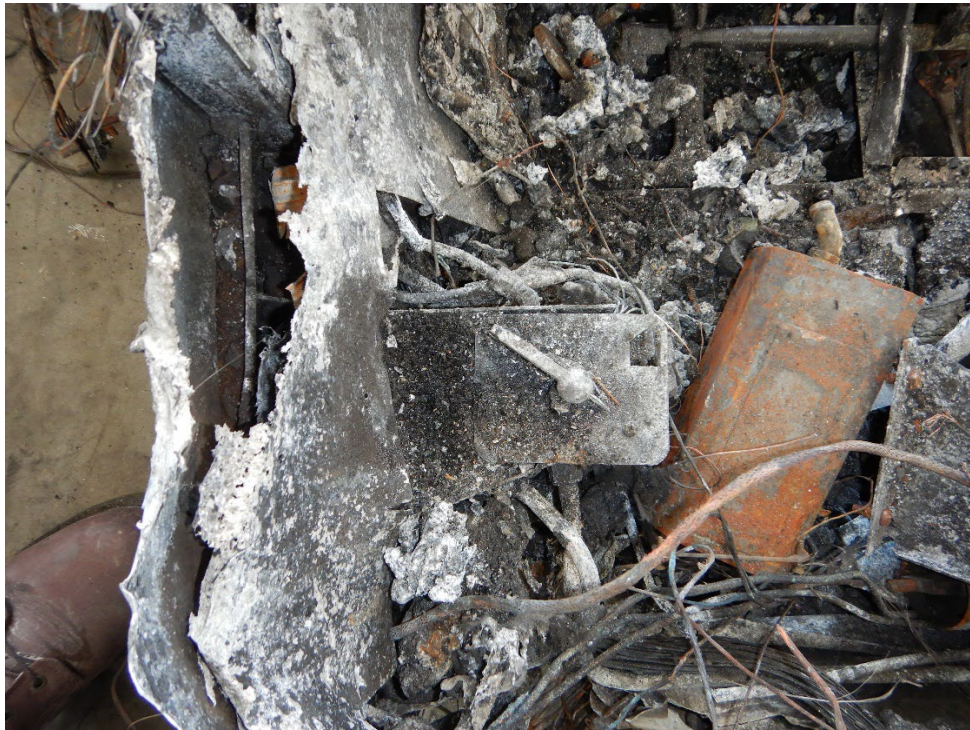
The fuel system hoses were destroyed by postcrash fire. The fuel selector valve and handle were in the right tank position. The gascolator screen was free of debris. Both fuel caps were observed in good working condition.

*Photograph 5: Fire damaged fuel selector*

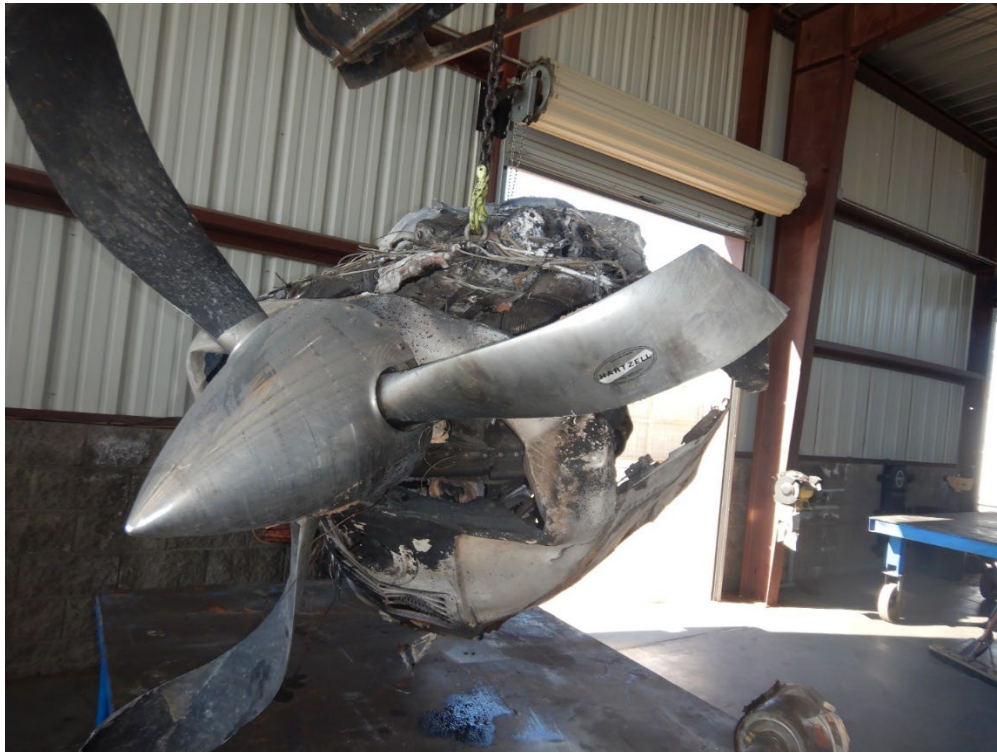
The engine was a Continental Motors IO-520-B-RA, s/n 299377R, an air-cooled, 300 hp reciprocating engine with RAM STC SE10746SC-D installed 11-09-16. The engine was damaged by post impact fire and could not be rotated. The accessory case was intact and the accessories were all mounted to their respective pads with secured fittings. Both magnetos were attached at their respective mounting pads and were thermally damaged. All six of the top spark plugs were secured at their respective plug ports. The fuel pump accessory drive was intact and the fuel pump was rotated using a hand tool with some resistance. Each intake and exhaust tube was securely connected to its respective cylinder. Fuel manifold was securely attached at the top of the engine case with each fuel line attached. The flame tubes on the exhaust mufflers were intact. The throttle and mixture control linkages were cut by recovery personnel near the accessory case and both control arms exhibited full travel from stop to stop when actuated by hand using the linkages. The propeller governor remained attached to the engine case and the governor linkage exhibited full travel when the linkage was actuated by hand. No evidence of catastrophic engine failure was observed.

*Photograph 6: Engine prior to examination*
