Dan Baker  
Senior Air Safety Investigator  
AS-WPR

**Date:** 01/26/2023

**Subject:** WPR23LA031, N3131J, Engine Examination Notes

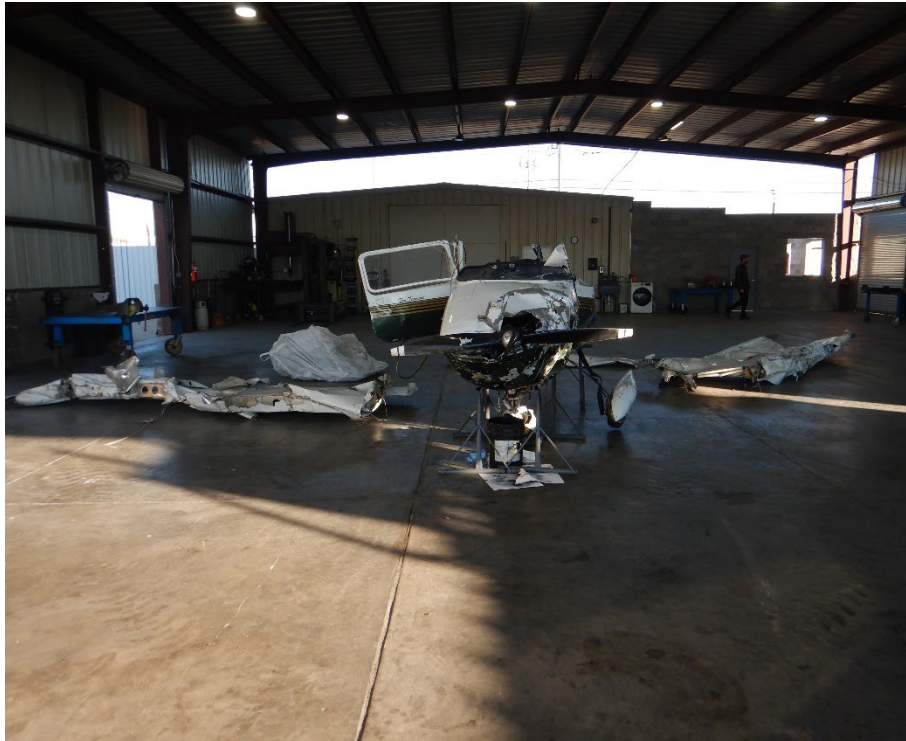
Figure 1 - Wreckage at Storage Facility

Crushing and deformation of the left side of the engine cowling was evident. The engine was broken free from the left rear engine mount and the remaining mounts were bent. The propeller remained attached the engine. One blade exhibited scratching along the length of the leading edge of the blade. No chordwise scratching was evident on either blade.

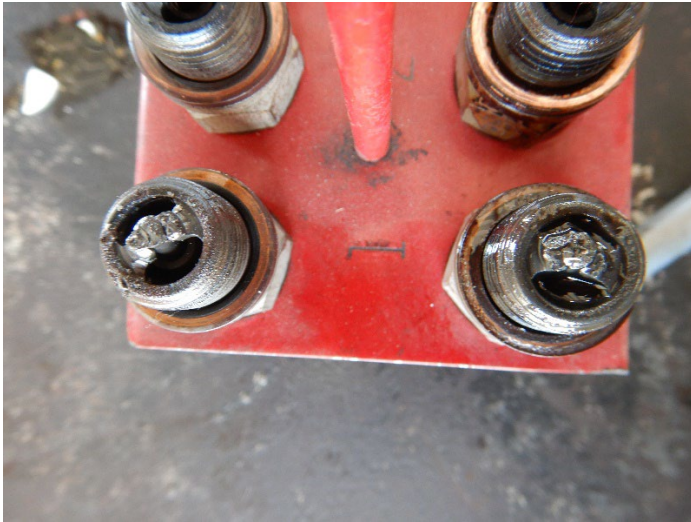
The top and bottom spark plugs were removed. Both of the No. 1 cylinder spark plugs exhibited damage consistent with material impacting them from inside the cylinder (figure 2). The No. 3 cylinder bottom spark plug had a flake of white foreign matter embedded between the electrode and plug wall. (figure 3).

Figure 2 - No 1 Cylinder Spark Plugs

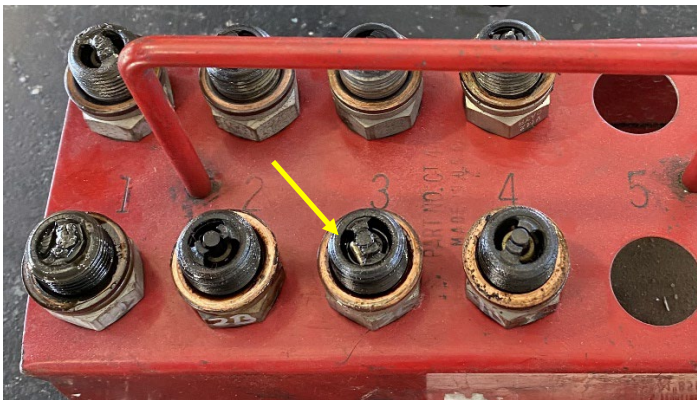
Figure 3 - No. 3 Cylinder Bottom Spark Plug Debris (FAA Photo)

The inside top and piston face of the no. 3 piston had a large buildup of carbon-like material (figure 6). The piece of debris found in the No. 3 bottom spark plug was of similar consistency.

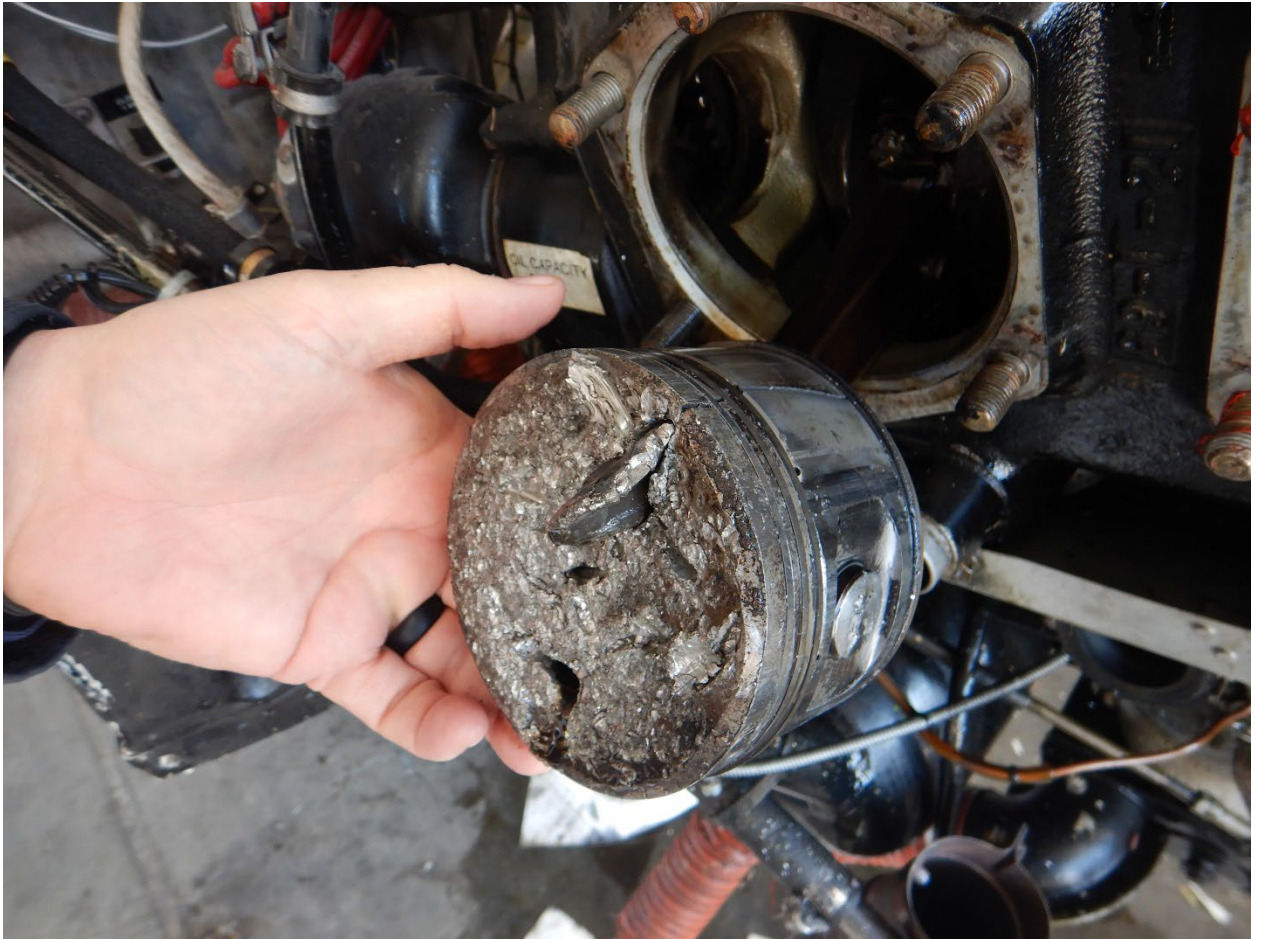
The No. 1 and 3 cylinders were removed. The No. 1 cylinder exhaust valve was found separated and embedded in the piston face, part of the intake valve was missing, and the piston was cracked. The cylinder top and piston face exhibited peening and impact damage (figures 4 and 5). Scoring damage was visible on the piston and cylinder wall surfaces. A section of a broken valve was recovered from inside the heat exchanger.

Figure 4 - No. 1 Piston with embedded Exhaust Valve and Crack

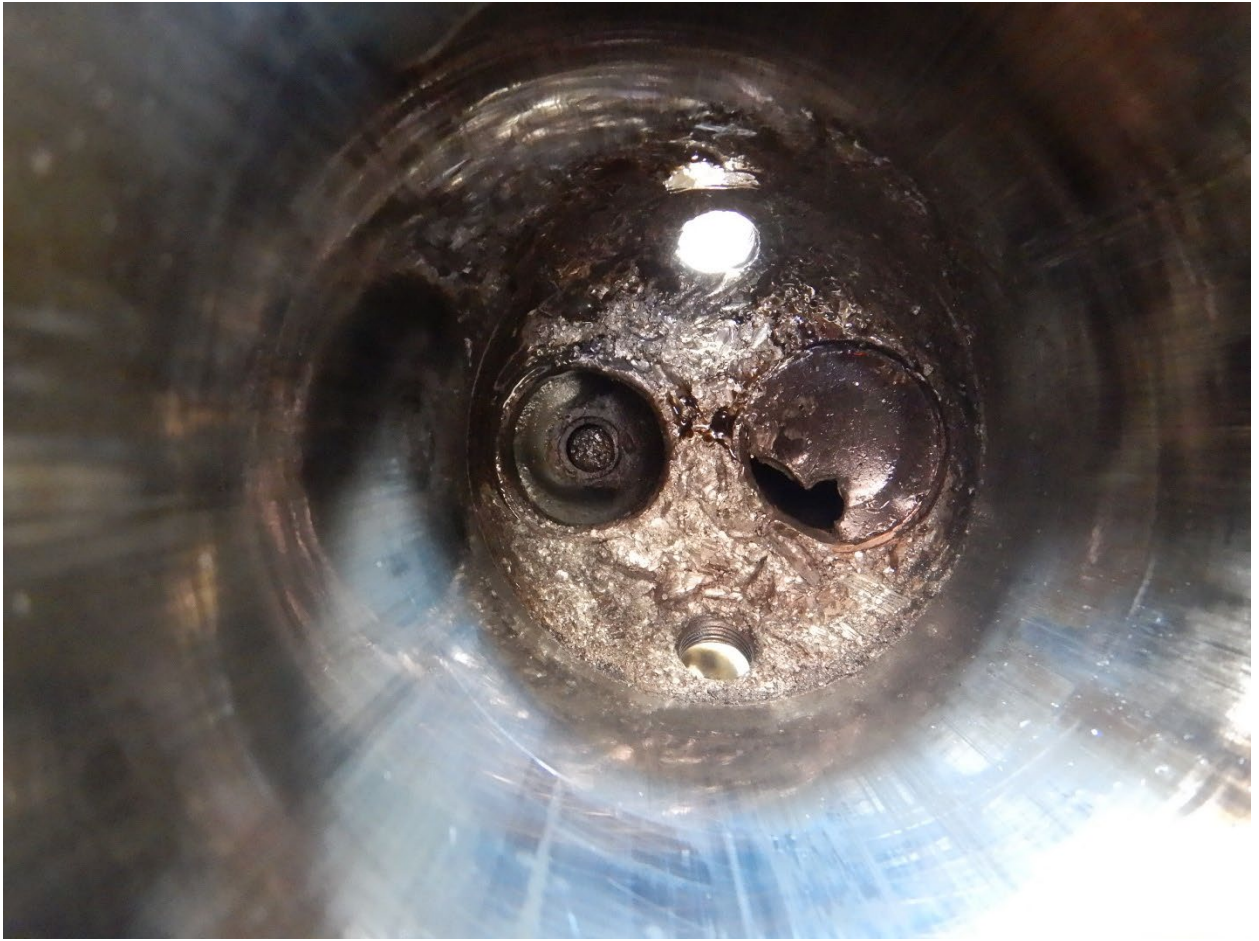
Figure 5 - No. 1 Cylinder Interior

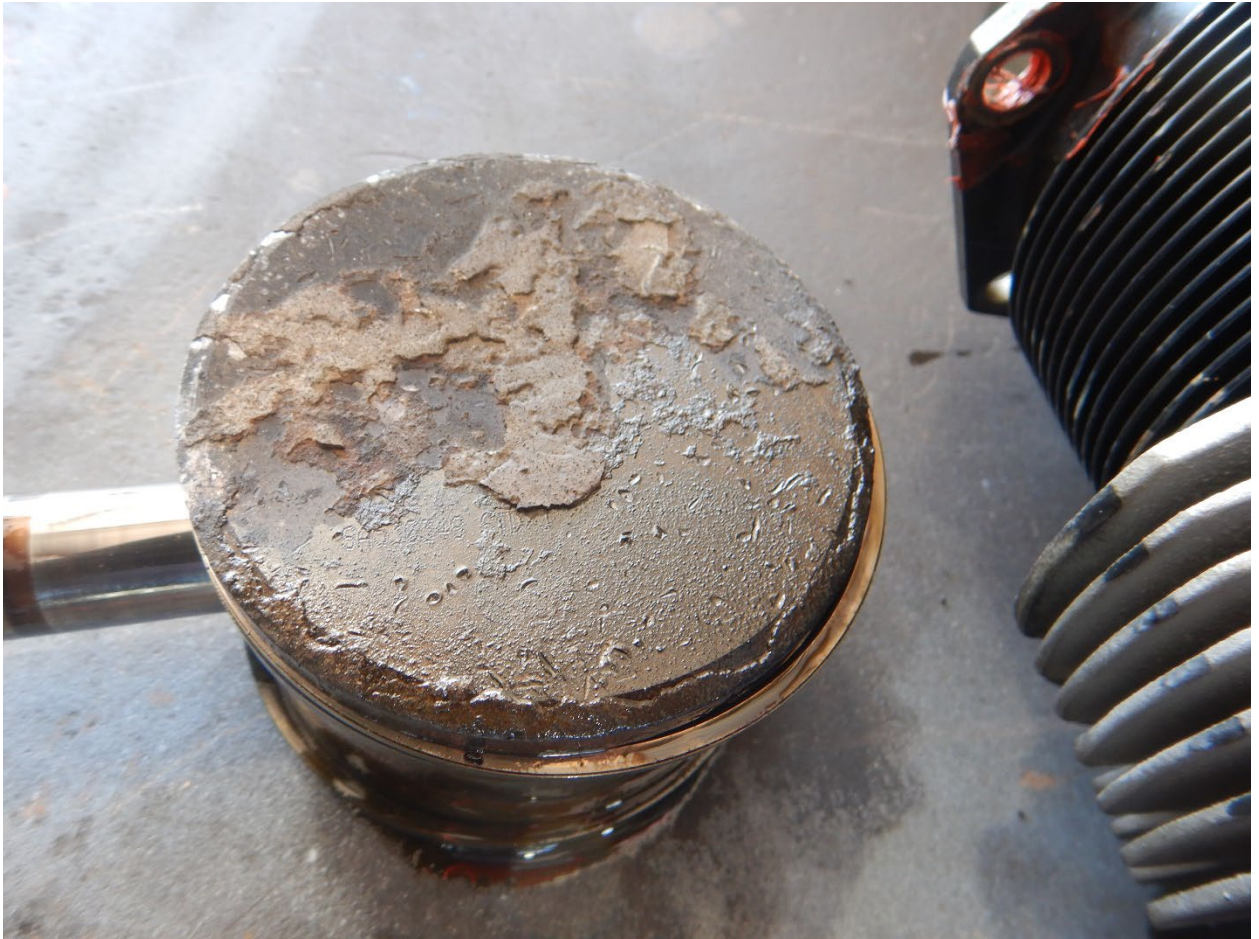
Figure 6 - No. 3 Piston
