WPR23LA041

## INVESTIGATION PHOTOGRAPHS

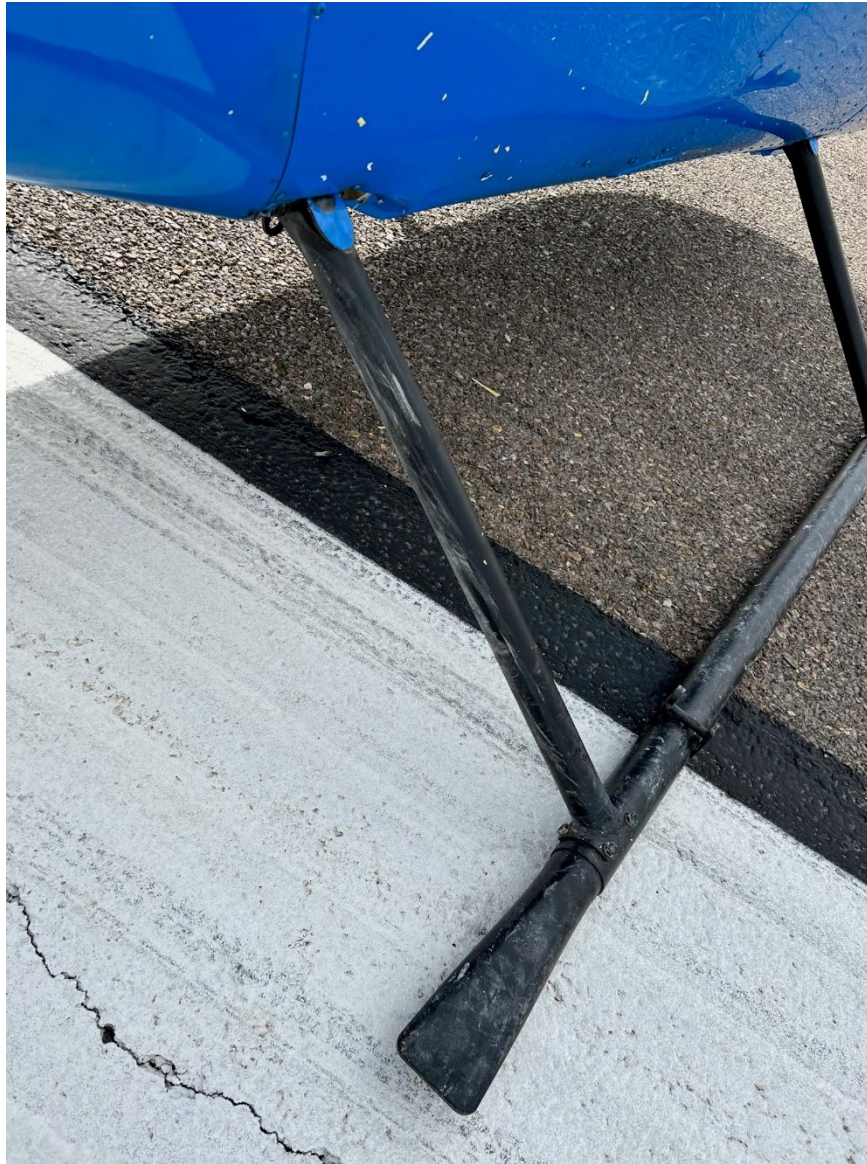
**Photograph 1 - View of the initial point of impact being the aft right skid (Courtesy of FAA)**

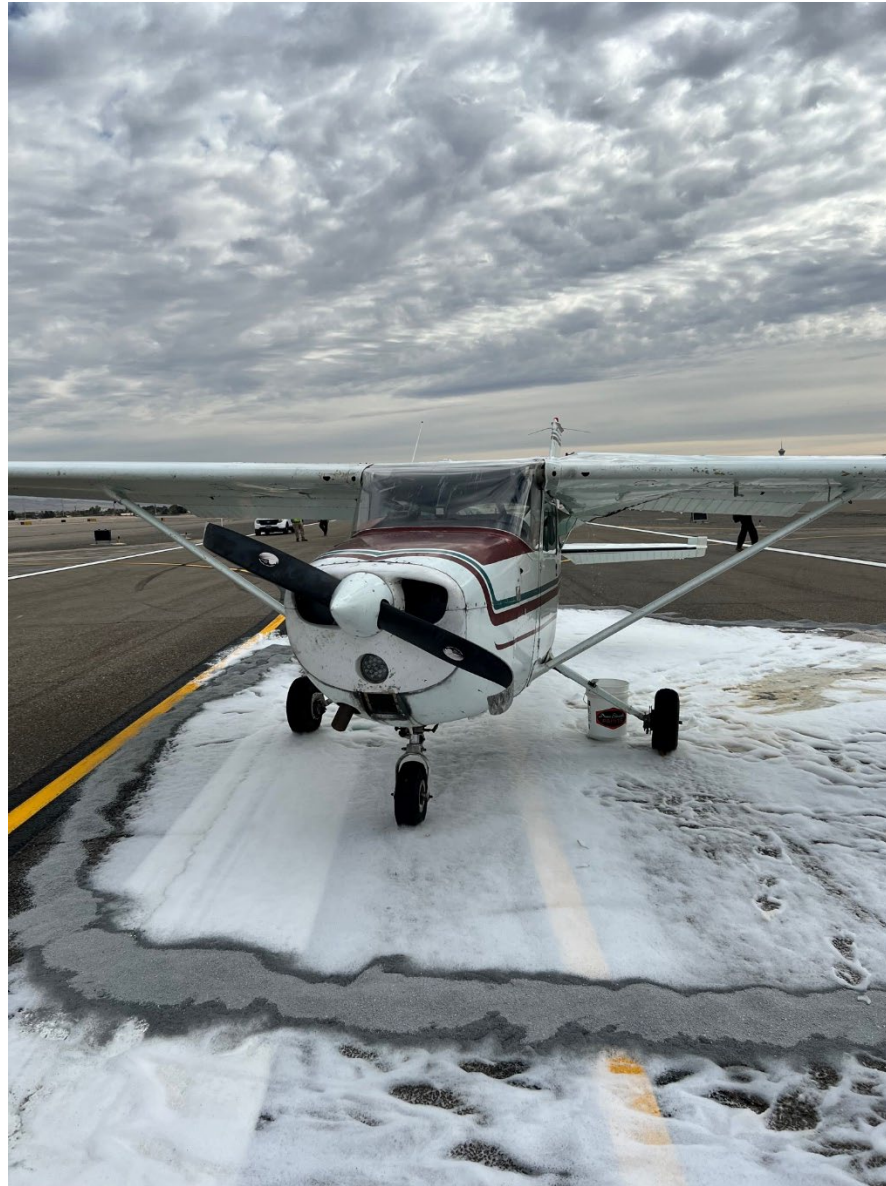
**Photograph 2 - View of the damage to the left wing root (Courtesy of FAA)**

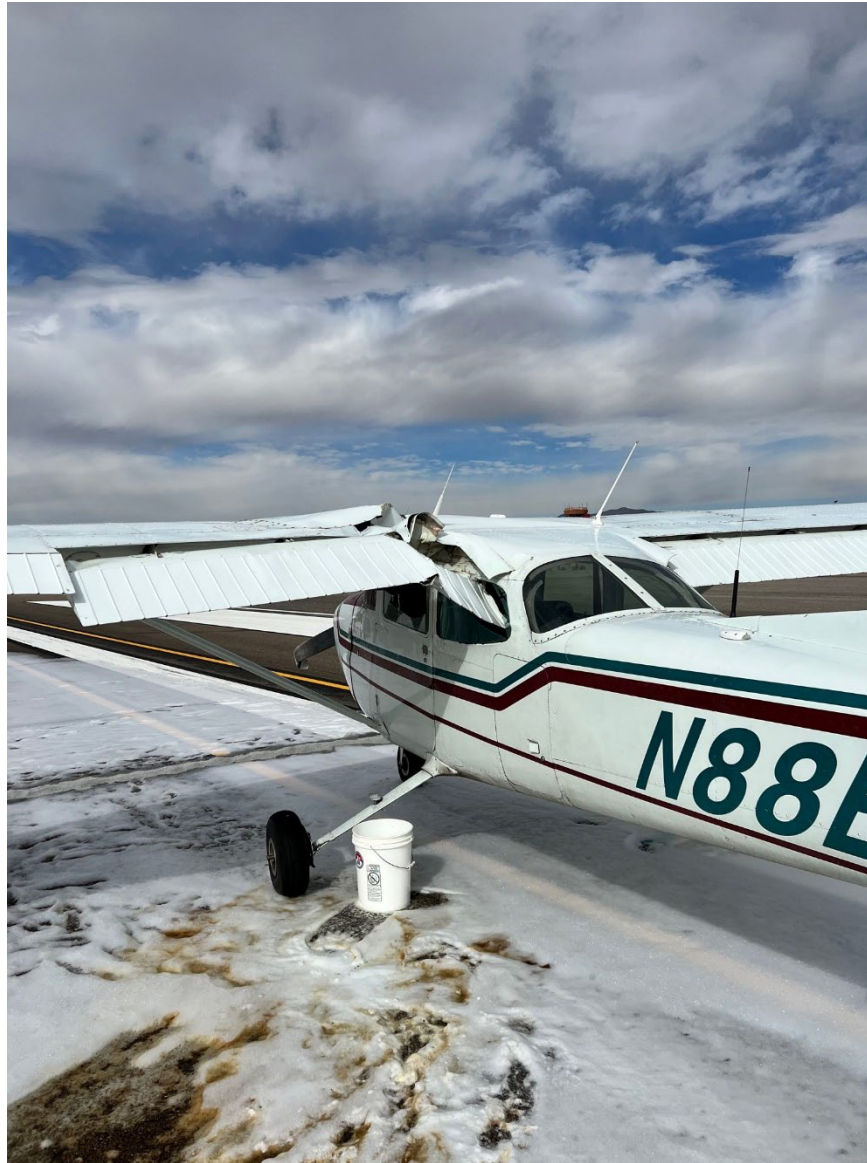
**Photograph 3 - View of damage to left wing root (Courtesy of FAA)**

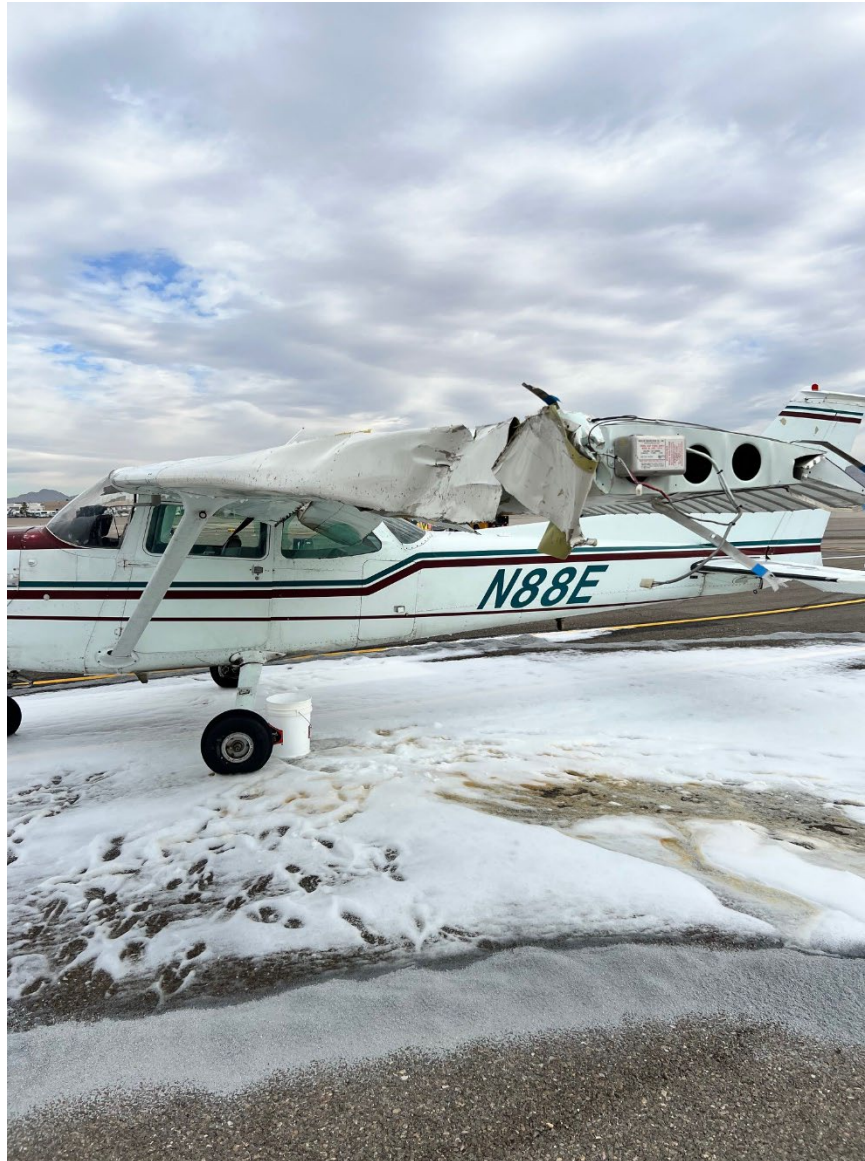
**Photograph 4 - View of damage to left wing leading edge and rib (Courtesy of FAA)**
