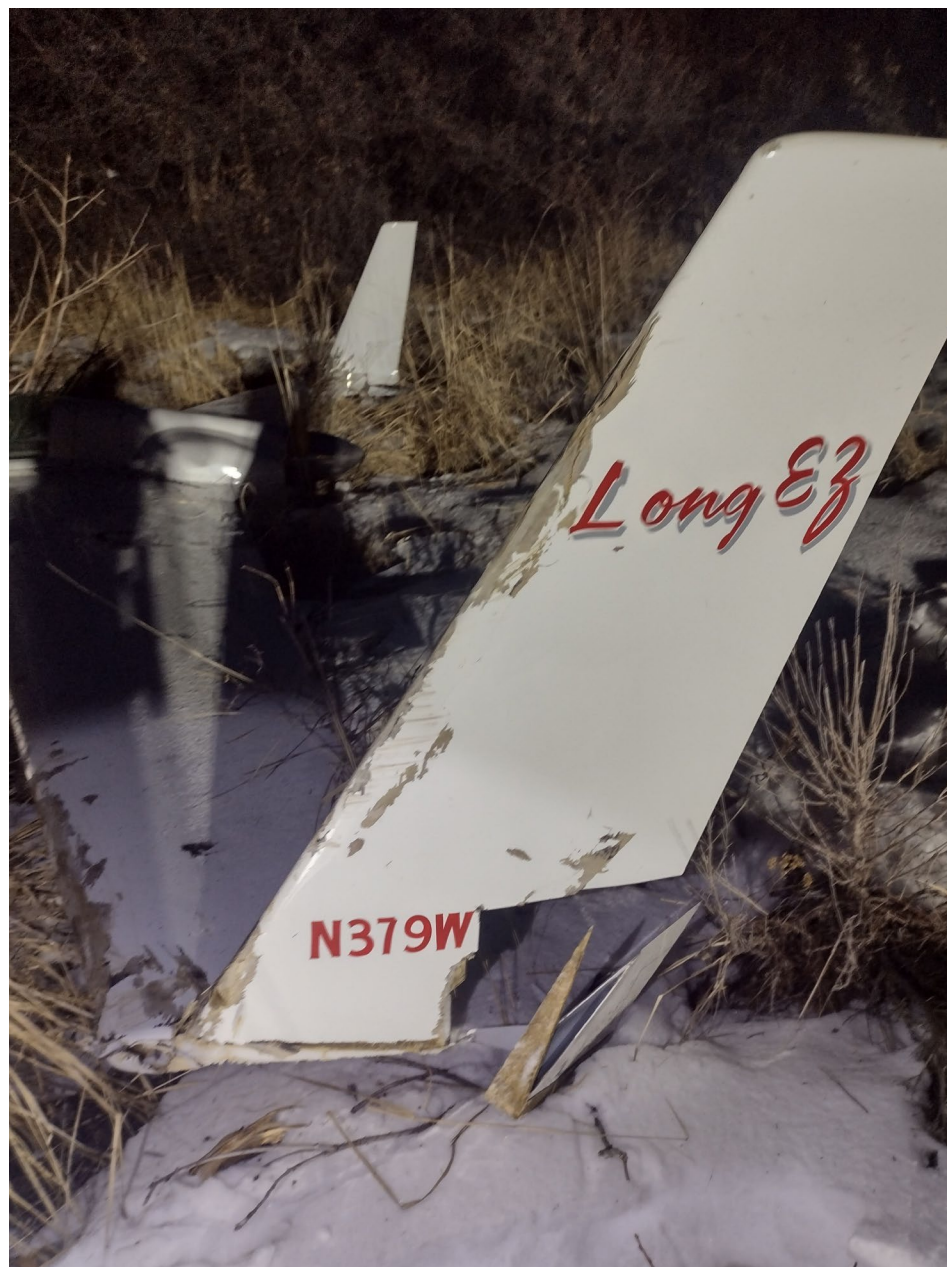
**Photo 1 – View of left aileron damage (photo courtesy of pilot)**

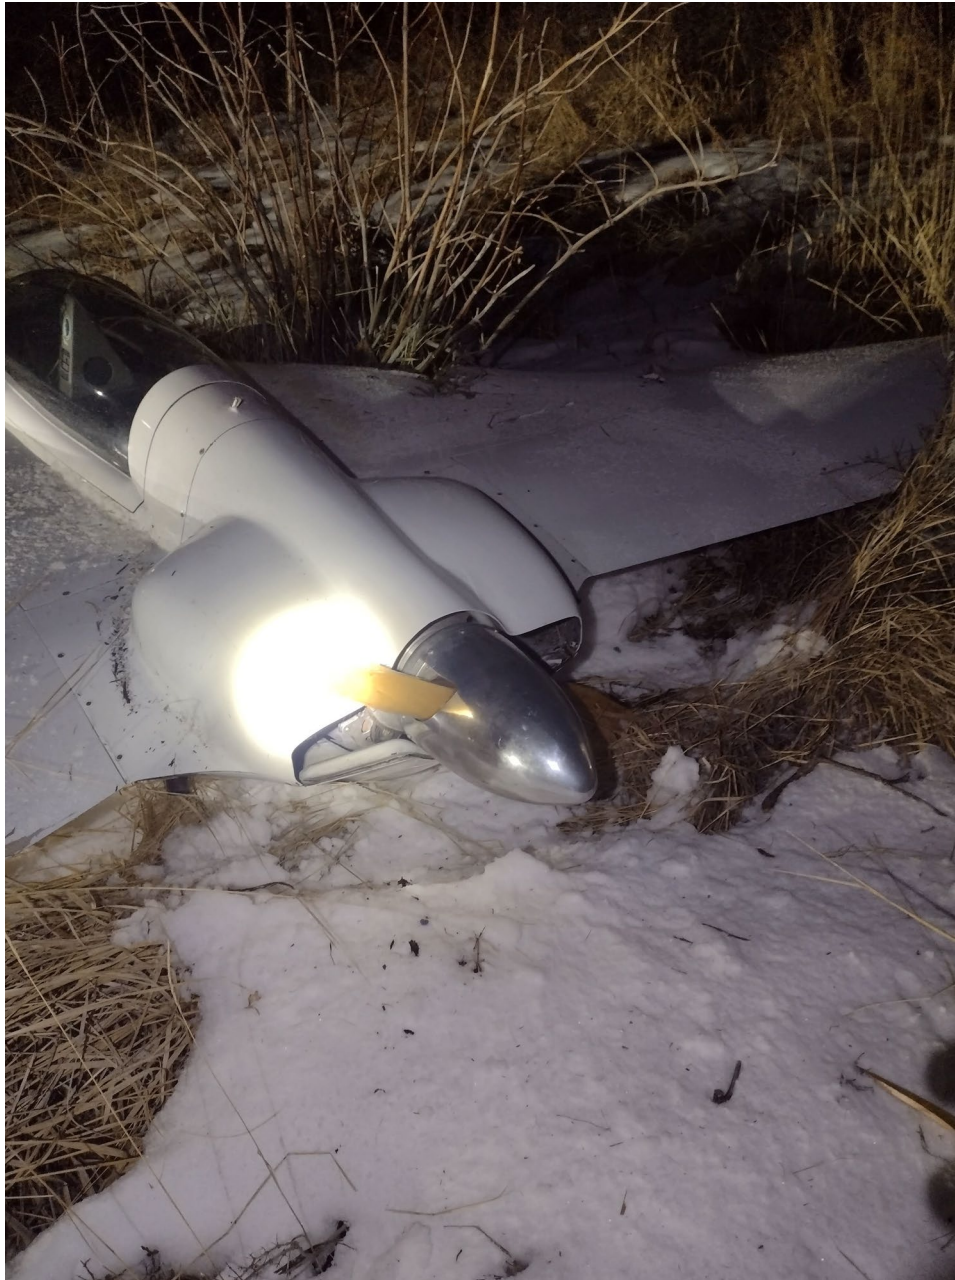
**Photo 2 – view of right wing leading edge damage (photo courtesy of pilot)**
