## SUPPLEMENTAL INVESTIGATIVE MATERIAL

### HISTORY OF FLIGHT

On November 27, 2022 about 1345 mountain standard time, a Cessna 177, N2994X, was substantially damaged when it was involved in an accident near Willow Spring, Arizona. The pilot and passenger sustained minor injuries. The airplane was operated as a Title 14 *Code of Federal Regulations* Part 91 personal flight.

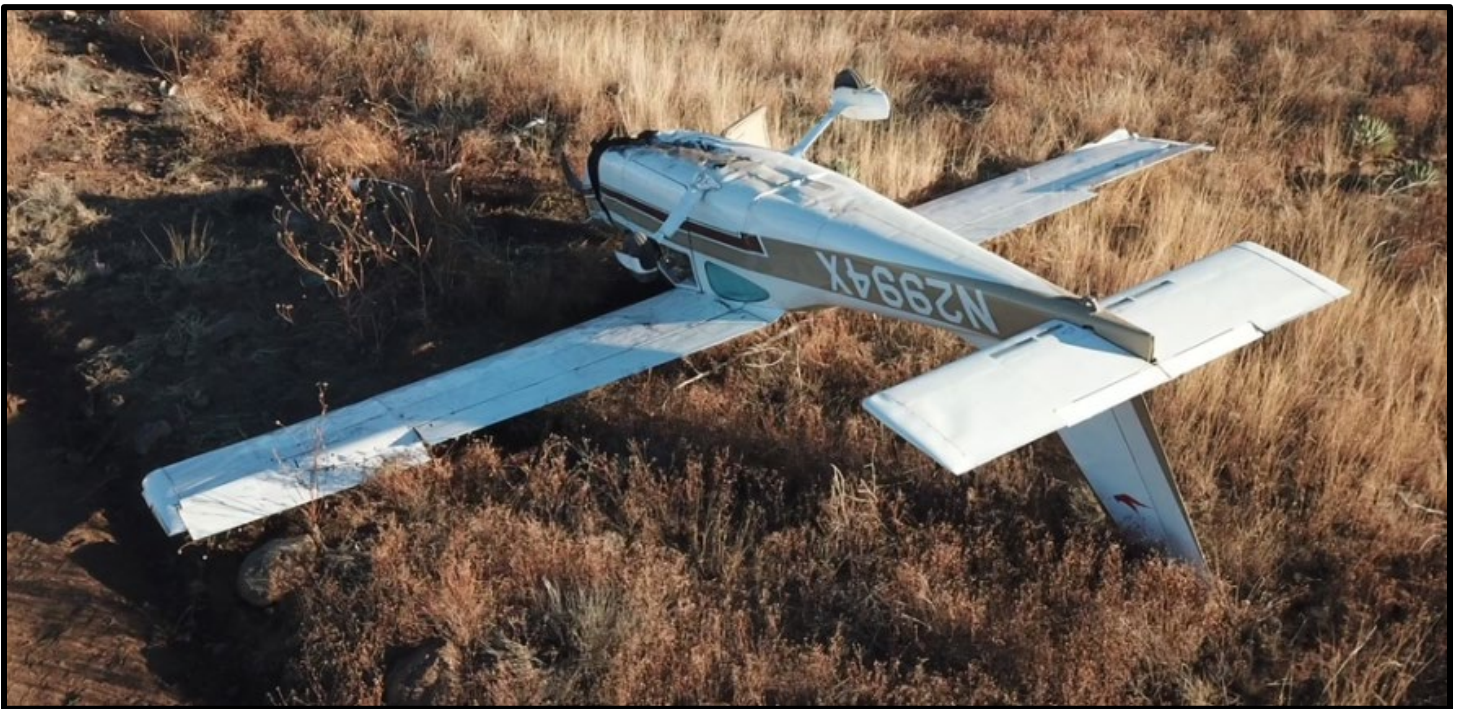
After departing about 1245, the airplane climbed to about 9,600 feet mean sea level (msl) for the en route portion of the flight. The airplane continued at that altitude for about ten minutes and then the engine experienced a total loss of power. The pilot attempted to troubleshoot the engine failure while preparing for an off-airport landing. He estimated the airplane had about 23 gallons of fuel at this time. The airplane came to rest inverted adjacent to a remote dirt road.

Figure 1: The Airplane at the Accident Site

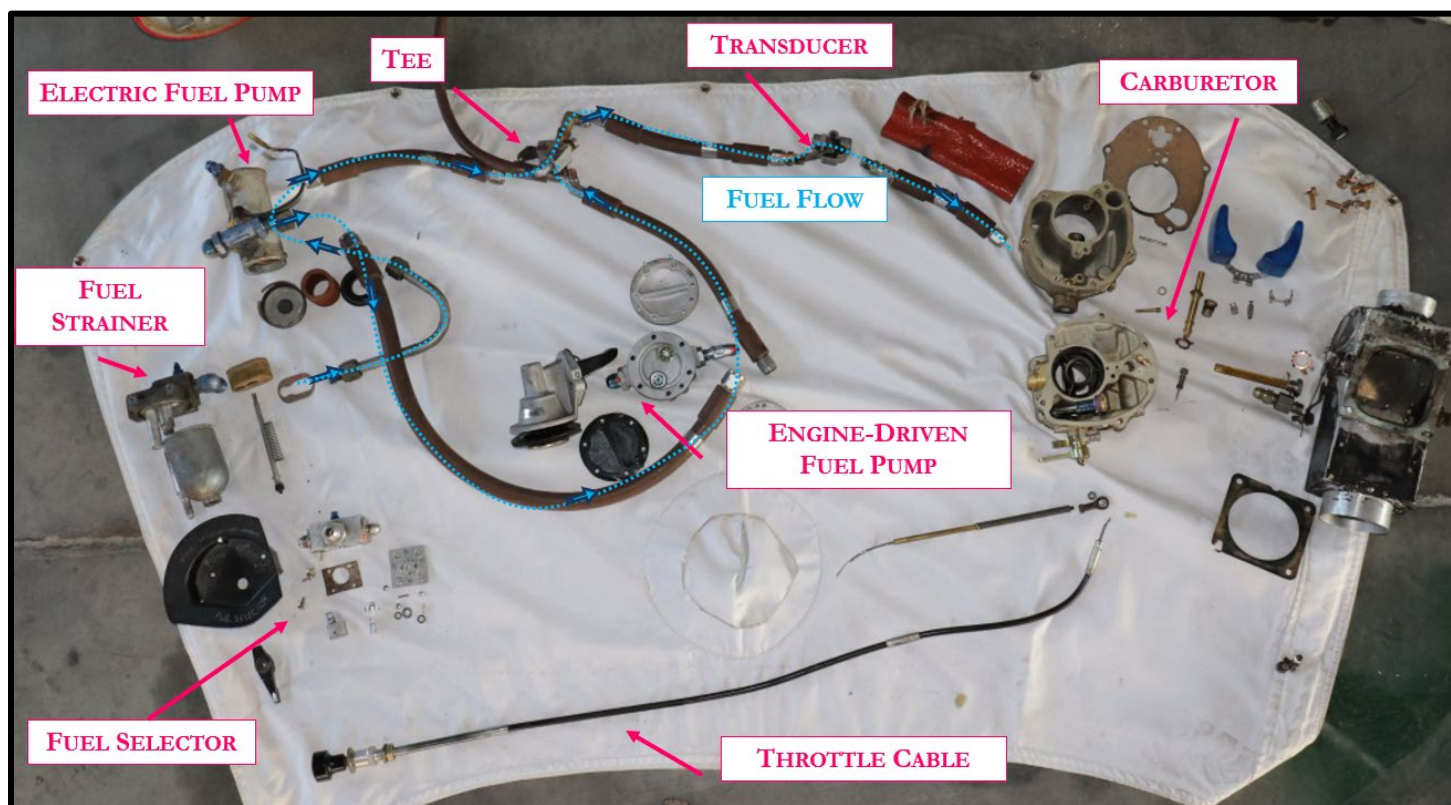
Taking off the fuel lines through the system resulted in fuel leaking out. The electric fuel pump remained attached to the firewall. Investigators connected an auxiliary battery the pump and could hear the pump audibly clicking coinciding with feeling light puffs of air on the outlet consistent with normal operation. At the electric pump, the fuel was routed to the mechanical fuel pump; the outlet of the electric pump went to a manifold. The mechanical pump was removed and disassembled. When the pump’s lever was manipulated up and down suction could be felt in the inlet and pressure could be felt on the outlet. When rotating the engine by the propeller, the pin that depresses the pump’s lever could be felt moving. From the mechanical pump, the fuel was routed to the tee. From the electric pump, fuel was routed to the tee. The tee also contained a smaller line to the cockpit; when that line was removed fuel that was inside contained debris.

Figure 3: Fuel System Disassembled

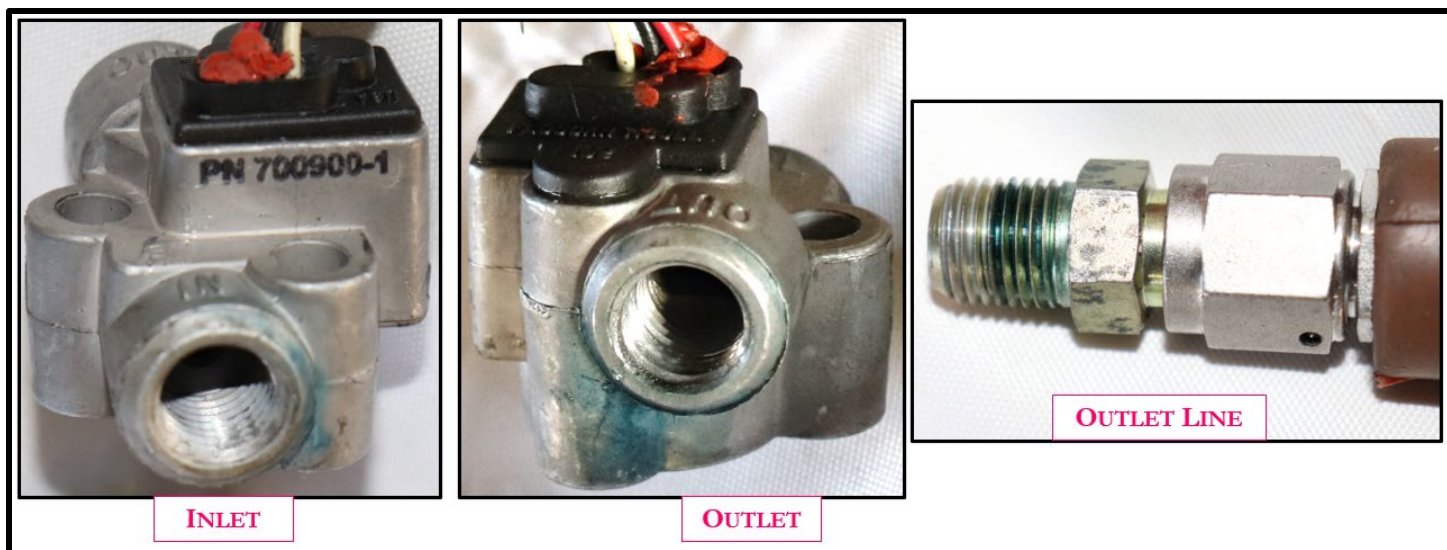
From the manifold the fuel was routed in one line to a transducer FloScan 201 that was wrapped in fire sleeve. The fitting was both stained blue consistent with leaking, The inside of the fire sleeve has one small area of blue staining. The transducer was removed an application of air produced a sound consistent with the paddle wheel inside spinning. The fuel then continued to the carburetor, which was attached and intact. Disassembly of the carburetor revealed that it contained trace amounts of fuel. The composite floats were removed and floated when placed in water. There was some small debris in the carb. The airbox was jammed in the open position and carburetor heat cable would not function.

Figure 4: Fuel Transducer

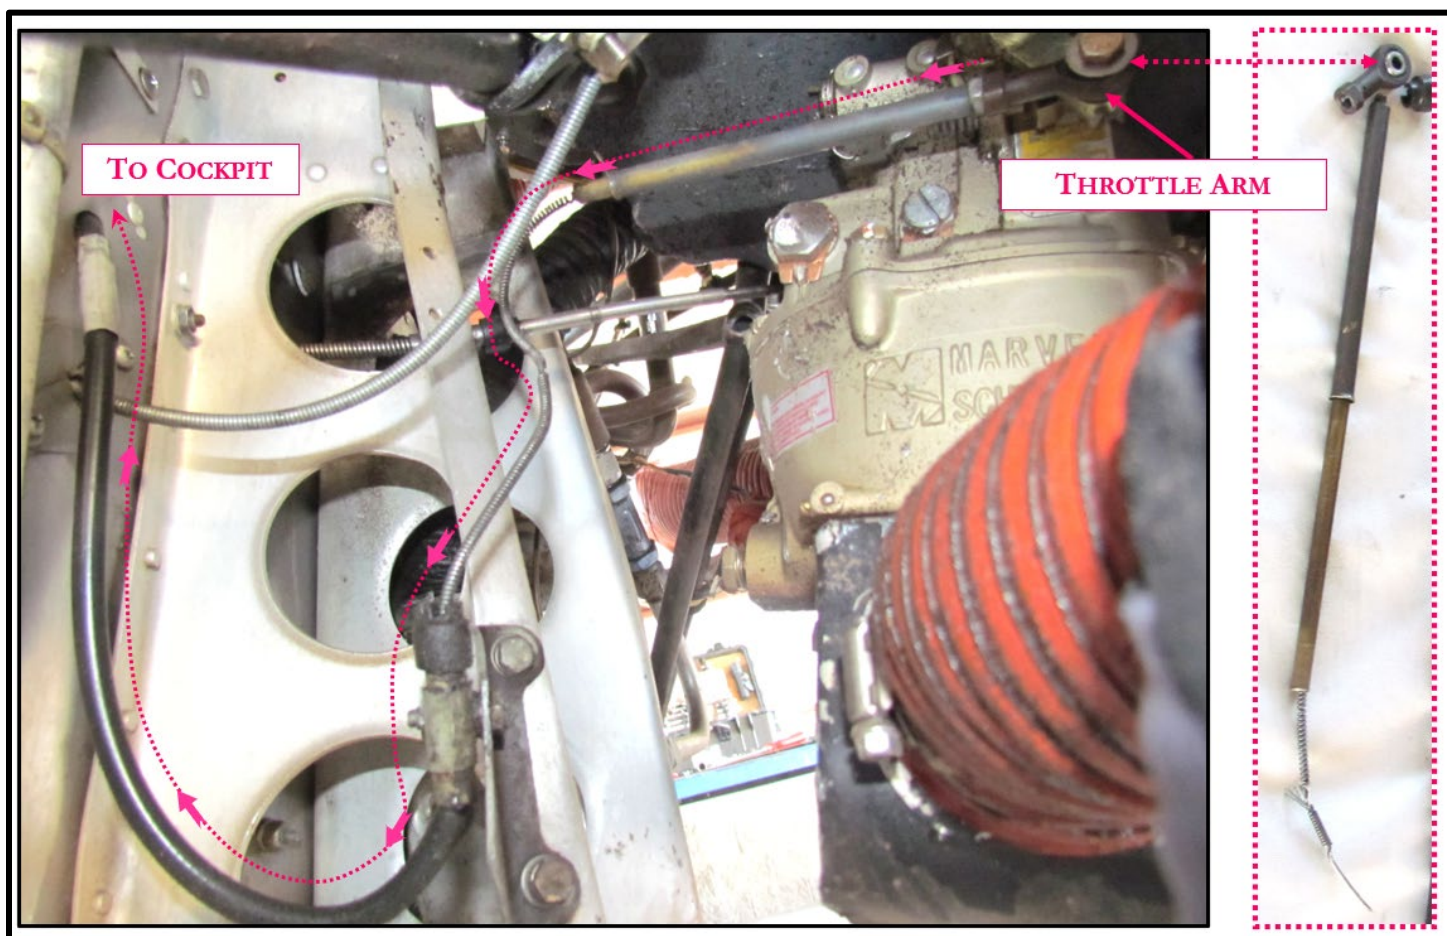
The throttle cable was frayed and had stretched out of its housing (inner wire pulled from the swage). It was attached to the carburetor arm and moved slightly when manipulating the control knob in the cockpit (full travel was not possible). It appeared that the coils had been stretched, but it could not be determined if it was done at impact. The airframe was missing the required bracket needed to attach it to the airframe; instead it was attached in an indirect route. The mixture control arm was separated from the mixture shaft and the shaft was bent.

Figure 5: Throttle Cable from Arm to Cockpit

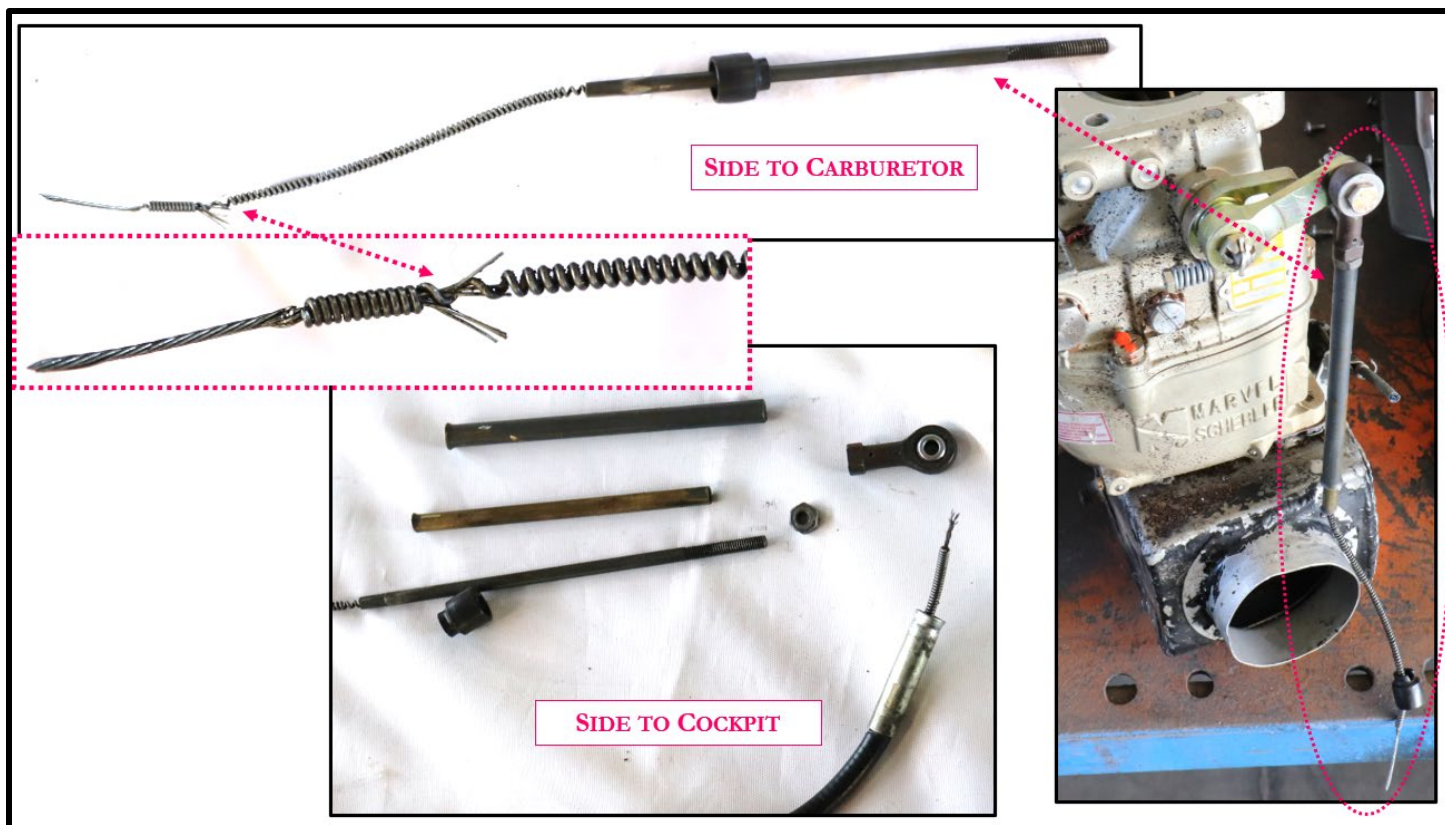
Figure 6: Throttle Cable

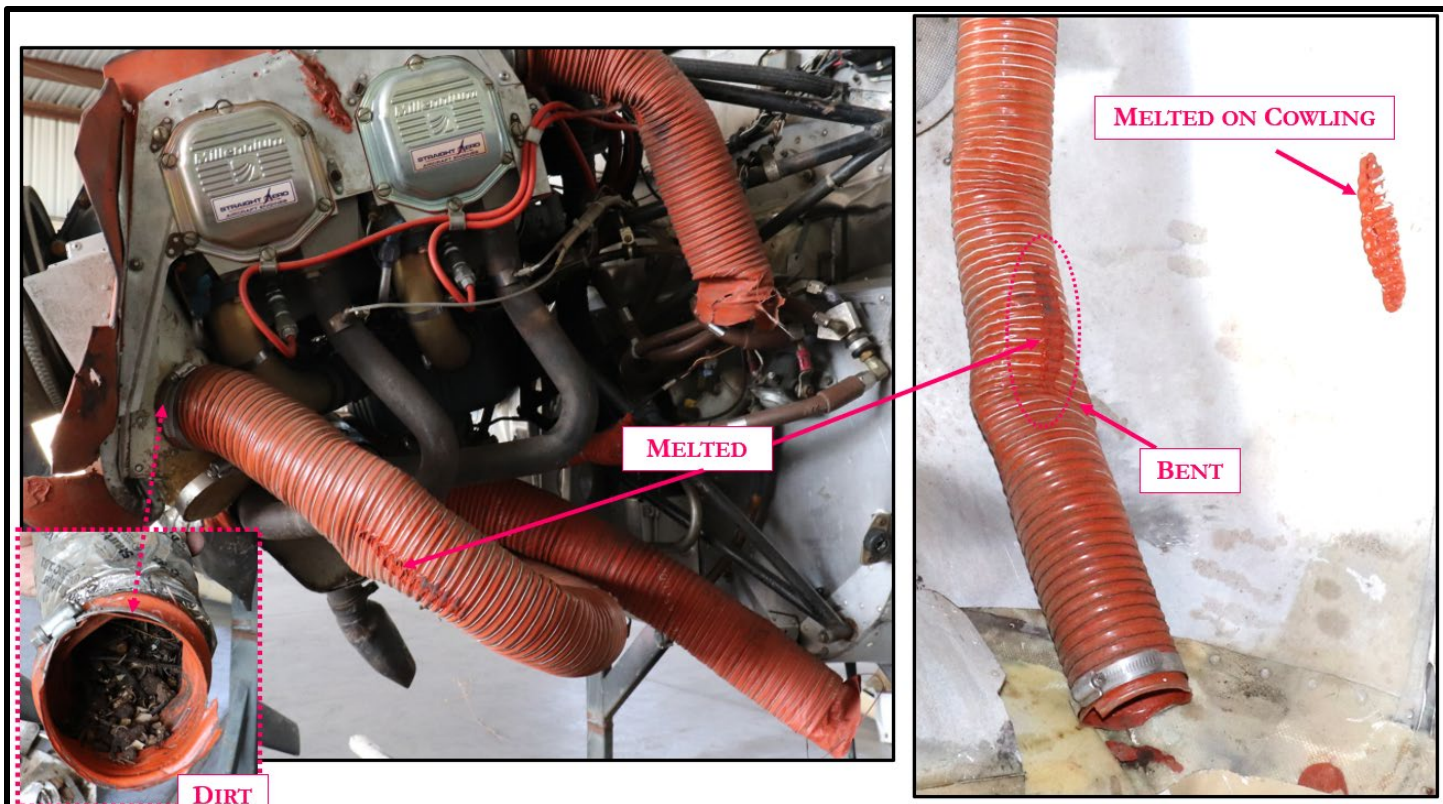
The air intake filter was dirt filled consistent with impact. The Scelet tubing (intake tube) extending from the air filter housing to the carburetor exhibited partial crushing. Additionally, wear marks and red sealant were observed on both the tubing and the cowling. Corresponding marks were identified on the #2 exhaust tube. Notably, modifications were evident on the air filter box, specifically involving the relocation of the tubing attaching flange.

Figure 7; Saeet Tubing
