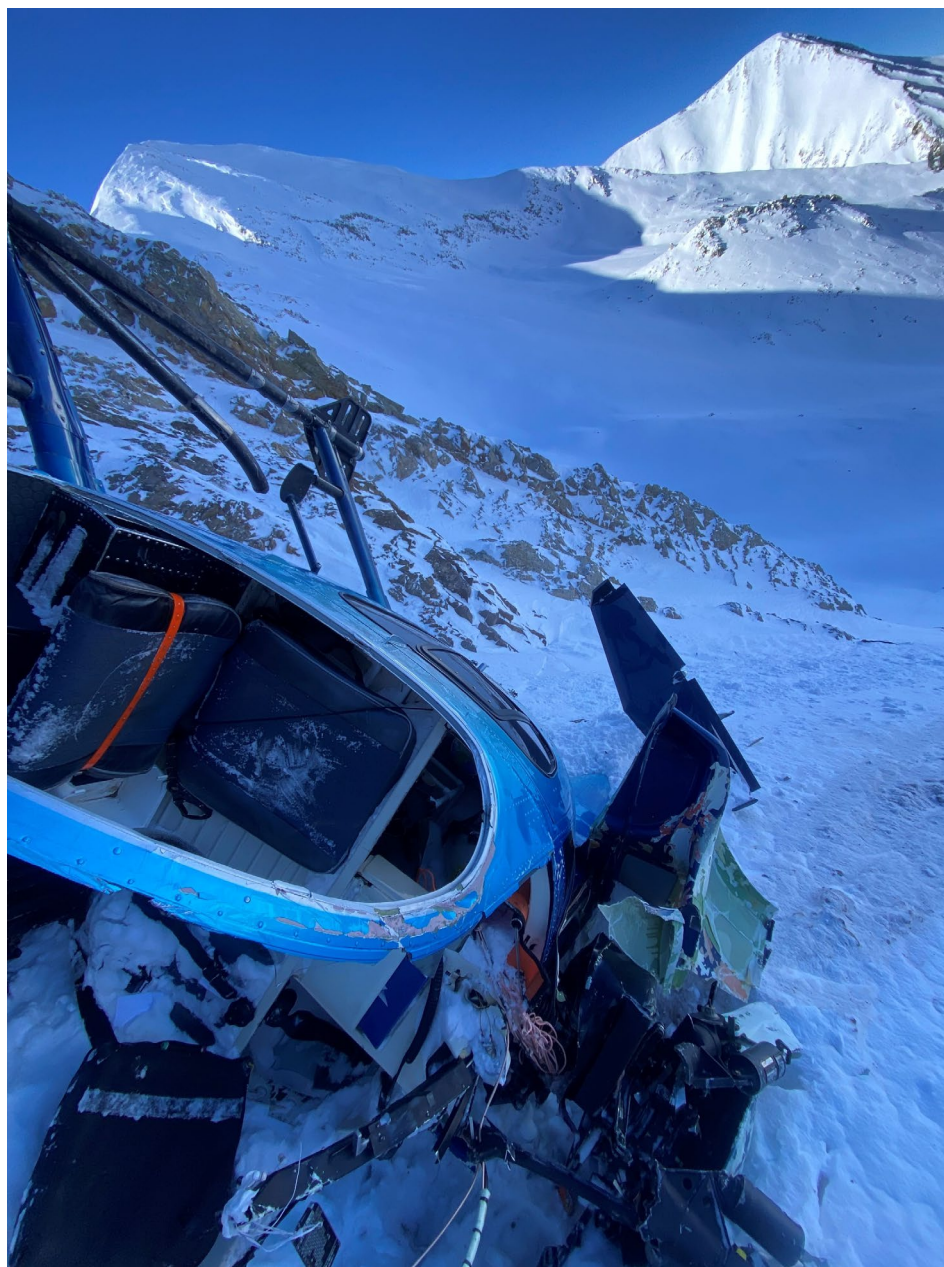
**Photo 1 –N458HW front view, showing the damage to the fuselage, tail cone, and main rotor head. Photo courtesy of the operator.**
