RE: N210CU post-accident brake inspection conducted Monday 20 Mar 2023

Per instructions from your office an inspection of Cessna 210N, N210CU, S/N 21064452 brakes was conducted at Morgan County Airport (42U) with Salt Lake FSDO representative Jon A. Hansen present. Focus of this inspection was directed at the left brake assembly of the subject aircraft due to pilot reporting this was the inoperative brake at the time of the runway excursion.

RE: N210CU post-accident brake inspection conducted Mar 20 and June 15 2023 and

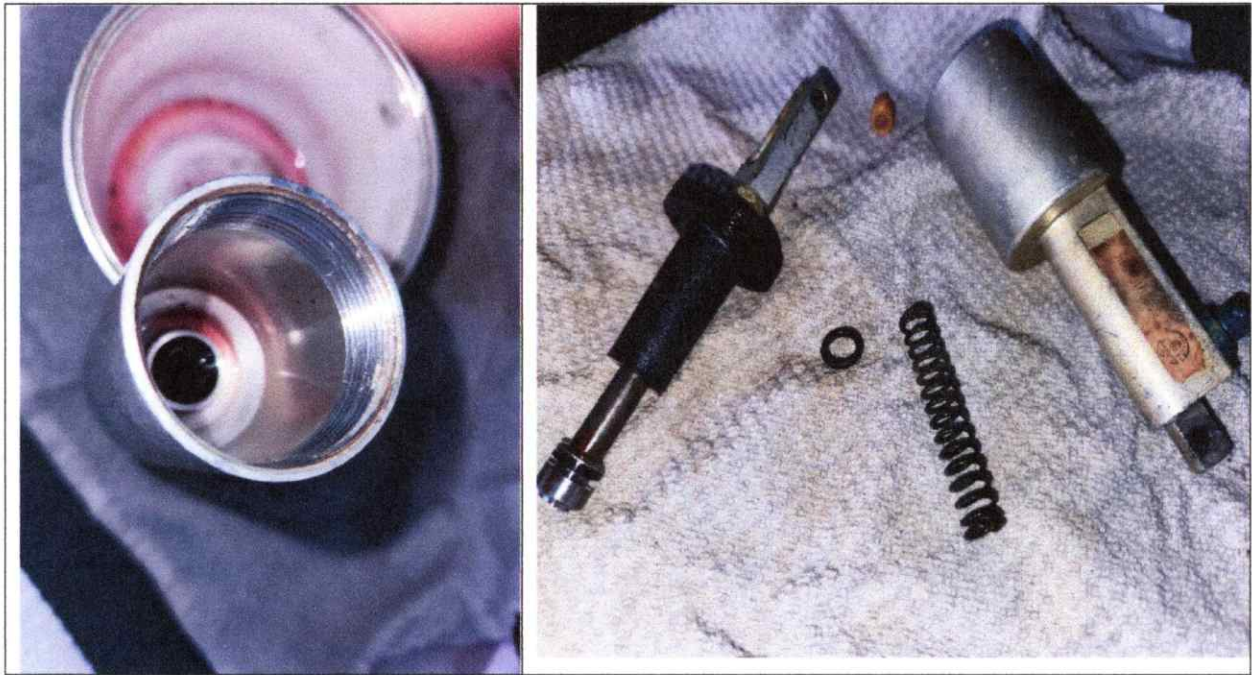
- 1) The Left brake was flat, no actuation. The Right brake operated in normal fashion with appropriate braking force applied to the right wheel.
- 2) The seats and floor panels were removed from the aircraft to facilitate brake component inspection for condition, potential damage and leaks.
- 3) The Left brake master cylinder was removed from the aircraft and disassembled for inspection. There was no evidence of leakage of brake fluid from the master cylinder or the brake lines in the forward cabin sub floor area.
  - The Left master cylinder was completely empty.
  - The "O" ring and master cylinder were in serviceable condition.

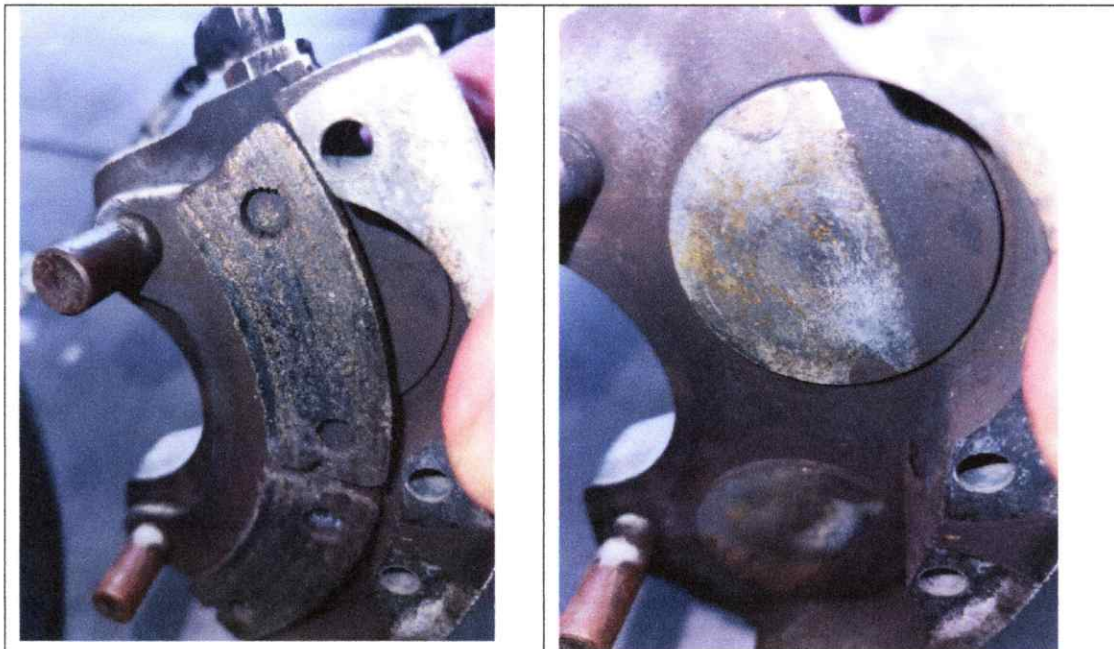
- 4) There was no evidence of leakage at wheel cylinder and the brake rotor is in serviceable condition.

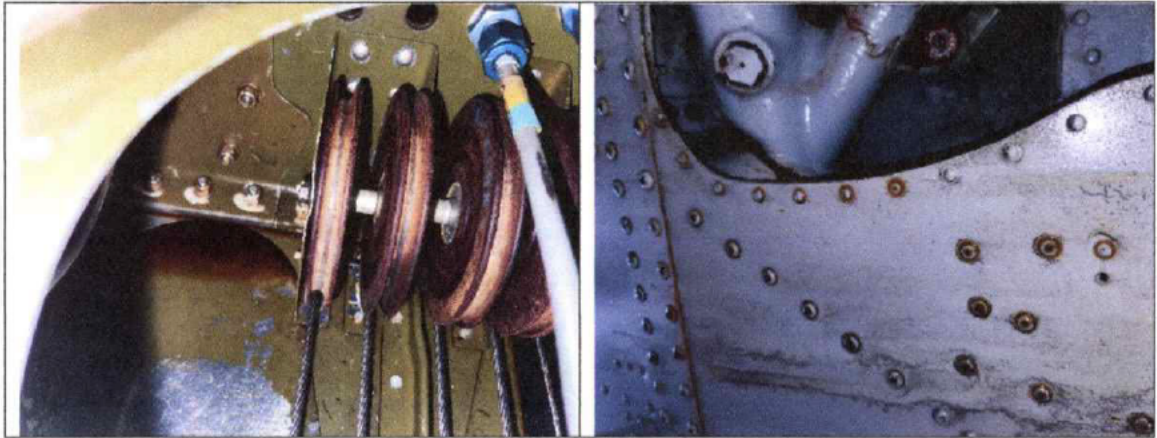
- 5) There was significant brake fluid under the aft cabin floor and on the aircraft belly. Most of the brake fluid was pooled in front of the bulkhead forward of the landing gear and brake line pivot fitting . There was no damage or leakage apparent with close inspection of any of the Left brake system lines and components under the cabin sub floor and landing gear actuator zone.

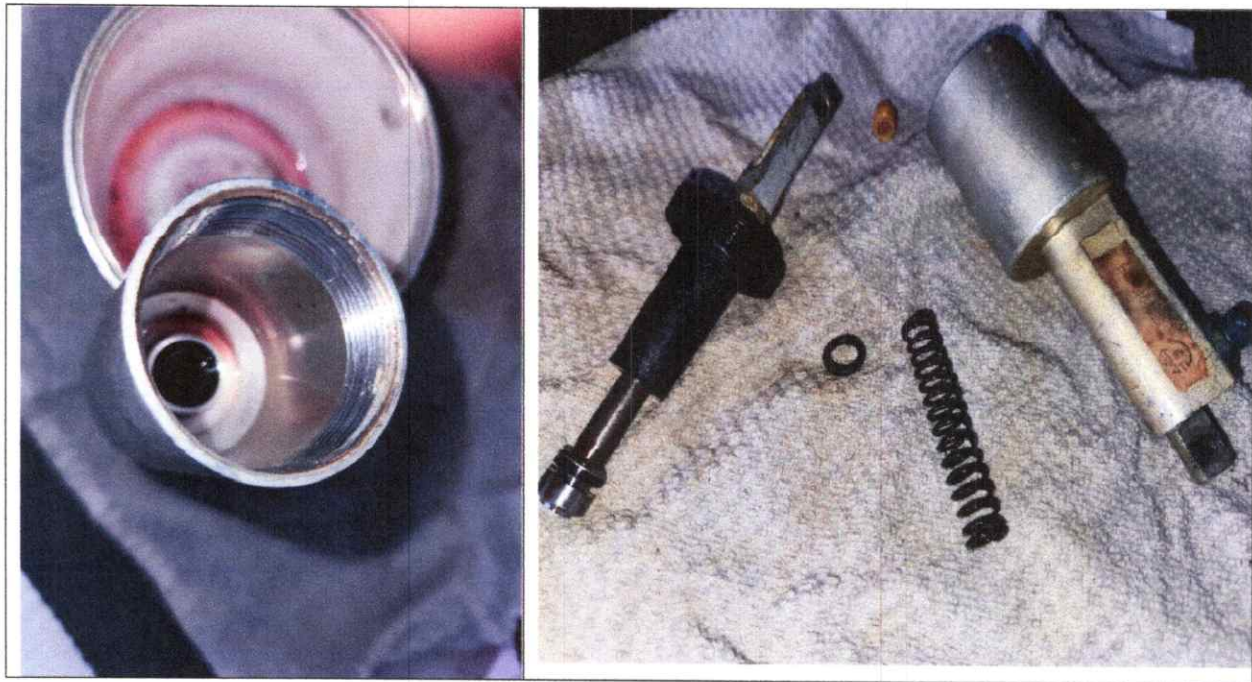
- 1) The Left brake was flat, no actuation. The Right brake operated in normal fashion with appropriate braking force applied to the right wheel.
- 2) The seats and floor panels were removed from the aircraft to facilitate brake component inspection for condition, potential damage and leaks.
- 3) The Left brake master cylinder was removed from the aircraft and disassembled for inspection. There was no evidence of leakage of brake fluid from the master cylinder or the brake lines in the forward cabin sub floor area.
  - The Left master cylinder was completely empty.
  - The "O" ring and master cylinder were in serviceable condition.

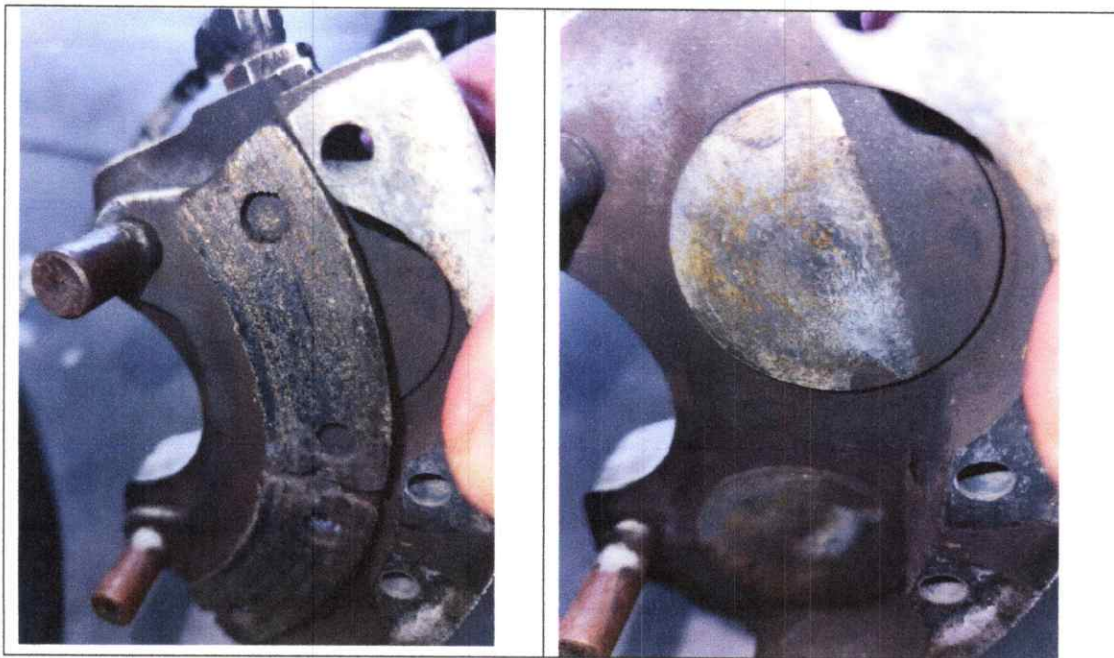
- 4) There was no evidence of leakage at wheel cylinder and the brake rotor is in serviceable condition.

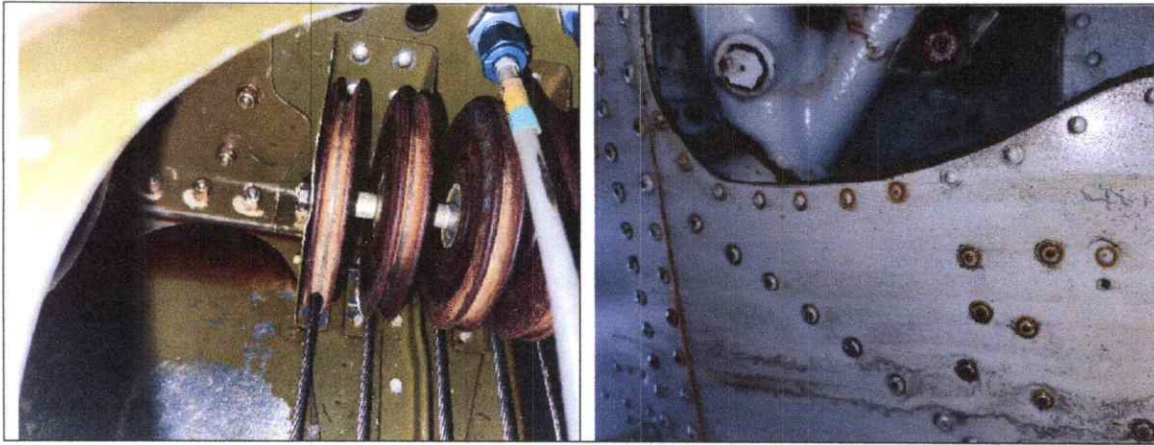
- 5) There was significant brake fluid under the aft cabin floor and on the aircraft belly. Most of the brake fluid was pooled in front of the bulkhead forward of the landing gear and brake line pivot fitting . There was no damage or leakage apparent with close inspection of any of the Left brake system lines and components under the cabin sub floor and landing gear actuator zone.

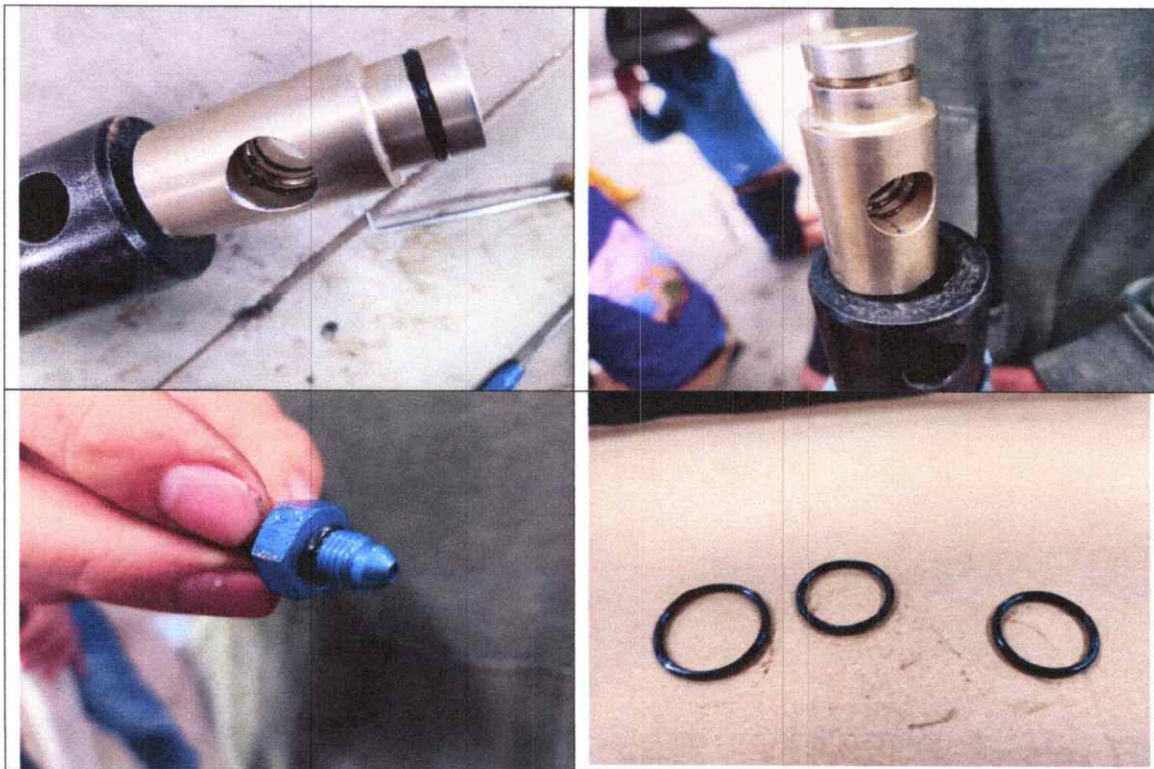
- 6) The brake system was assembled and serviced with fluid. No defect or leak was apparent through the left side brake system from master cylinder to wheel cylinder. The brakes were actuated to maximum pressure that a pilot could apply for 5 minutes with no failure or leakage in the system.
- 7) The Left landing gear leg and pivot assembly was removed from the aircraft. The "O" rings from the brake fluid transition assembly were flexible, normal shape and undamaged.

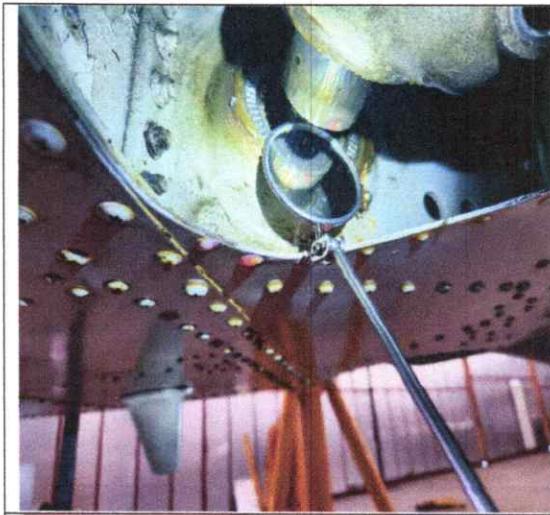
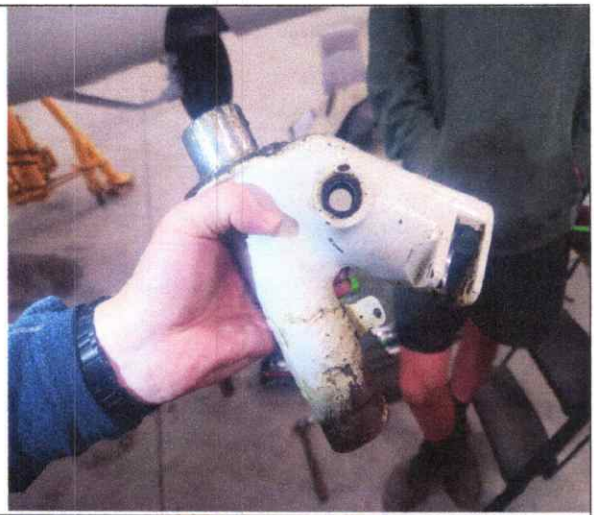
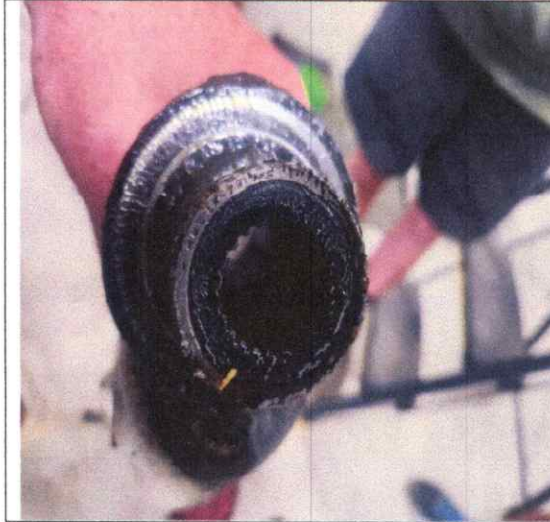
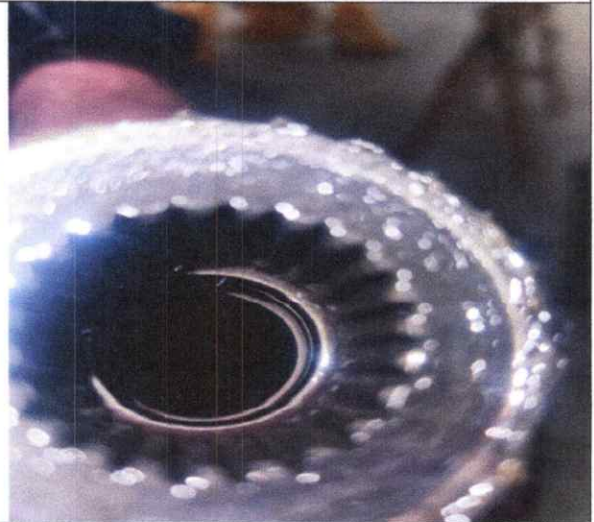
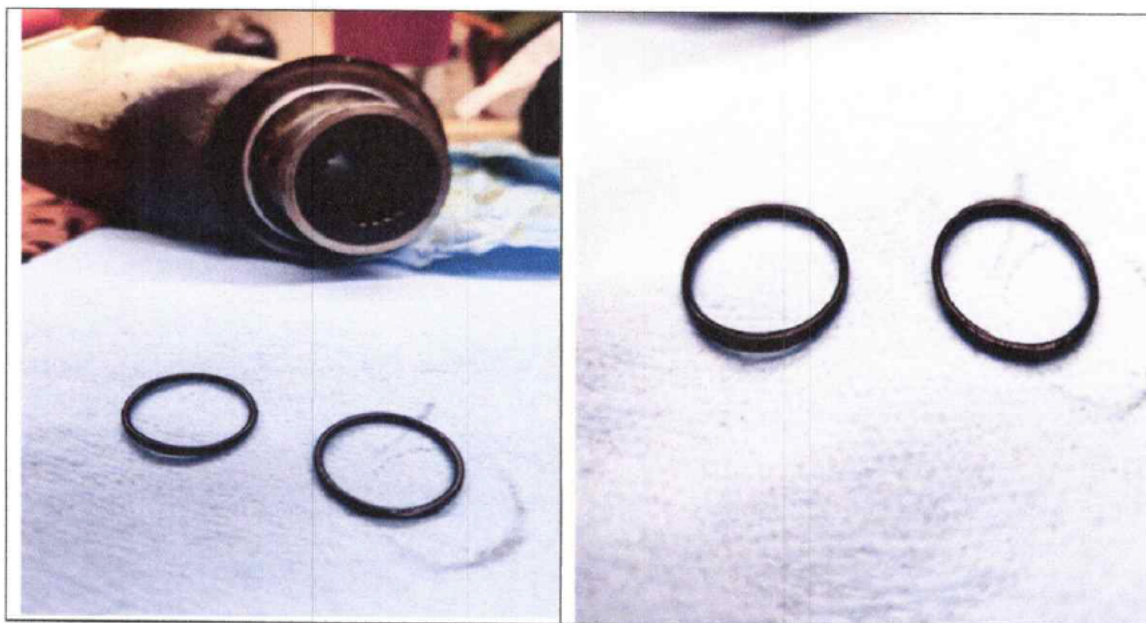
- 8) The main landing gear pivot trunnion was disassembled, and "O" rings inspected. These "O" rings were stiff and flattened but with no obvious damage. These are the most likely leak path as

the cavity they seal is full of hydraulic fluid for brake line and wheel cylinder use and with lading gear in the up position will leak directly into the belly of the aircraft.

With the entire left landing gear and trunnion removed all seals in the system were able to be inspected. It was determined the most likely brake fluid leakage path was through the main landing gear trunnion seals with the landing gear rotated to the up position, allowing brake fluid to leak into the belly of the aircraft through the trunnion to actuator interface joint.
