# National Transportation Safety Board

WPR23LA086

## **MATERIALS LABORATORY**

Factual Report 23-025

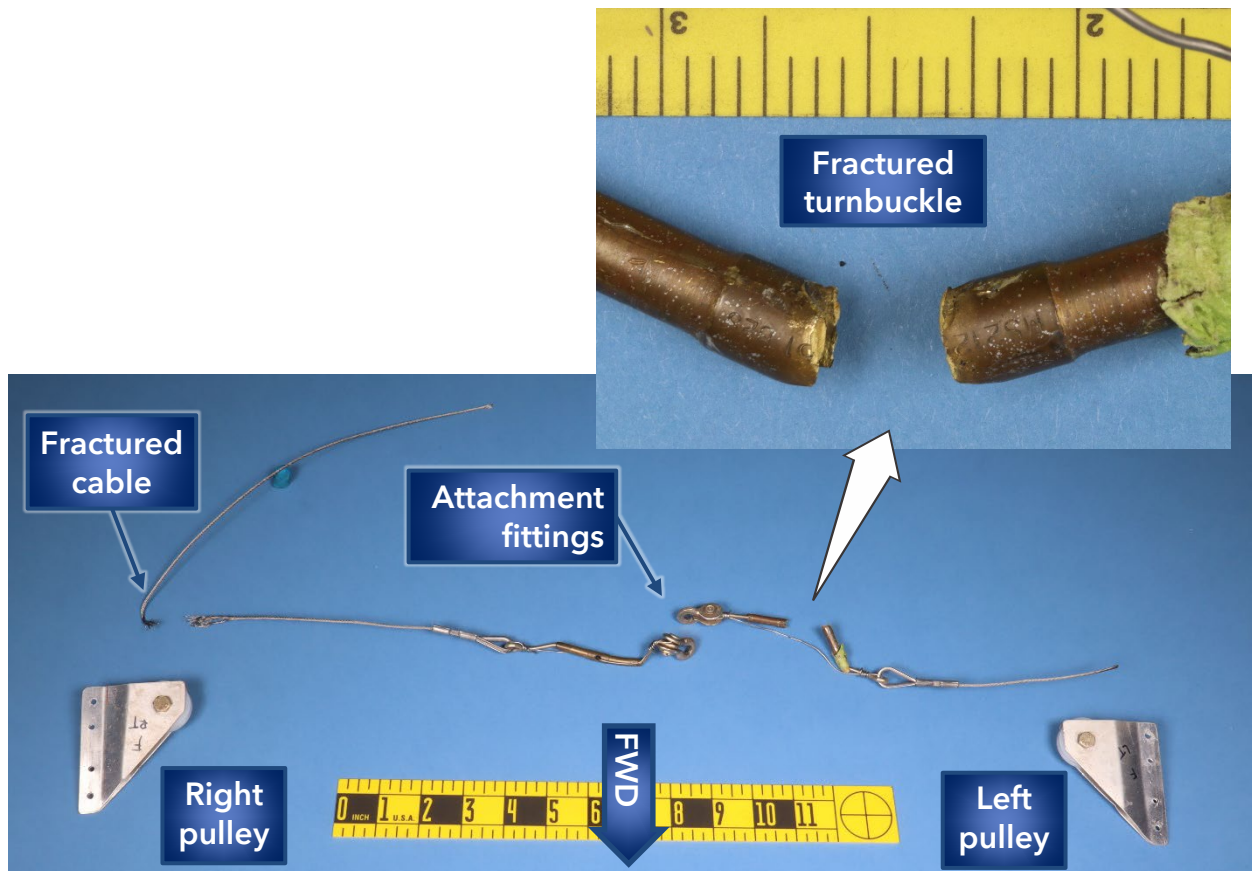
An overall view of the submitted components is shown in figure 1. The components included aileron cable pieces that were attached to the control stick at the forward cockpit position, a mating piece of the fractured right control cable, and forward pulleys from the aileron control system that had been removed from the left and right sides of the fuselage at the forward cockpit position. The turnbuckle on the left control cable was fractured, and an inset image shows a closer view of the fracture.

The turnbuckle for the right control cable was bent in the barrel and in the shanks of the eye fittings at each end of the barrel. The control cable was also bent adjacent to the cable fracture. The fractured end of the cable was splayed consistent with an overload fracture. Individual wire fractures were examined using an optical stereomicroscope, and necking deformation was observed at the fracture locations consistent with ductile overstress fracture.

The turnbuckle for the left control cable was fractured, and the shanks of the eye fittings at each end were bent. The turnbuckle fracture occurred through the safety wire through-hole in the middle of the barrel, and the safety wire remained intact. The fracture surfaces for the turnbuckle were rough and on slant angles relative to the longitudinal axis, features consistent with ductile overstress fracture. Deformation associated with the fracture was consistent with fracture from bending loads with relative orientation of the two sides as shown in the inset image in figure 1.

**Figure 1.** Overall view of the submitted components from the aileron control system at the forward cockpit position with a closer view of the fractured turnbuckle from the left cable assembly.

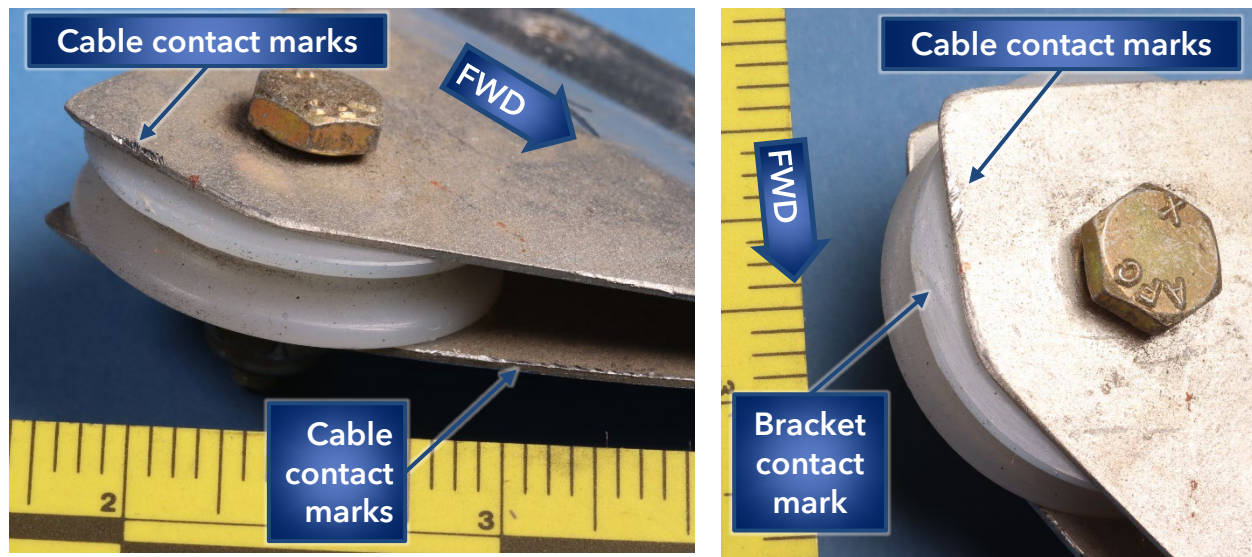
Cable contact marks were observed on the sides of the pulley grooves and on the cable bracket for the left pulley. Normally, the control cable contacts the pulley groove at the forward outboard quadrant of each pulley as the cable is routed

between the transverse direction at the forward side of the pulley and longitudinally aft at the outboard side of the pulley. As shown in figure 2, contact marks were observed on the upper inboard edge of the lower bracket forward of the pulley and on the upper inboard edge of the upper bracket aft of the pulley axis. Cable contact marks were also observed on the upper and lower sides of the pulley groove as shown in figure 3. The contact mark on the upper side of the groove corresponded to a bracket contact mark on the upper face as indicated in figure 3. When the bracket contact mark on the pulley upper face was aligned with the bracket edge, the cable contact marks on the upper side of the pulley coincided with the contact marks on the inboard edge of the upper bracket.

**Figure 2.** Close views of the upper inboard side of the left pulley showing areas of cable contact on the bracket edges and bracket contact on the upper face of the pulley.

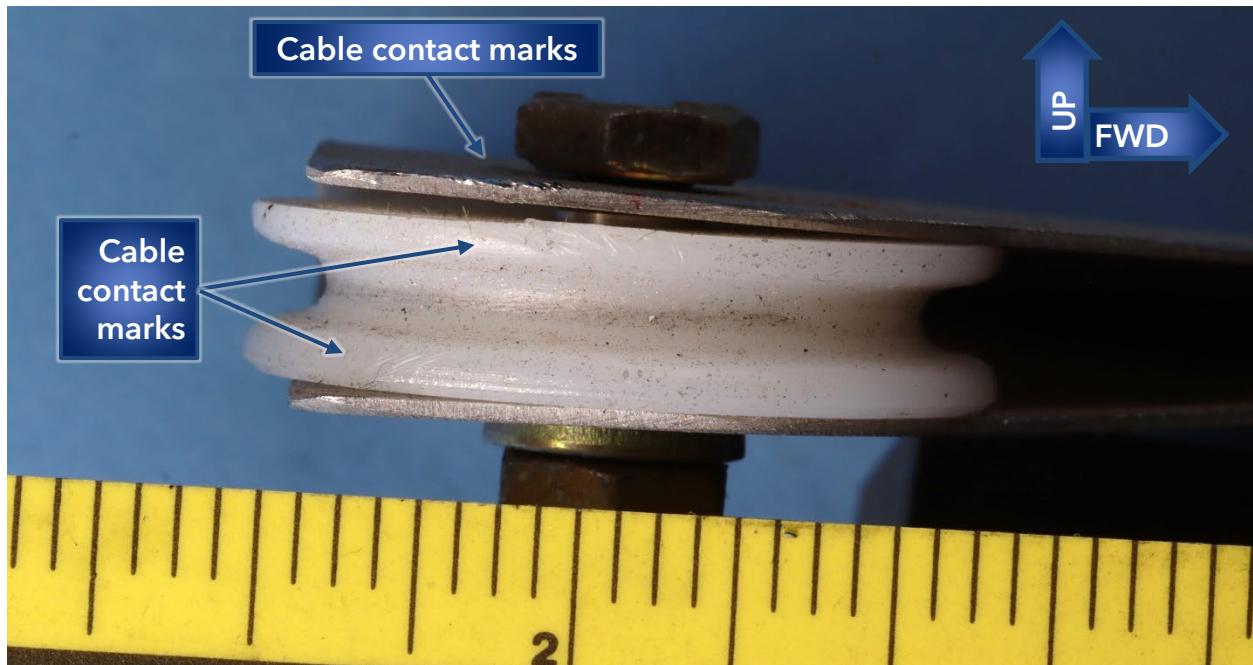
**Figure 3.** Cable contact marks on the sides of the pulley groove and on the inboard edge of the upper bracket.

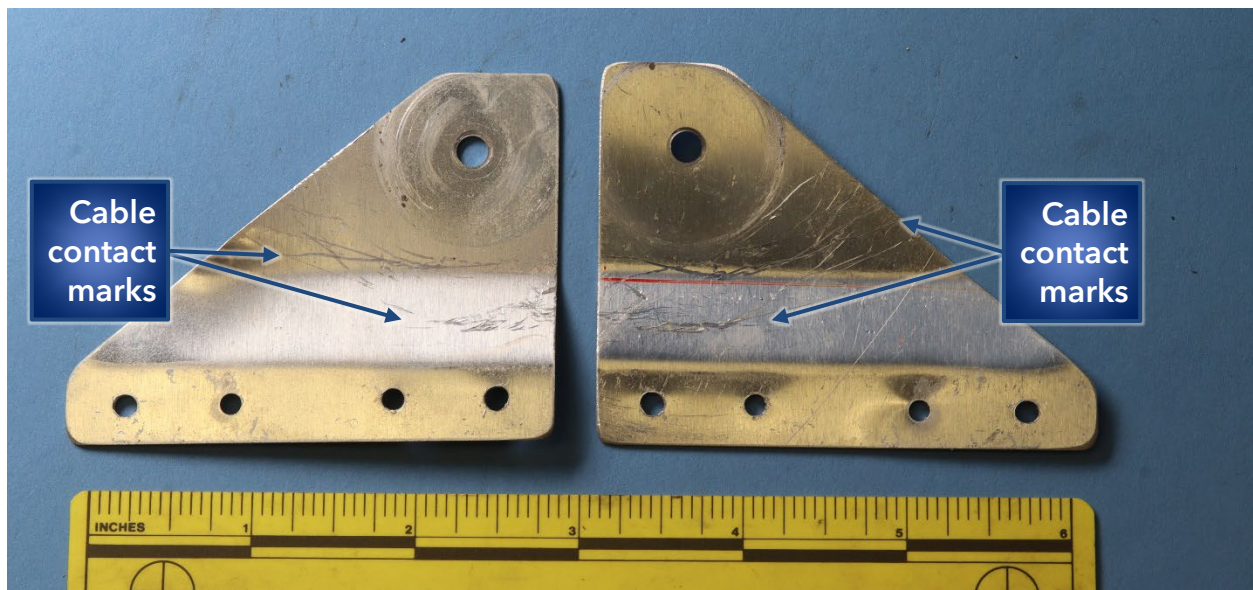
The left pulley was disassembled from the brackets. Scratches consistent with cable contact were observed on the interior surfaces of the brackets between the pulley outer diameter and the bracket attachment flange as shown in figure 4.

**Figure 4.** Cable contact marks on interior surfaces of the upper and lower brackets for the left pulley.
