# National Transportation Safety Board

WPR23LA086

## **WRECKAGE EXAMINATION**

Location: Kent, Washington  
Date: 10/02/2022  
Time: 2000 PDT  
0300 UTC  
Airplane: Cessna 182C

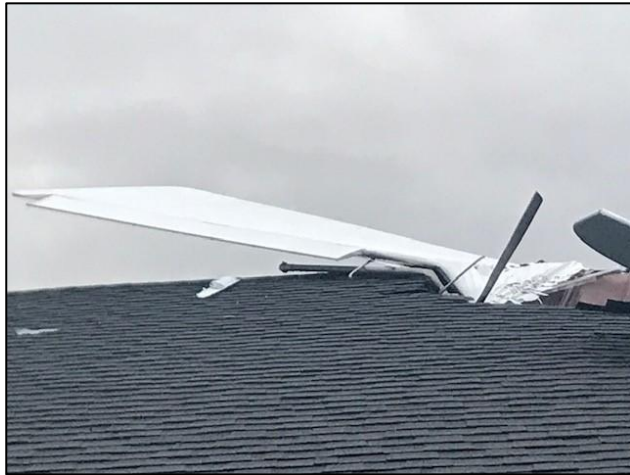
The airplane wreckage was located on the top of a storage facility. According to photos supplied by the FAA, the forward cabin structure and the left wing had impact damage. Onsite photos prior to the onsite wreckage exam show the flaperons were near the 20° down position (See Figures 1-2). The empennage was separated during the relocation of the wreckage.

**Figure 1-Left wing view from the aft side.**  
(Photo courtesy of the FAA)

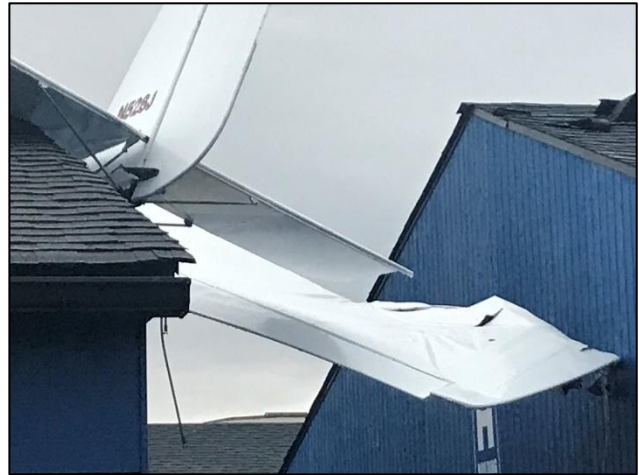
**Figure 2-Empennage and right wing view from the aft side.** (Photo courtesy of the FAA)

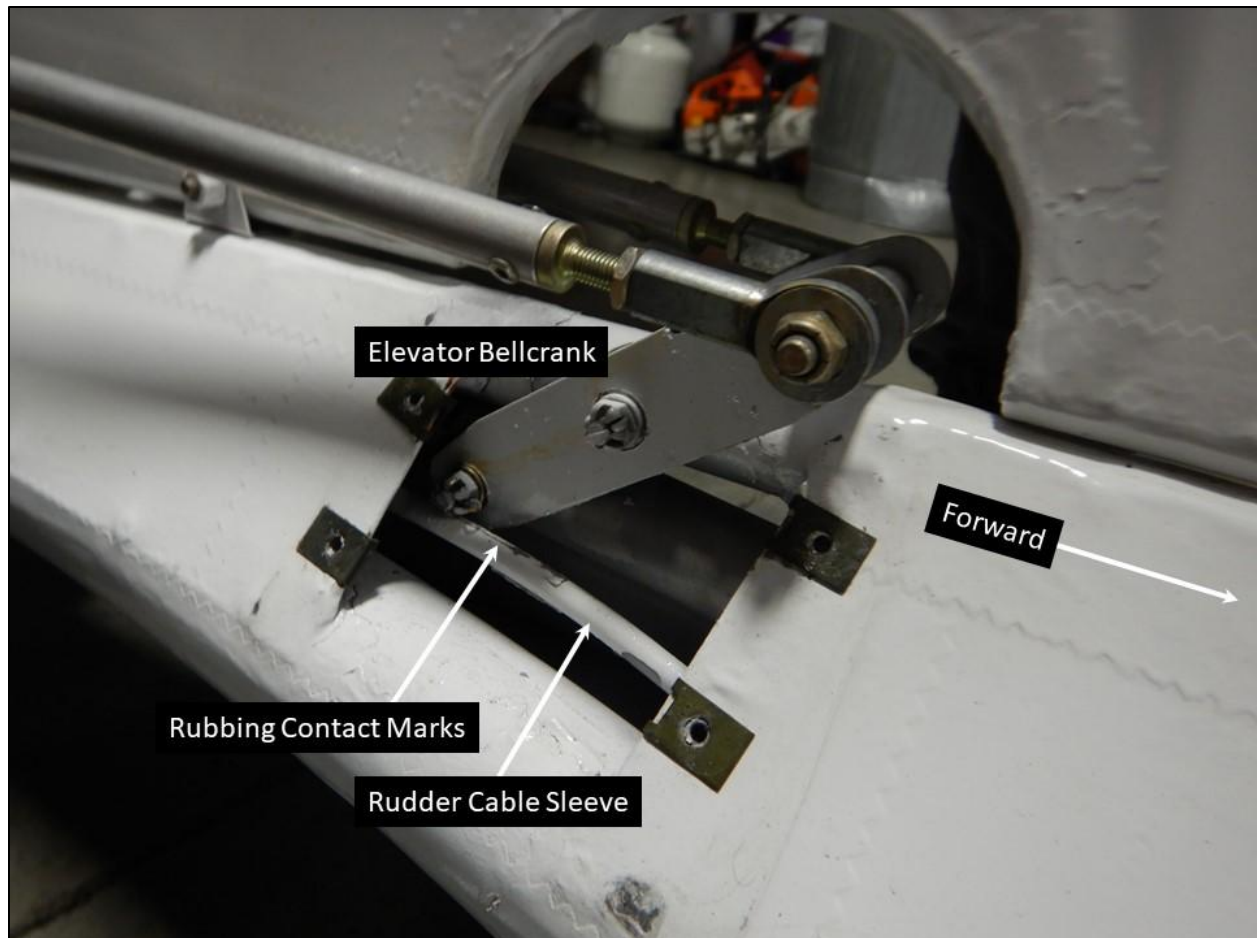
The left stabilizer forward side strut separated from the stabilizer. The vertical and horizontal stabilizers, rudder and elevators were undamaged and flight control continuity was established from the cut rudder cables and elevator control tube. While checking the elevator control continuity, the elevator bellcrank lower control rod nut and cotter pin were making contact the left rudder cable sleeve during the bellcrank movement. The nut contacted the sleeve at the elevator full down position and slid along the top of the cable sleeve about 1-inch in length before the sleeve would drop suddenly to the outboard side. Scraped paint from the cable sleeve was visible. The cable sleeve was attached to the structural tubing with clamps in several locations along the structural tubing. The clamps were intact and there were no signatures of sleeve movement from the attached locations. The left side of the elevator bellcrank and hardware were free of contact with the sleeved cable. A video of this bellcrank movement is in the public docket.

**Figure 5-Elevator bellcrank in the elevator full down position.**

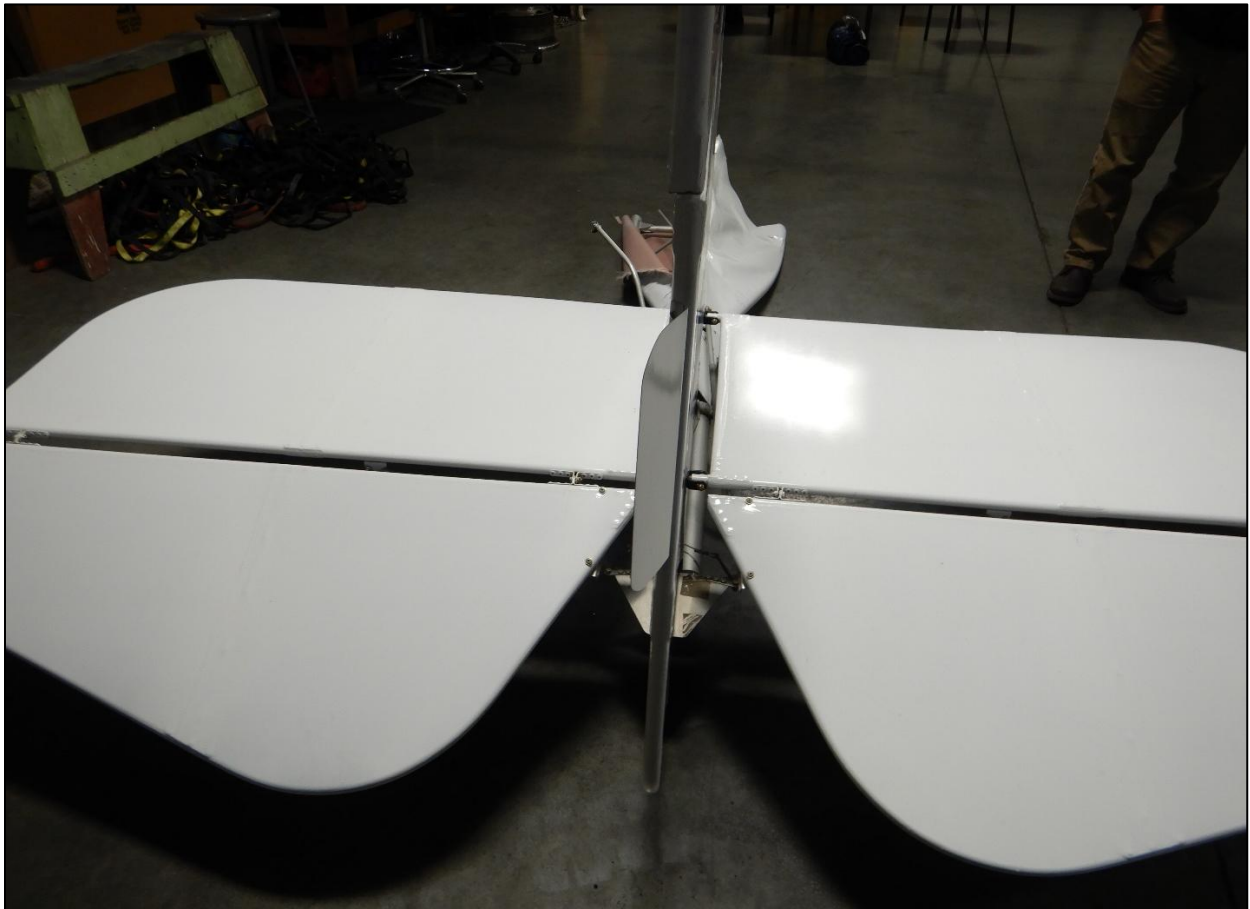
The rudder ground adjustable trim tab was undamaged and positioned about 20-degrees to the left.

**Figure 6-Empennage, ground adjustable rudder trim tab.**

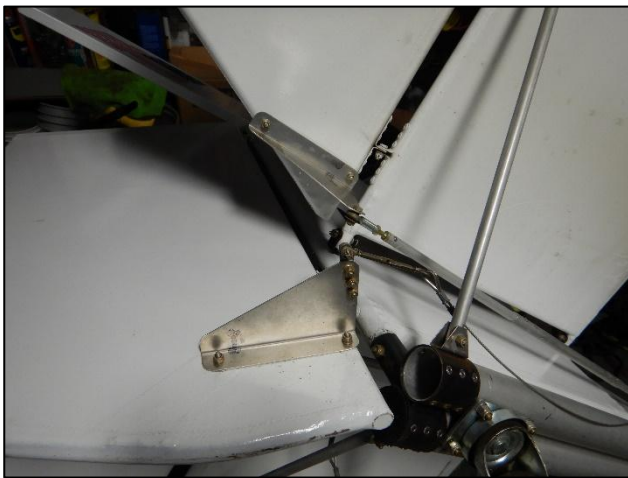
**Figure 7-Right side elevator and rudder control attachments.**

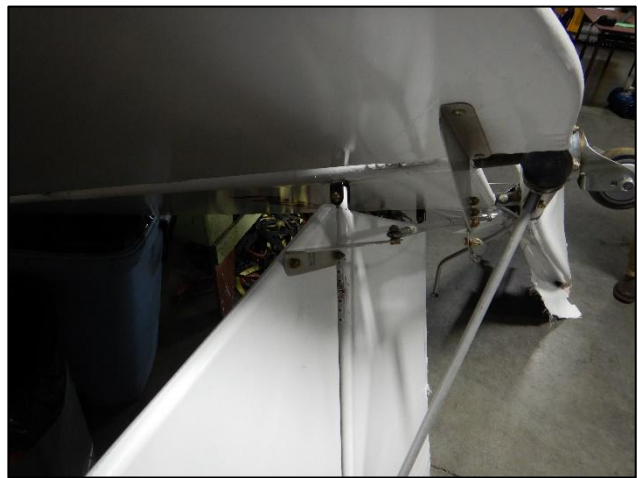
**Figure 8-Left side elevator and rudder control attachments.**

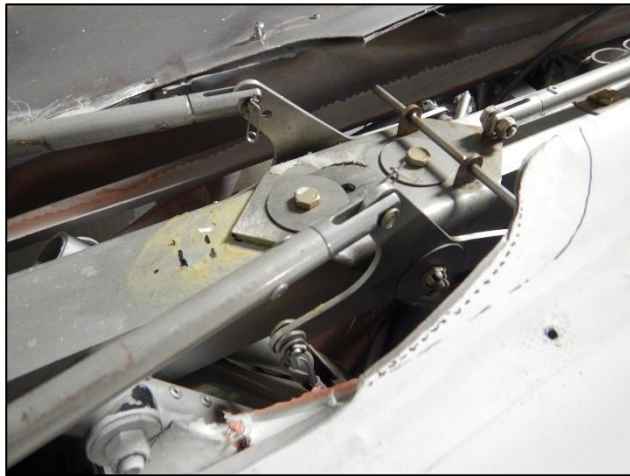
**Figure 9-Flaperon slide bracket assembly, aileron bellcranks and aileron control rods.**

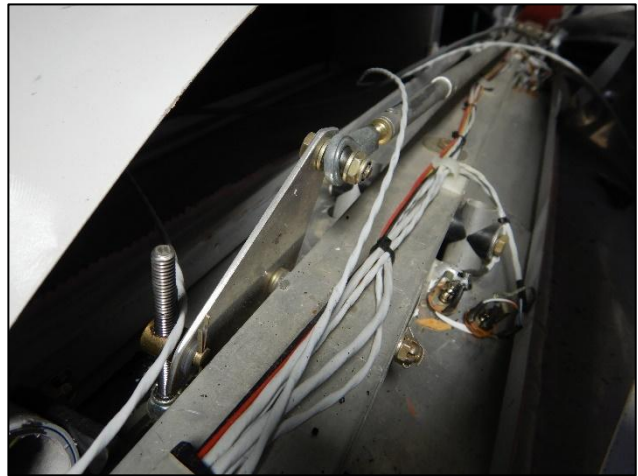
The flaperon control handle was adjusted from the cabin area and control continuity was established to the flaperon slide bracket assembly. Near the jackscrew for the handle adjustment, an electrical wire was found wrapped across the jackscrew assembly. See Figure 10.

**Figure 10-Flaperon crank assembly, bellcrank and control rod (looking from the top to aft).**

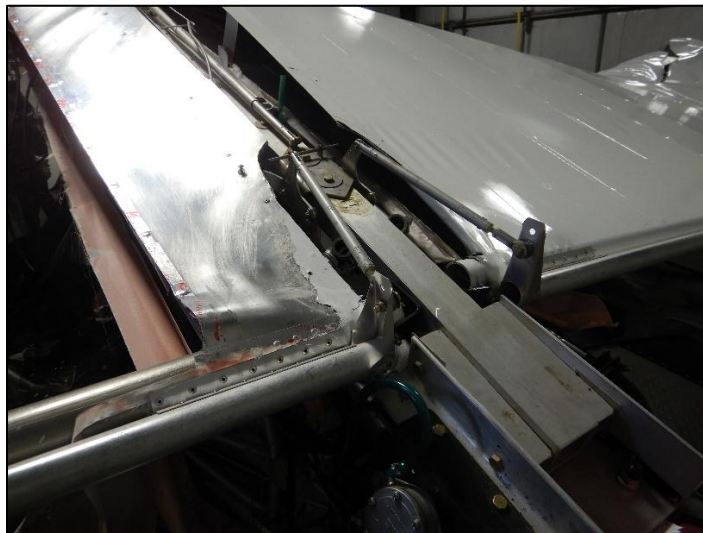
**Figure 11-Aileron control tubes.**

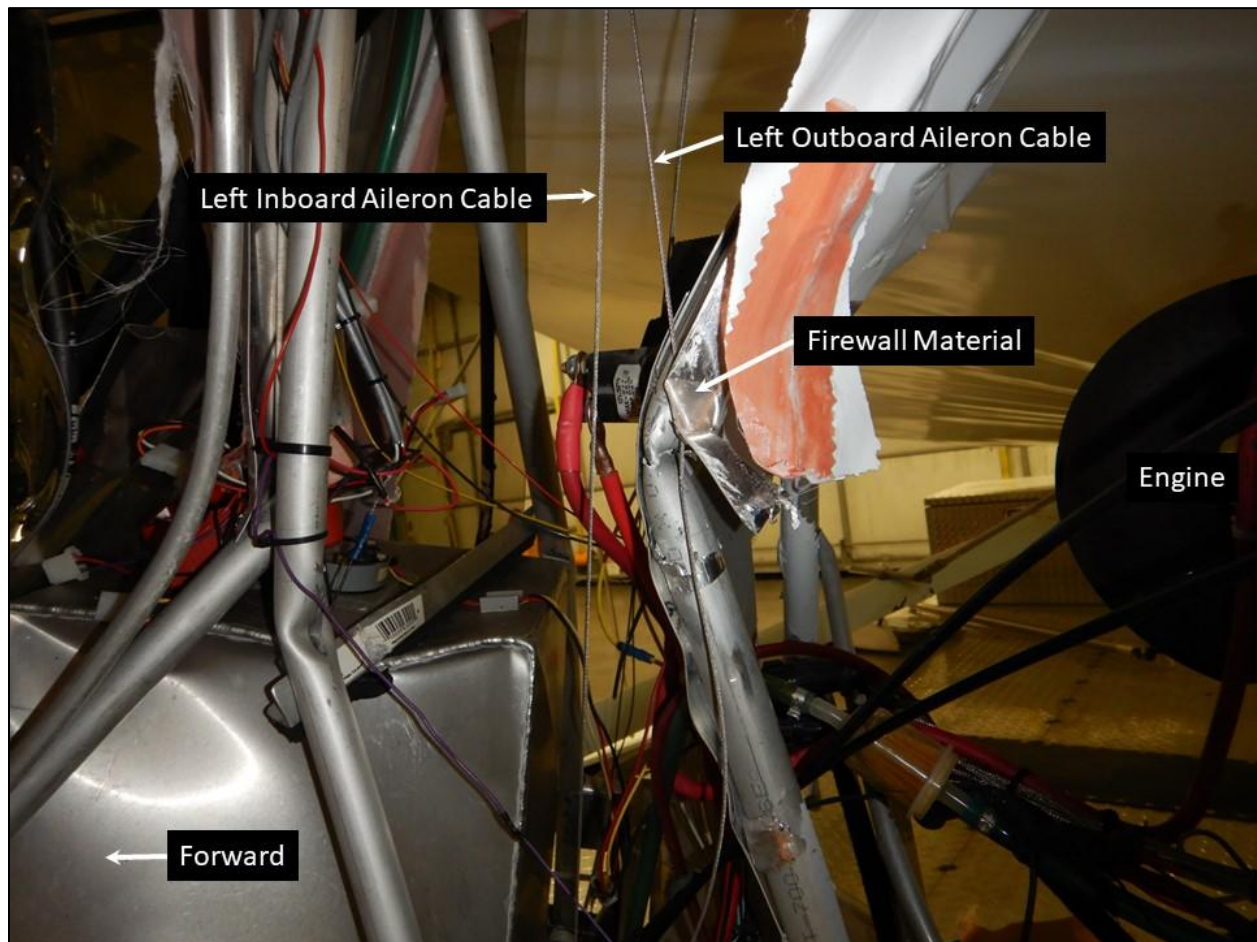
The aileron bellcranks remained attached to the flaperon slide bracket. The attaching hardware for the aileron cables and aileron control rods was secured to both aileron bellcranks. The left outboard aileron cable [forward seat position], connecting to the aileron bellcrank, was loose and twisted around the left inboard cable. The cable was pinched between the left rear vertical tubular structure and a portion of firewall material. See Figure 12. The cable was freed, and the cable alignment from the bellcrank to the pulley assembly was normal.

**Figure 12-Left aileron cables and aft airframe structure.**

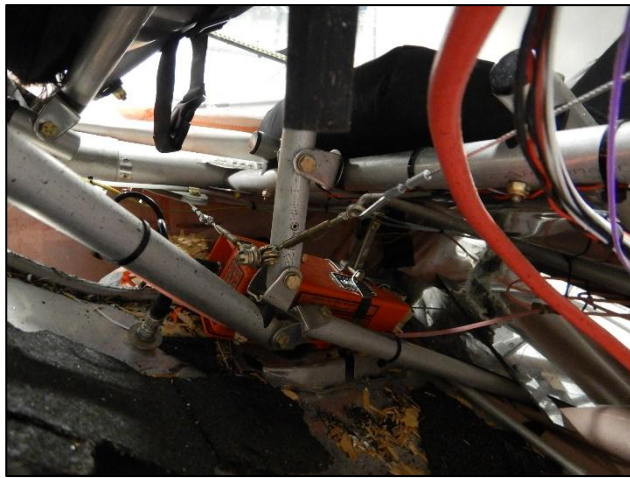
**Figure 13-Aft control stick and aileron cable attachments.**

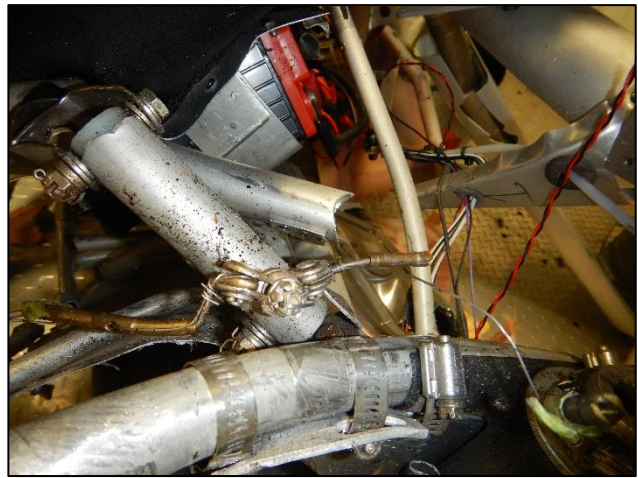
The aileron cables continued through the pulleys located on the cabin structure. The pulley assemblies were undamaged and showed no signatures of cables slipping between the pulley and its bracket. The aileron cables remained attached to the rear control stick. The left aileron cable turnbuckle at the forward control stick position had impact damage. The turnbuckle barrel section was broken in two and both eye ends were bent. An unraveled safety wire kept the parts from separating. The right aileron cable separated near the forward pulley assembly and the cable ends had broomstraw signatures. Both aileron cables remained attached to the forward control stick. The forward control stick separated from the lower linkage.

**Figure 14-Forward control stick and aileron cable attachments.**

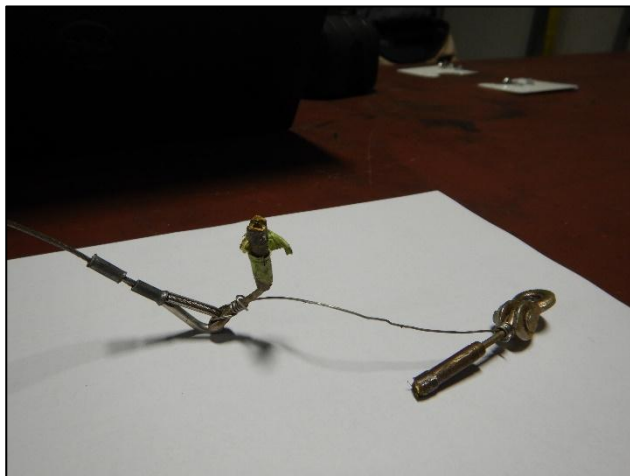
**Figure 15-Left aileron cable at the forward stick position.**

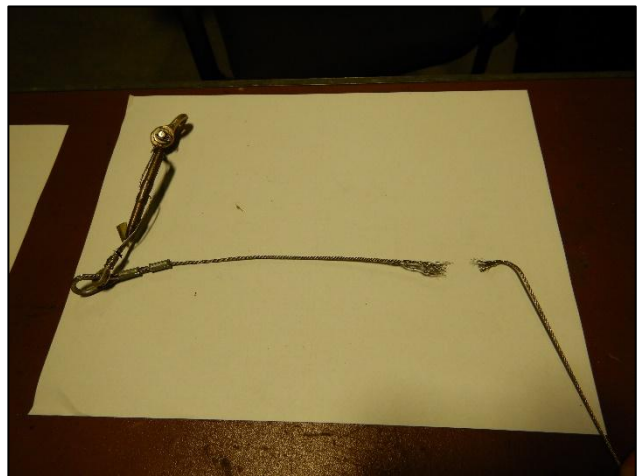
**Figure 16-Right aileron cable at the forward stick position**

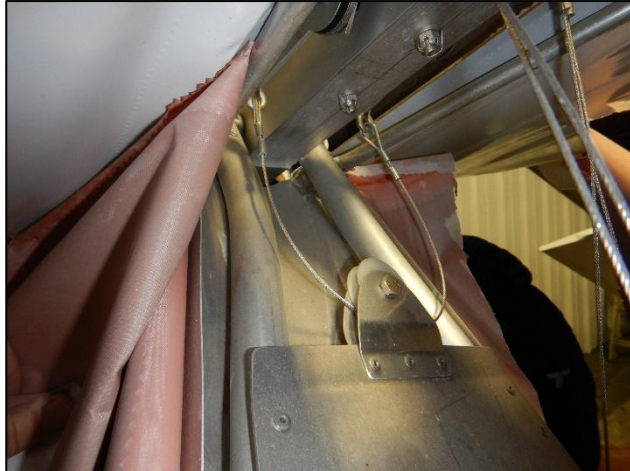
The idler pulley was undamaged and showed no signatures of the cable slipping between the pulley and its bracket. The idler cable was intact and was loose around the pulley. The tubular structure supporting the idler pulley assembly was positioned forward of its original position.

**Figure 17-Aileron idler pulley and cable.**

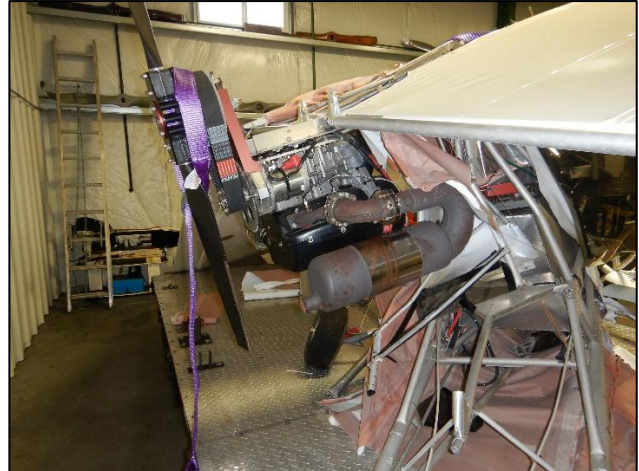
**Figure 18-Engine and aft fuselage structure.**

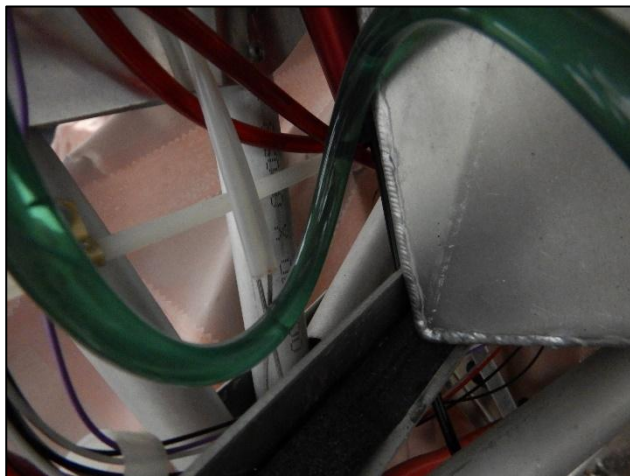
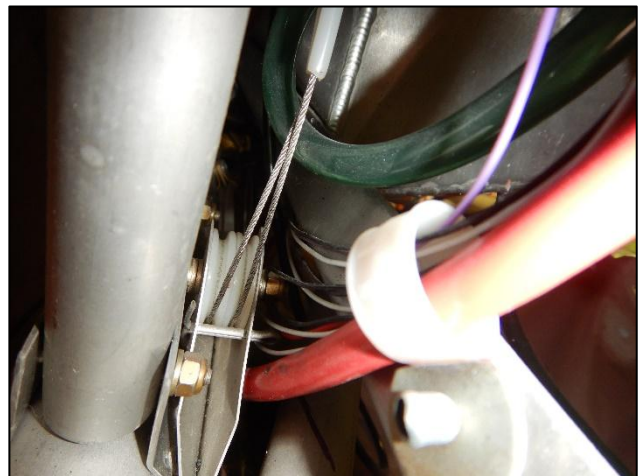
The left aileron cables located near the rear pulley assembly was rubbing on the fuel tube from the fuel tank. No damage was noted to the fuel tube.

**Figure 19-Fuel line and left aileron cables.**

**Figure 20-Fuel line and left aileron cables.**

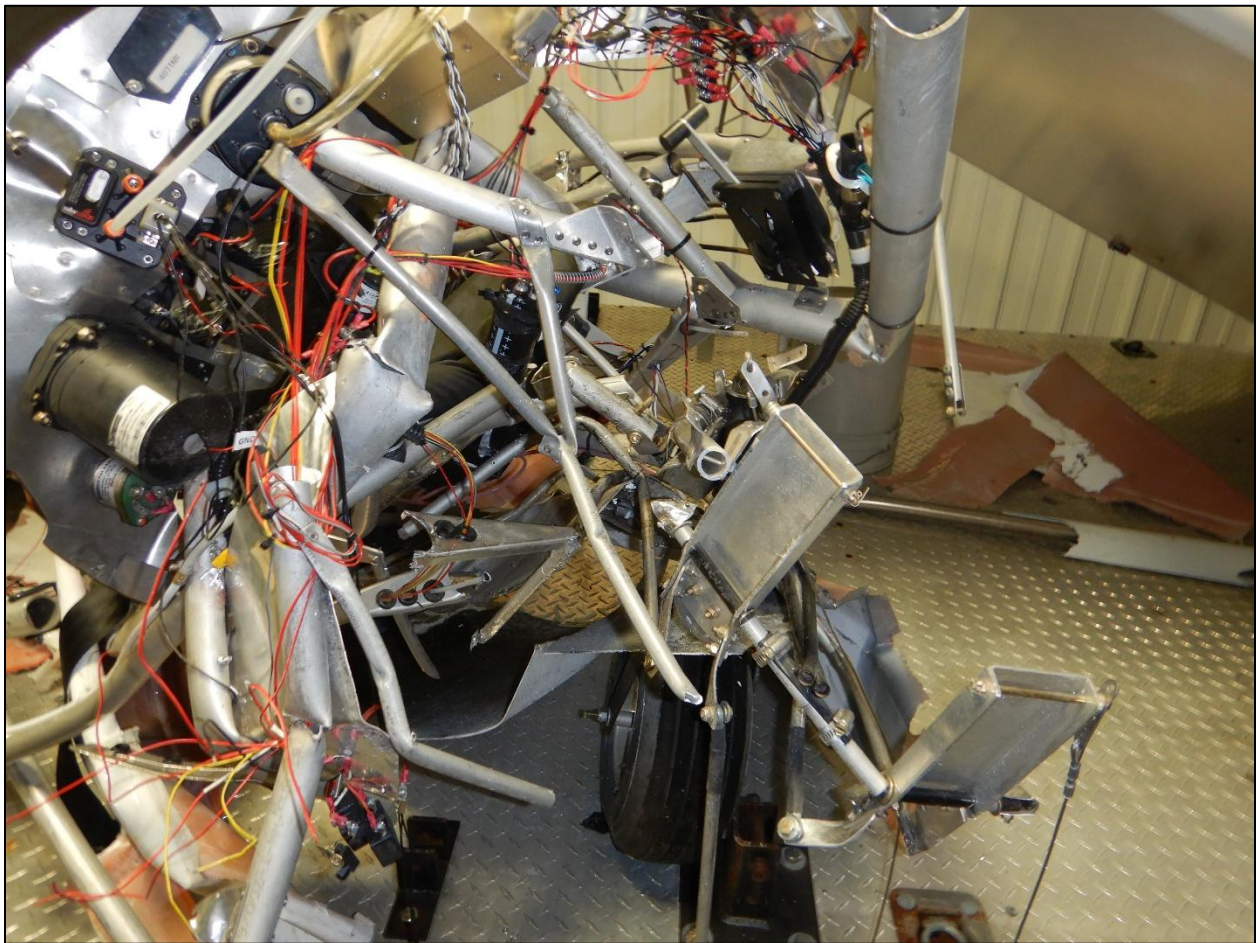
The forward fuselage including the forward rudder pedals, forward control stick, nose landing gear, nose cone and structural tubing had extensive impact damage. See figure 21. Structural tubing surrounding the fuel tank had impact damage. The fuel tank remained intact and had crushing near the top side from adjacent structure. The rear support structure was crushed forward, consistent with forward impact from the engine.

**Figure 21-Forward fuselage, instrument panel and forward seat rudder pedal assembly.**
