# National Transportation Safety Board

WPR23LA094

## **AIRFRAME AND ENGINE EXAM**

Location: Carlsbad, California  
Date: January 19, 2023  
Time: 0800 Pacific standard time  
Airplane: Piper PA-28R-200, N57355

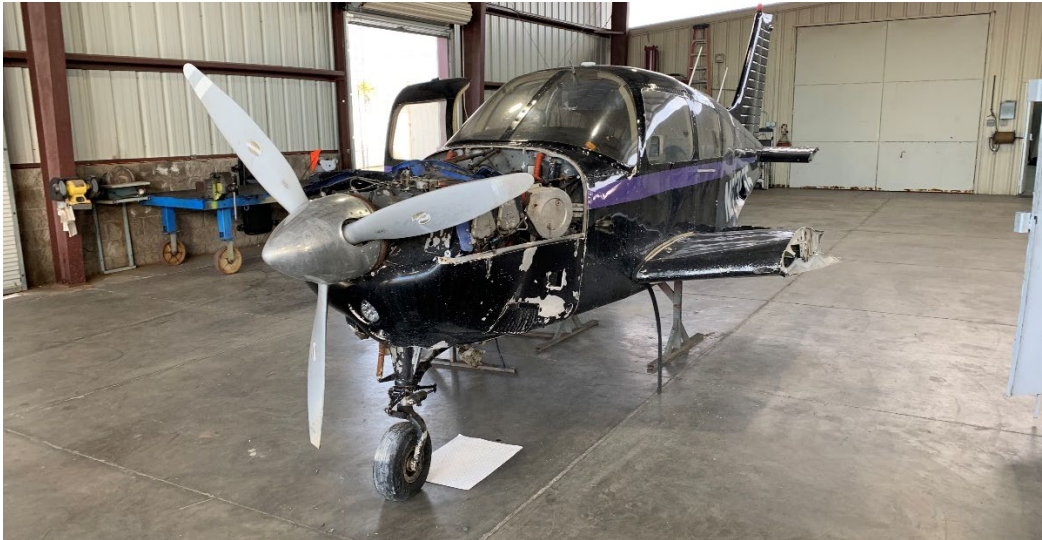
Examination of the recovered wreckage revealed that the nose landing gear remained attached to the fuselage, was extended and the airplane was placed on a metal stand to facilitate the examination. The fuselage exhibited crushing and scraping to the undercarriage. A large amount of sand and rounded stones were observed within the cabin, empennage, and wings. Corrosion, consistent with saltwater immersion, was noted throughout the airplane's structure.

**Figure 1: Front view of airplane during exam.**

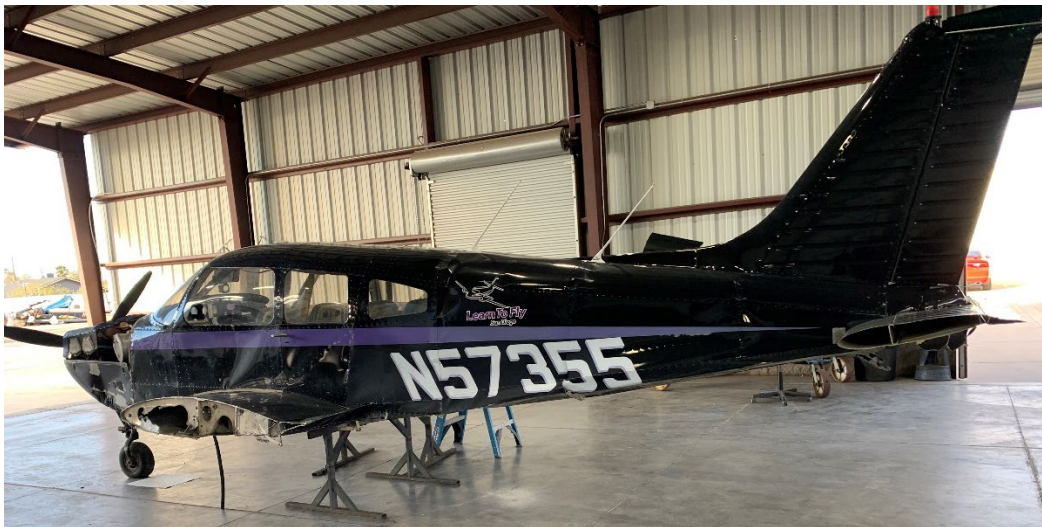
The vertical stabilizer and rudder remained attached to the empennage. No visible damage was observed. The left and right side of the stabilator and been cut about 1 ft from the attachment fittings by recovery personnel to facilitate recovery. The stabilator trim tab remained attached to the stabilator.

**Figure 2: Left, rear view of accident airplane.**

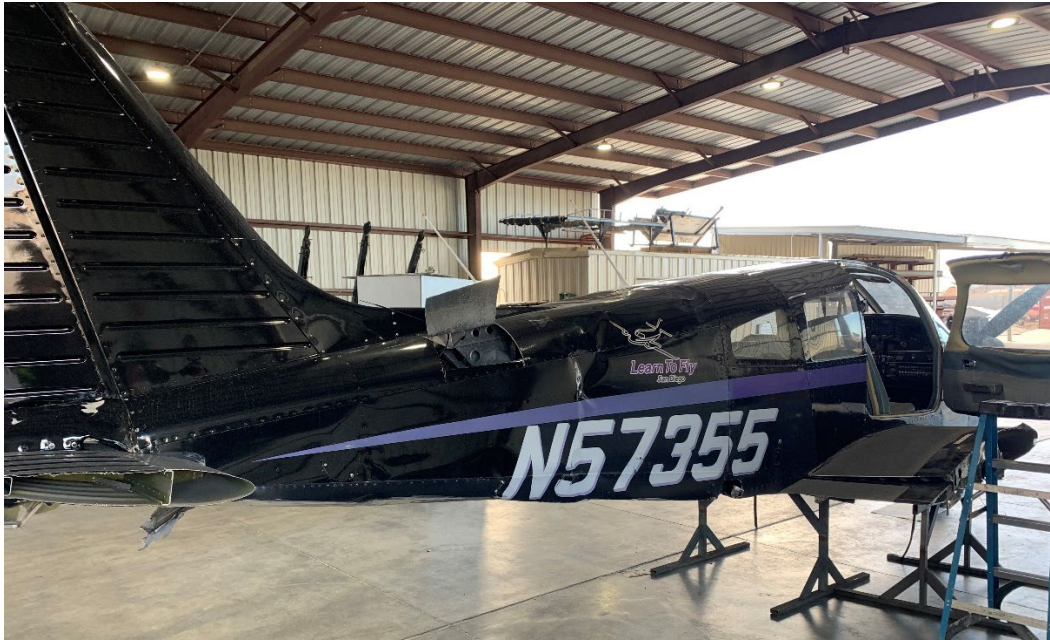
**Figure 3: Right, rear view of accident airplane.**

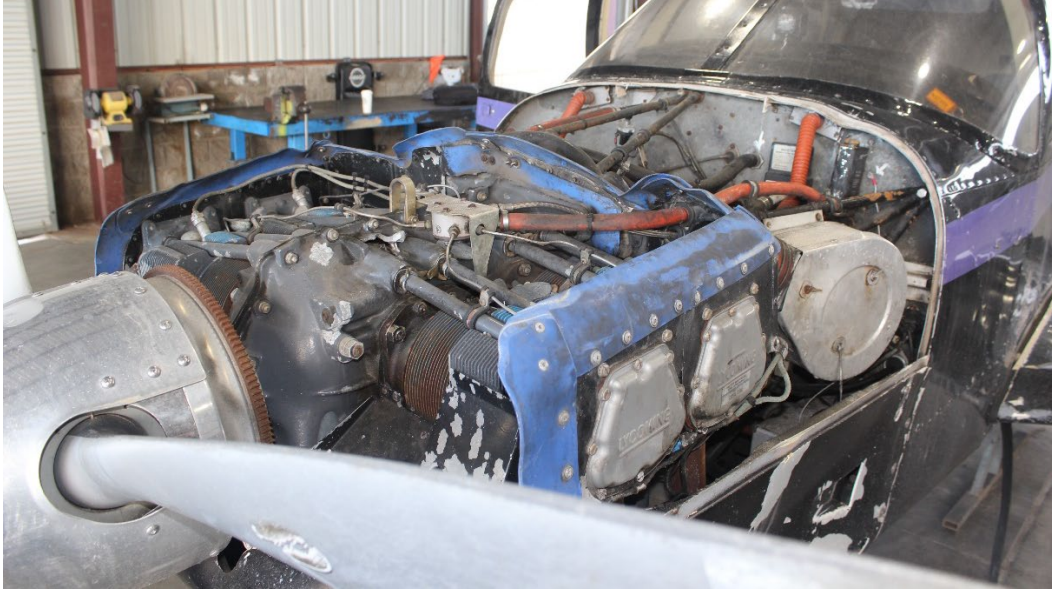
Examination of the recovered engine revealed that it remained attached to the engine mounts. The engine was exposed to salt water during the accident and contained rock debris from its impact with terrain. All of the engine accessories remained attached to their respective mounting pads and no loose wiring or fluid leakage was observed throughout the engine. The engine case was breached between the push tubes of the no. 2 cylinder, showing a visible puncture along the push rod tube channel at cylinder. A mixture of oil, water, and sand was observed on the engine oil dipstick.

**Figure 4: Left side view of the engine during the exam.**

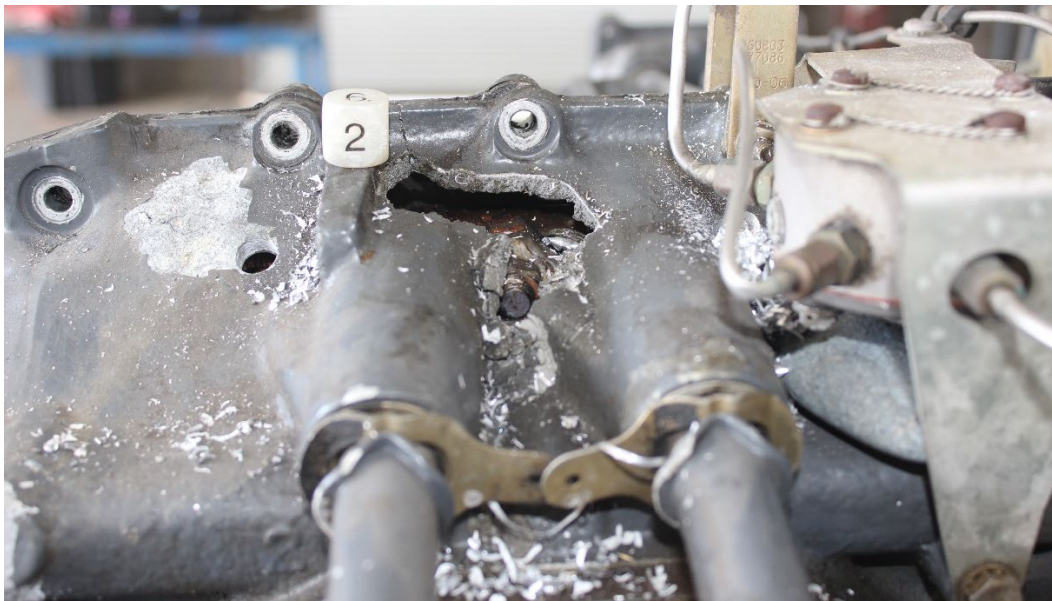
**Figure 5: View of engine case breach.**

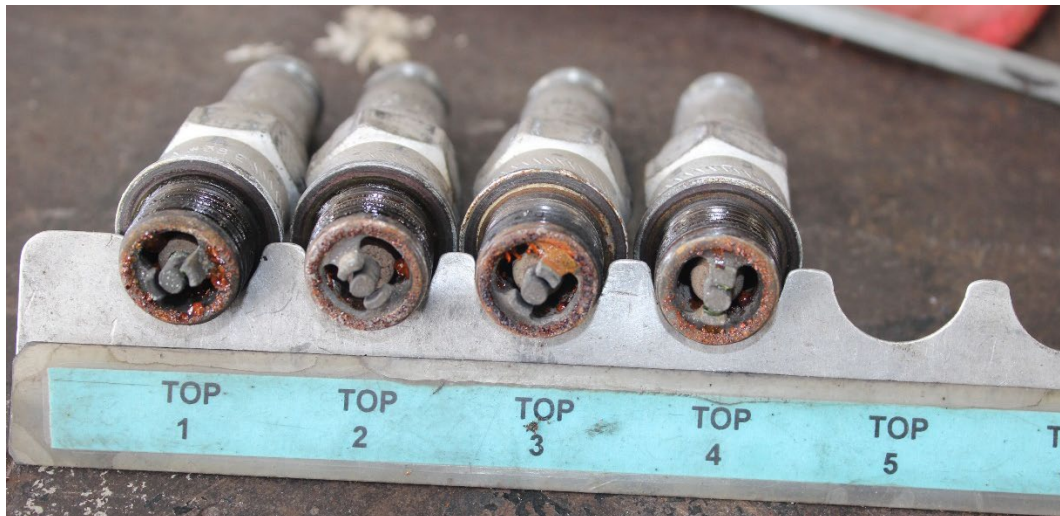
The spark plugs were removed from the engine, and they were the massive electrode type. The sparkplugs exhibited rust and gray deposits within the electrode area, consistent corrosion resulting from salt water immersion. All spark plugs exhibited signatures consistent with WORN NORMAL when compared to the Champion Check-A-Plug comparison chart. No mechanical damage was observed to the electrode area of any sparkplug.

**Figure 6: View of spark plugs.**

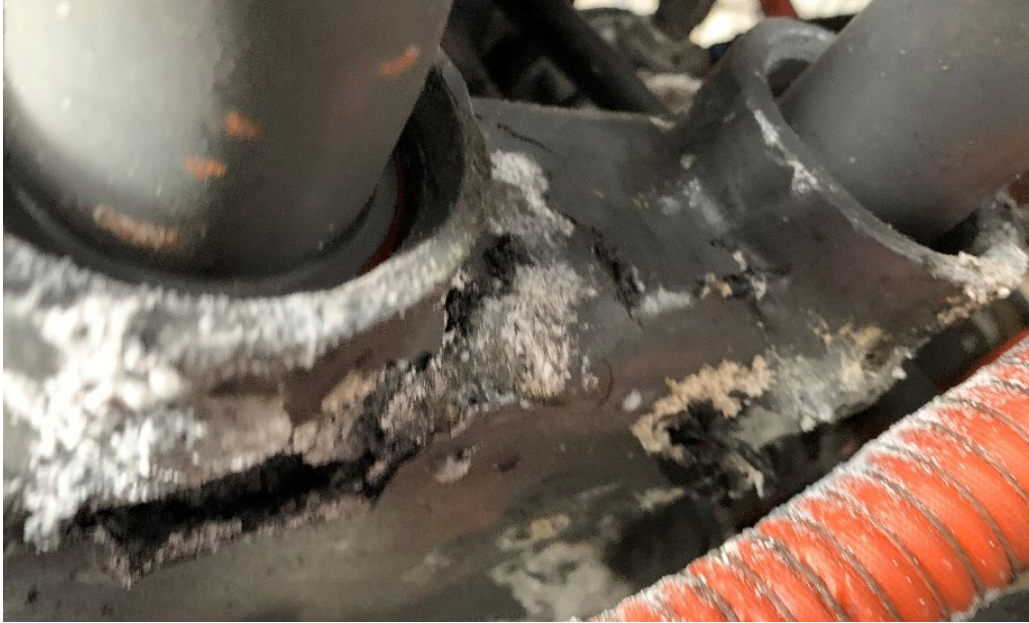
The oil sump was attached to the engine case, but was severely corroded due to salt water exposure/submersion. An approximately 3 inch wide hole was observed in the oil sump below the no. 2 cylinder induction tube connection. The area was white, consistent with salt water corrosion and the area was soft and was easily penetrated when pressure was applied. The low profile oil sump quick drain plug was in the closed position and operated normally when depressed by hand.

**Figure 7: Hole in oil sump near the no. 2 cylinder induction tube.**

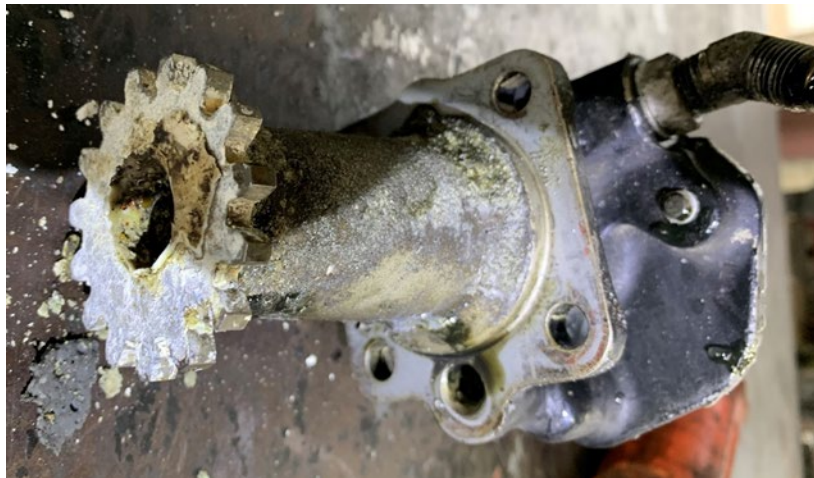
The oil pump was corroded, consistent with salt water immersion and could not be rotated by hand. A trace amount of oil was observed at the mating surfaces of the oil pump housing.

**Figure 8: View of oil pump and impeller.**

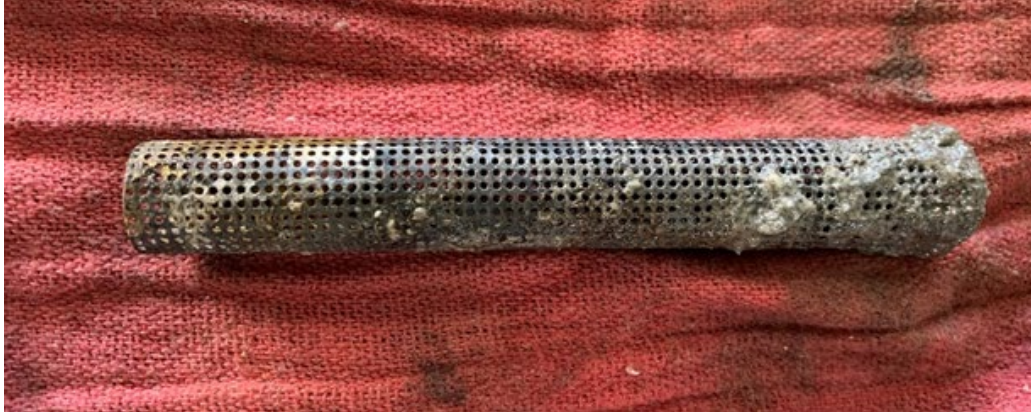
The oil suction screen and oil filter were removed. The oil suction screen contained sand, organic material and two small flakes of ferrous metal. The full flow oil filter was cut open to expose the filter media and remained free of any pre-mishap debris.

**Figure 9: View of oil suction screen.**

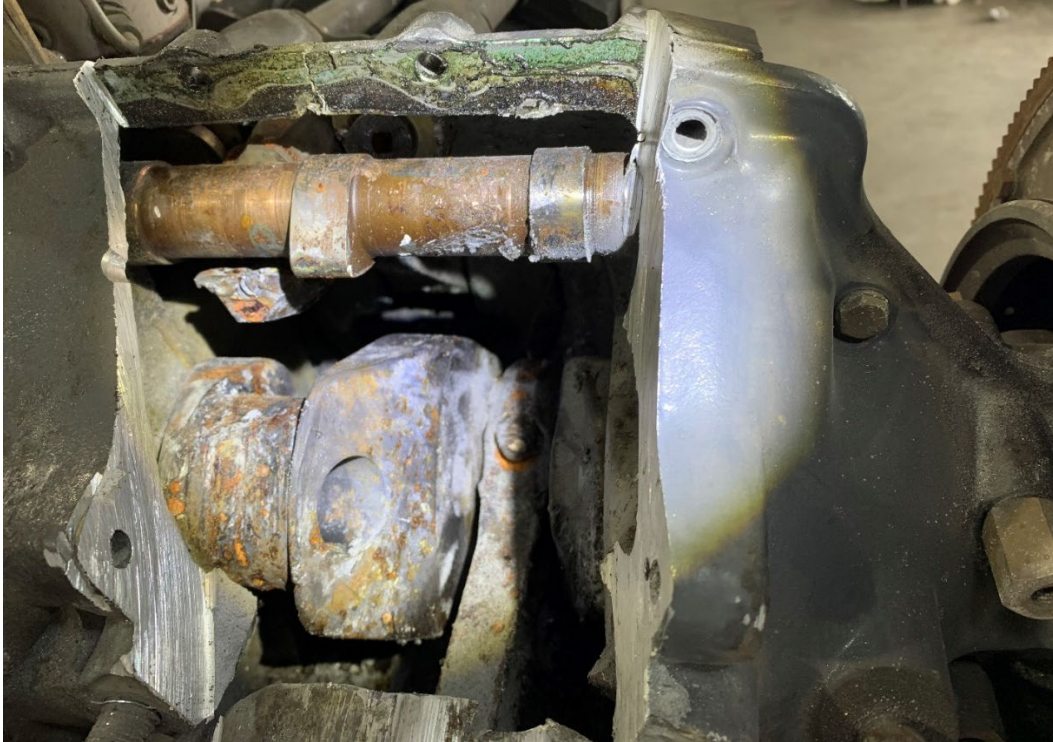
The no. 1 cylinder was removed to facilitate internal examination of the engine crankcase. Internal examination of the engine revealed that the no. 2 connecting rod separated from the crankshaft and a small portion of the connecting rod end cap (cylinder no. 2) remained attached to the rod shank. Rotational score marks were observed along a visible portion of the camshaft at the no 2 cylinder connecting rod. A heat gradient was observed along the shank of the no. 2 cylinder connecting rod, consistent with thermal stress. The no. 2 connecting rod bearing had separated from the journal, which was mechanically damaged. A remaining section of the no. 2 connecting rod end cap displayed score marks consistent with interfacing at the no. 2 crankshaft journal. Metallic remnants recovered from the bottom of the engine case included fragments from a no. 1 cylinder tappet, the cylinder no. 2 connecting rod end cap, a portion of the cylinder no. 1 combustion chamber, and other metallic debris.

**Figure 10: View of internal damage to the connecting rod and crankshaft journal.**

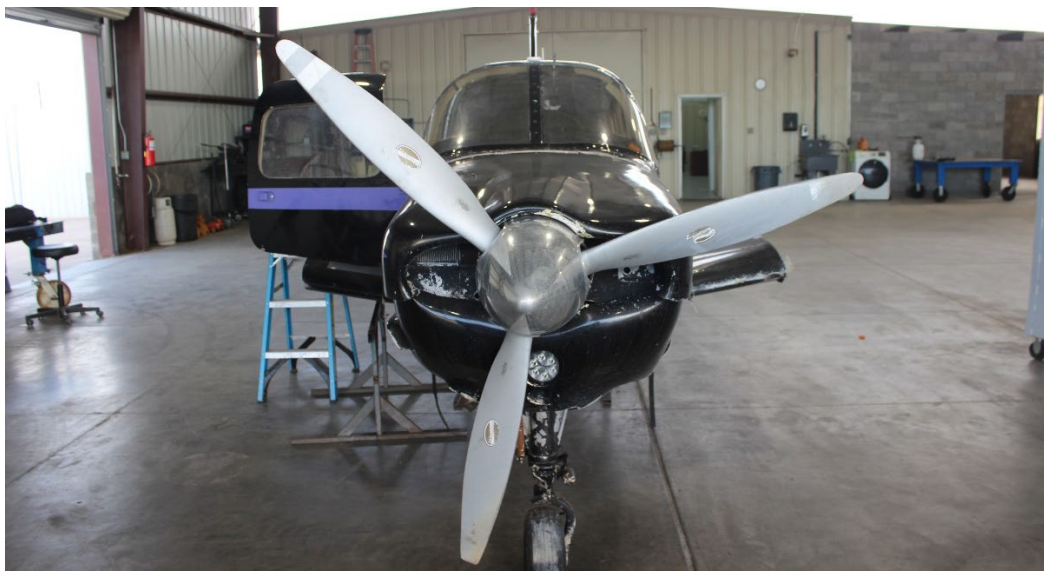
The airplane was equipped with a three blade constant speed Hartzell propeller. The propeller and propeller hub propeller remained attached at the crankshaft flange. One propeller blade exhibited aft bending near the propeller tip. No visible damage was observed to the remaining propeller blades.

**Figure 11: Front view of propeller.**
