# National Transportation Safety Board

WPR23LA094 N57355

## **ENGINE EXAMINATION**

Location: Carlsbad, California  
Date: January 19, 2023  
Time: 0800 LCL  
Airplane: Piper PA-28R-200, N57355

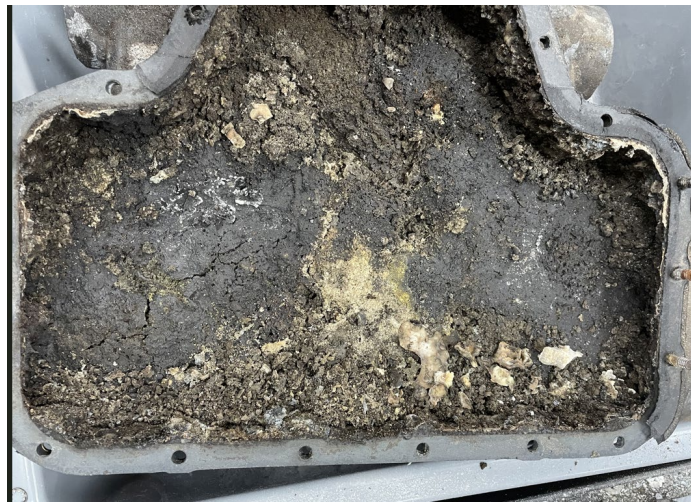
The engine was mostly devoid of oil. The oil return line at cylinder 3 contained oil sludge as did the oil sump, which also exhibited evidence of salt water corrosion. The accessory housing was mostly unremarkable, with exception of the oil pump, which exhibited heavy resistance when rotated by hand. The pump gears and housing contained oil throughout along with non-ferrous fragments, sludge along the track of the gears, and rust on one of the gears. The oil pump turned normally after the gears and housing were cleaned. No obstructions were observed in either of the 2 oil galleys.

**Figure 1: Lower oil sump with sludge**

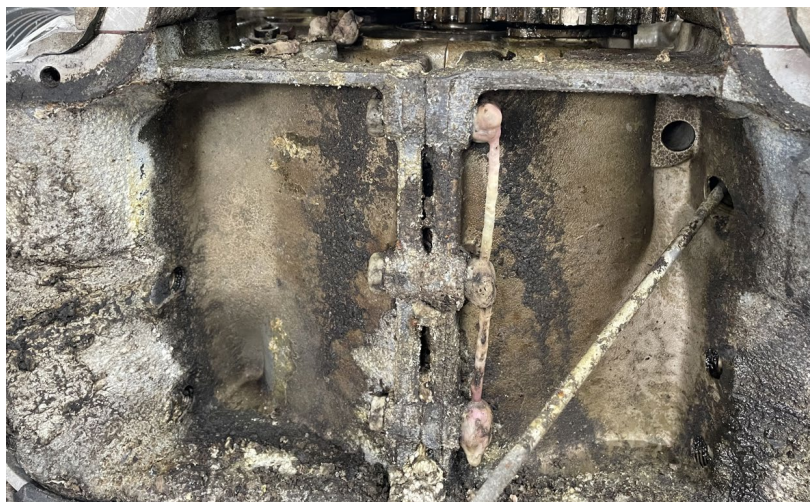
**Figure 2: Upper section of oil sump with saltwater corrosion**

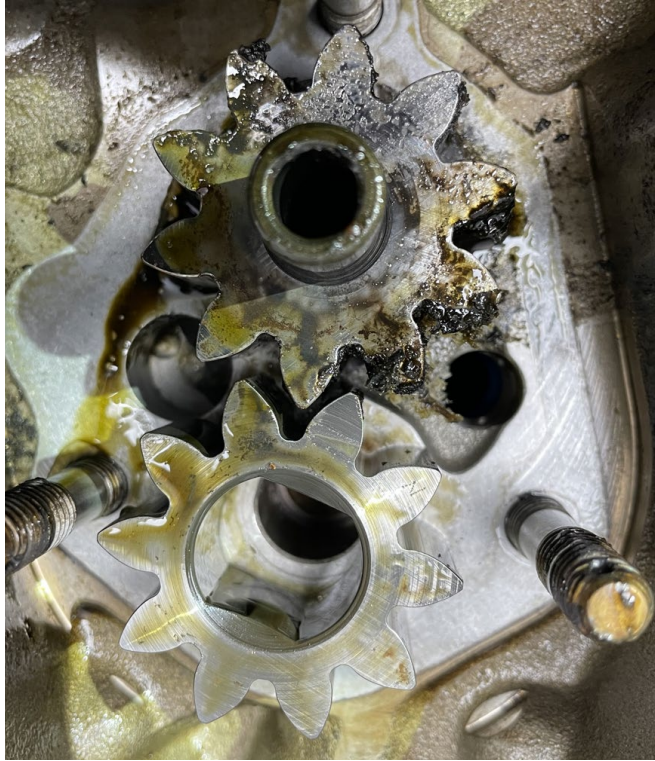
**Figure 3: Oil pump gear and driving impeller**

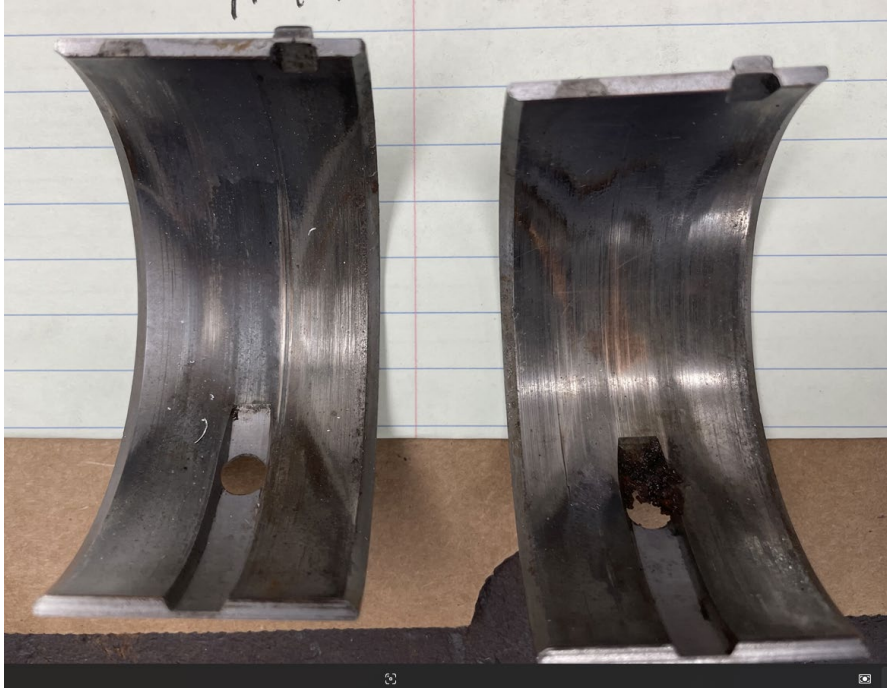
The center bearing exhibited evidence of thermal distress and rotational scoring. The cylinder 1 connecting rod bearing was intact. The cylinder 2 connecting rod end bearing was fractured and the connecting rod journal exhibited evidence of thermal damage and a flat spot with significant deformation along the journal circumference. The cylinder 2 bearing had also disintegrated. The cylinder 3 connecting rod bearing displayed some heat distress and rotational scoring.

**Figure 4: Center bearing with heat damage and rotational scoring**

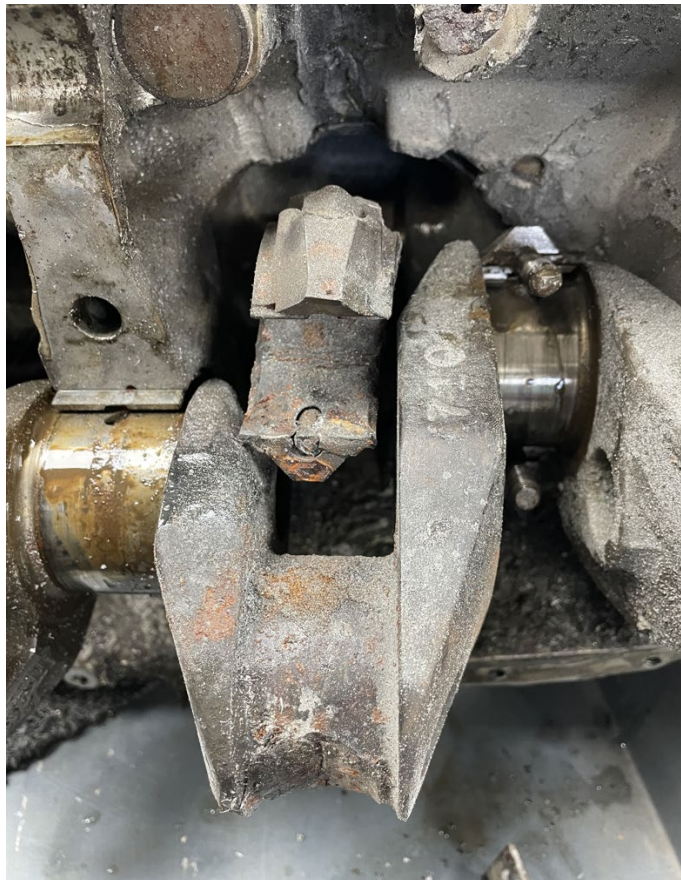
The cylinder 2 connecting rod was damaged.

**Figure 5: Cylinder 2 connecting rod end and cylinder 2 crankshaft journal**

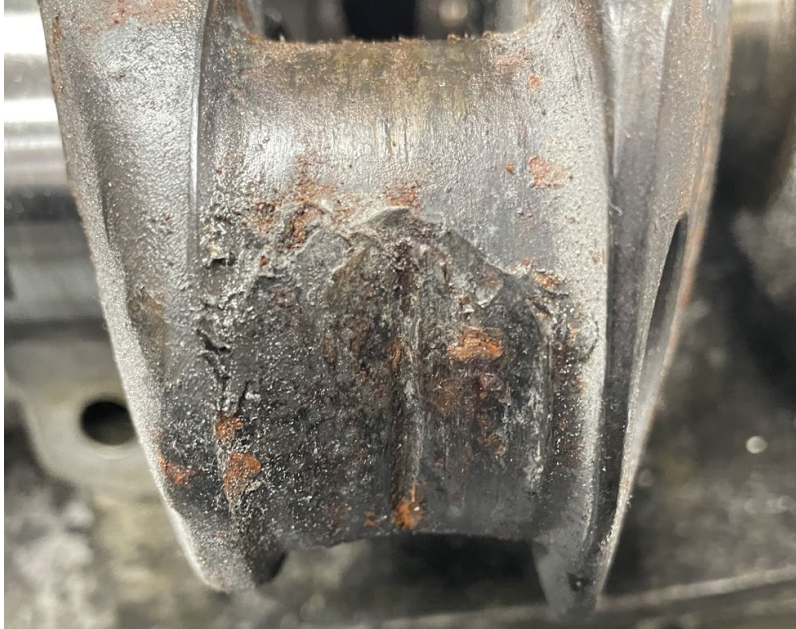
**Figure 6: Cylinder 2 crankshaft journal**
