# National Transportation Safety Board

WPR23LA096

## **MATERIALS LABORATORY**

Factual Report 23-059

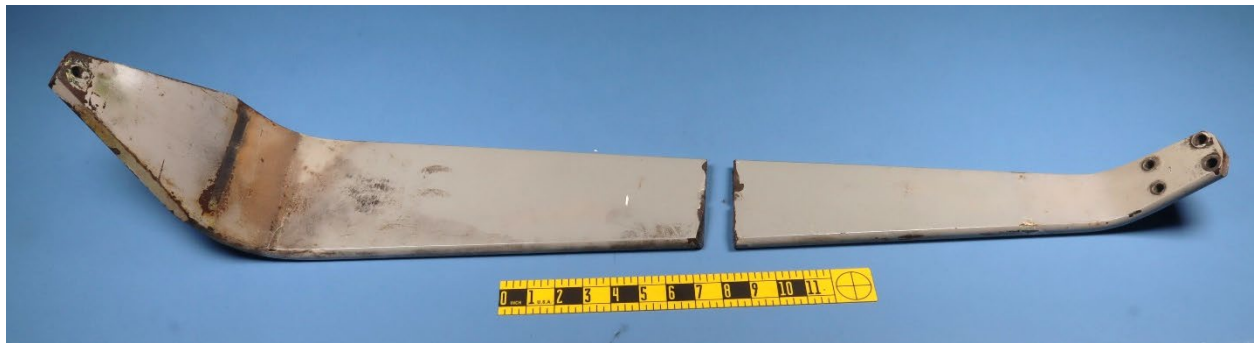
Figure 1 shows the landing gear leg (skid) as received. The leg had broken 17.75 inches from the narrow downward-facing end on the right side of the figure and 23.25 inches from the wider upward-facing end (left in Figure 1).

**Figure 1.** View of the landing gear leg pieces, as received.

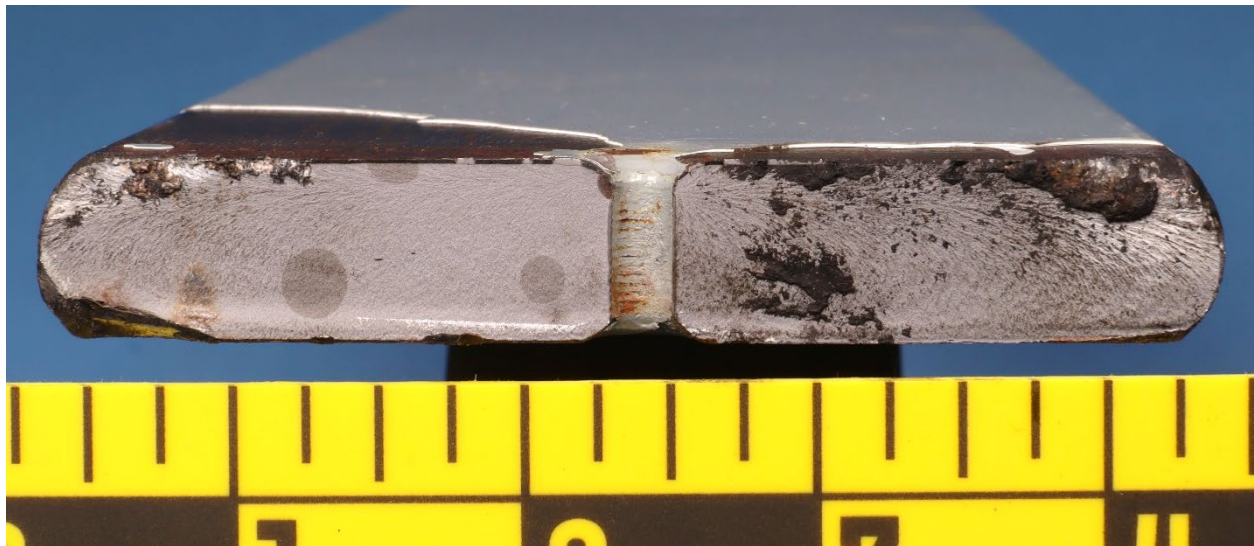
Figure 2 shows the inboard fracture surface. Most of this fracture surface exhibited a rough, fibrous texture with a dull luster. This fracture surface exhibited chevron marks, consistent with fracture outward, starting along the centerline bore of the retaining clip. The chevron marks emanated from the upper location of the leg, along the inside bore, shown in Figure 3.

**Figure 2.** View of the downward leg fracture surface, as received.

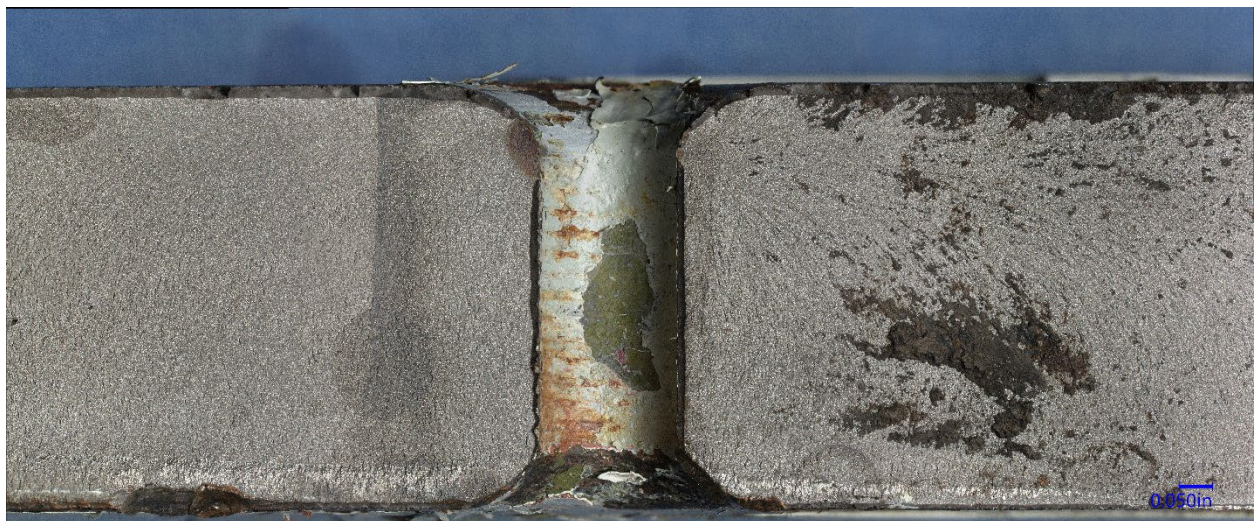
The most prominent fracture features originated at small thumbnail cracks, contrasting darker and flatter against the rest of the rougher surface (Figure 3). Figure 4 shows these cracks, annotated to show location and later fracture direction. On the left side of the figure was the largest of the cracks, measuring 2.49 mm (0.098 inches)

**Figure 3.** Montage of the cleaned fracture surface near the centerline clip bore.

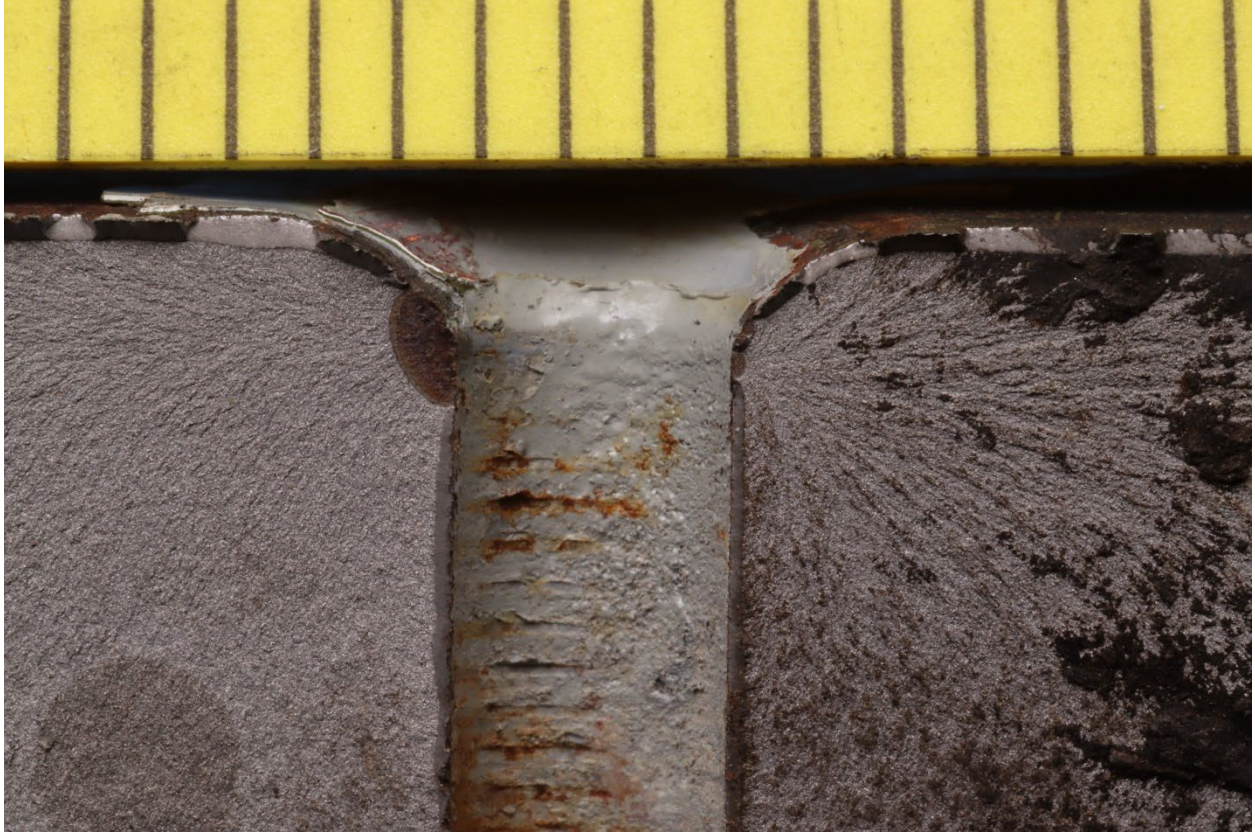
**Figure 4.** View of the outboard edge of the fractured leg in **Figure 2**, along the center clip bore, showing chevron marks emanating from darker colored thumbnail cracks.

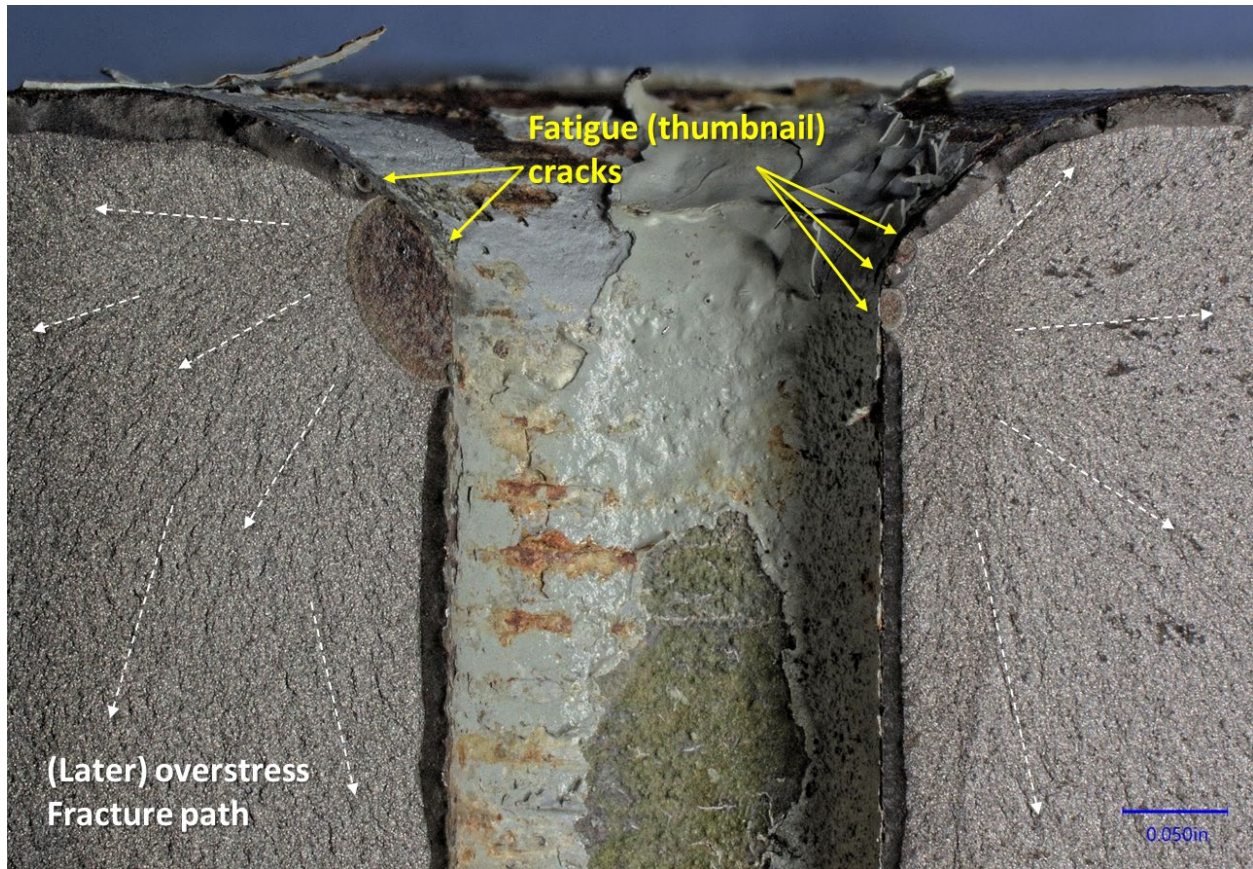
**Figure 5.** Closer view of the thumbnail cracks, after cleaning with acetone.

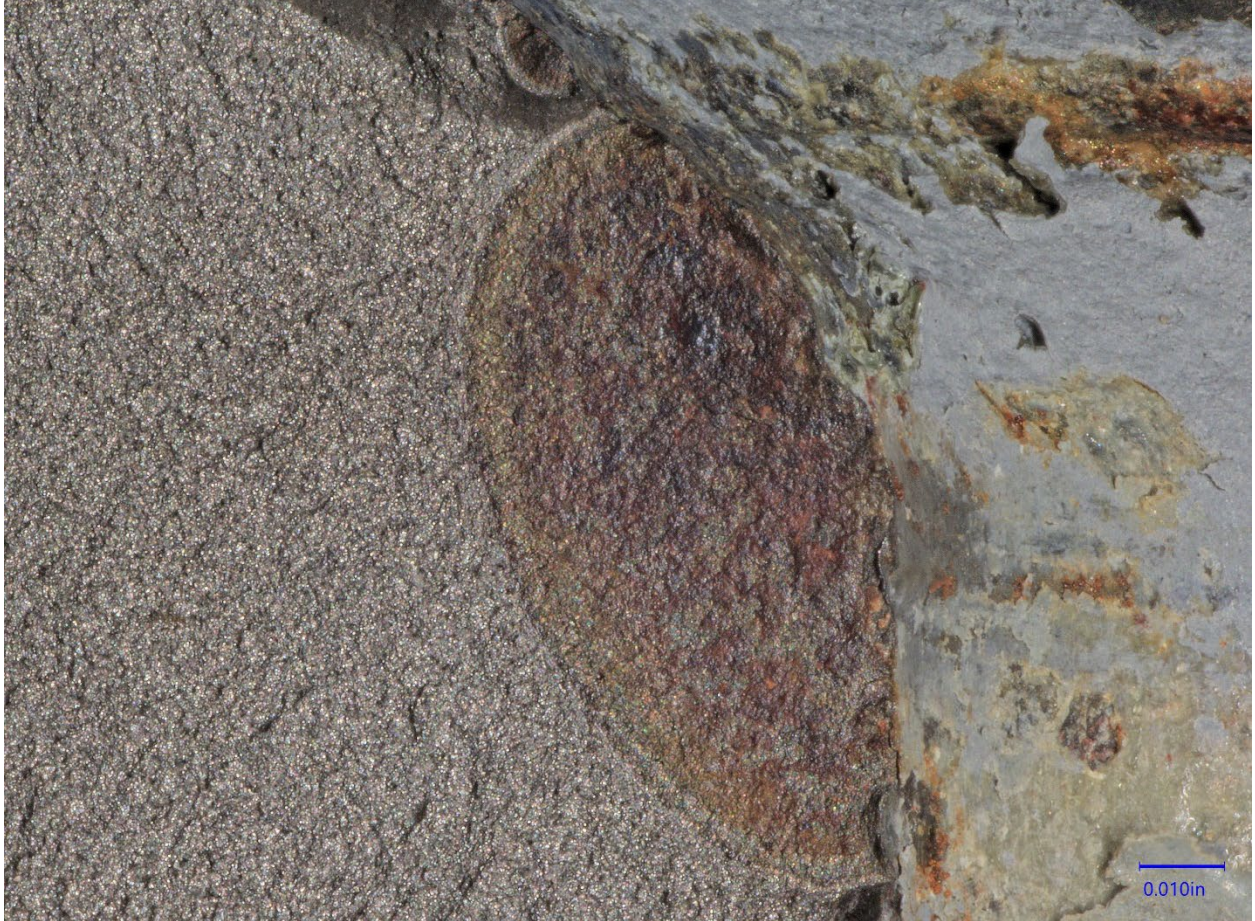
wide by 1.2 mm (0.047 inches) deep (see Figure 6). A smaller crack was adjacent to the largest one, located just above it.

**Figure 6.** The largest thumbnail crack in the upper left of **Figure 5**, showing crack arrest marks.

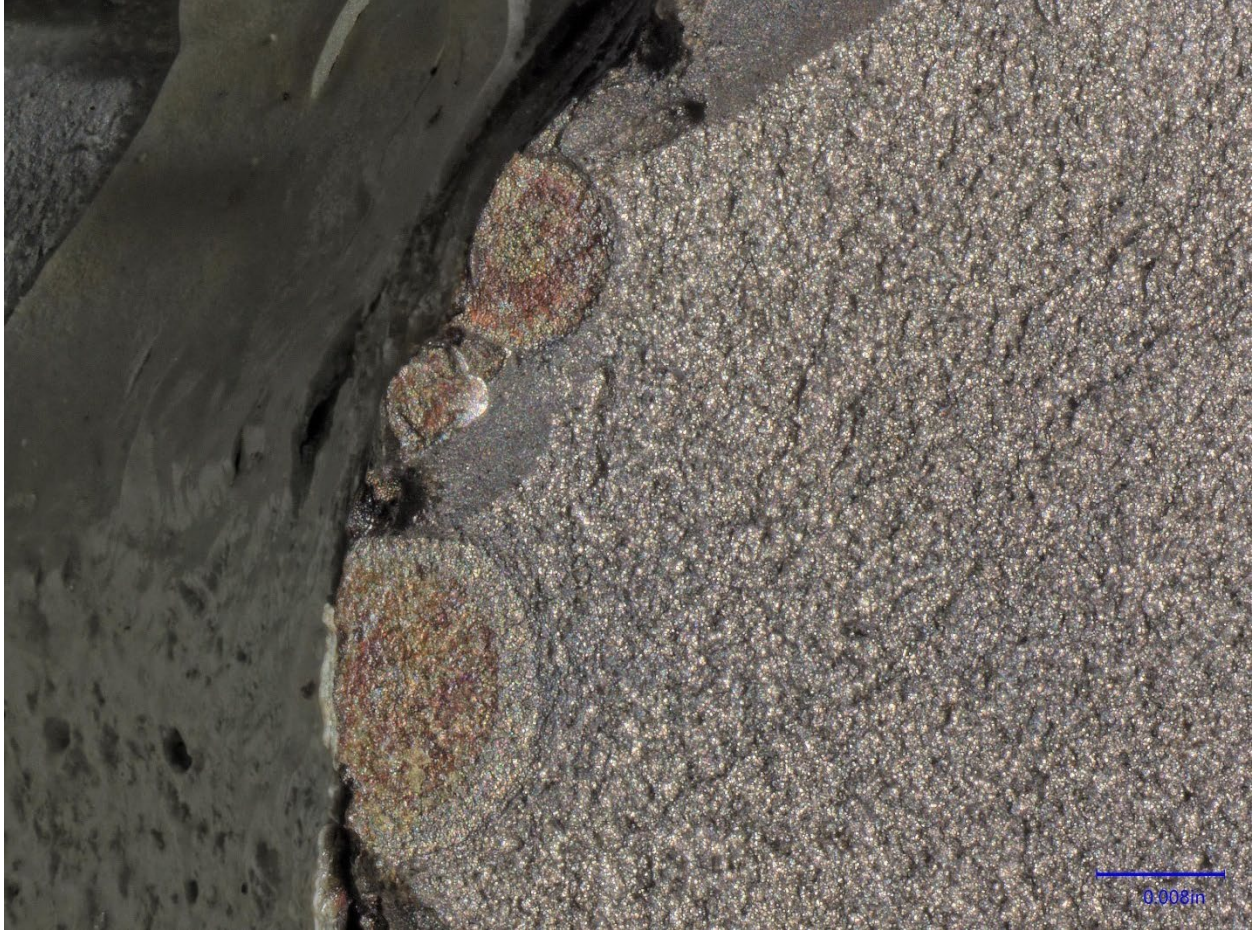
On the opposite side were three smaller thumbnail cracks, the largest of which measured 0.49 mm (0.019 inches) wide by 0.33 mm (0.013 inches) deep (see Figure 7). Along the edge of the fracture surface with the radius of the bore, the periphery outside of the cracks exhibited either outward or inward surface features, oriented about 45° to the fracture. These features were consistent with shear lips.

**Figure 7.** View of the smaller thumbnail cracks in the upper right of **Figure 5**, showing crack arrest marks.

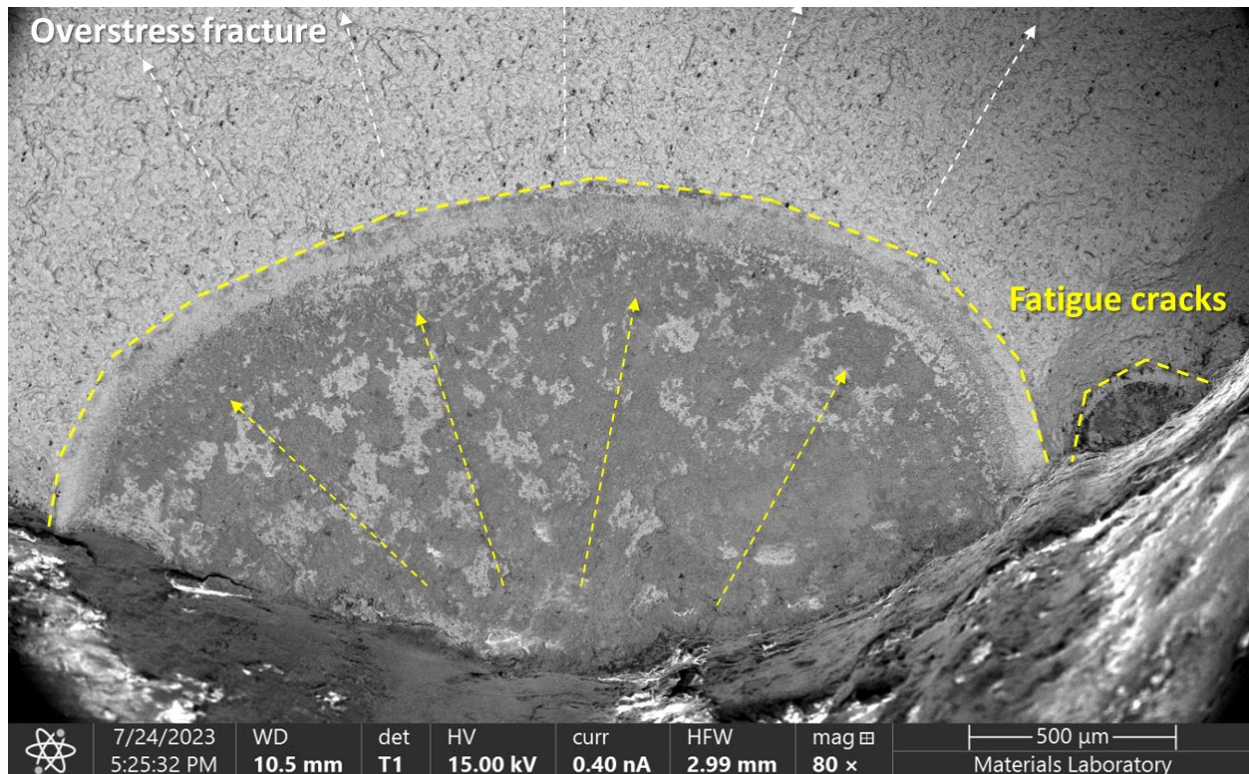
The fracture surface was cleaned in an ultrasonic bath using acetone and then examined using a field emission scanning electron microscope (SEM). Figure 8 shows a closer view of the largest thumbnail crack. The features from this region of the fracture surface exhibited striations consistent with fatigue crack propagation (see Figure 9). The fatigue crack possessed oxide significant enough to obscure the underlying fatigue striations, demonstrated in Figure 10 by the darker gray areas.<sup>1</sup> However, as shown in a secondary electron micrograph in Figure 11, located in the same spot as Figure 10, all the fatigue crack surfaces exhibited some degree of surface oxidation, obscuring many underlying features.

**Figure 8.** Backscattered electron (BE) micrograph of the largest thumbnail crack, showing lower-mass material on the surface and a second, smaller crack on the right.

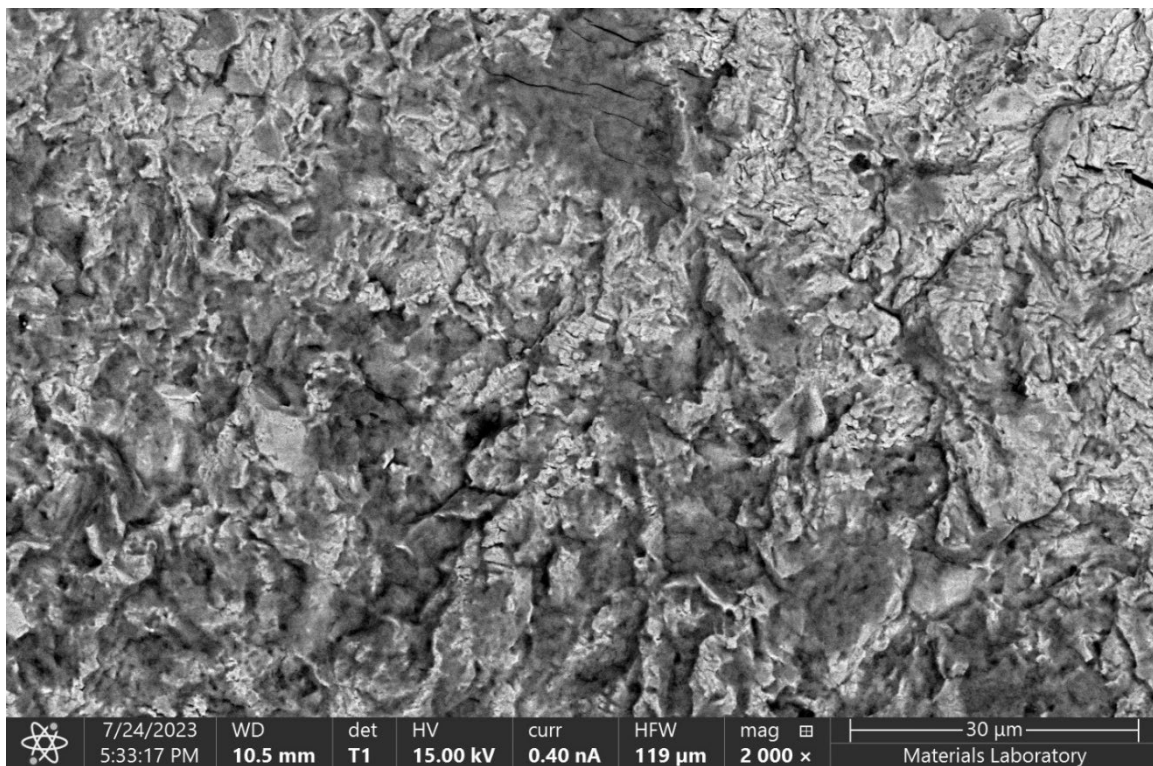
**Figure 9.** BE micrograph showing a closer view of the end of the crack, revealing fatigue striations.

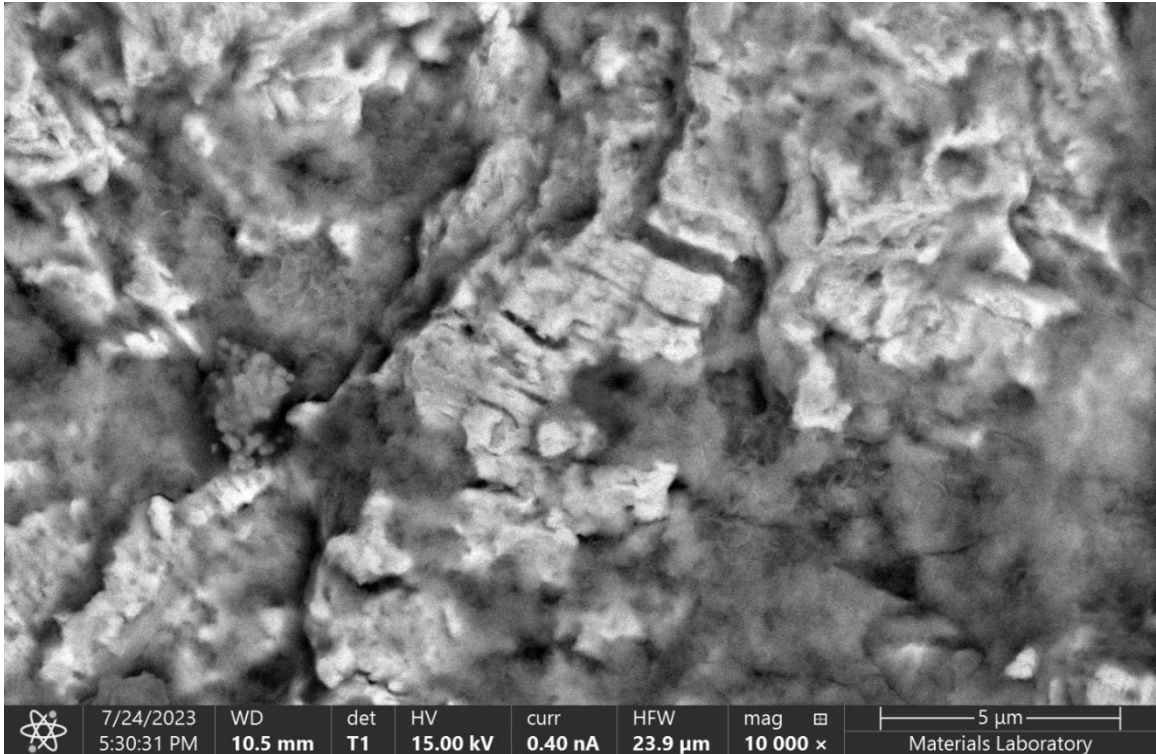
**Figure 10.** BE micrograph of fatigue striations from the area in **Figure 9**.

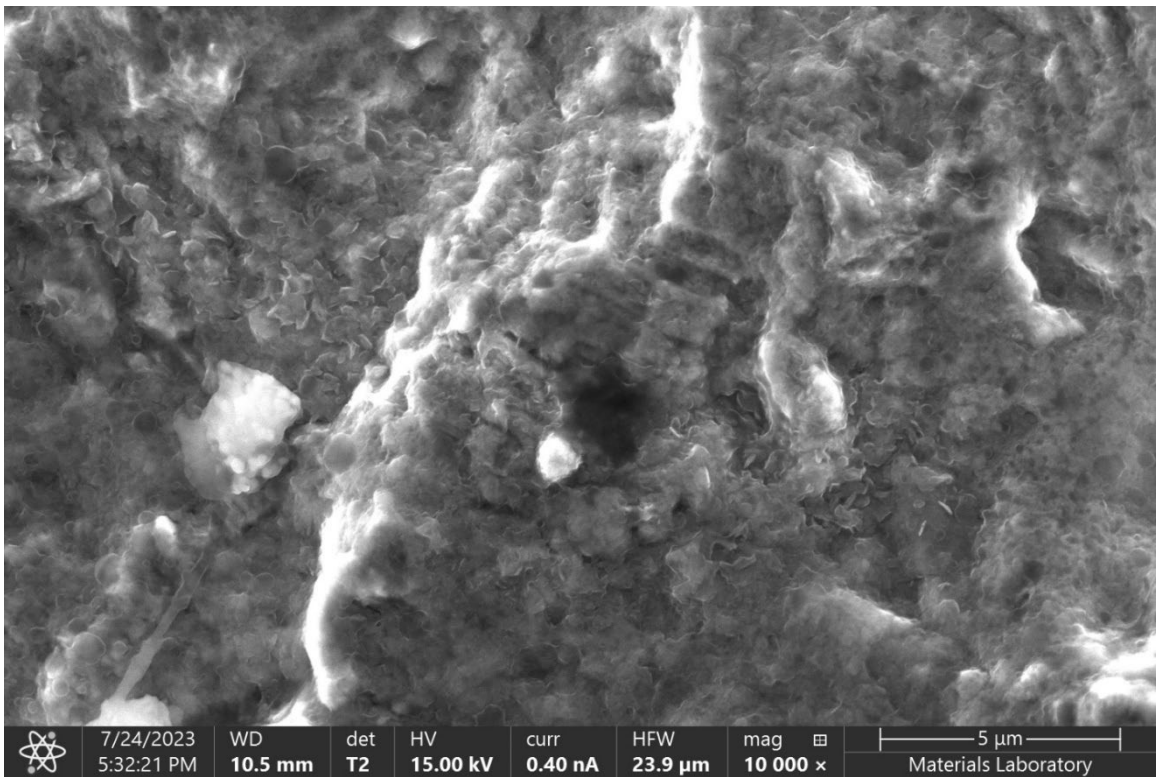
**Figure 11.** Secondary electron (SE) micrograph of the fatigue striations in **Figure 10**, showing the surface oxide layer.

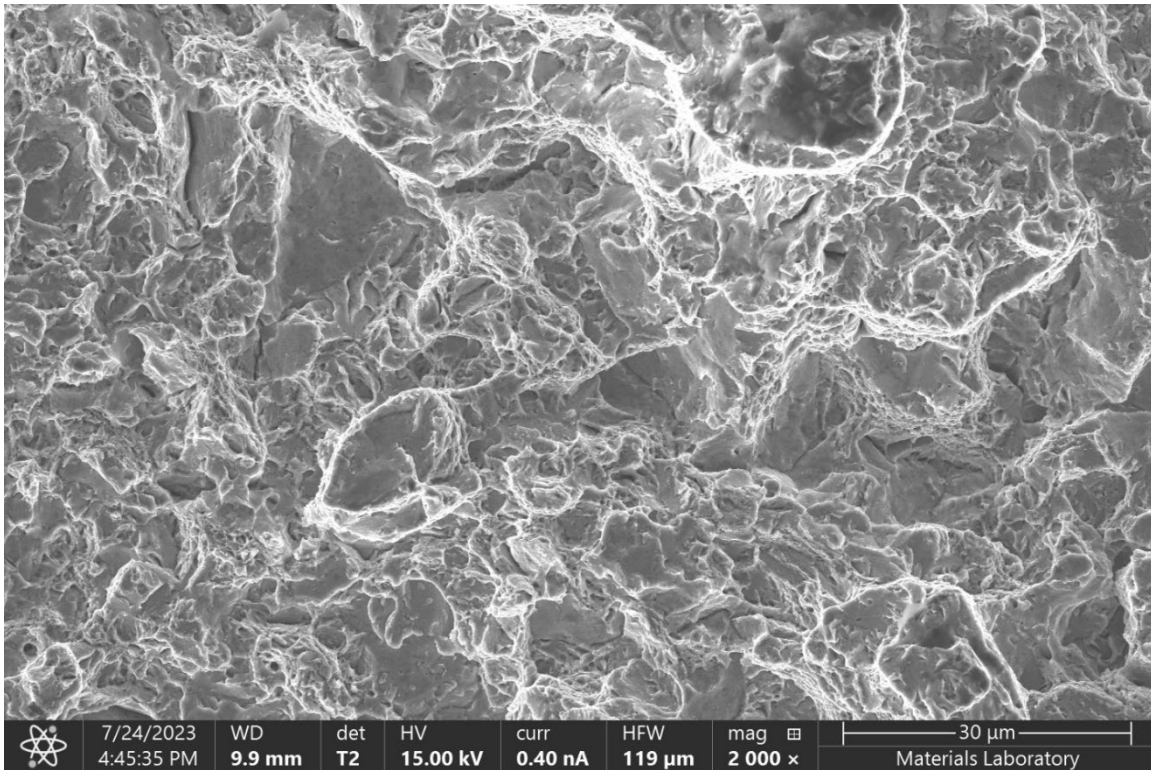
Outside the fatigue crack, the fracture surface exhibited dimpled rupture, consistent with overstress fracture. Figure 12 shows a typical area of the subsequent overstress fracture, located just outside the largest fatigue thumbnail crack.

**Figure 12.** SE micrograph of dimpled rupture outside the thumbnail cracks on the fracture surface.

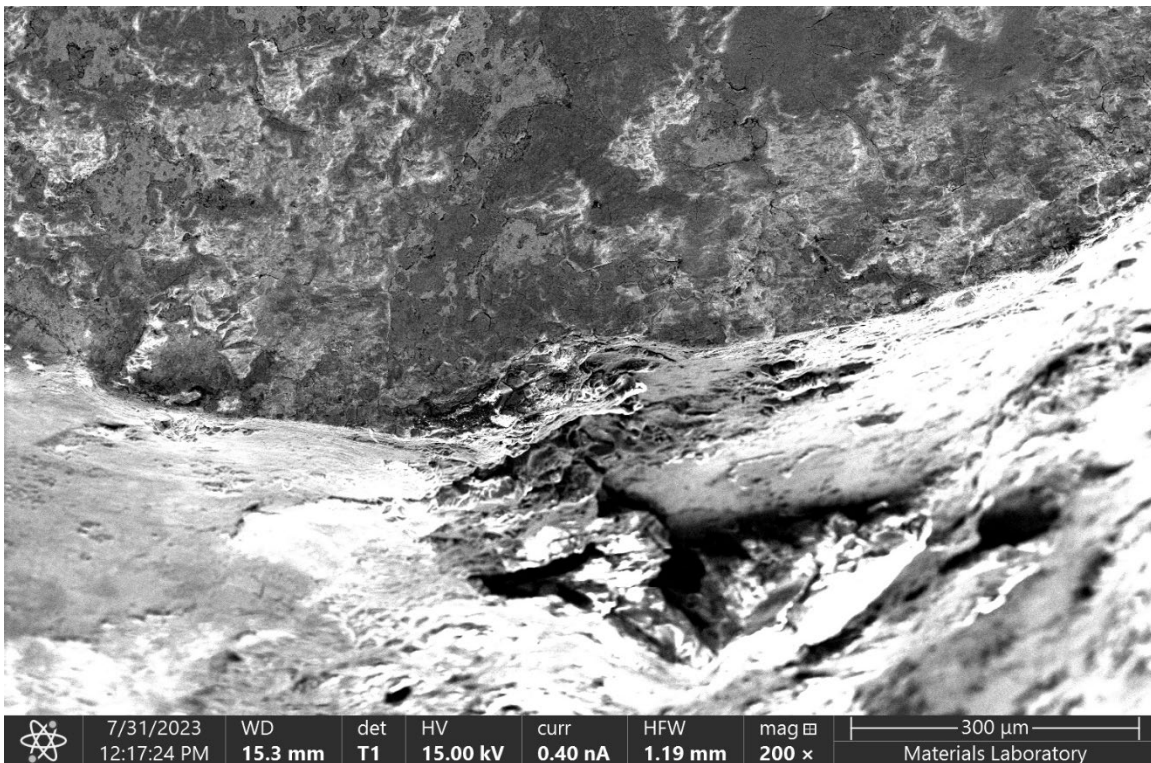
The fracture surface was cleaned again in an ultrasonic bath with an aqueous solution of Evapo-Rust.<sup>2</sup> Figure 13 shows the crack initiation site located at the radius of the bore. This location exhibited an inward recess with nonconductive compounds. Figure 14 shows a closer view of this area. The material was examined using energy dispersive x-ray spectroscopy (EDS) to determine its chemical composition.<sup>3</sup> The material was consistent with iron oxide, with major amounts of sodium, potassium, calcium, chlorine, and phosphorus. These features were consistent with a corrosion pit at the fatigue crack initiation site.

**Figure 13.** BE micrograph of the edge of the fracture, showing the fatigue crack initiation site obscured by surface oxide and contamination.

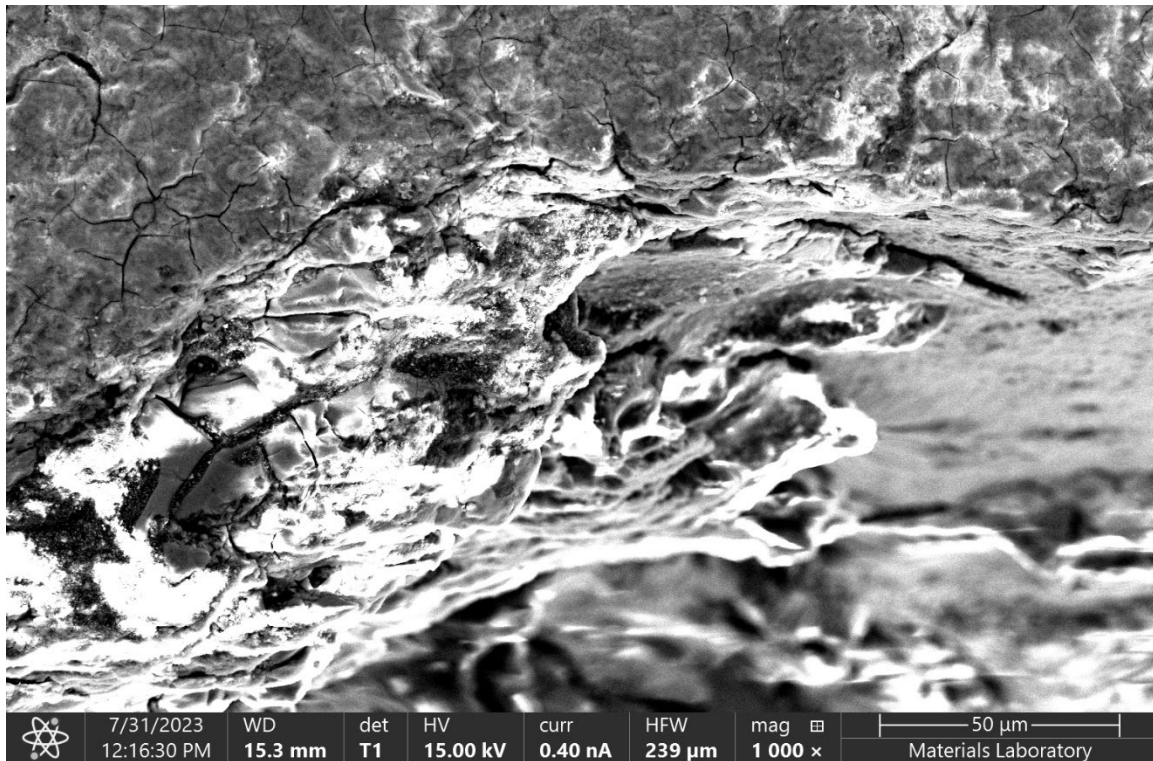
Significant amounts of cadmium were also found in this area and along the fatigue crack. Cadmium was also found along the bore but was absent on surfaces outside this area. These data were consistent with a cadmium coating process along the valve bore.

**Figure 14.** BE micrograph of the corrosion pit at the crack initiation site in **Figure 13**.

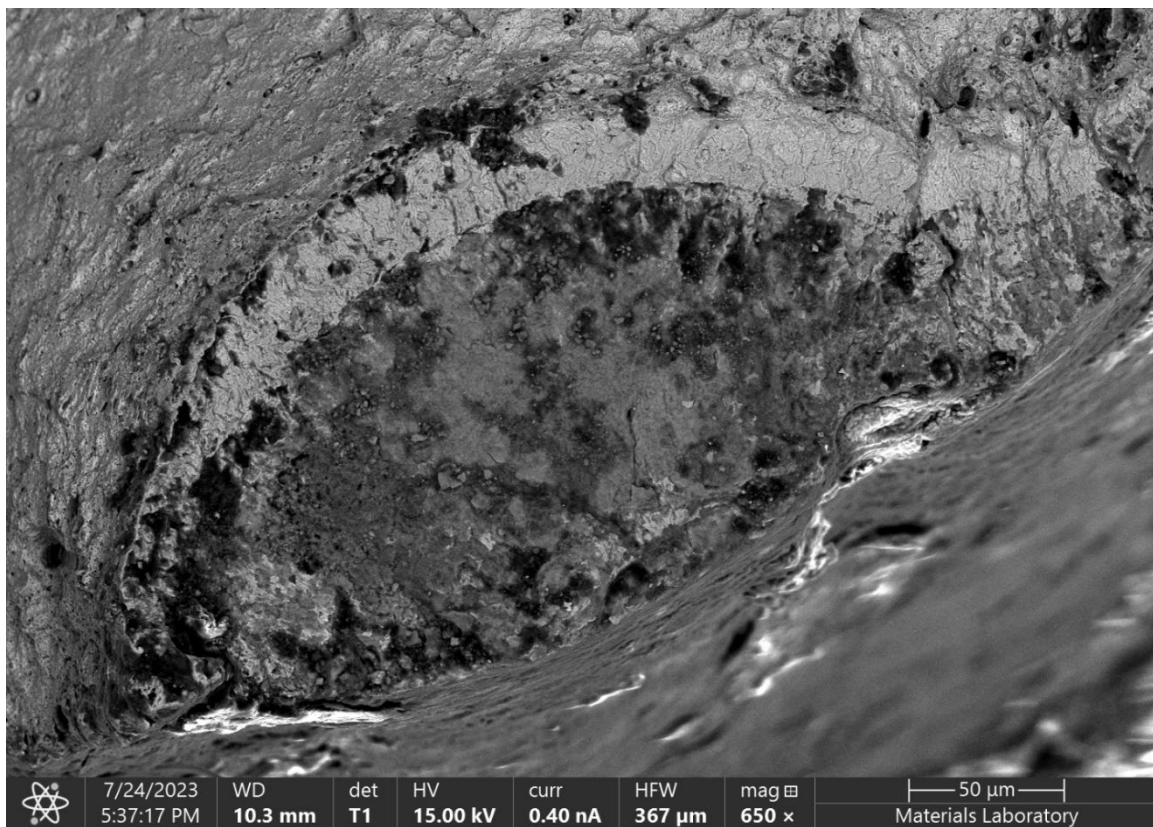
Figure 15 shows the smaller fatigue crack adjacent to the largest fatigue crack. This fatigue crack exhibited a corrosion pit at its crack initiation site, shown in Figures 16 and 17.

**Figure 15.** BE micrograph of the smaller fatigue crack towards the right in **Figure 8**.

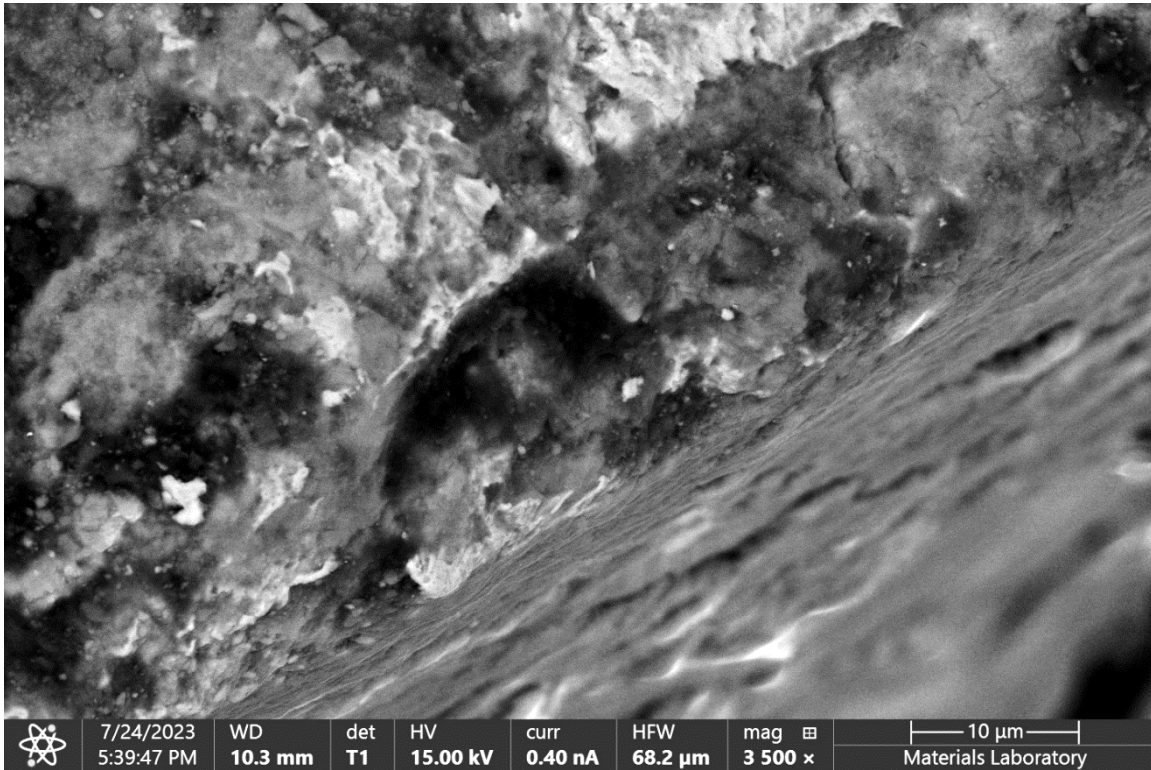
**Figure 16.** BE micrograph of the initiation site of the fatigue crack in **Figure 14**, showing a pit like divot.

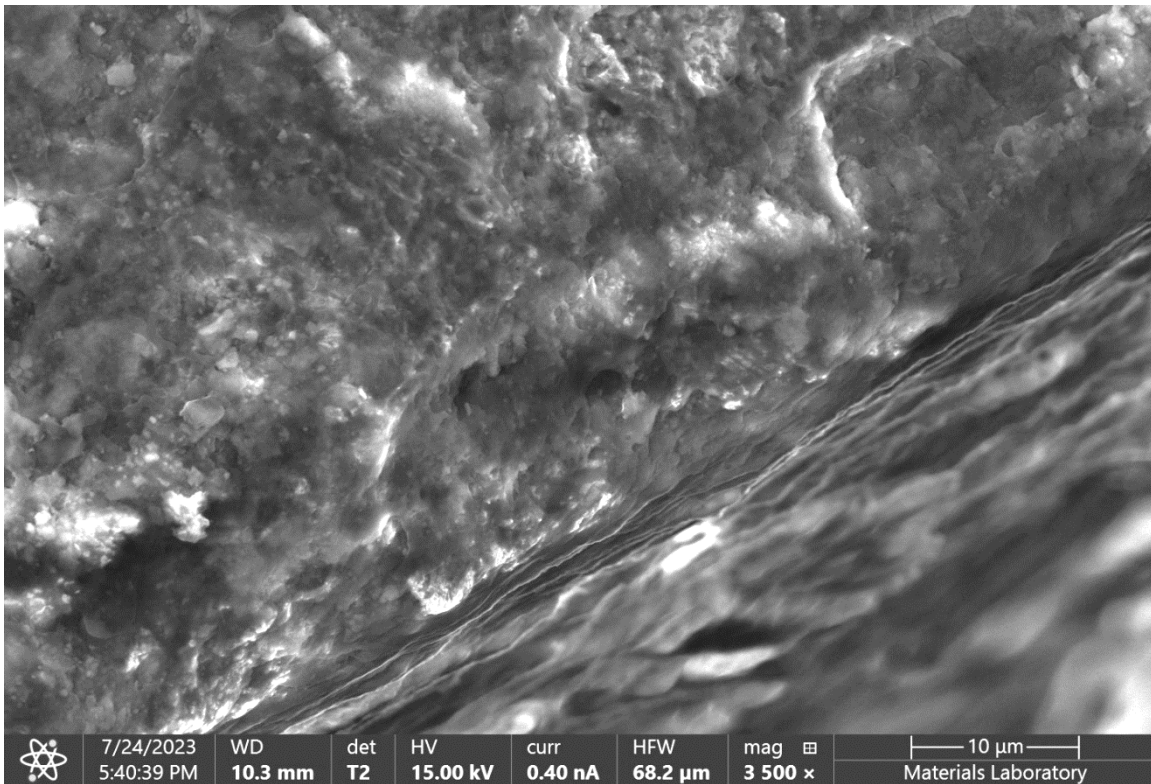
**Figure 17.** SE micrograph of the crack initiation site in **Figure 15**.

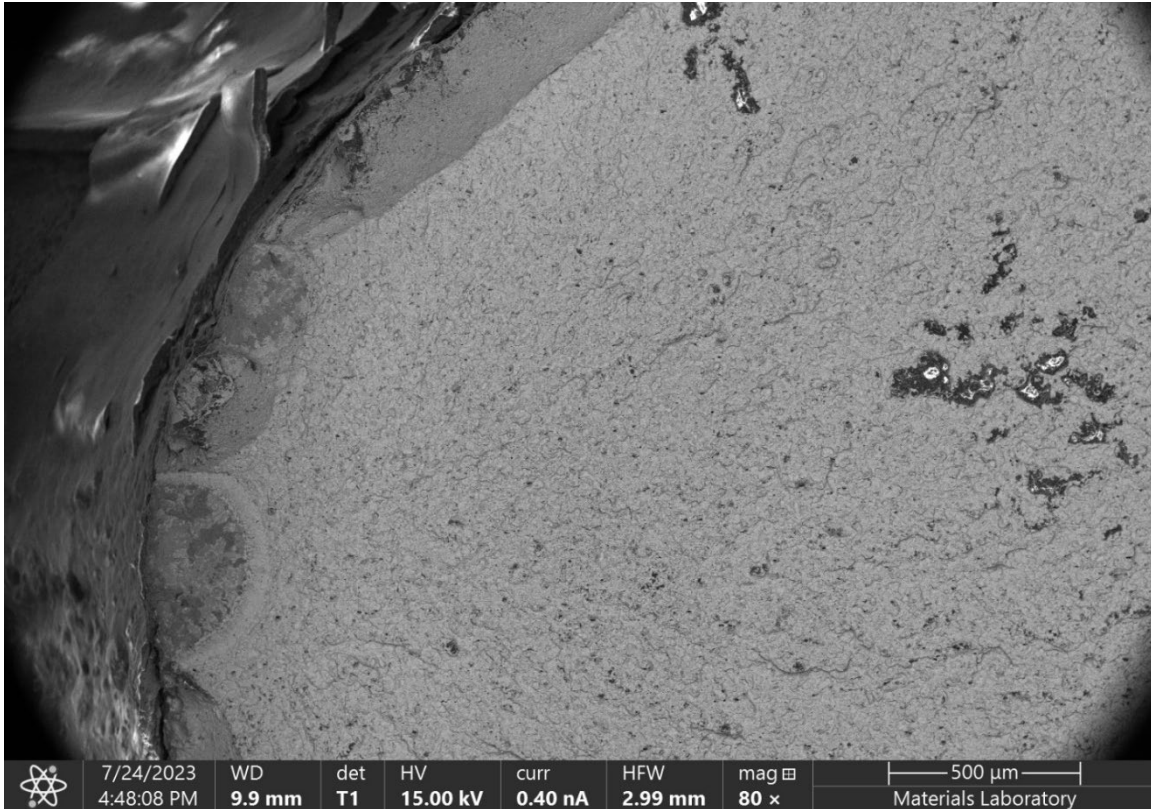
Figure 18 shows the trio of fatigue cracks on the opposite side of the bore. The largest of these cracks is shown in Figure 19, and with annotations in Figure 20. These figures demonstrate a unique quality of the cracks, which exhibited distinct subregions. Most of the fatigue crack located towards the initiation area showed enough surface oxide and contamination to obscure the underlying fracture features.

**Figure 18.** BE micrograph of the smaller fatigue cracks in the right in **Figure 5**.

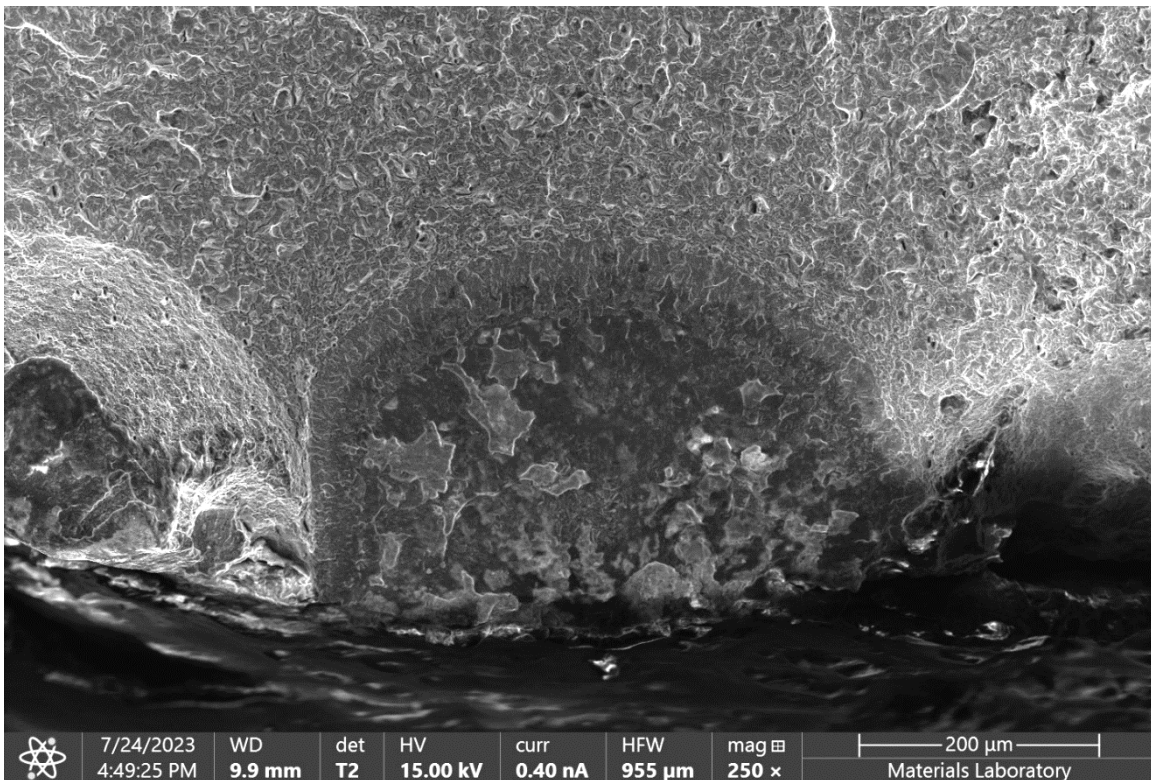
**Figure 19.** SE micrograph of the largest of the three cracks in **Figure 17**, rotated 90°.

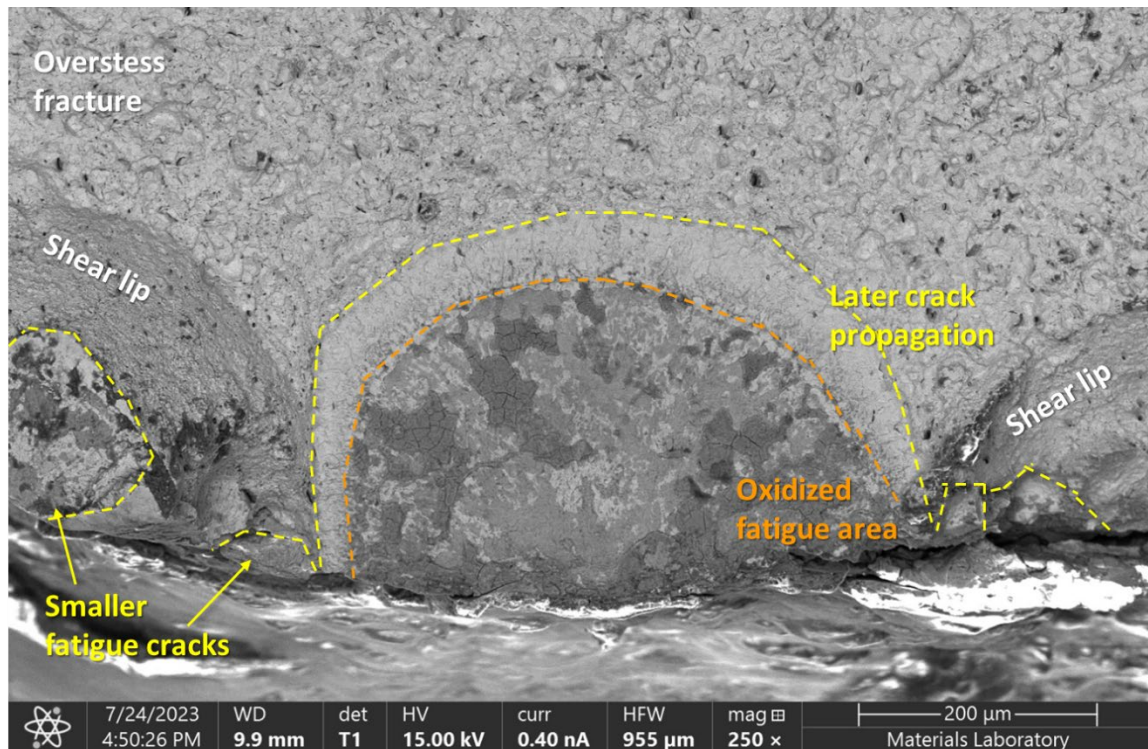
The later portions of the crack were absent much of this surface contamination and exhibited clearer striations. Figure 20 demonstrates a demarcation between the two regions, with the lower area appearing darker, consistent with more (thicker) surface oxidation, and the upper area being lighter with more pronounced features. These striations continued at the end of the crack, consistent with the propagation direction until abruptly transitioning to the subsequent overstress fracture, consistent with the final landing event (see Figure 21).

**Figure 20.** BE micrograph of the fatigue crack in **Figure 18**, showing areas of surface oxide and later crack growth.

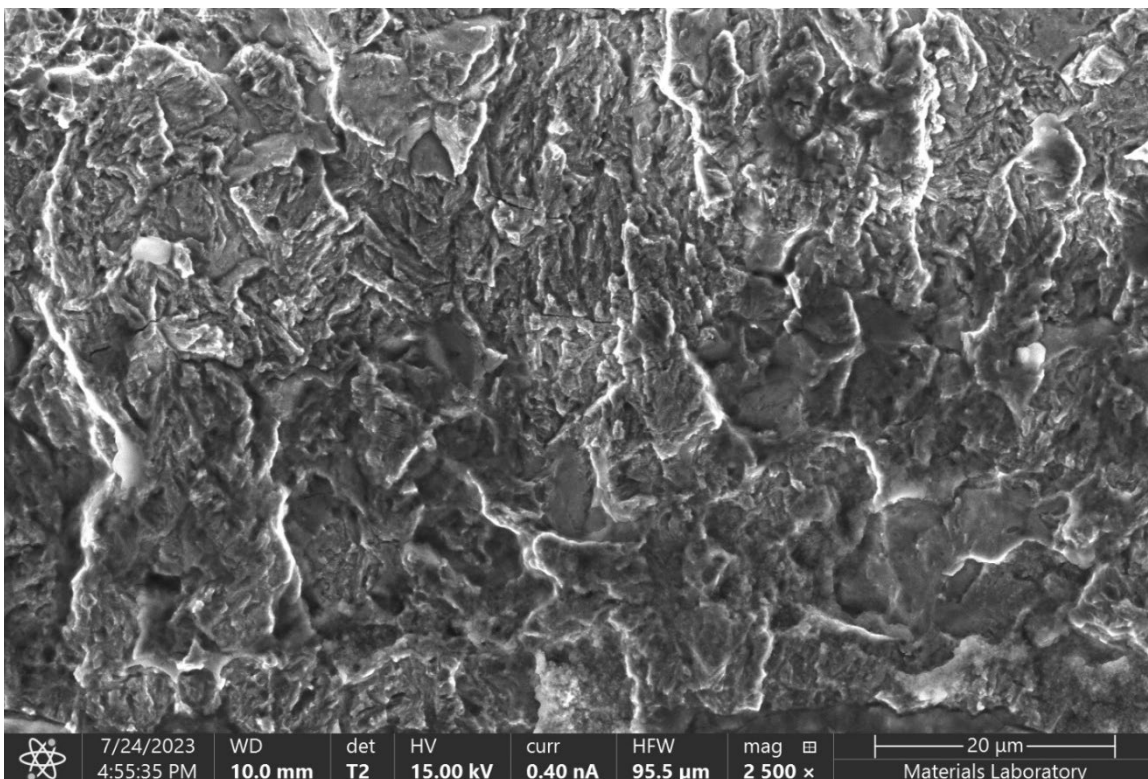
**Figure 21.** SE micrograph of the area of demarcation between the earlier (lower) and later (upper) crack growth in the fatigue crack in **Figure 19**.

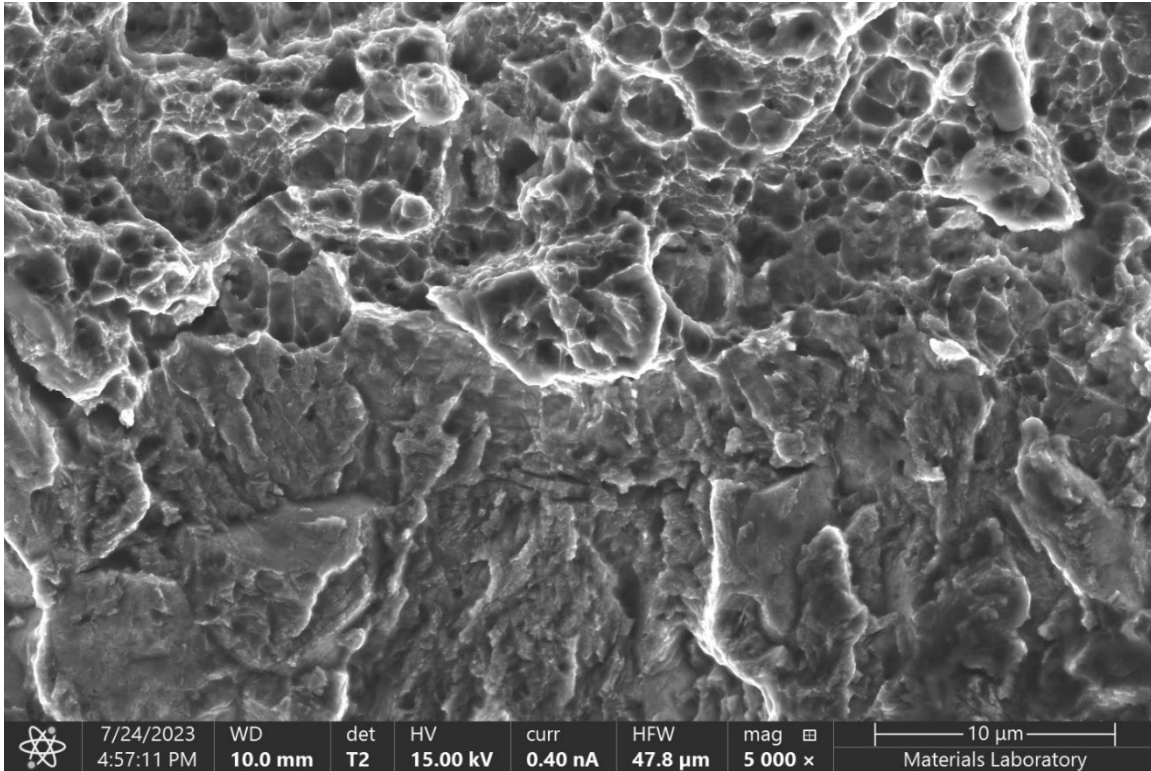
The different oxide areas were examined using EDS, based on their contrast color in backscattered mode in the SEM. Figure 22 shows some of the lighter gray oxides. This material was primarily iron oxide, with minor amounts of zinc and cadmium. Figure 23 shows a closer view of the darker gray oxide. This area exhibited mud-cracking and charging effects, consistent with nonconductive material. Per EDS probes, this area was primarily iron oxide but with high amounts of phosphorus and minor amounts of sodium.

**Figure 22.** SE micrograph of the line of demarcation between the fatigue crack (lower) and the overstress fracture / dimpled rupture (upper) regions in **Figure 19**.

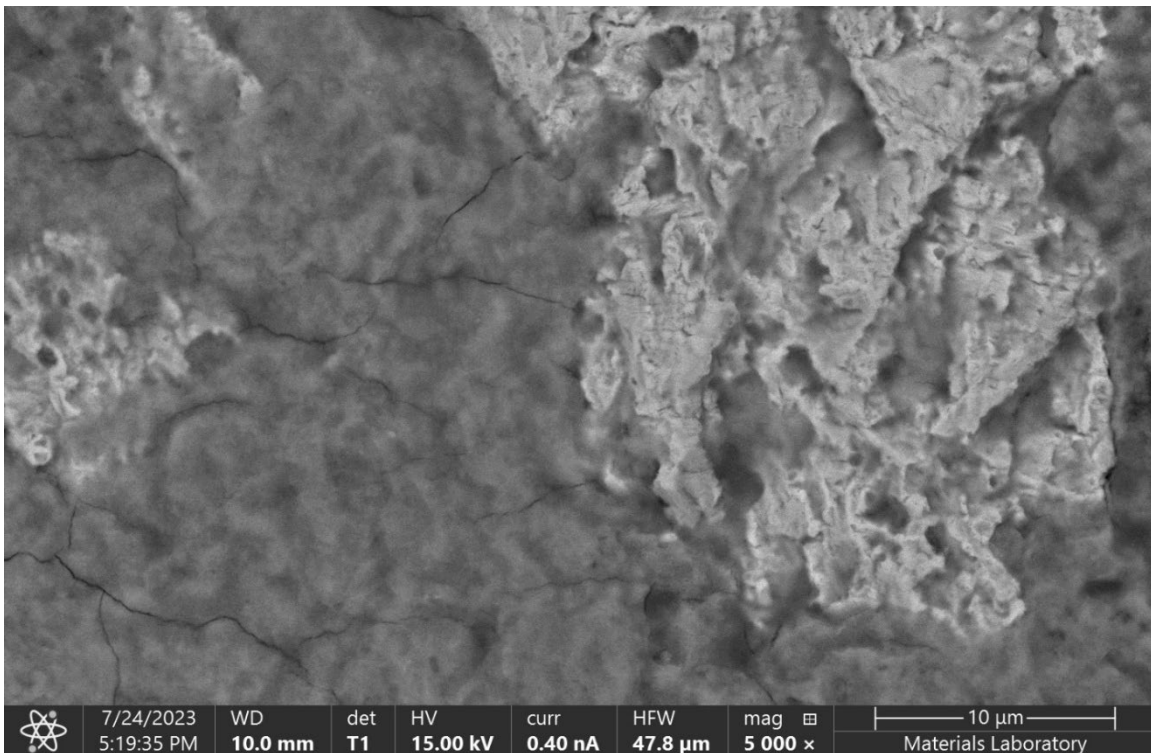
**Figure 23.** BE micrograph near the crack initiation site, showing darker-contrasting oxide over underlying fatigue striations (lighter contrast).
