# National Transportation Safety Board

WPR23LA096

## **MATERIALS LABORATORY**

Factual Report 23-059

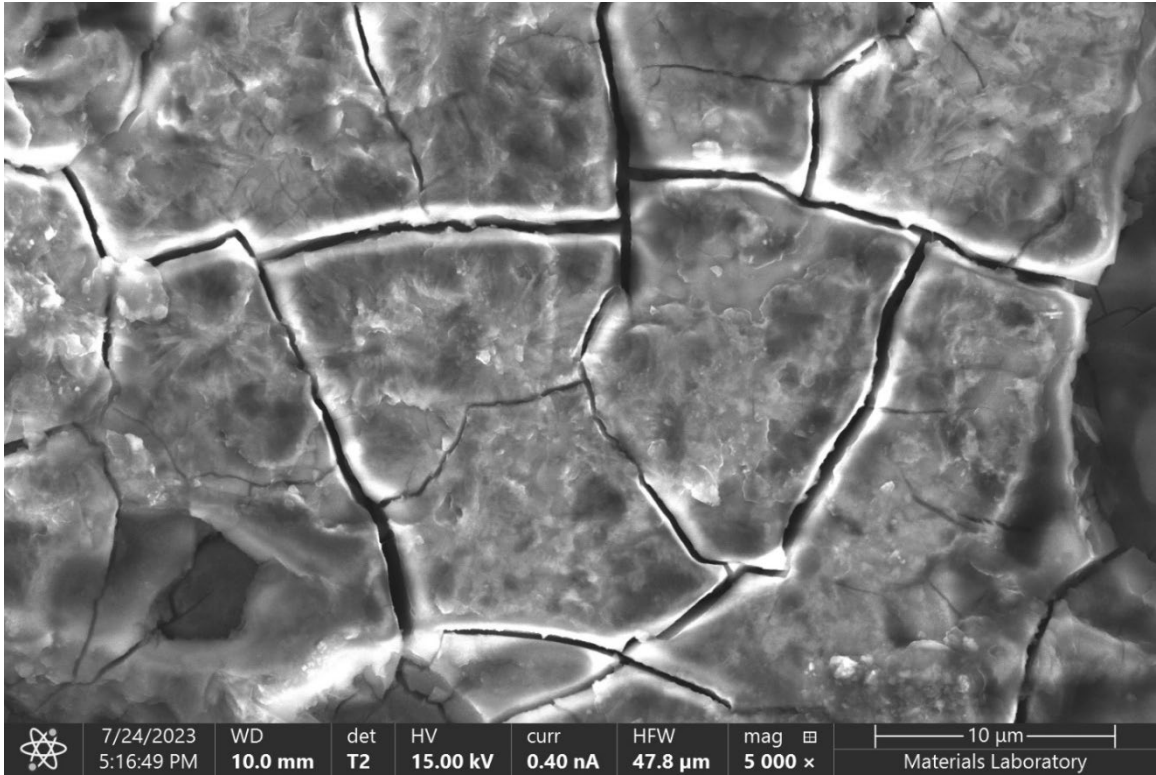
**Figure 24.** SE micrograph of thicker oxide near the crack initiation site.
