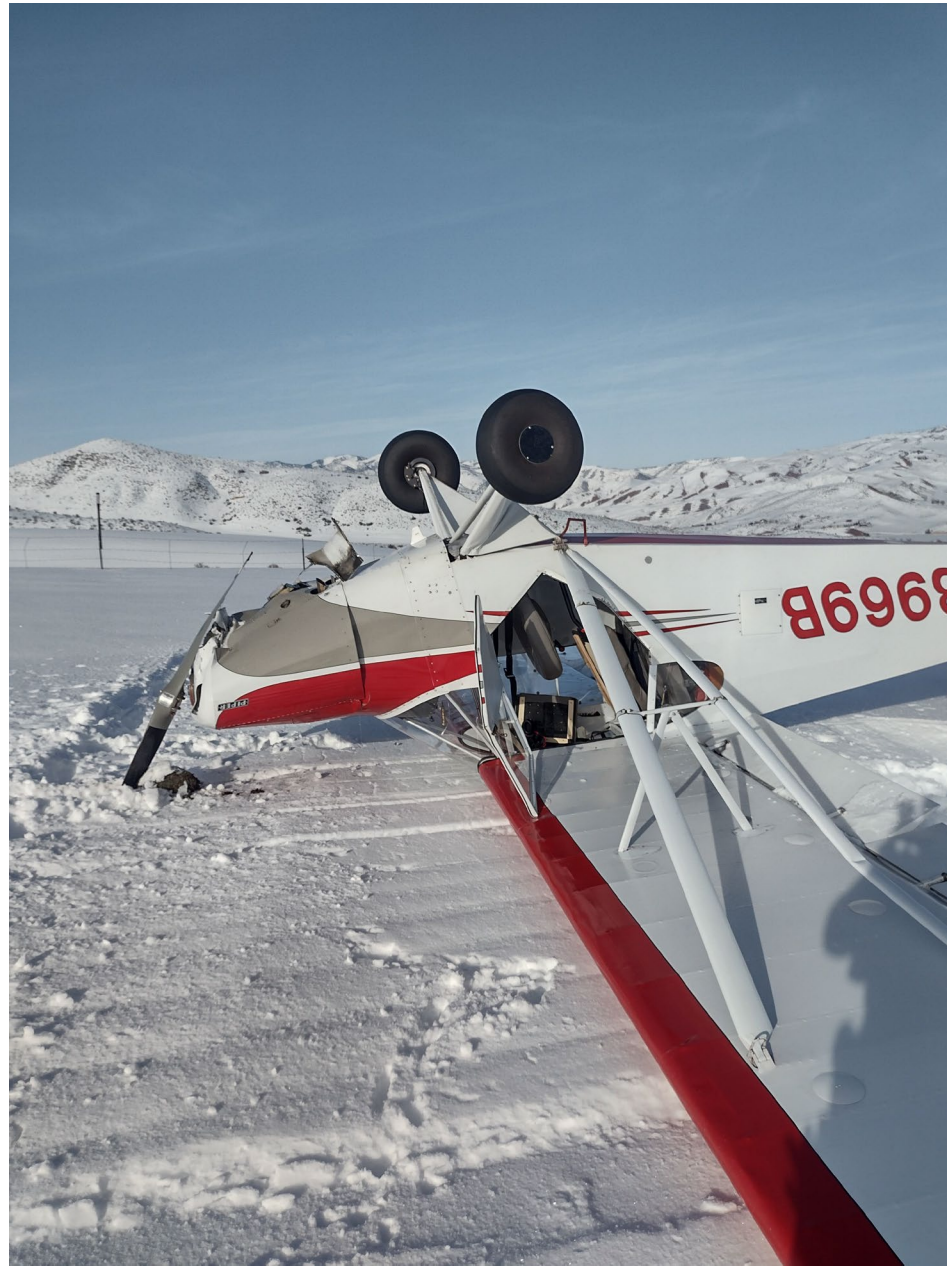
**Photo 1 – View of Wing Strut Damage (Courtesy of Deputy Sheriff)**

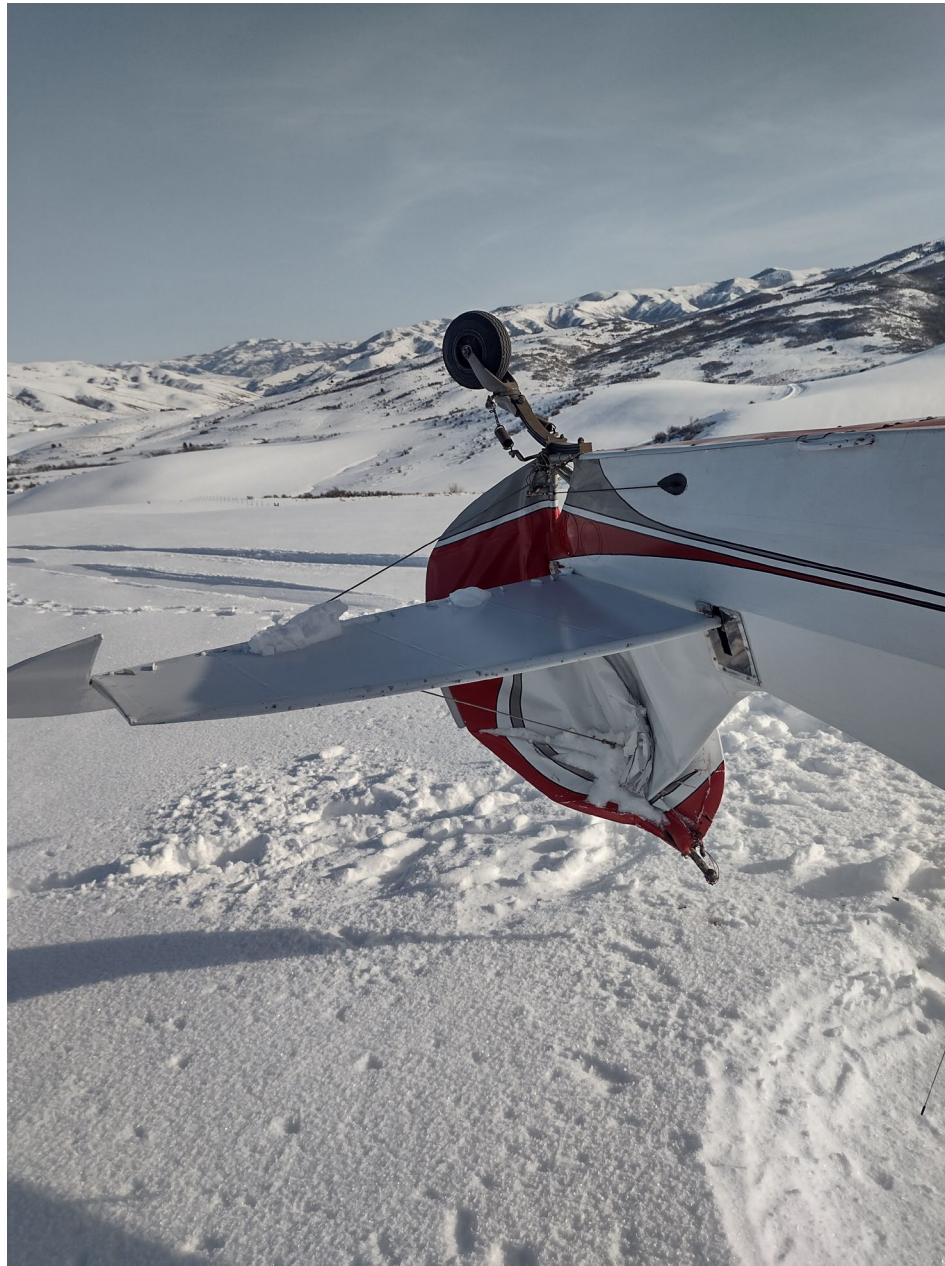
**Photo 2 – View of Rudder and Vertical Stabilizer Damage**
