# National Transportation Safety Board

WPR23LA104

## **AIRFRAME AND ENGINE EXAMINATION SUMMARY**

Location: Gladewater, TX  
Date: 02/05/2023  
Time: 1300 CST  
1900 UTC  
Airplane: N123JV, Bonanza F-35

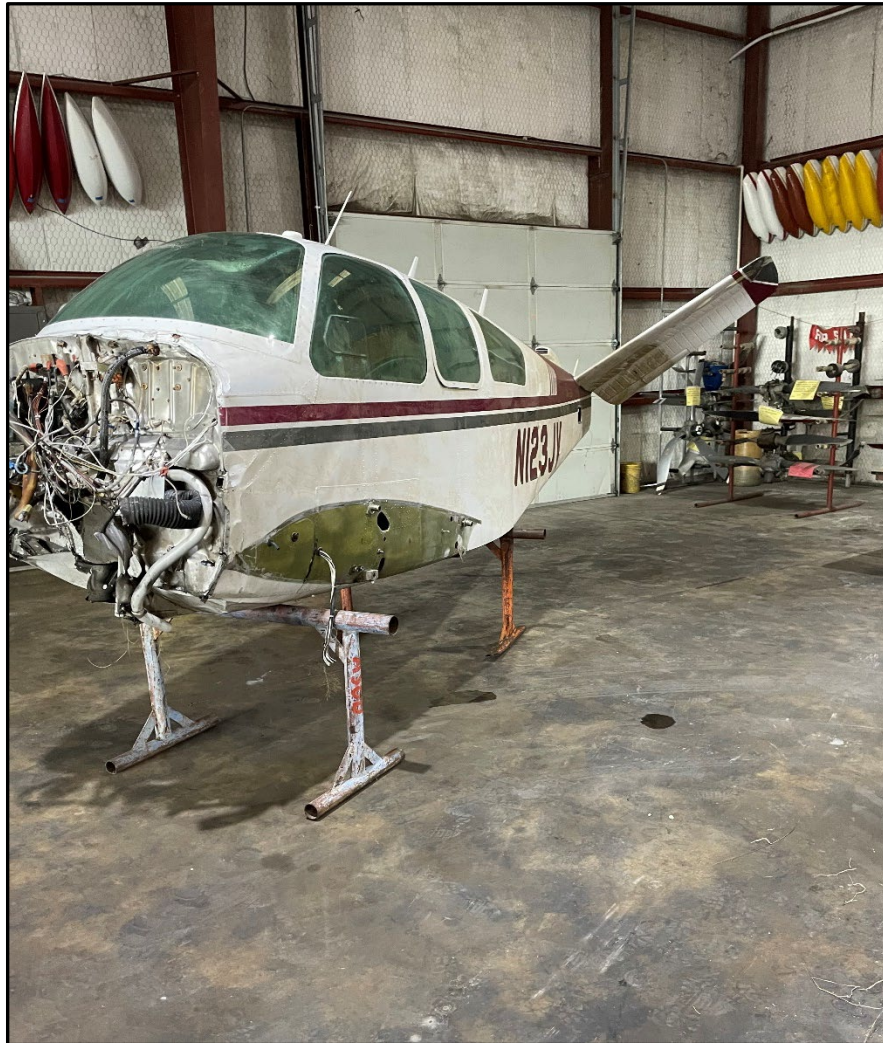
The wings were found separated from the fuselage. The left wing was removed, and the flap and aileron were attached to the wing. The left-wing inboard portion of the flap sustained damage. The left main landing gear was in the retracted position but had mud in the wheel area consistent with it being extended during impact.

The right wing sustained damage mid-span from an impact that damaged the wing from the leading edge to the trailing edge portion of the wing. The right flap and aileron were attached. The right flap was separated in half about mid-span.

**Figure 1: Airplane wreckage as viewed from the left.**

The fuselage was relatively intact with some damage sustained to the front bottom section and the bottom section of the fuselage aft of the cabin.

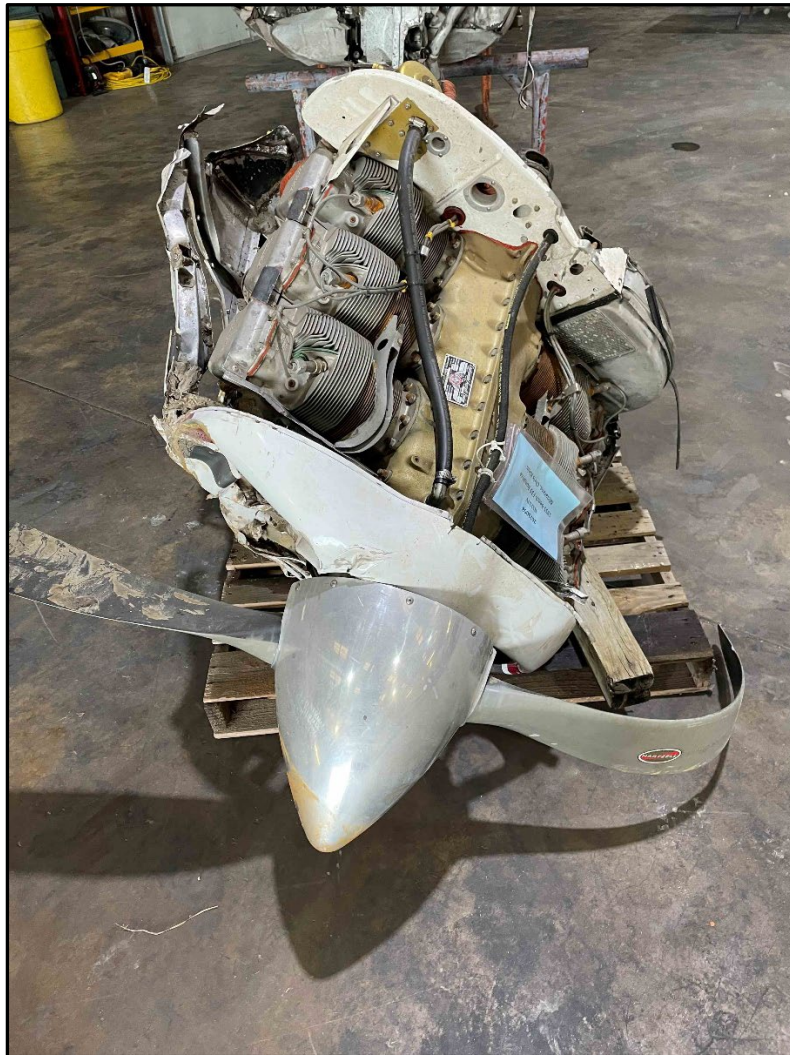
The engine was separated from the fuselage. The exhaust tubing was intact, and examination of the mufflers revealed no anomalies. The propeller remained attached to the crankshaft propeller flange. One blade was bent aft mid-span. and the other blade was slightly bent aft and had a mark about 29 inches, twisted, and a portion of the tip was separated and had a leading gouge about 29 inches from the hub. The spinner was attached and had a few markings.

The top sparkplugs were removed, and the rocker covers were removed from the cylinders. All sparkplug electrodes were undamaged and showed normal worn-out wear conditions and oily consist with the engine setting submerged in the water and at the recovery facility. The engine was able to be partially rotated through the propeller and engine continuity was confirmed to the accessory drive. Thumb compression was unable to established due to lack of rotation consistent with rust and corrosion from water exposure. During partial rotation, water would exit the

The carburetor inlet was removed and examined, and no contaminants or anomalies were noted. The engine driven fuel pump was removed and disassembled and examined with no anomalies noted. The drive coupling was intact, but the pump was frozen in place consistent with corrosion from being submerged in the water.

**Figure 2: Engine as viewed from the front.**
