**From:** [REDACTED]  
**To:** [REDACTED]  
**Subject:** WPR23LA107 - Yuma, AZ - Materials Laboratory Examination Report  
**Date:** Wednesday, April 24, 2024 11:26:02 AM  
**Attachments:** [IMG\\_1614.JPG](#)  
[IMG\\_1618.JPG](#)  
[image002.png](#)

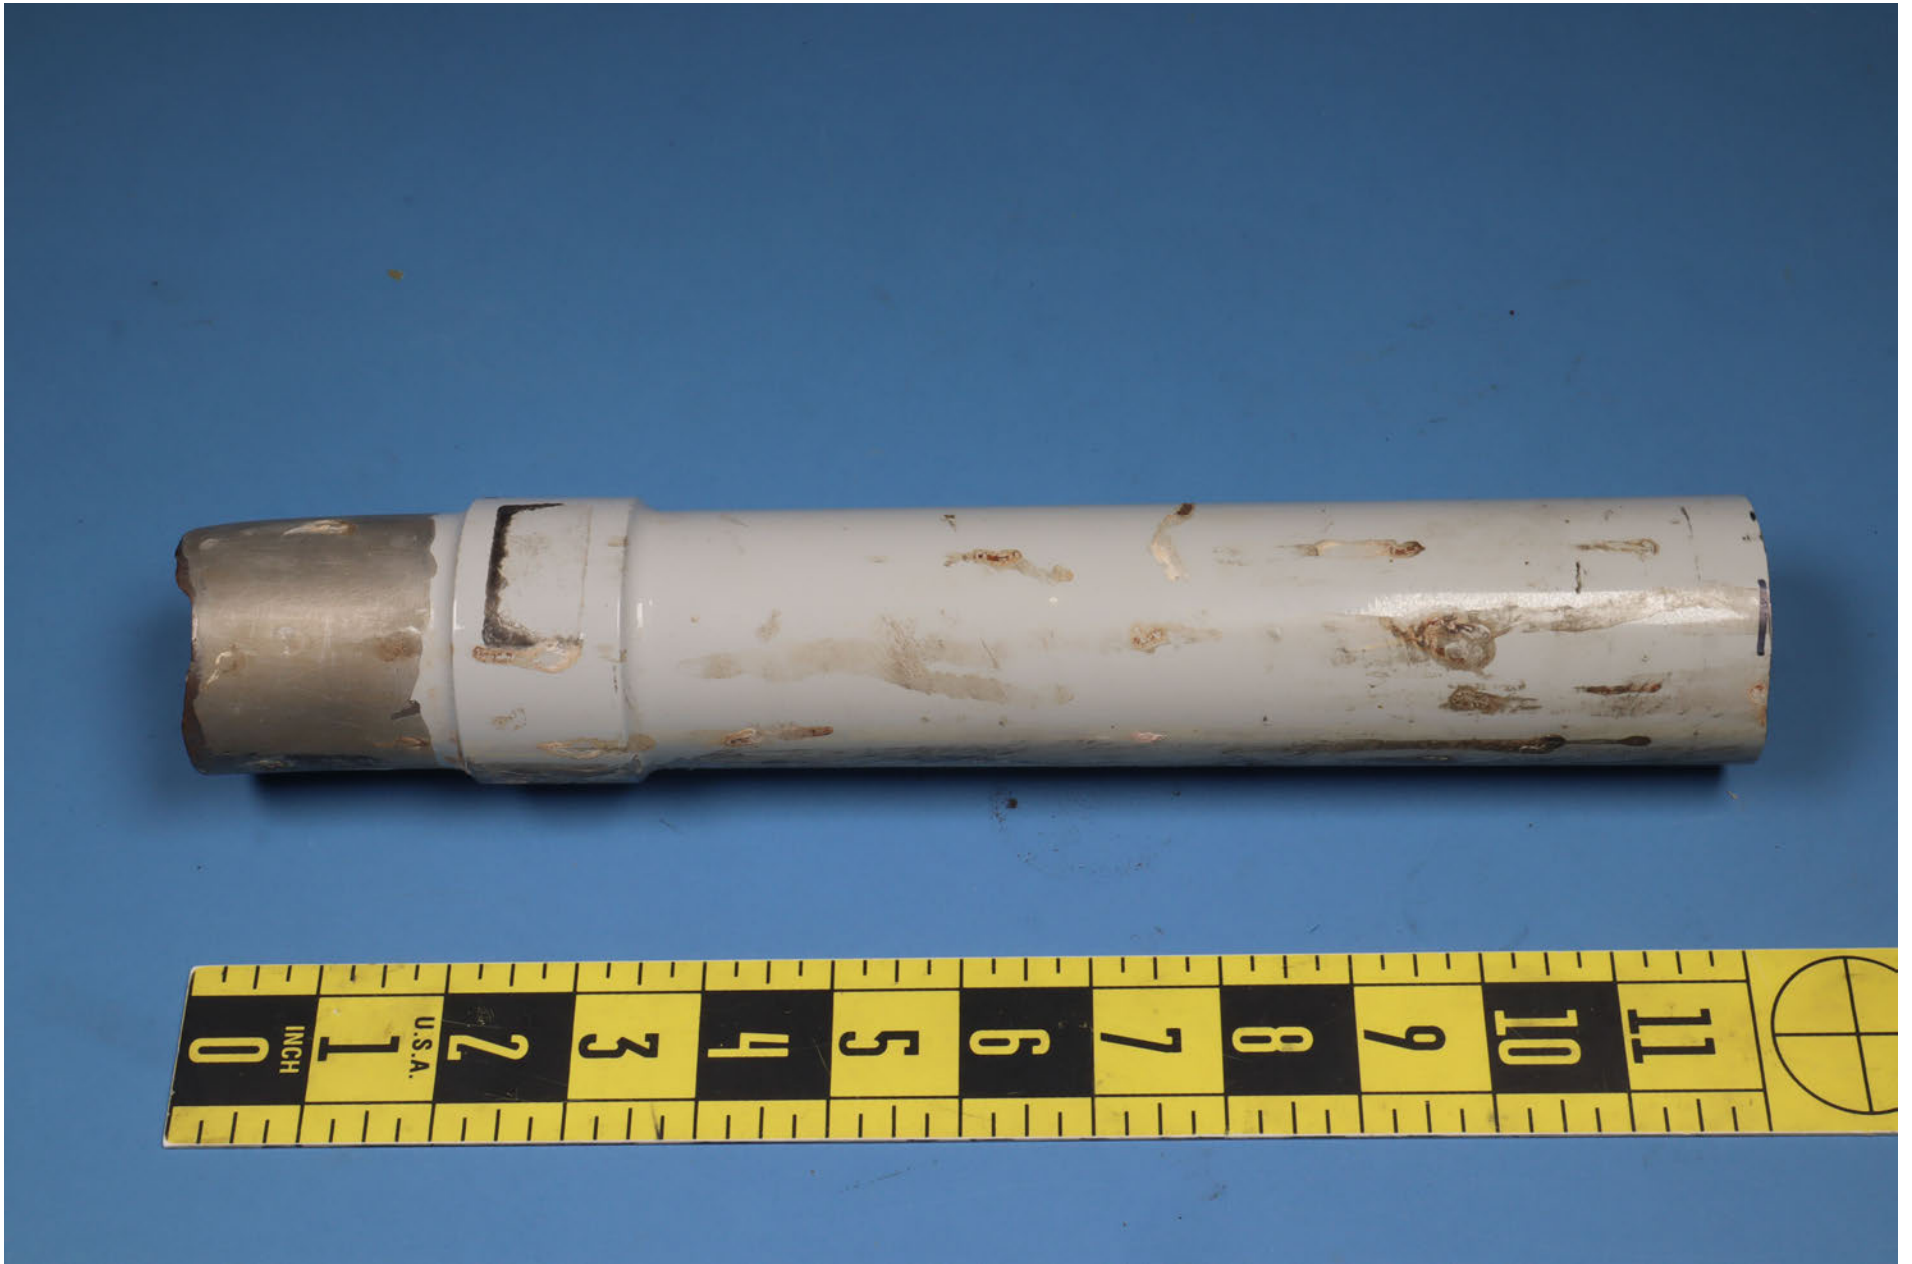
**Photo 1 – Main Rotor Mast N36FA**

The main rotor mast piece and the fracture surface on the mast piece are shown as received in the attached images. The main rotor mast was bent slightly adjacent to the fracture surface. The fracture surface was oriented primarily in the plane perpendicular to the mast axis, consistent with ductile overstress fracture under torsion loading. A portion of the fracture surface appeared relatively smooth and flat, and the remainder of the fracture surface had radial features and lipped material at the edges consistent with ductile overstress fracture in the shear plane. For a closer examination of the smooth area, a piece of the mast with the fracture surface was cut from the remainder of the piece, and the fracture surface was cleaned using an ultrasonic cleaner while submerged in a solution of Alconox detergent and warm water. The cleaned fracture surface was then examined using a scanning electron microscope. The fracture surface showed elongated dimple features with elongation in the circumferential plane, features consistent with ductile overstress fracture from torsion loading.
