# National Transportation Safety Board

WPR23LA107

## **WRECKAGE EXAM**

Helicopter: OH-58C/N36FA

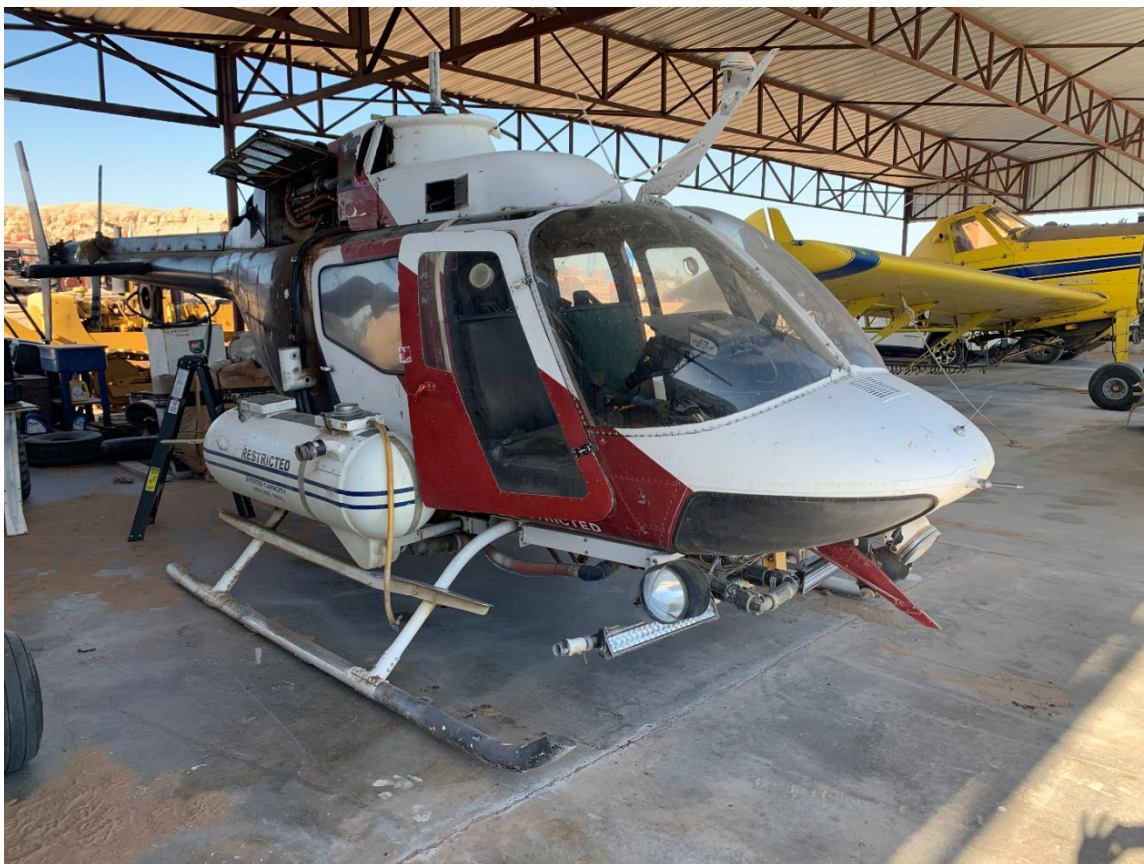
The fuselage sustained minor damage from the nose to the beginning of the tailboom. The tail boom received substantial damage along the top, about 24 inches forward of the 90° gearbox. The SatLoc CPU was recovered from the cockpit and retained for further examination.

**Figure 1. N36FA, right-side view.**

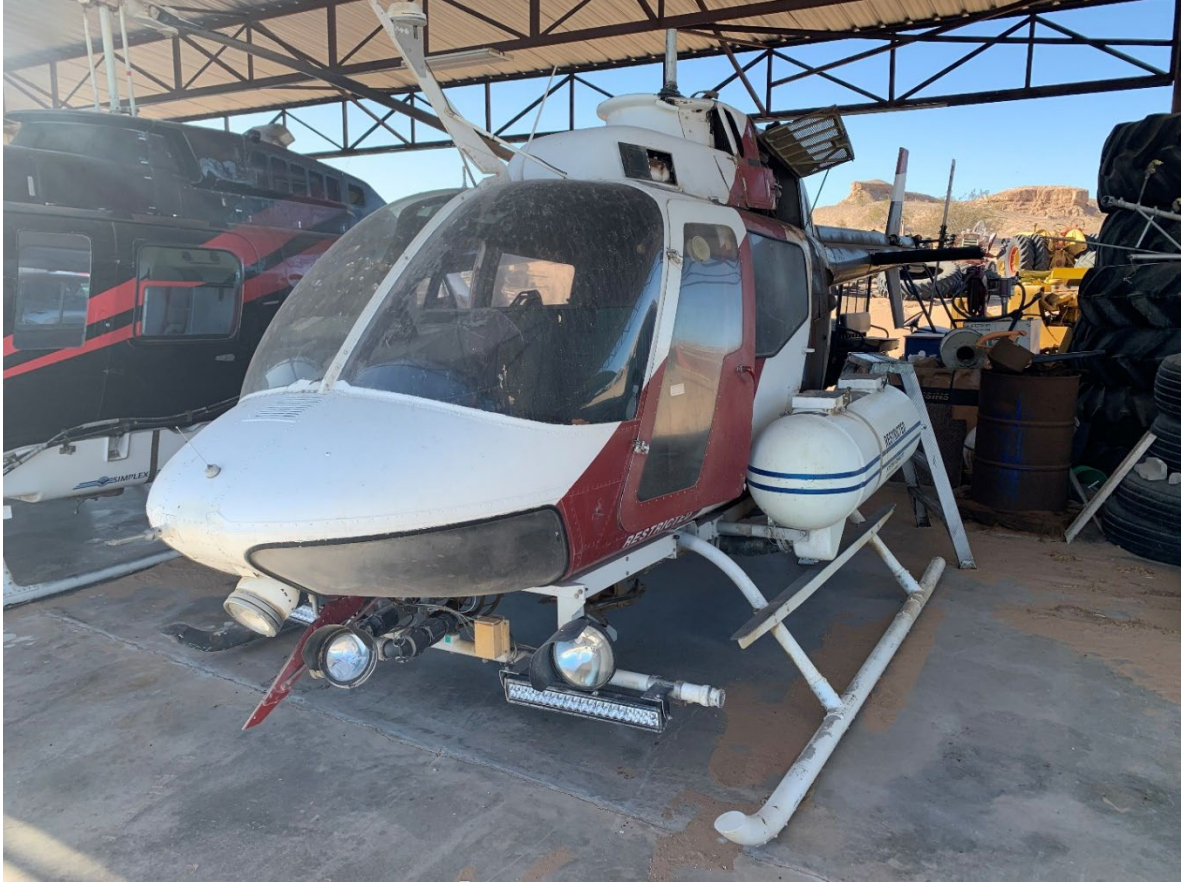
**Figure 2. Left-side view.**

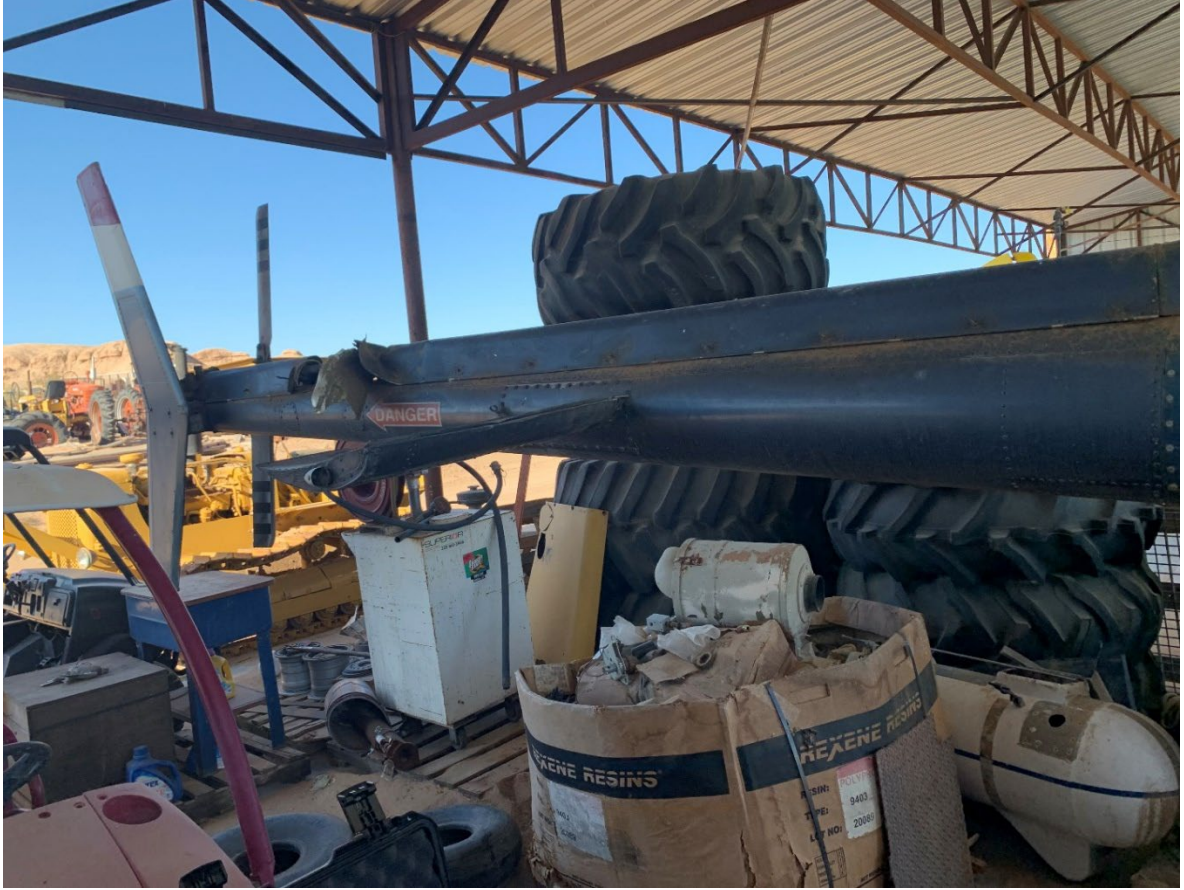
The tailboom remained attached to the fuselage and exhibited one area of damage along the top, about 24 inches inboard of the 90° gearbox. The tail rotor driveshaft cover, tail rotor drive shaft exhibited sideward impact marks consistent with contact with the main rotor blades. The right-side elevator exhibited denting and deformation.

**Figure 3. Tailboom, right-side view.**

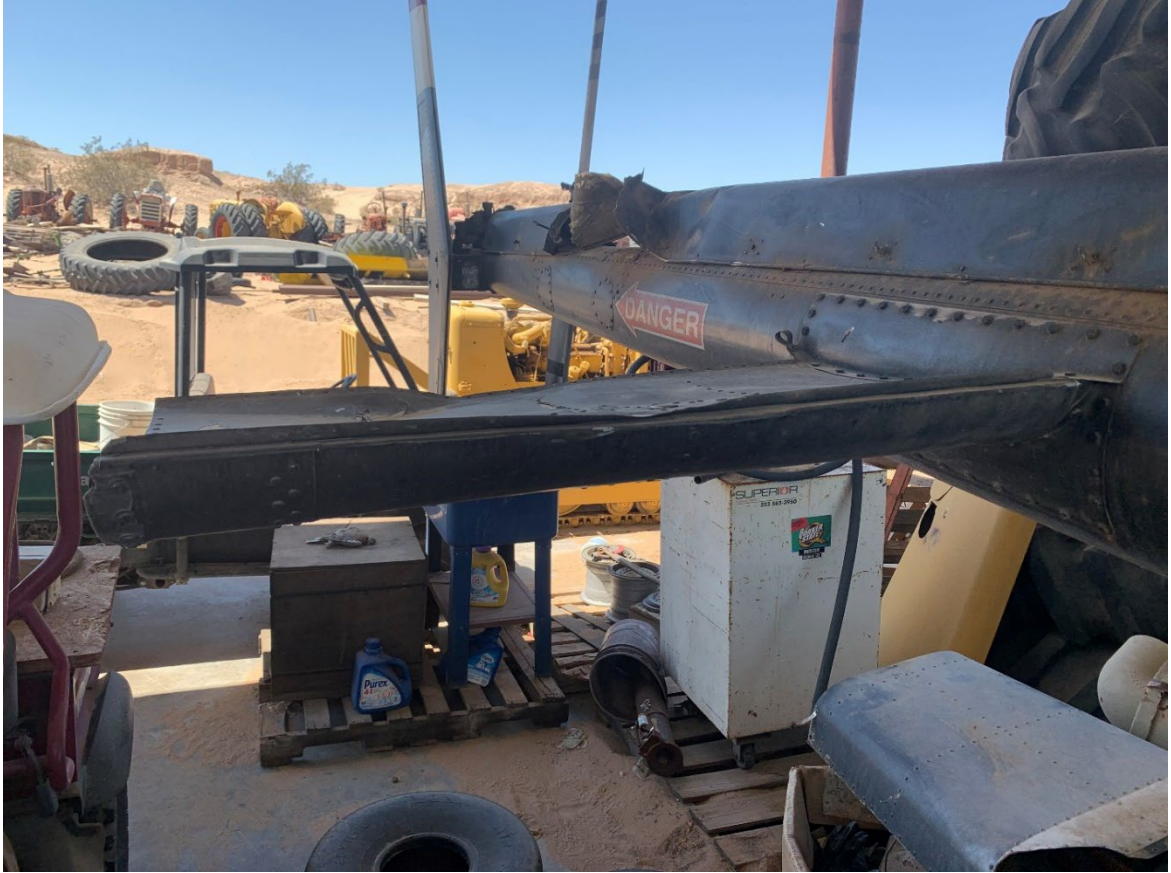
**Figure 4. Right-side elevator.**

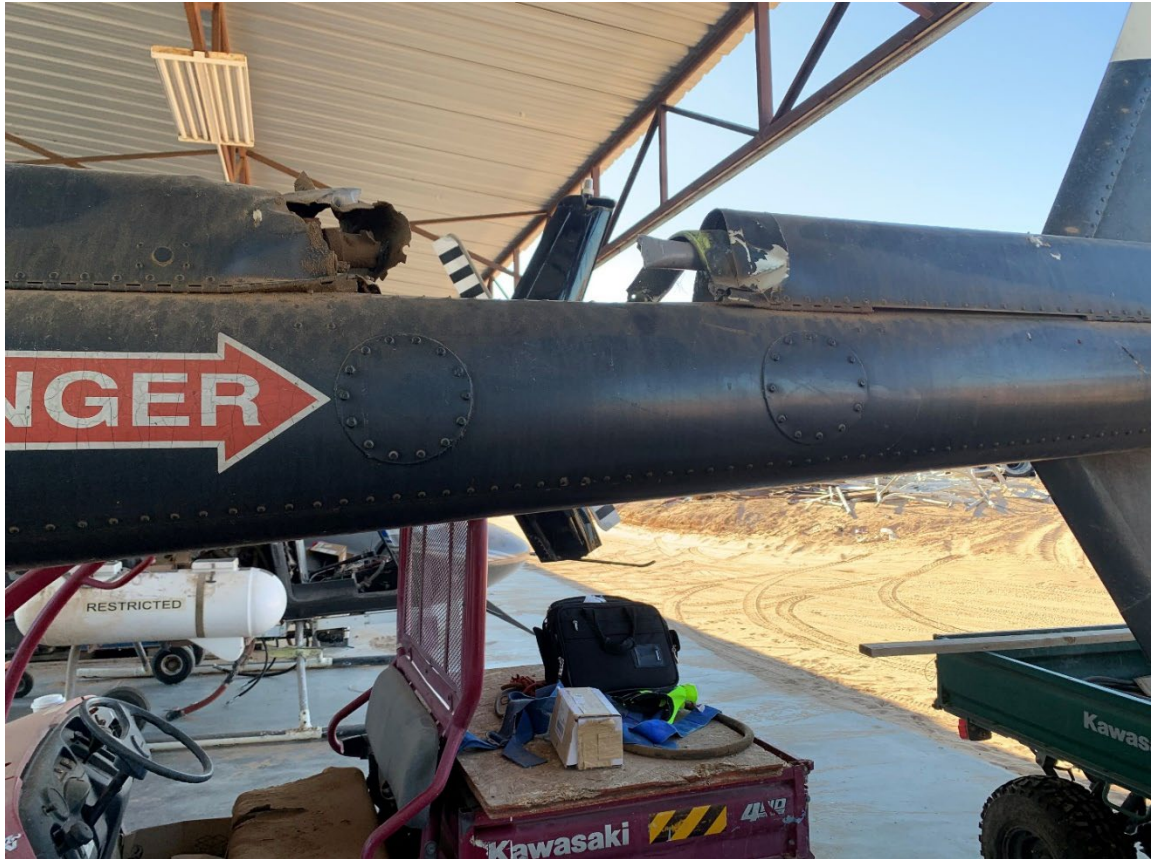
**Figure 5. Tailboom, left-side view.**

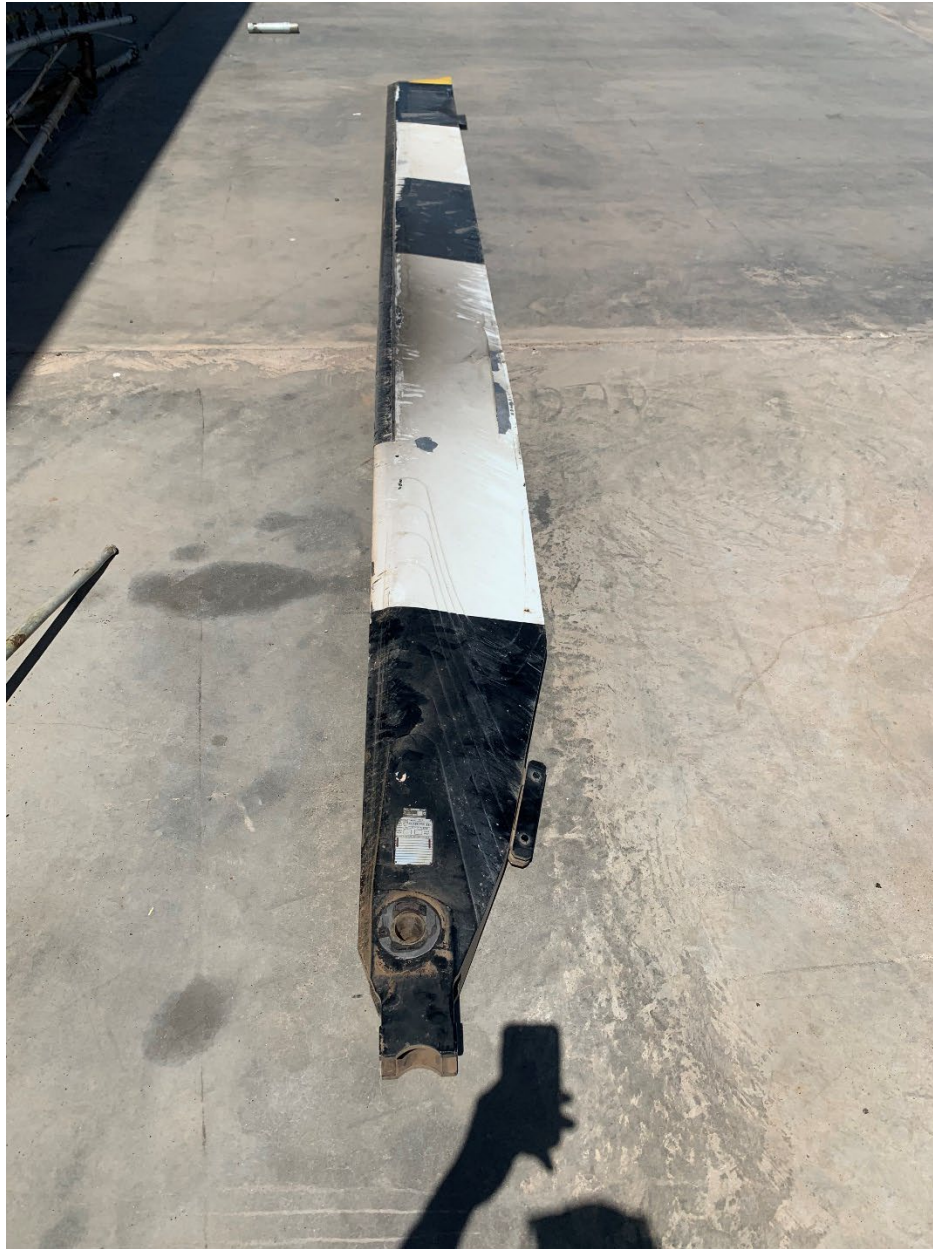
One blade (S/N: CSFS999) exhibited some damage to the tip but no other damage. The other blade (T-FS-451) exhibited a downward bend about 36 inches inboard of the root of the blade. The bend also exhibited inward crushing consistent with contact with the exhaust pipes of the engine. The tip of the blade also exhibited damage consistent with contact with the tail rotor drive shaft cover, tail rotor drive shaft and upper tailboom.

**Figure 6. Blade T-FS-451, top view.**

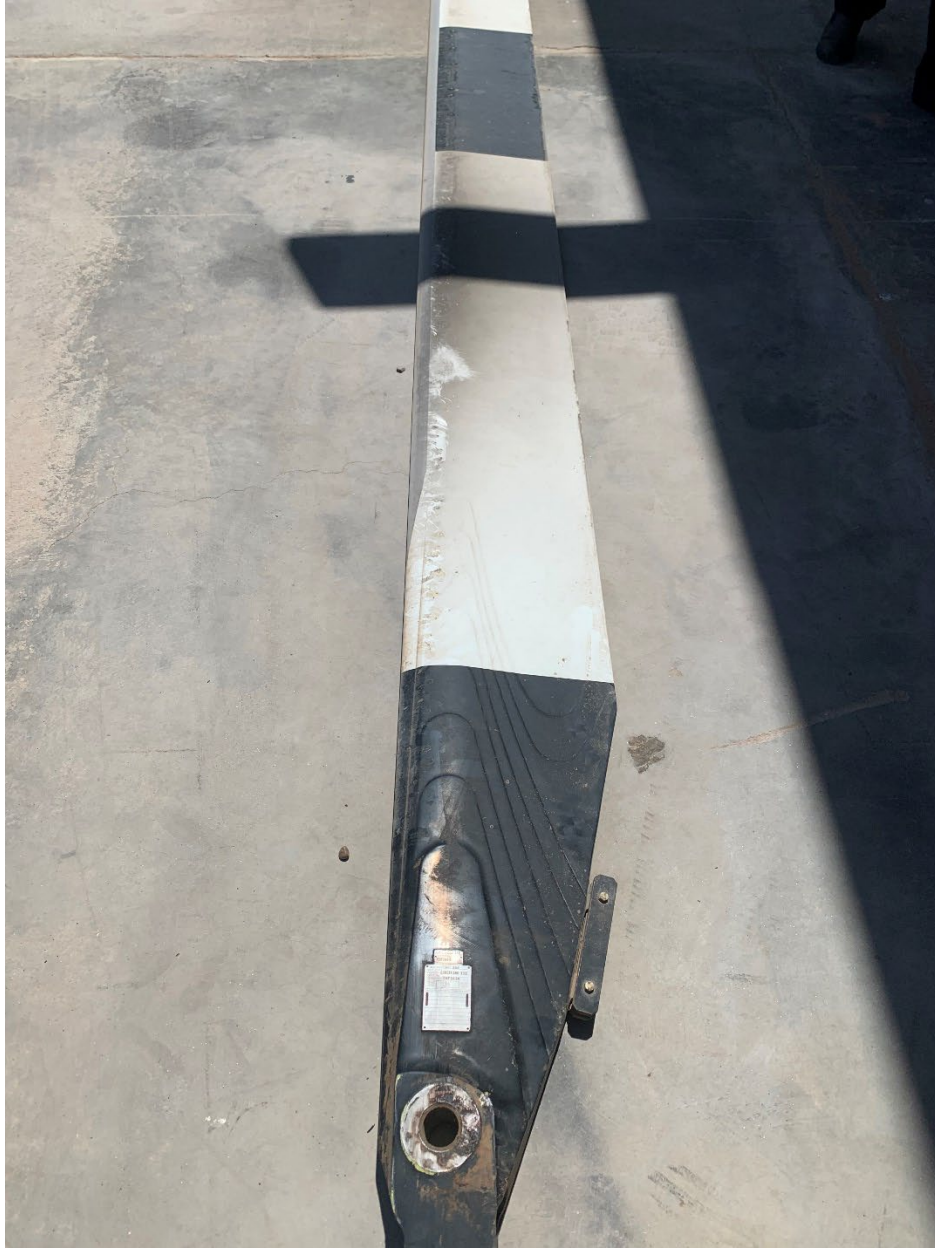
**Figure 7. Blade CSFS-999, top view.**

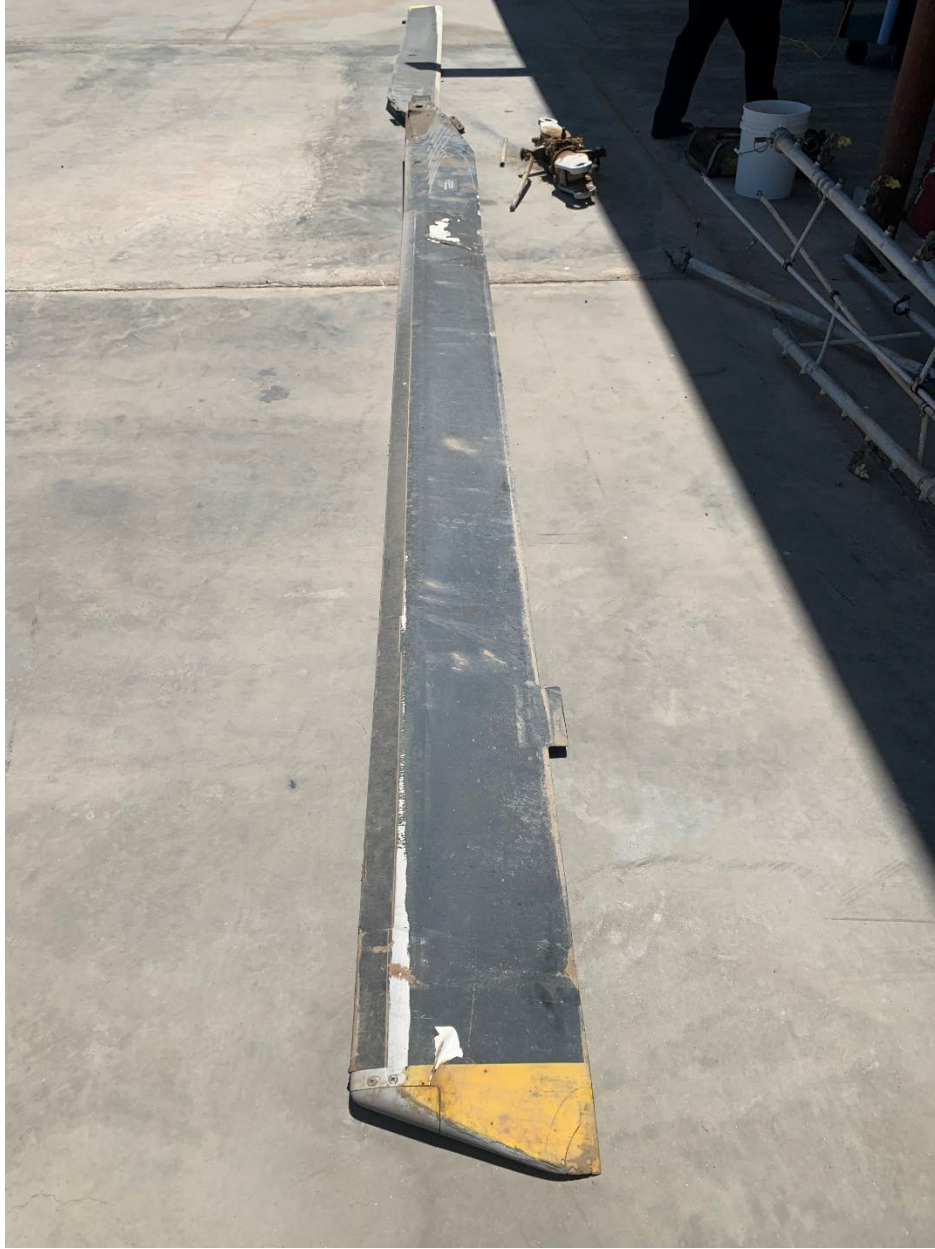
**Figure 8. Blade T-FS-451 underside view. Note the damage near the root.**

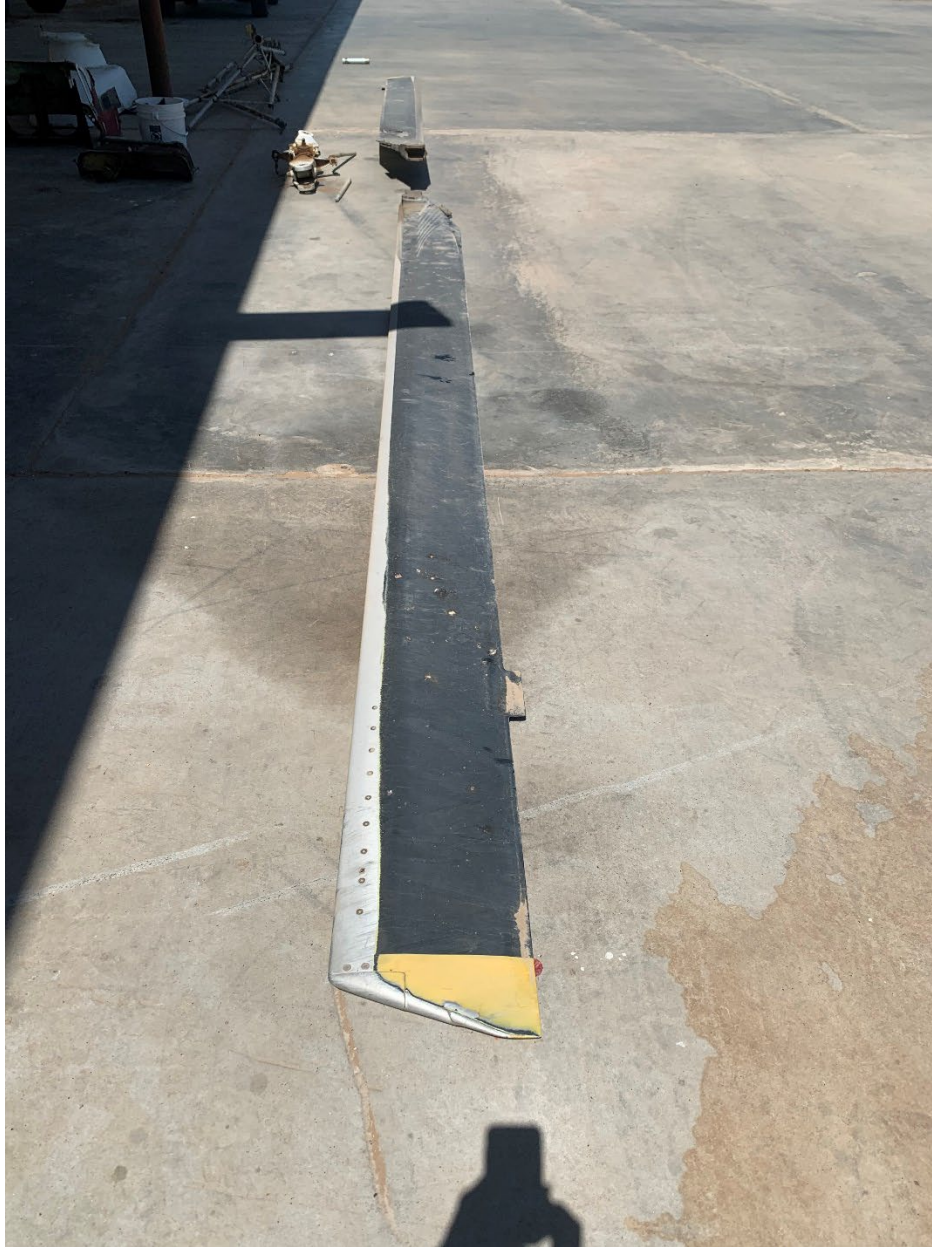
**Figure 9. Blade CSFS-999, underside view. Note the damage at the tip.**

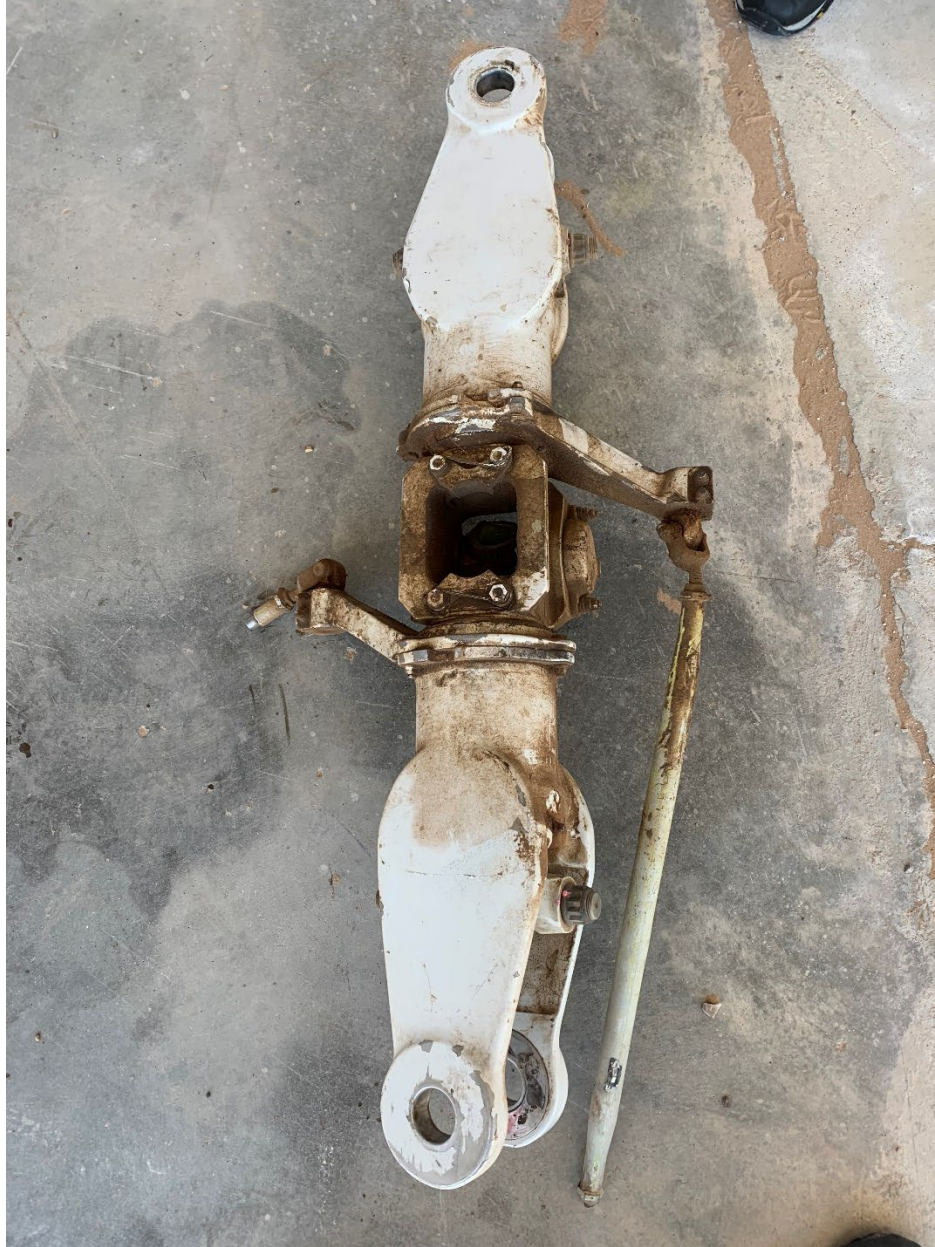
The main rotor blades and rotor hub (yoke) separated from the mast. The main rotor blades were removed from the yoke during recovery. The top of the mast exhibited a fracture and the remnant of the mast remained secured inside the yoke. The top of the mast was cut about 18 inches below the fracture and retained for further examination.

**Figure 10. Main rotor yoke assembly.**

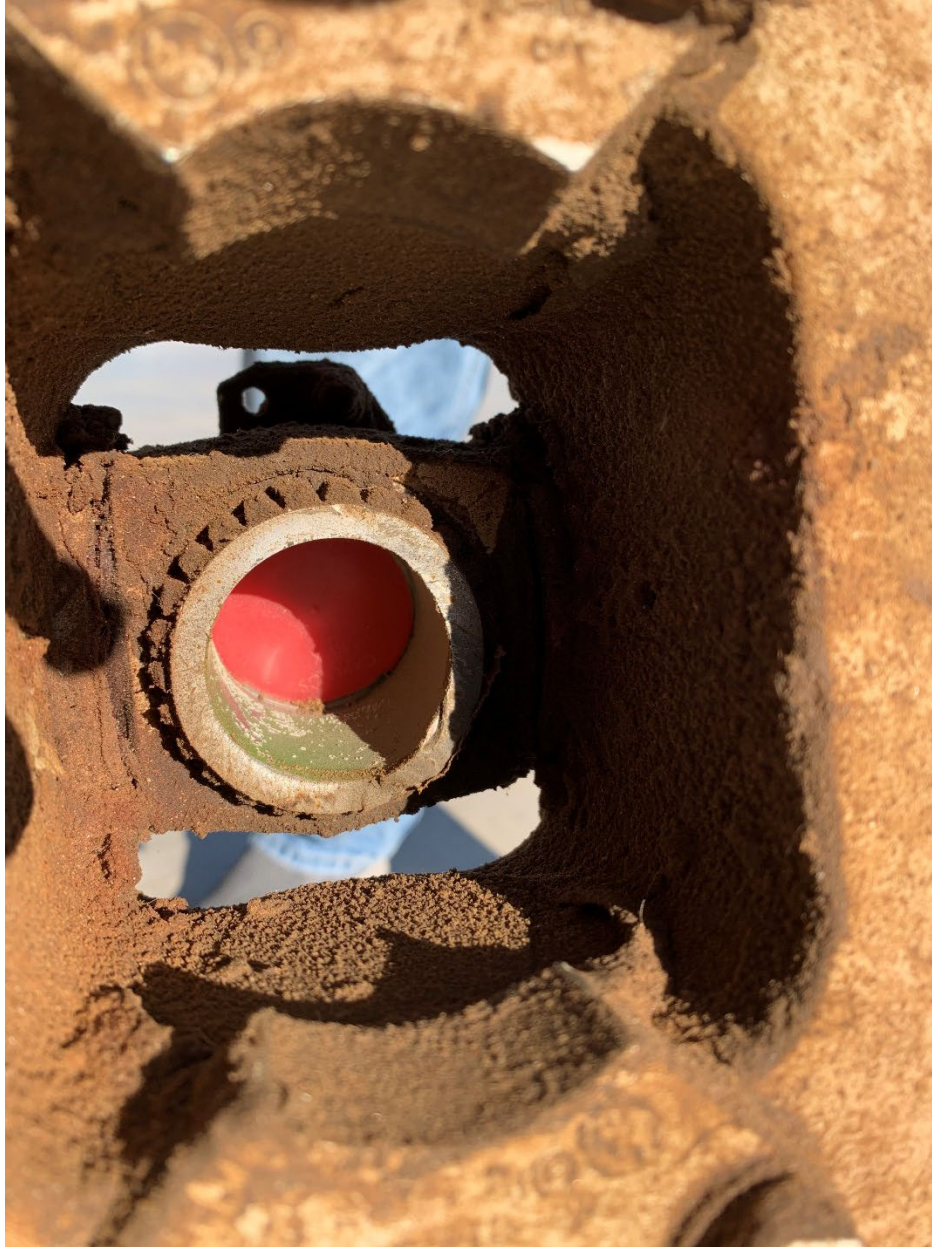
**Figure 11. Upper section of mast in yoke.**

The mast exhibited a fracture separation in an area not normally associated with a mast bumping event. The area of yoke to mast contact was not deformed and exhibited signs of normal yoke stop to mast contact. The mast was not dented inward. There was a slight deformation to the mast, near the area of separation. The stub of the mast remained inside the yoke and was secured with the retention nut.

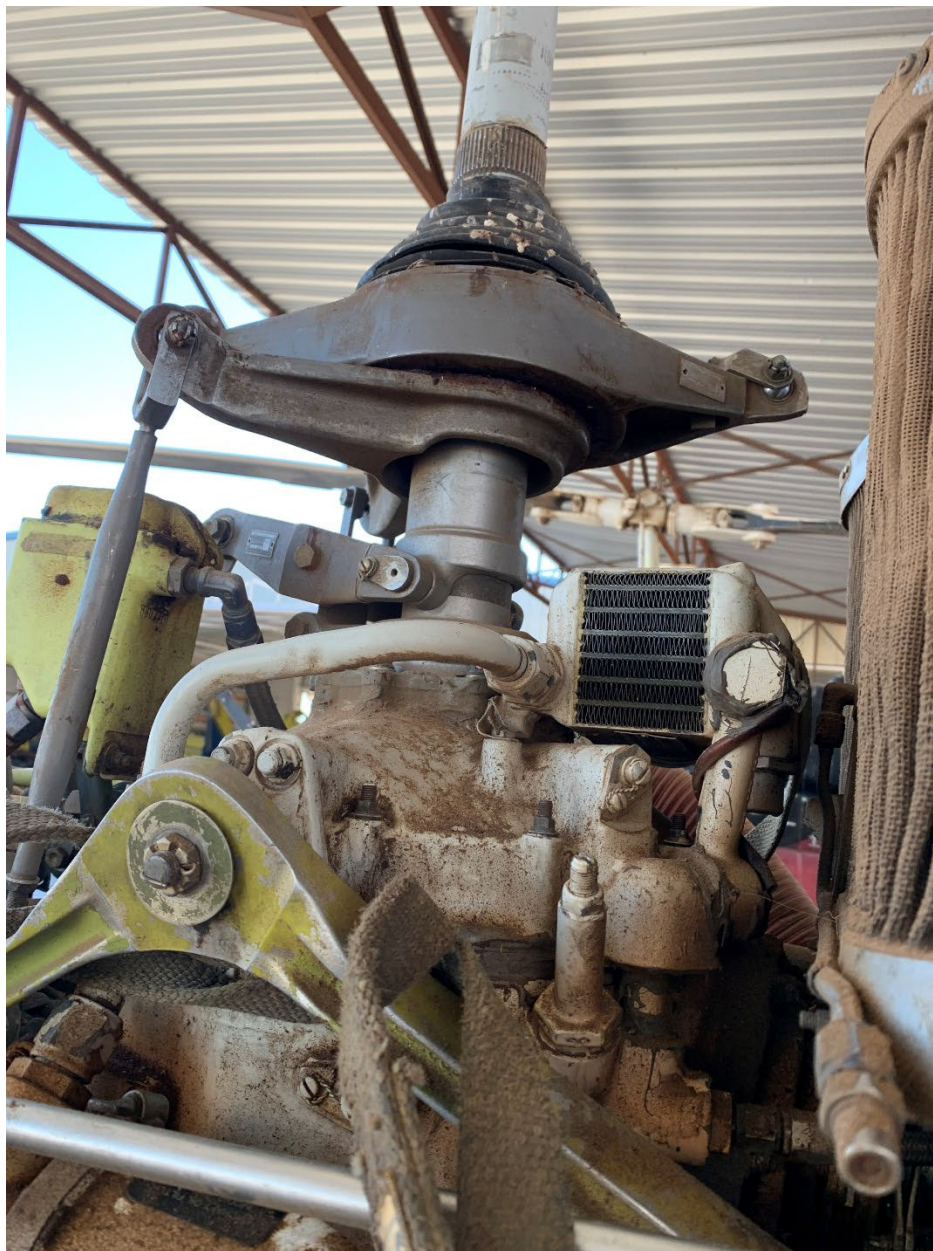
The rotating and non-rotating swashplate remained secured to the top of the transmission and exhibited normal appearance and functionality. The mixing assembly exhibited normal appearance and functionality. The hydraulics remained secured to the top of the fuselage and exhibited normal appearance. The hydraulics were not tested for pressure.

**Figure 12. Swashplate.**

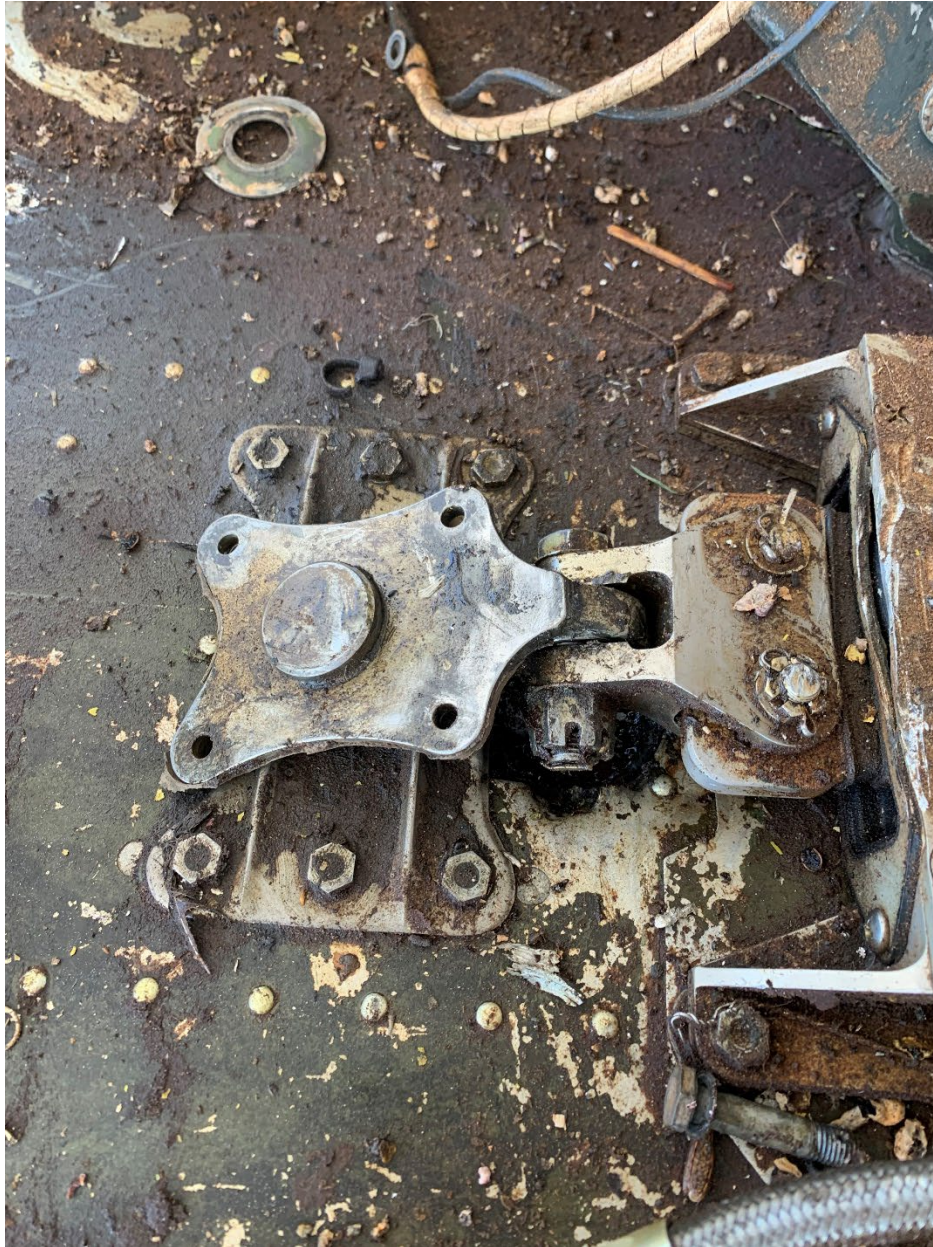
The transmission remained attached to the transmission deck by the two beams. The lower mount separated from the transmission. When visually examined, the four mounting studs exhibited fracture separations. The deck under the transmission exhibited downward denting consistent with contact from the transmission. The transmission rotated freely. The sprag clutch rotated freely in one direction and engaged when rotated in the opposite direction, consistent with normal operation.

**Figure 13. Lower transmission mount.**

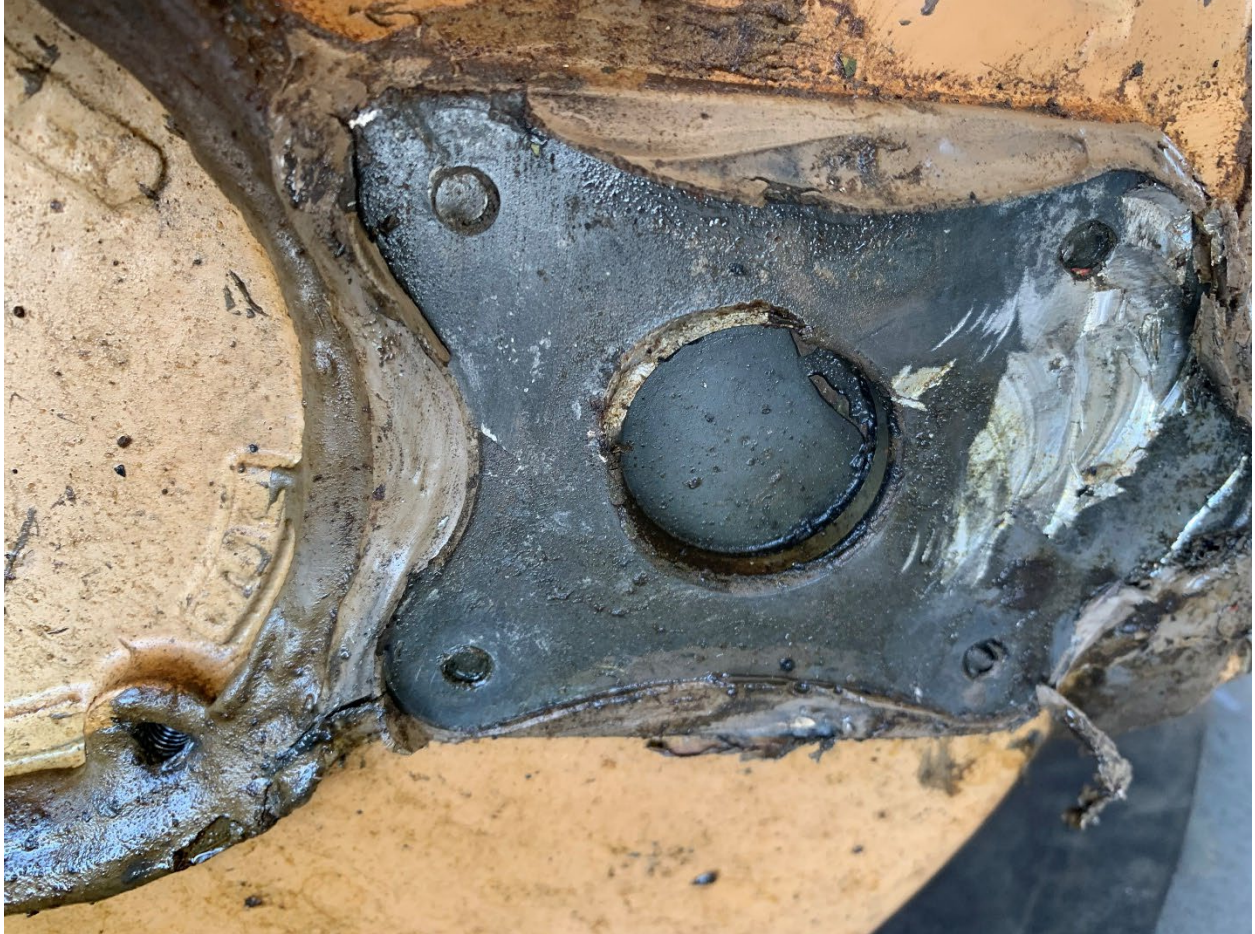
**Figure 14. Lower transmission. Note the four sheared attachment studs.**

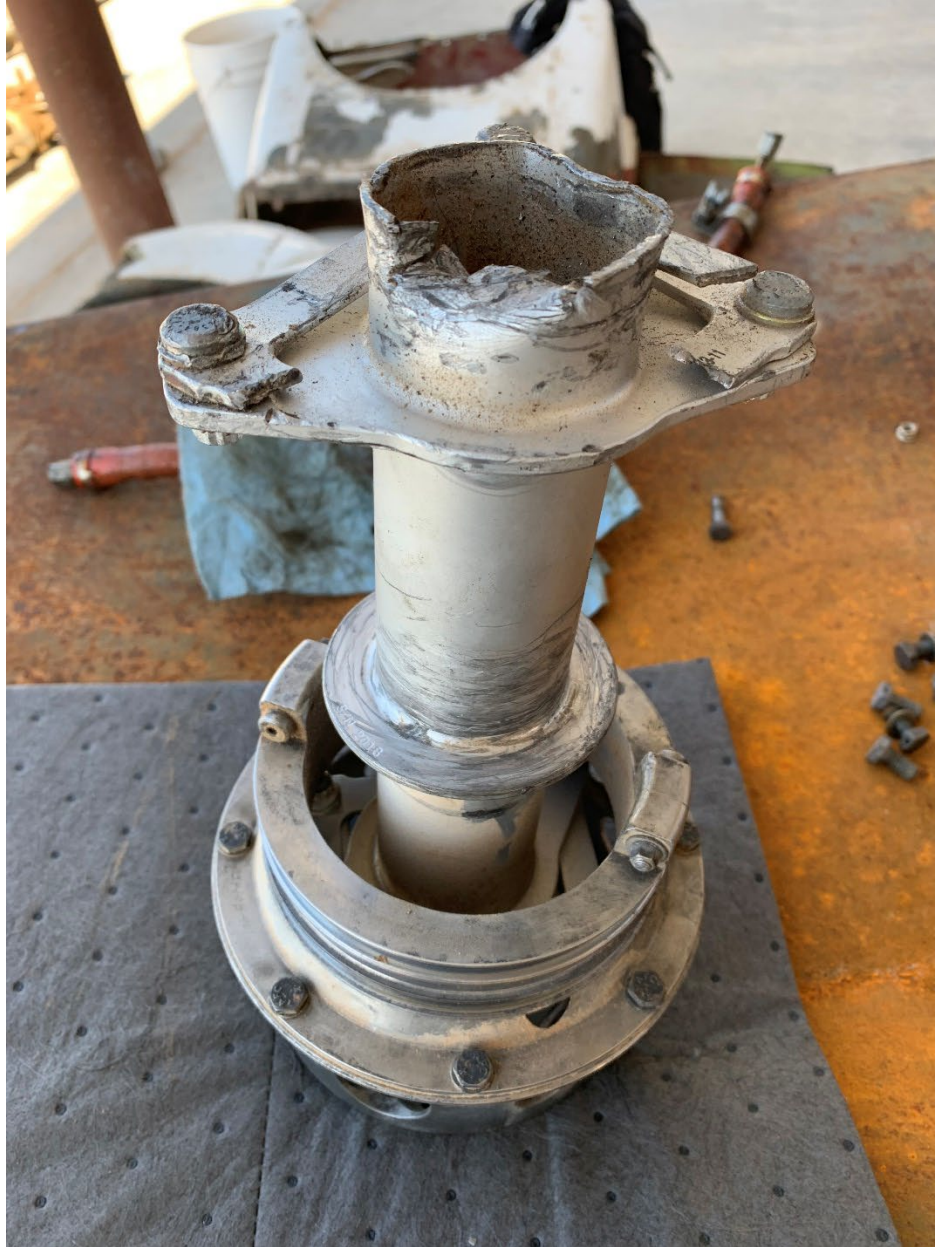
The KAflex drive shaft remained secured to the engine output quill but partially separated from the transmission input quill. Some rotational scoring was observed on the components surrounding the drive shaft.

**Figure 15. KAflex drive shaft. The damaged end attached to the transmission.**

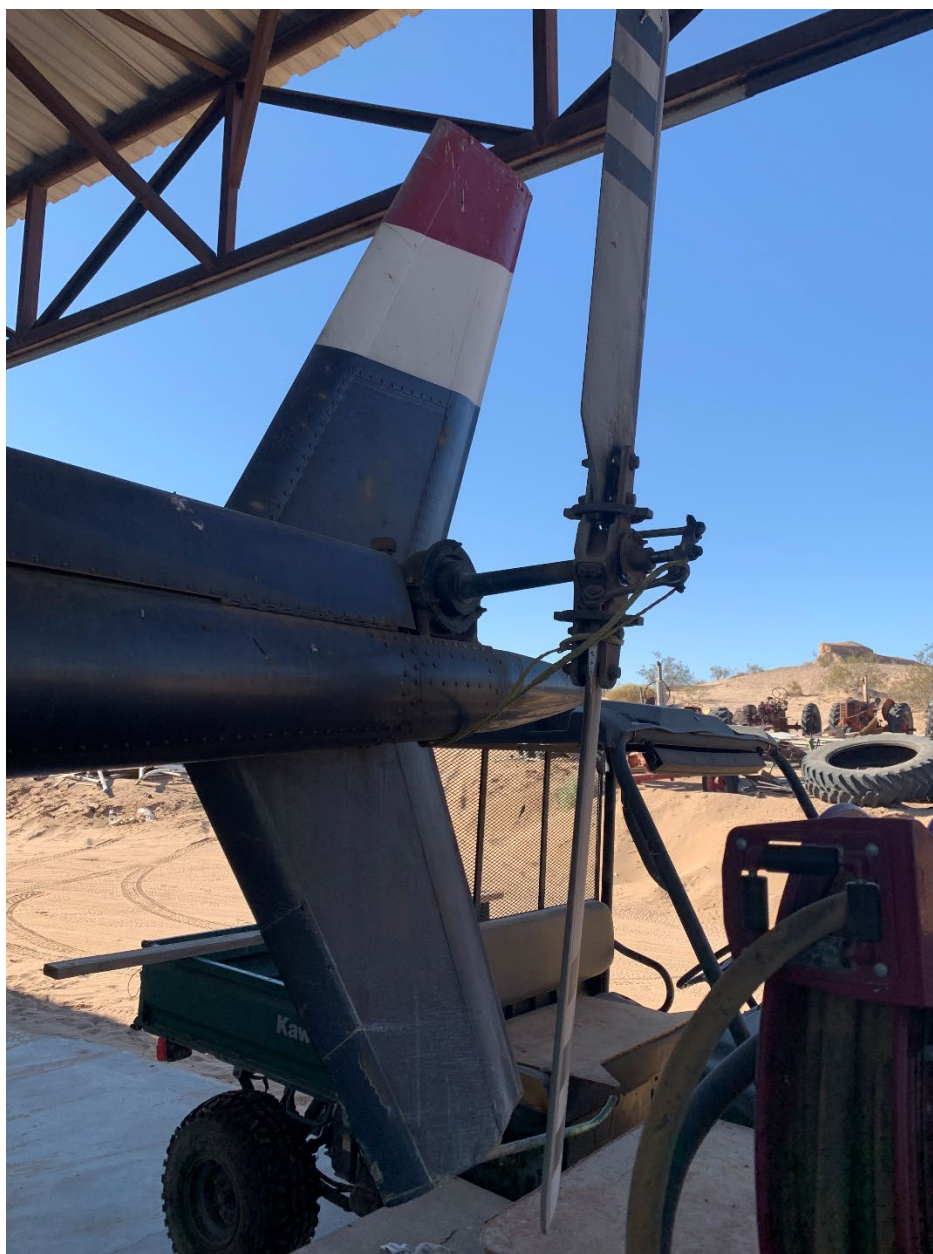
The tail rotor assembly remained attached to the 90° gear box output shaft and exhibited no damage. The tail rotor drive shaft exhibited a fracture separation about 24 inches from the 90° gearbox.

**Figure 16. Tail rotor assembly and vertical stabilizer.**

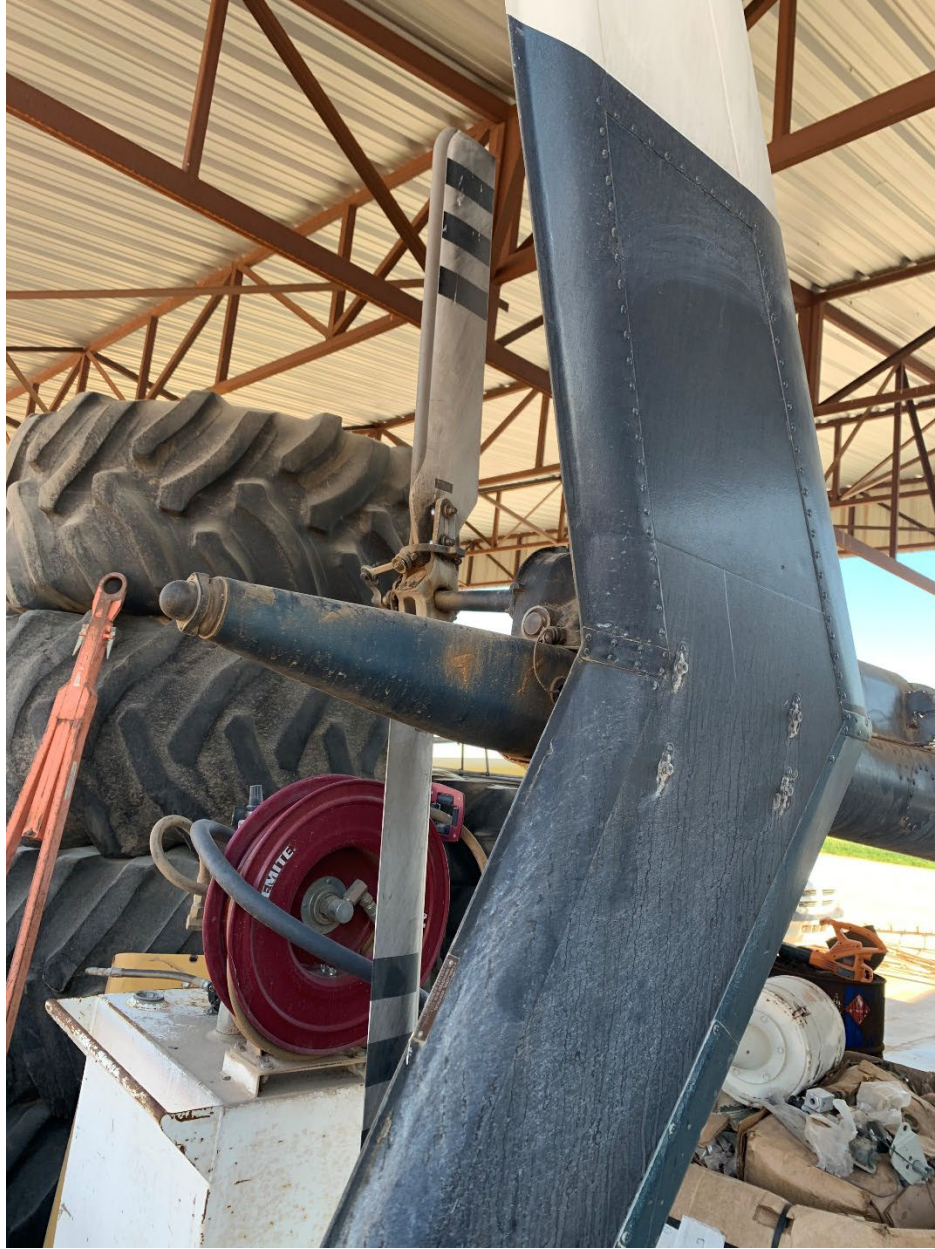
**Figure 17. Right-side tail rotor assembly and vertical stabilizer.**

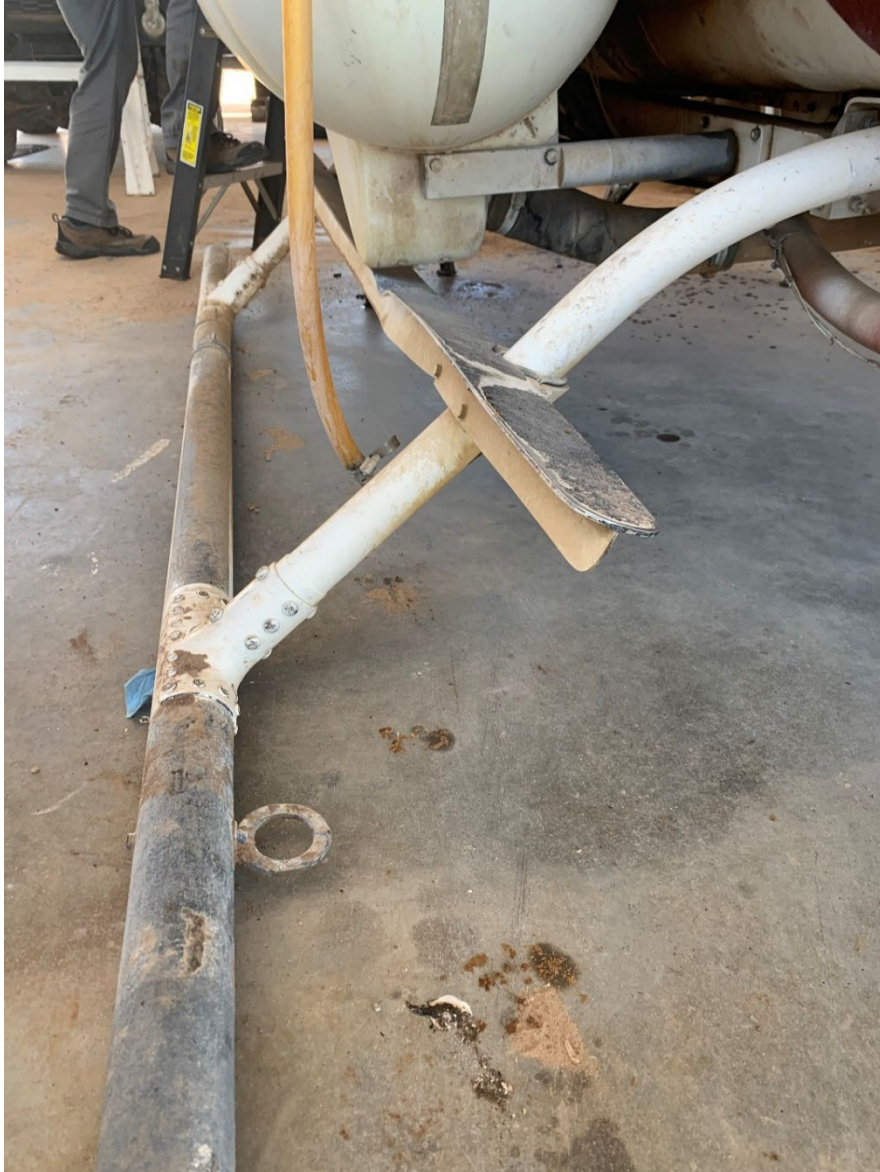
The landing gear consisted of skids and cross tubes. The right cross tube exhibited slight bending outwards that allowed the fuselage to assume a lowered appearance when viewed from the front of the helicopter. The right top step exhibited a downward bend consistent with contact from the right chemical tank.

**Figure 18. Right-side landing gear, showing downward dent to the upper step.**

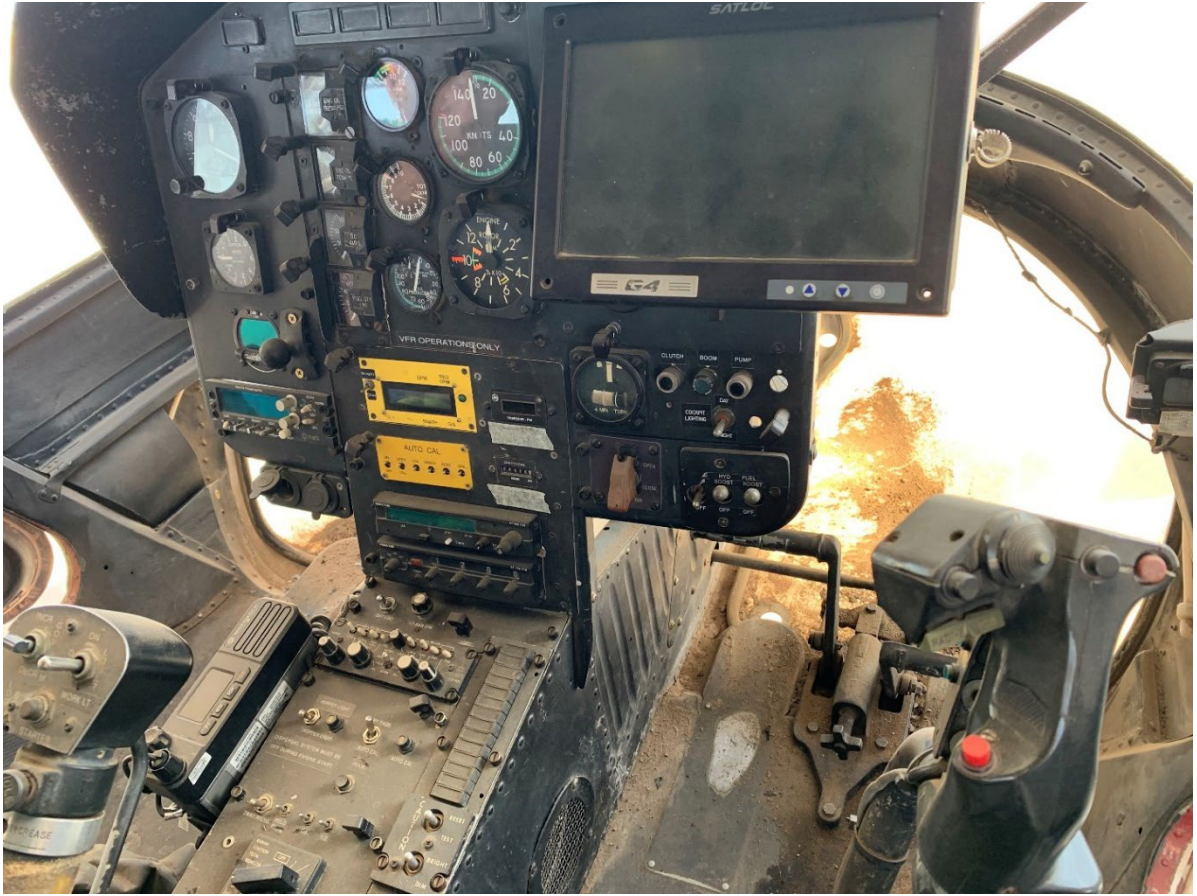
The cockpit exhibited no damage. All instruments remained secured in their mounts. When battery power was applied, all indications appeared normal. The fuel gauge registered a jump but settled down to near empty.

**Figure 19. Cockpit view of the instruments panel.**
