# National Transportation Safety Board

WPR23LA107

## **WRECKAGE EXAM**

Helicopter: OH-58C/N36FA

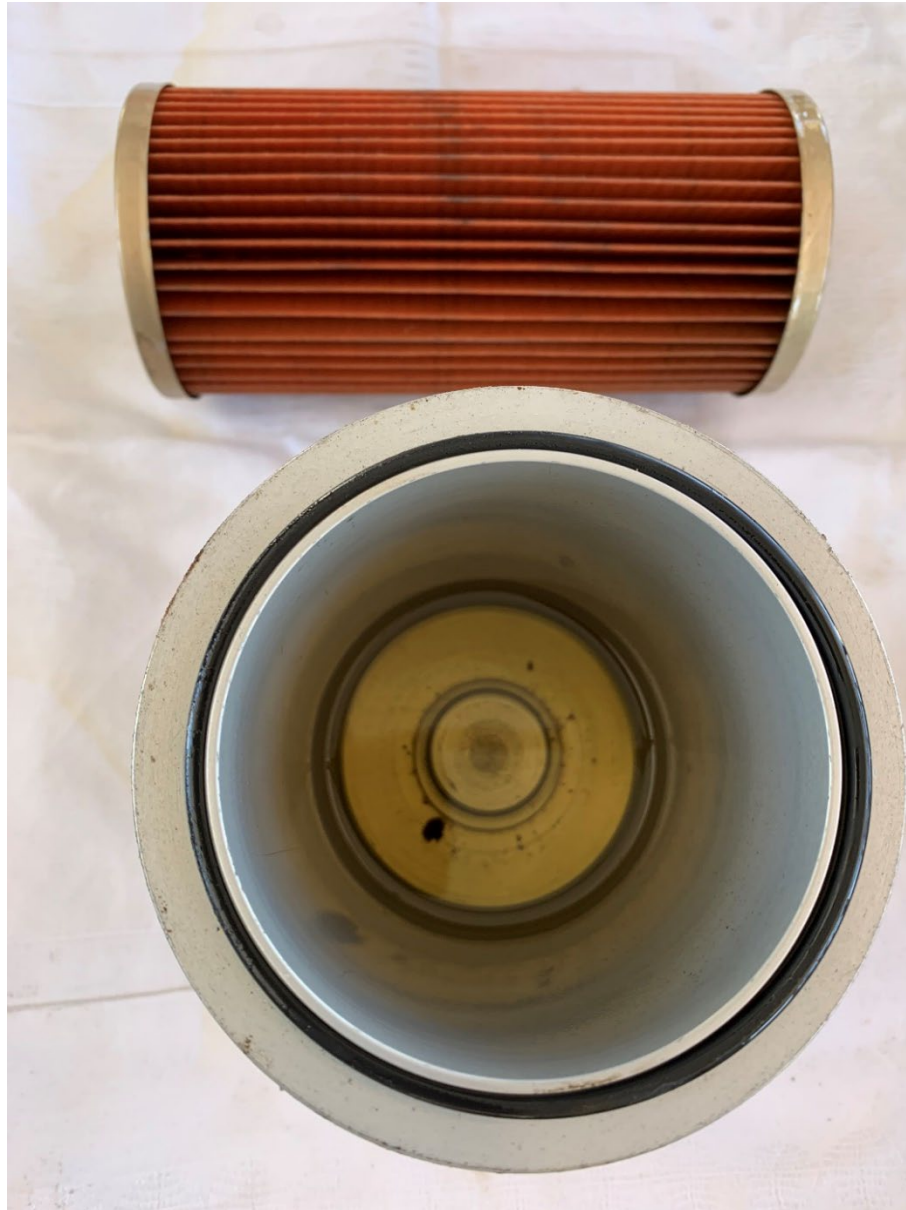
When visually inspected there appeared to be about 4 inches of fuel remaining in the tank. When power was applied and the fuel boost pump was switched to the ON position, the amber fuel pump light on the caution panel illuminated. No sound of the boost pump was heard, and fuel did not flow from the fuel line to the fuel filter. The fuel filter was located on the engine deck and when opened, exhibited clean amber colored fluid consistent with jet fuel. The filter element exhibited a clean appearance with no contaminants visible.

**Figure 20. Residual fuel in deck-mounted fuel filter and filter element.**

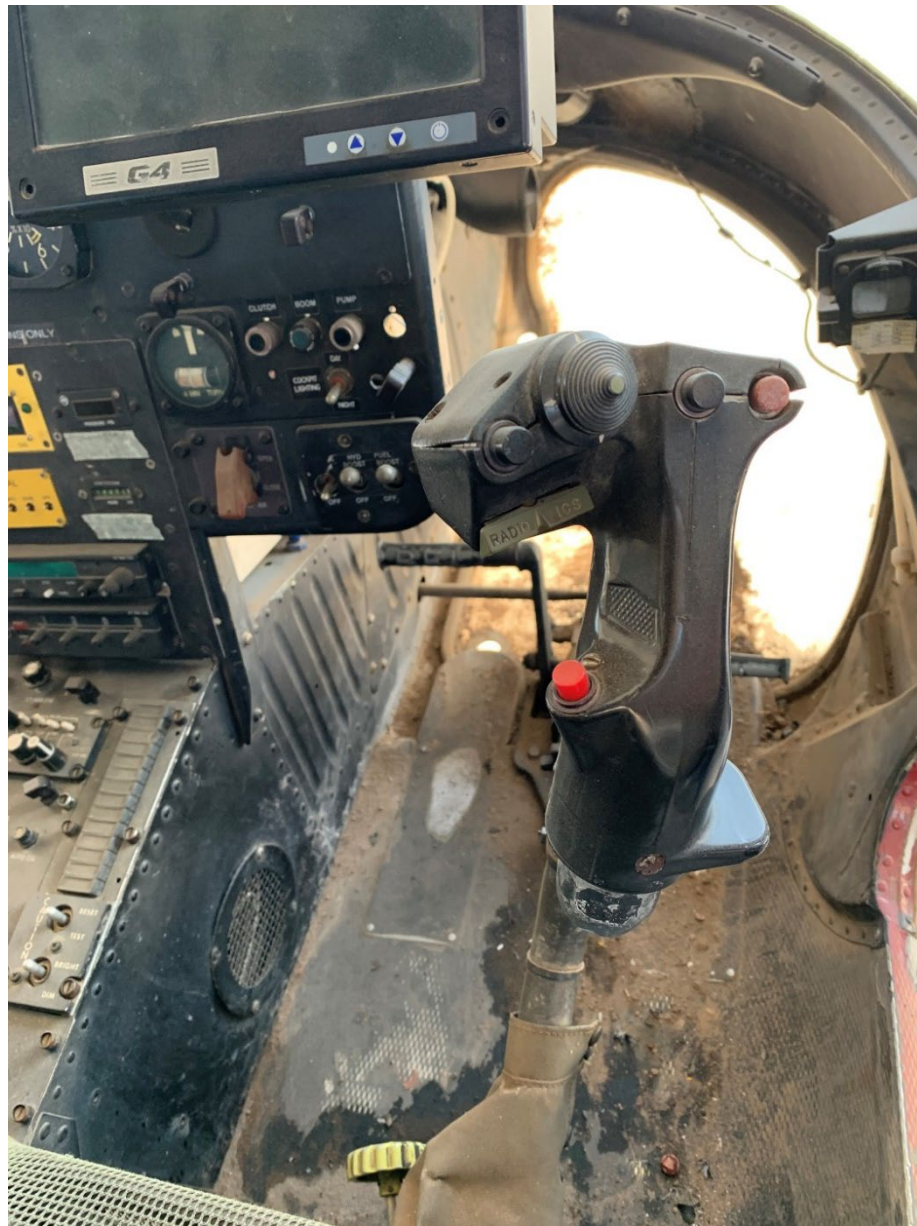
Fight control continuity was established from the cyclic and collective control to the hydraulic servos and from the hydraulic servos to the non-rotating swashplate.

Flight control continuity was established from the anti-torque pedals to the tail rotor pitch control rods.

**Figure 21. Cyclic control and anti-torque pedals.**

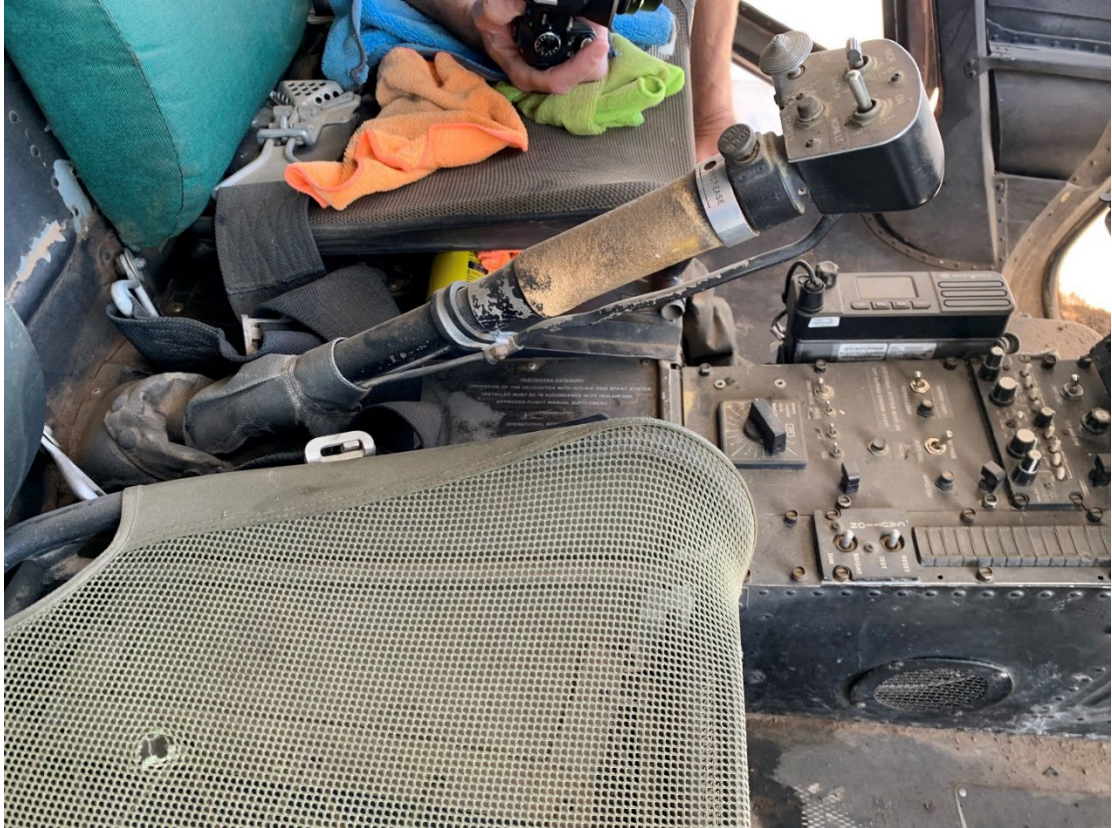
Continuity was established from the throttle twist grip to the fuel control, and from the collective to the fuel governor.

**Figure 22. Collective control.**
