# National Transportation Safety Board

WPR23LA107

## ENGINE EXAM

Location: Yuma, AZ  
Date: February 06, 2023  
Time: 21:35 local  
0435 UTC  
Helicopter: Bell OH-58A Engine 250-C20B

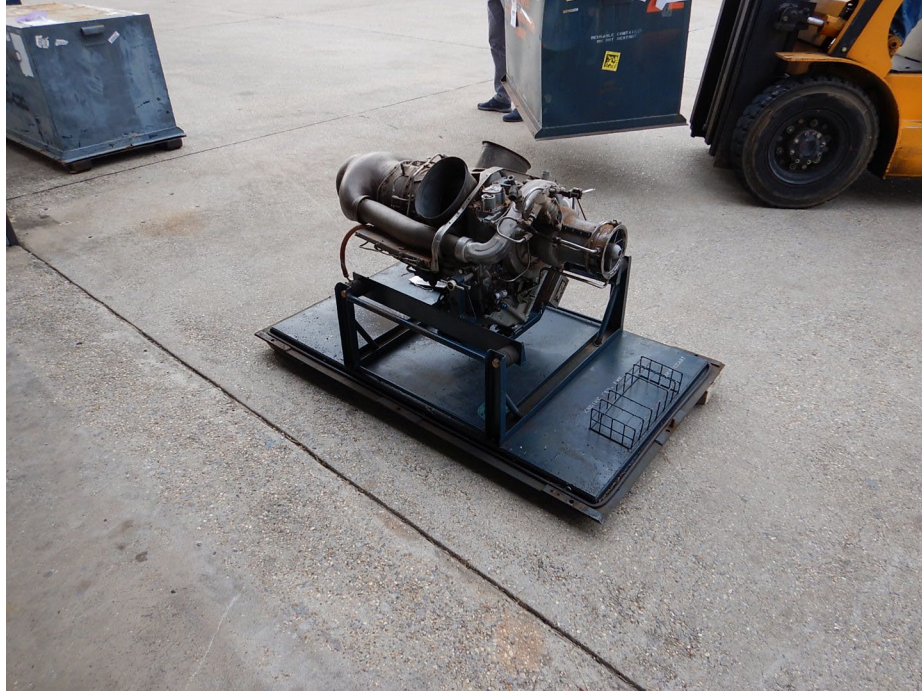
*Figure 1. Uncrating engine box*

- Engine was removed from the crate box which did have shipping damage confirmed by Rolls-Royce as pre-existing. A visual exam revealed the engine was unremarkable with no damage to the inlet, case, or gearbox. The left exhaust stack had minor impact damage from helicopter accident. All accessories and all corresponding lines remained intact and unremarkable. The fuel nozzle and igniter were found loose removed and found unremarkable. RR had mistakenly began prepping the engine.

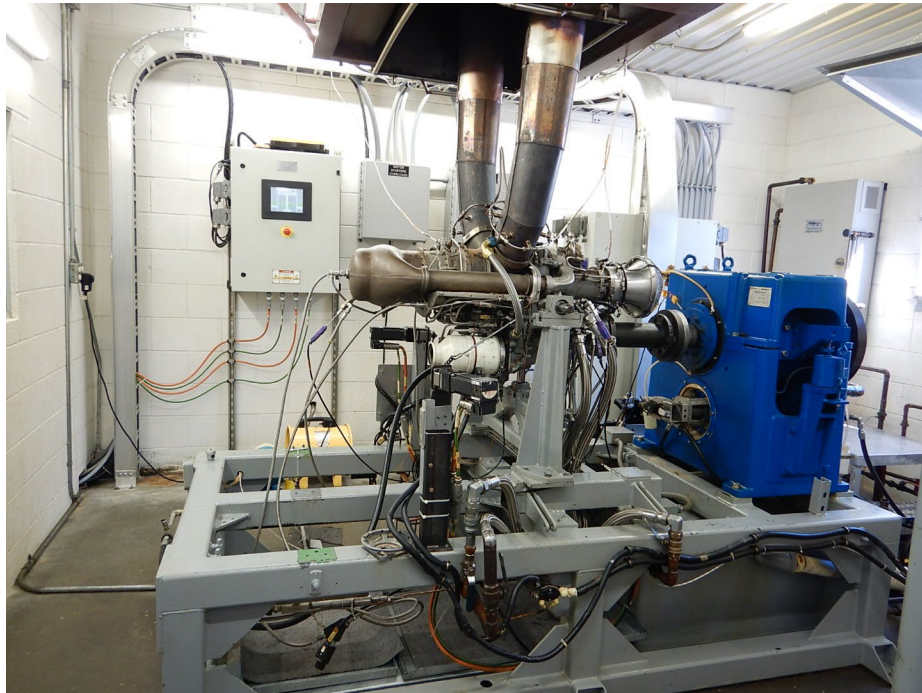
*Figure 2. View of right side of engine in test cell.*

Test run revealed no anomalies or mechanical malfunctions during various power settings in accordance to Rolls Royce manufacturer standards.
