## **Engine Investigation Report**

**Model: T63-A-720**

**Serial: AE-405882**

**Accident Date: 6 February 2023  
Wreckage Exam Date: 13 June 2023  
Engine Exam Date: 28 November 2023  
Report Date: 2 January 2024  
NTSB Case: WPR23LA107**

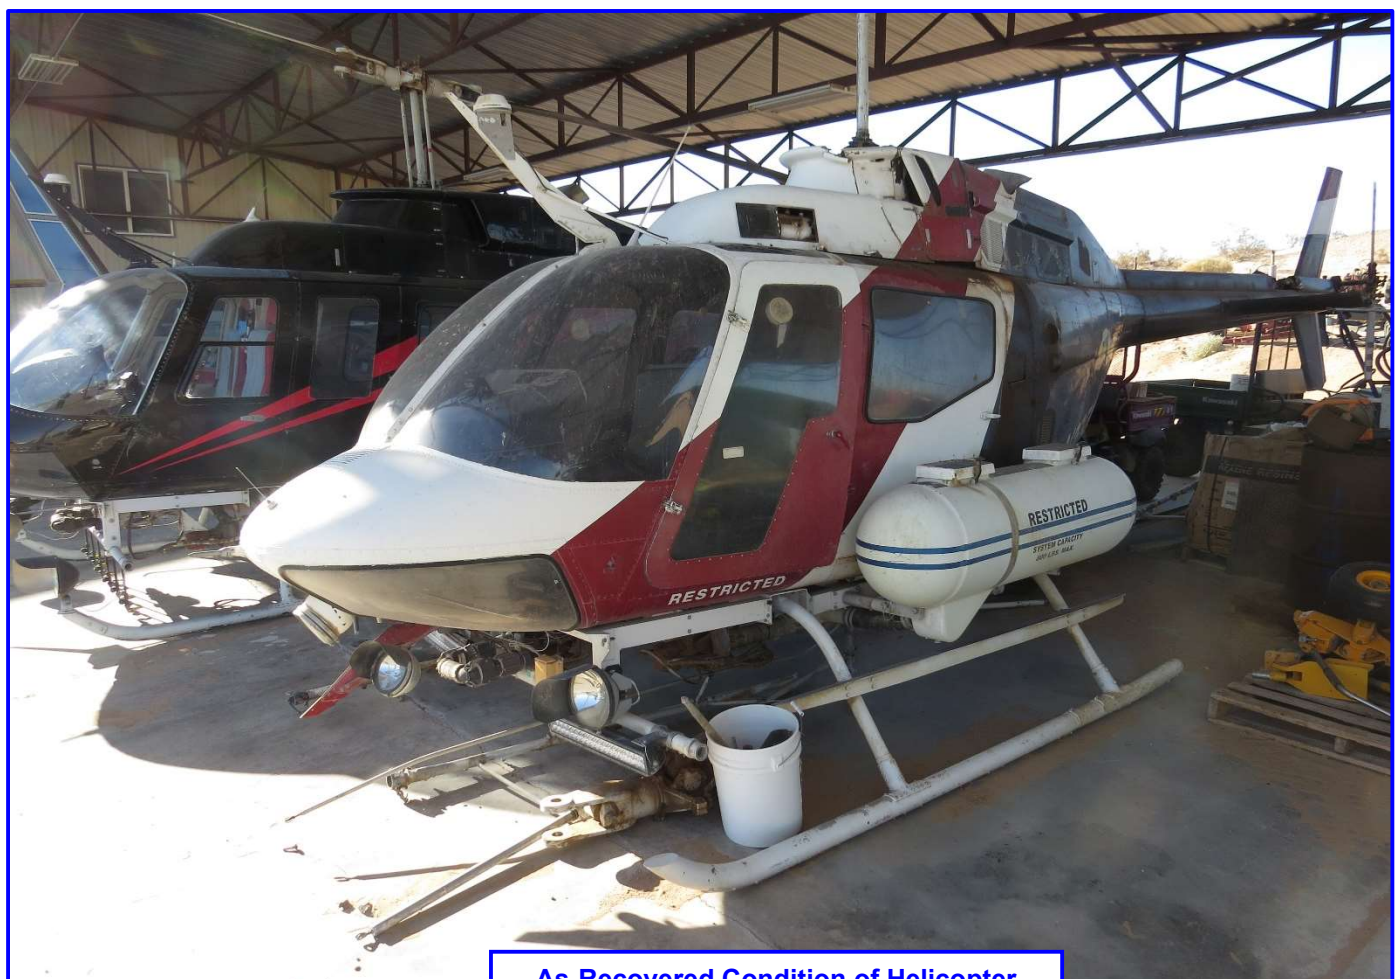
**As-Recovered Condition of Helicopter**

The aircraft sustained damage consistent with vertical impact resulting in a spread of the landing gear skids and bowing of the cross tubes. The aircraft was leaning more heavily to the right indicative of a harder impact on the right-hand skid. The steel tail rotor drive shaft section remained securely attached to the engine gearbox and associated flange connection at the rear vertical firewall in the engine compartment.

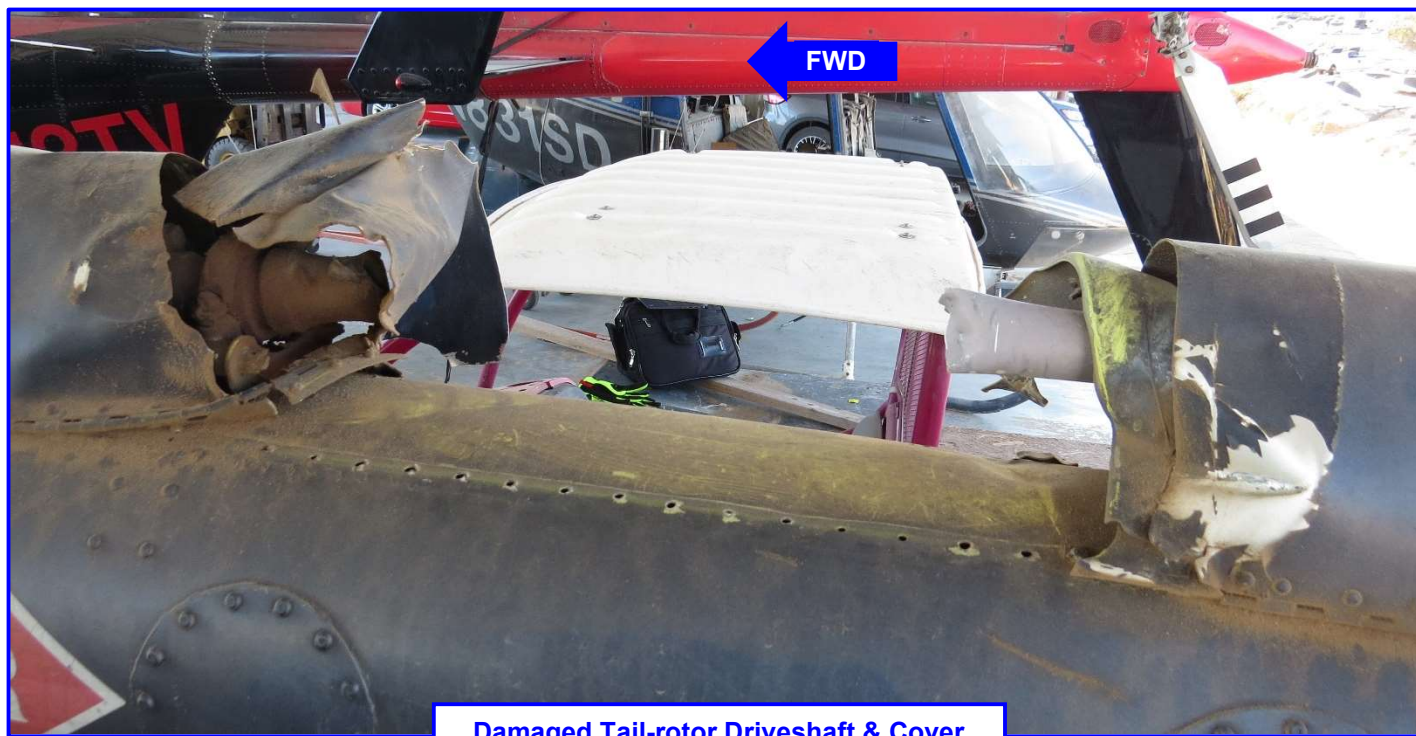
**Damaged Tail-rotor Driveshaft & Cover**

The KAflex™ driveshaft was fractured in the strap links at the main rotor transmission connection. The shaft remained securely attached within the cage at the freewheeling unit connection on the engine gearbox. Significant rotational scoring was noted in the middle of the shaft as well as on the isolator mount below the front-end connection.

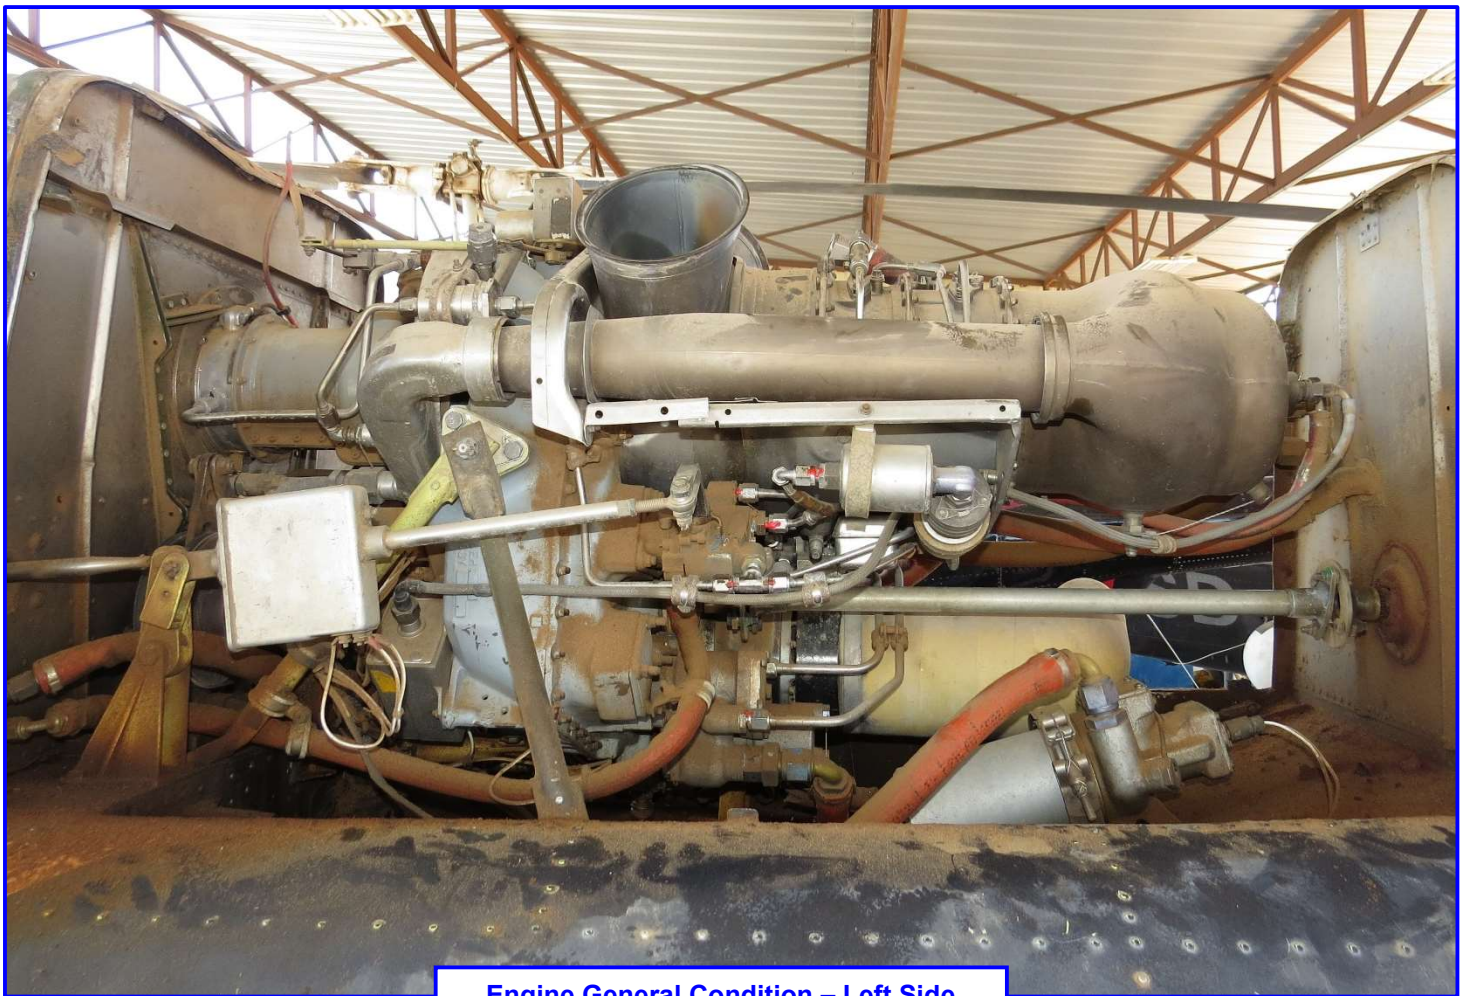
**Engine General Condition – Left Side**

The engine remained within the engine compartment. All three mount struts were secure with no sign of bending, fracture, or lateral displacement. Much of the external of the engine was coated with a sand/dirt appearance that may be the result of not being adequately protected during storage awaiting the wreckage examination. The engine exterior did not reveal any obvious signs of damage from impact forces, internal engine failure, or evidence of fire.

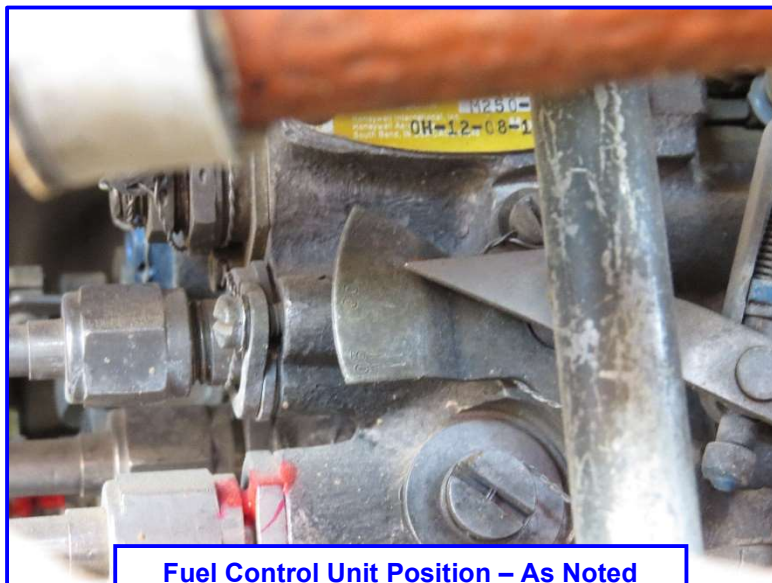
**Fuel Control Unit Position – As Noted**

The FCU demonstrated continuity from the cockpit collective control with no influence from aircraft damage. The FCU input lever was capable of full stop-to-stop travel once disconnected from the input linkage and following engine removal. The pointer indicator on the FCU was initially documented at the approximate 60-70% location. However, it is unclear if the throttle had been moved from its position at the time of the accident & prior to the wreckage examination.

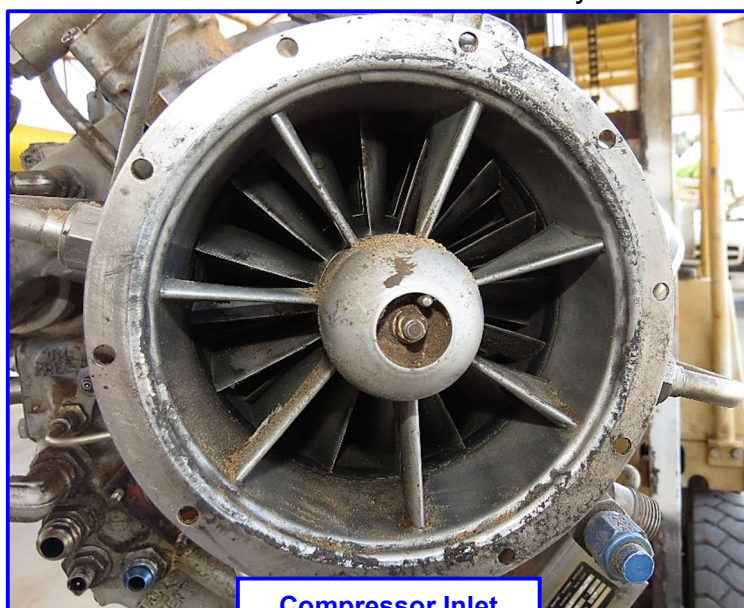
**Compressor Inlet**

The compressor front support and guide vanes (struts) were noticeably dirty with sand & dirt deposits likely from the atmospheric conditions exposed to during storage. The guide vane struts & visible compressor blades/vanes were void of any visually noticeable evidence of foreign object damage or high metal conditions.

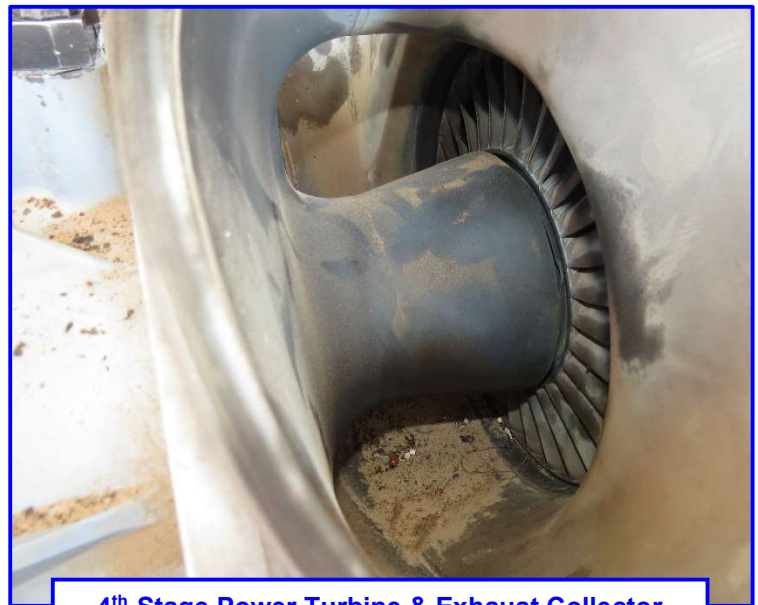
**4<sup>th</sup>-Stage Power Turbine & Exhaust Collector**

The 4th-stage turbine blades appeared undamaged and void of thermal distress as did the surrounding turbine sections and exhaust plenum.

The exhaust collector support “tunnel” displayed an extensive amount of deposited sand and other random debris.

There was no evidence of oil wetting on the tunnel adjacent to or on the 4th-stage turbine wheel. Random amounts of surface rust or equivalent appearance was noticed on the internal surfaces of the support. Both exhaust stacks were noticeably damaged however, the exhaust collector support & exhaust mounting flanges were unremarkable.

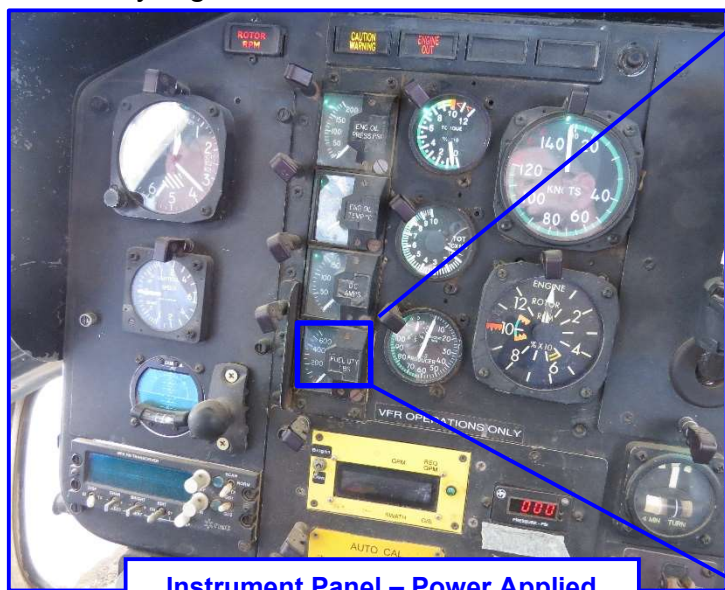
**Instrument Panel – Power Applied**

Battery power was applied to the aircraft to check the cockpit annunciation/warning panel. Upon power application, the aural warning horn was noticeably audible, and the following warning lights illuminated: ROTOR RPM, ENG OUT, FUEL BOOST, & DC GENERATOR. All warning lights illuminated when depressing the test button.

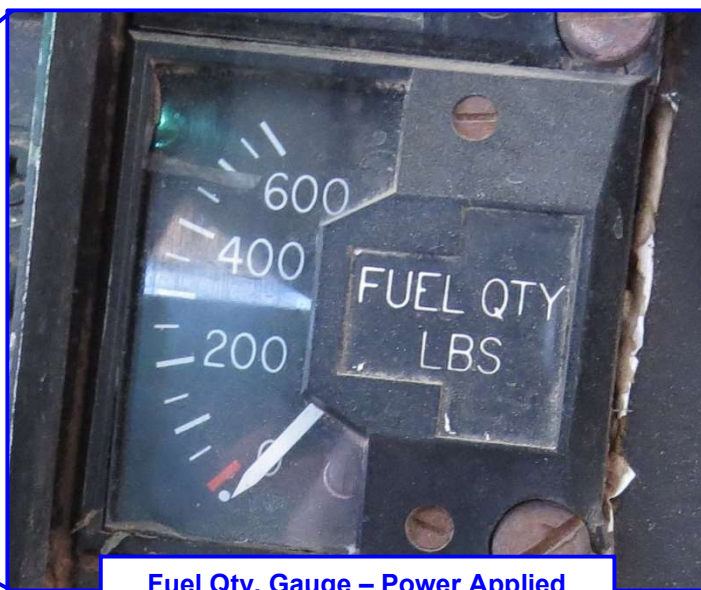
**Fuel Qty. Gauge – Power Applied**

The fuel quantity gauge “flickered” to just above the empty mark upon initial power application but ultimately registered zero fuel on board.

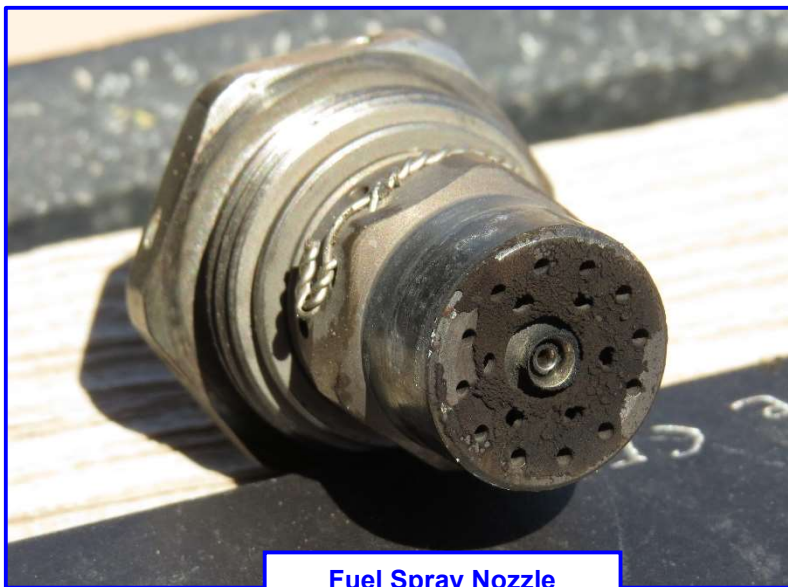
**Fuel Spray Nozzle**

The fuel spray nozzle was removed & inspected. The spray face (tip) contained uniform light layer of black soot. None of the air distribution holes appeared blocked & the nozzle was visually unremarkable. The nozzle was not further disassembled.

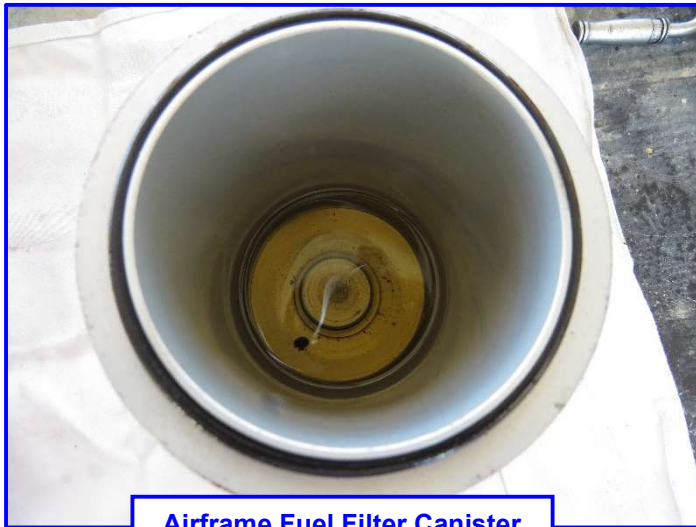
**Airframe Fuel Filter Canister**

The airframe fuel filter canister was removed for examination. The assembly was not equipped with a bypass indicator. The canister was full of clean, clear fuel. Fuel was drained from the canister revealing only minor elements of residual debris in the bottom. The internal fuel filter was clean and void of any captured debris within the pleats.

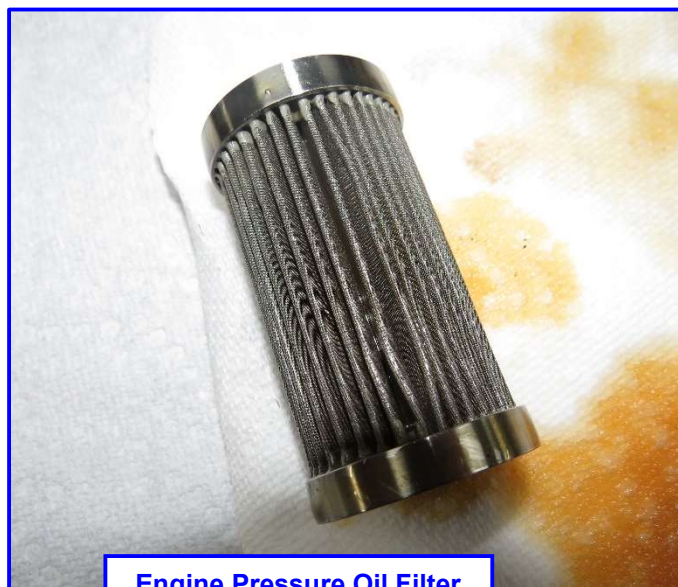
Engine Pressure Oil Filter

The pressure oil filter appeared clean & clear with no discernible metallic debris within the pleats. The filter bowl housing in the gearbox was oil wetted and free of any notable findings after the engine was rotated to its upright position.

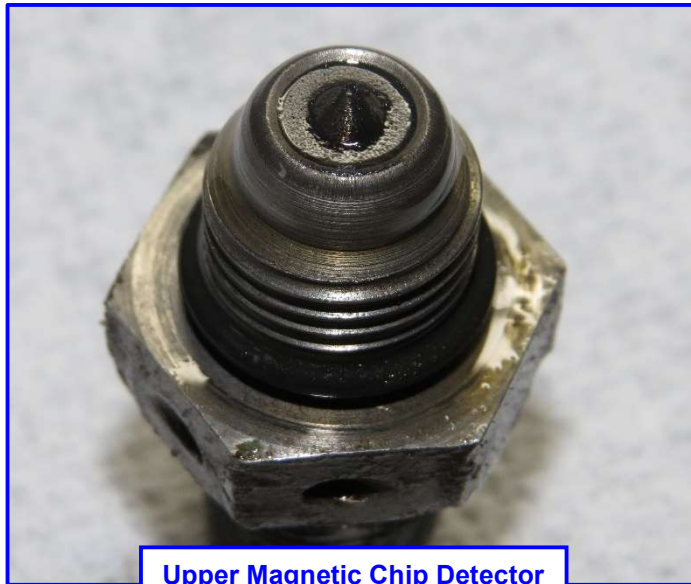
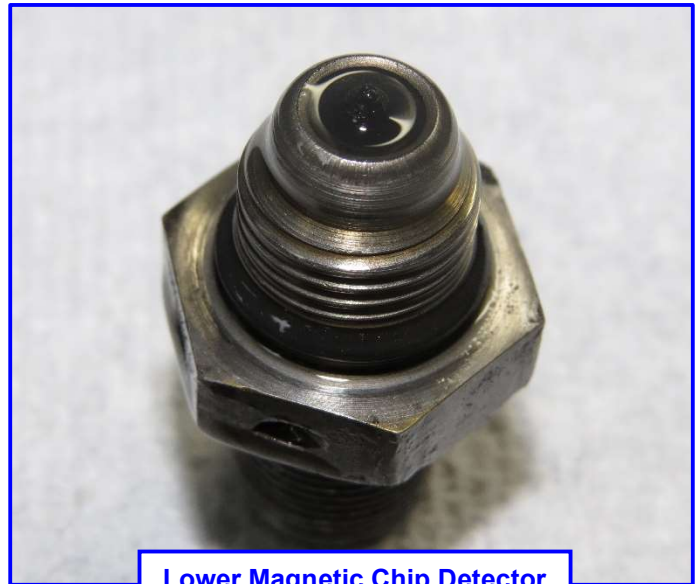
Both the upper and lower Magnetic Chip Detectors (MCDs) were removed and examined. No evidence of flakes or related metallic debris was noted on either MCD.

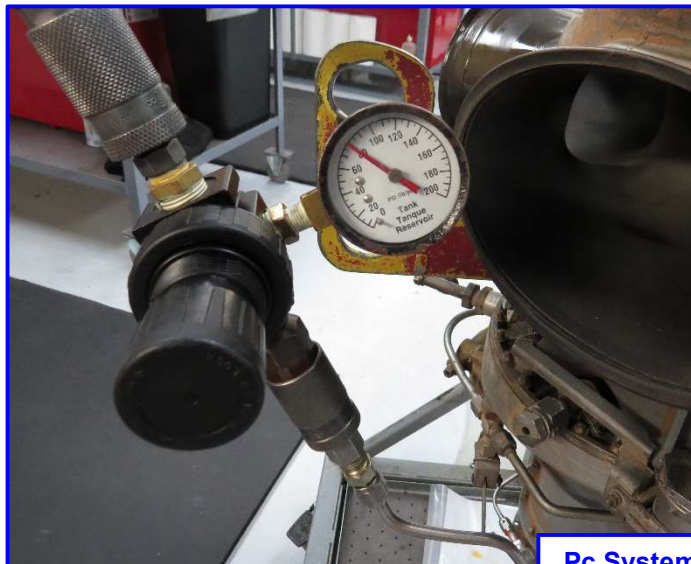
Pc System Leak Check

A check of the Pc system was conducted using shop air at the inlet side of the Pc air filter at 80 psi. A soapy water solution was applied to the Pc system B-nuts and rigid tubing. Pressure was then decreased to 20 psi to check for leakage at the governor diaphragm. Minor bubbling was detected at three locations on the fuel control unit however, as the engine test would show, those leaks were not a fuel limiting condition since the engine would later demonstrate being temperature limited during test.

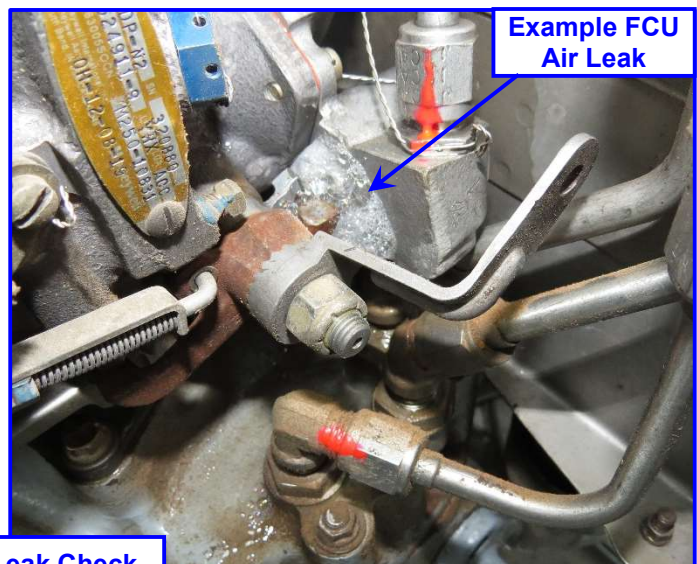
Example FCU  
Air Leak

- The Pc system contained minor air leaks at 3 points on the fuel control unit. These leaks were not “corrected” prior to engine test but were not a fuel limiting factor during test.

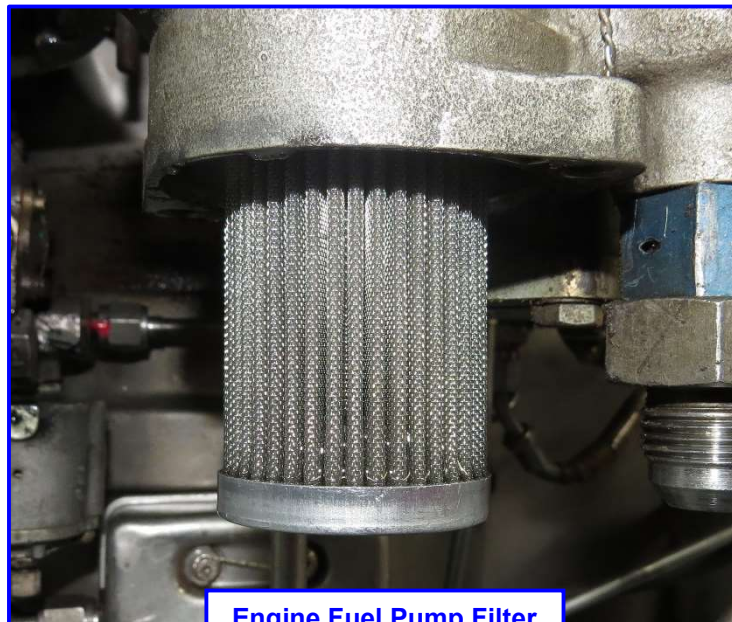
**Engine Fuel Pump Filter**

The engine fuel pump filter bowl & filter were removed and inspected. The filter bowl was full of clean, clear, odor free fuel and the filter was clean & free of debris within the pleats.

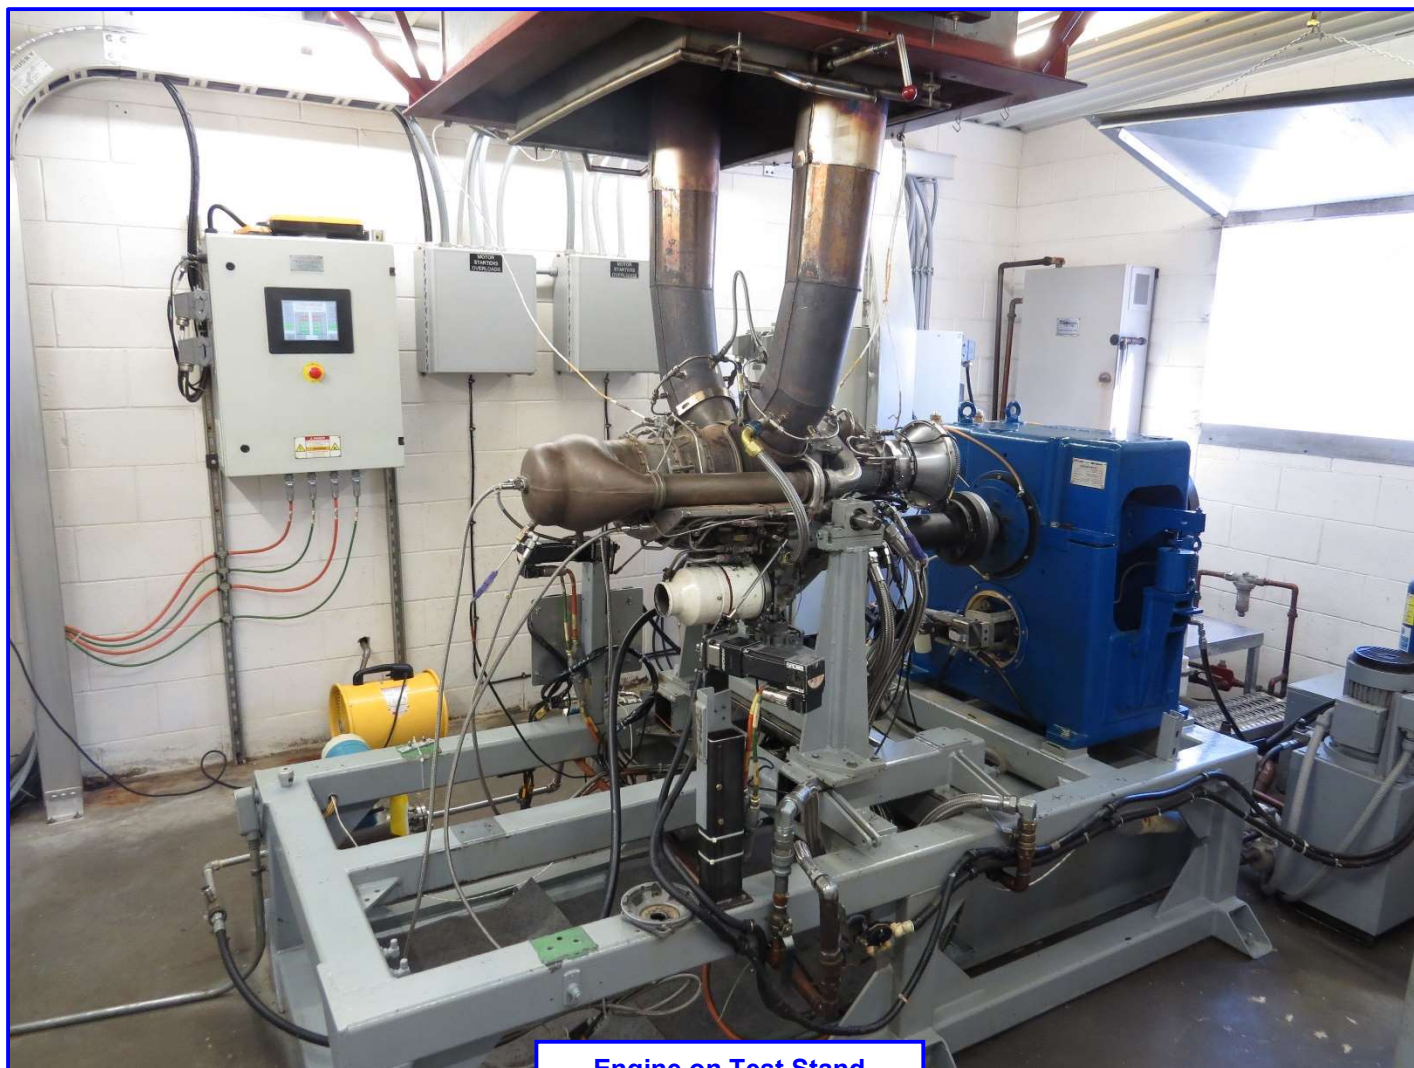
**Engine on Test Stand**

The engine successfully started, ran & shut down. When corrected for standard atmospheric conditions, the engine yielded performance -14.3% below new-production standards at “low cruise” (300 horsepower), -11.9% below new production standards at normal cruise (370 horsepower), and -2.6% below new production standards at maximum (Take-Off) power (420 horsepower) achieving a maximum predicted 409 SHP at the specification 1490°F MGT (measured gas temperature). The performance data was reflective of the engine hitting the max allowable MGT limit at each of the 5 calibration points before achieving the specified horsepower value.

The engine’s test performance was likely indicative of the noted dirty compressor condition. Additionally, a slight leak was noted during the run at the anti-ice valve that was hard-wired in the closed position by the operator. The burner drain valve on the outer combustion case was also noted as having an air leak during test.
