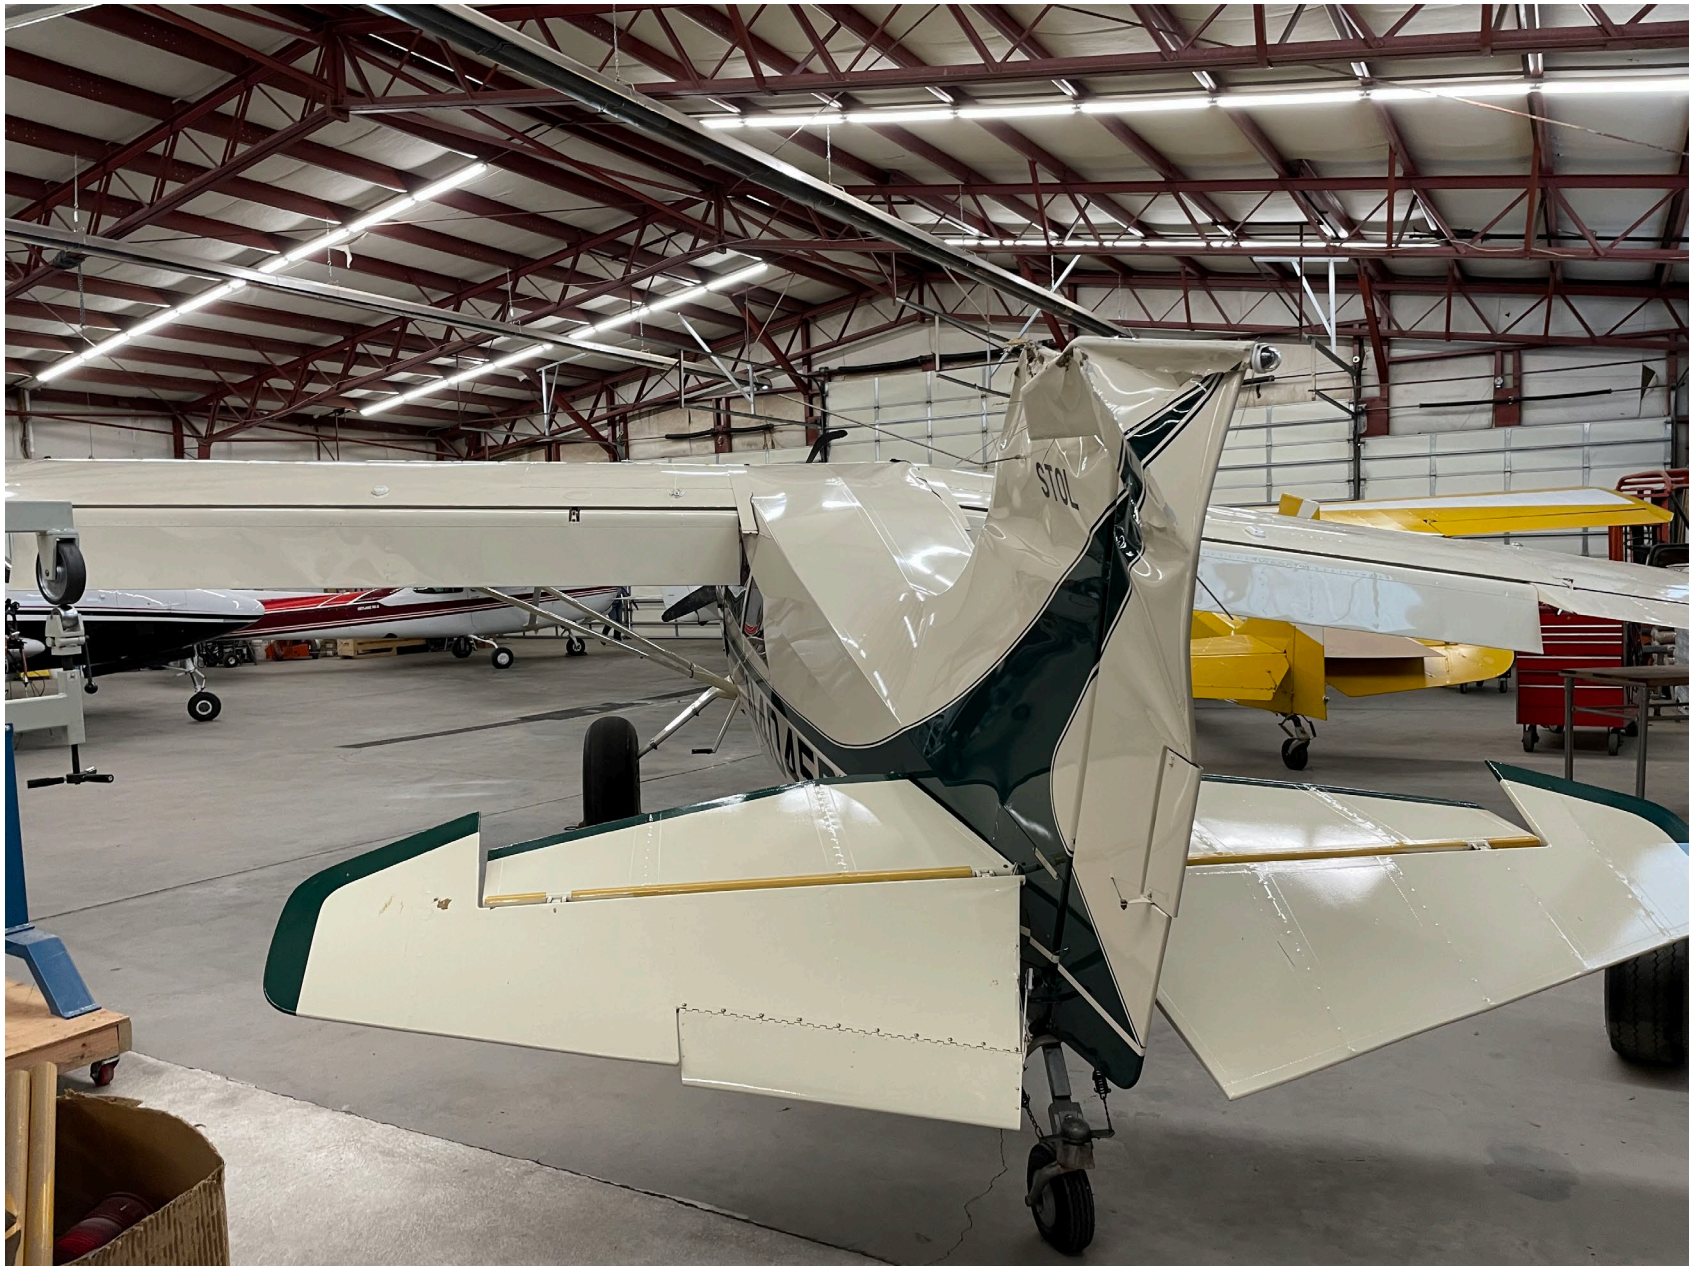
**Photo 1 – View of substantial damage to vertical stabilizer and rudder**

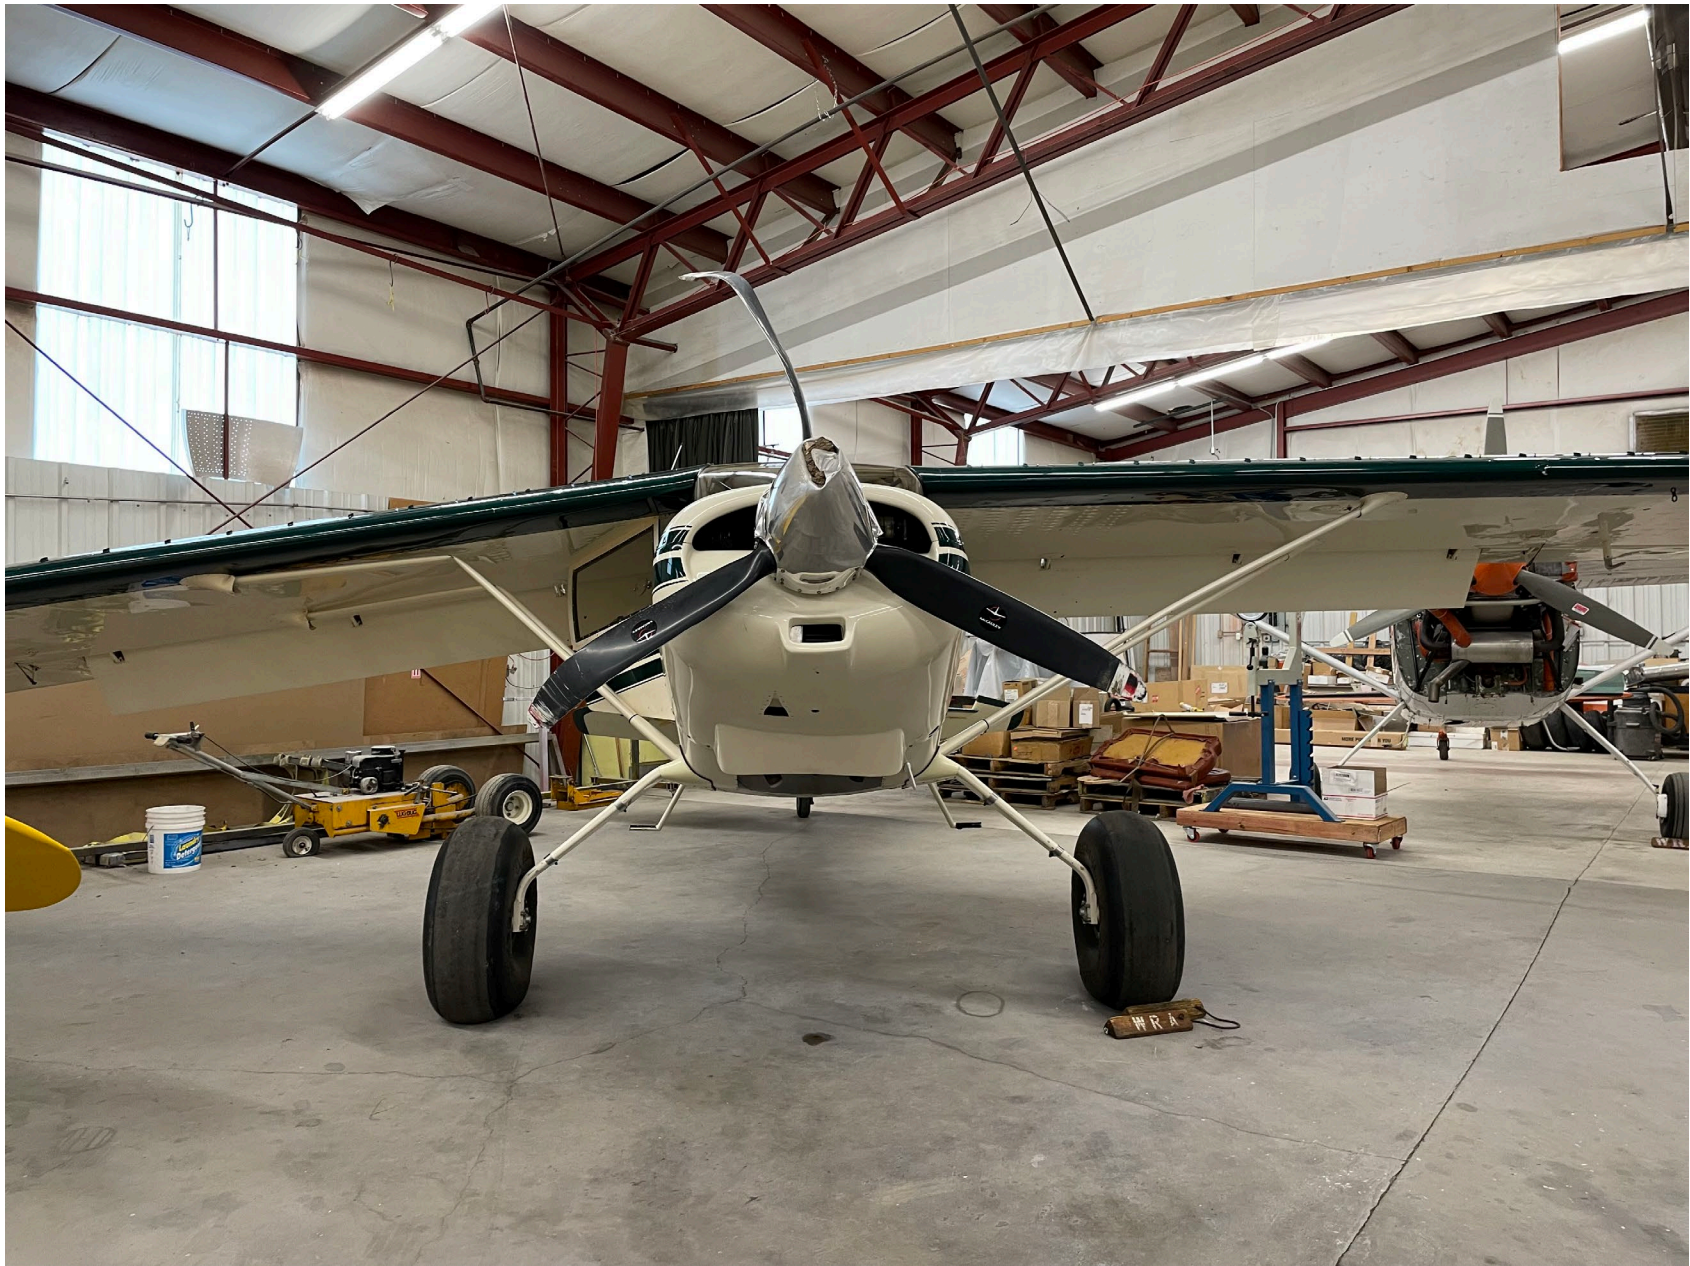
**Photo 2 – View of substantial damage to wing struts**
