**Subject:** WPR23LA128 Structures Report

**Contact:** Clinton Crookshanks, Structures Engineer, NTSB

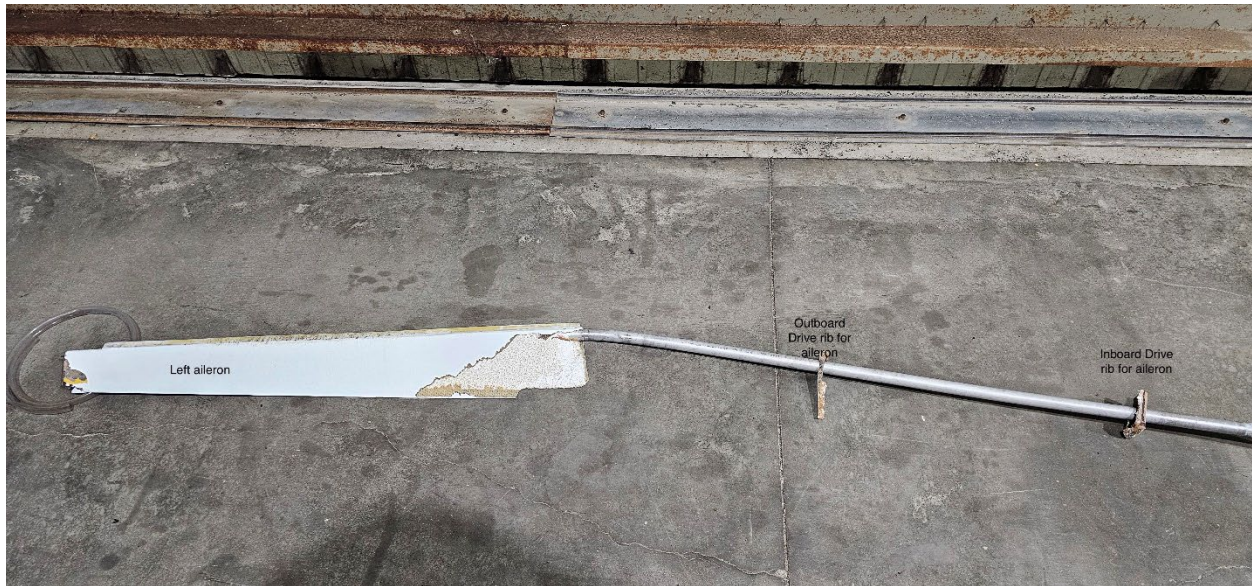
Figure 1 - Left Aileron and Torque Tube (Courtesy of Pilot)

The aileron is connected to a torque tube that runs along the aft side of the rear spar into the fuselage. The torque tube passes through an inboard trailing edge rib at the wing root and an outboard trailing edge rib adjacent to the inboard end of the aileron. The trailing edge is made from carbon fiber skins with a foam core. The mostly intact aileron, attached torque tube, and both trailing edge ribs separated from the wing and the torque tube fractured from the bellcrank in the fuselage (figures 1 and 2).

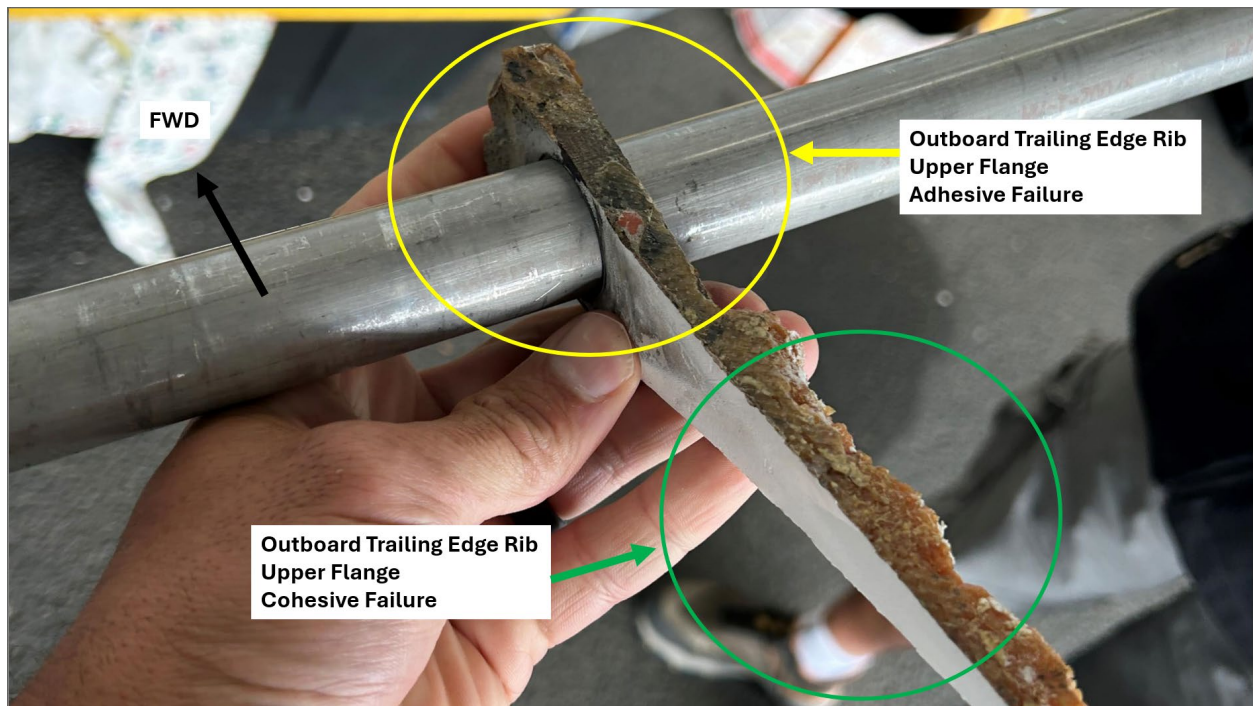
Figure 3 - Outboard Trailing Edge Rib Upper Flange (Courtesy of Pilot)

The intact carbon fiber outboard trailing edge rib remained with the torque tube. There was no apparent damage to the outboard trailing edge rib carbon laminate. The forward halves of the upper and lower flanges and the forward flange of the outboard trailing edge rib were separated cleanly from the wing consistent

with an adhesive type failure at the interface between the carbon and adhesive (figures 3-5).

The aft halves of the upper and lower flanges of the outboard trailing edge rib were separated from the trailing edge skins with a cohesive type failure through the adhesive (figures 3 and 5). The lower flange also had evidence of foam core material in the bond line (figure 6). There was excess adhesive on the inboard side of the outboard trailing edge rib (figure 7). In contrast the inboard trailing edge rib was fractured through the carbon and the remaining upper and lower flanges had portions of the wing structure substrate still attached. There was not a failure in the bond line at the inboard trailing edge rib. There was no damage to the outboard aileron pin. The aileron torque tube was bent aft near its attach point to the aileron.

**Outboard Trailing Edge Rib  
Upper Flange  
Cohesive Failure**

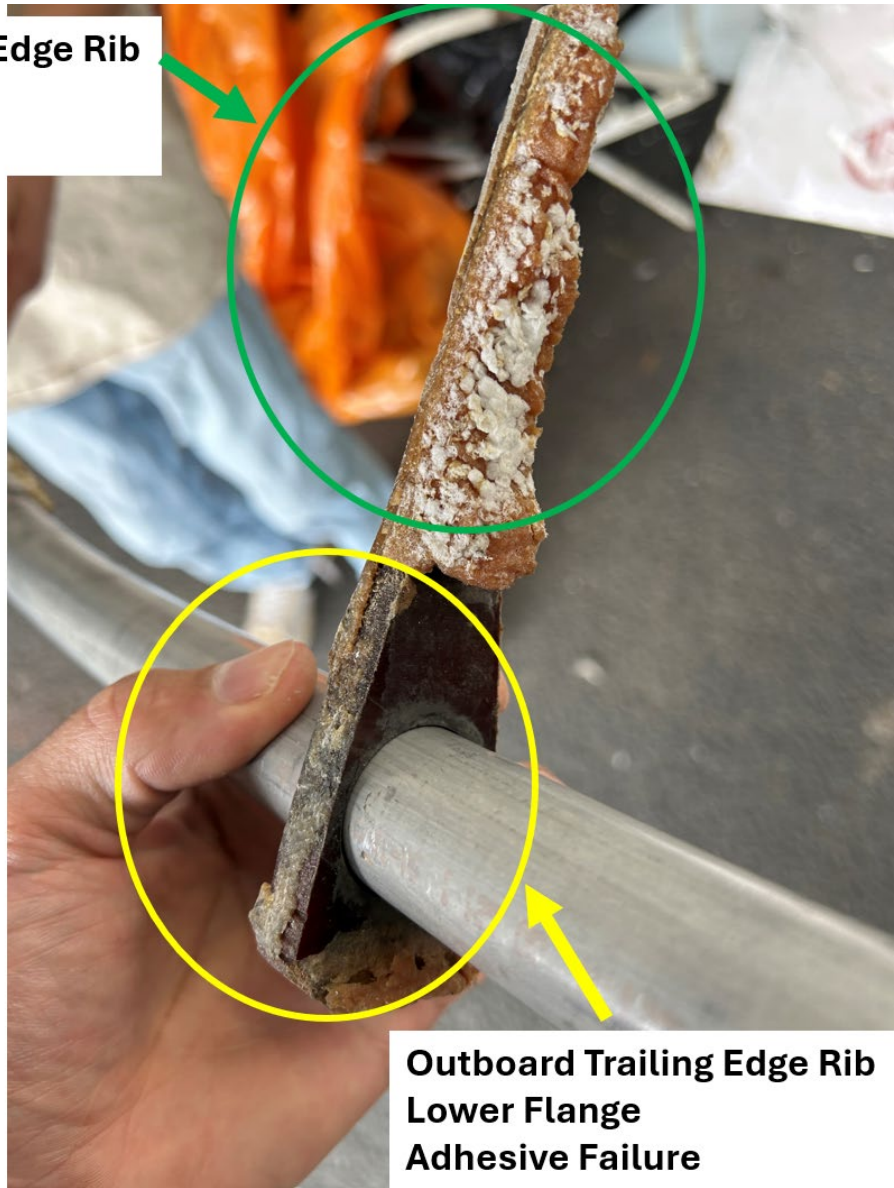
Figure 5 - Outboard Trailing Edge Rib Lower Flange (Courtesy of Pilot)

**Outboard Trailing Edge Rib  
Lower Flange  
Adhesive Failure**

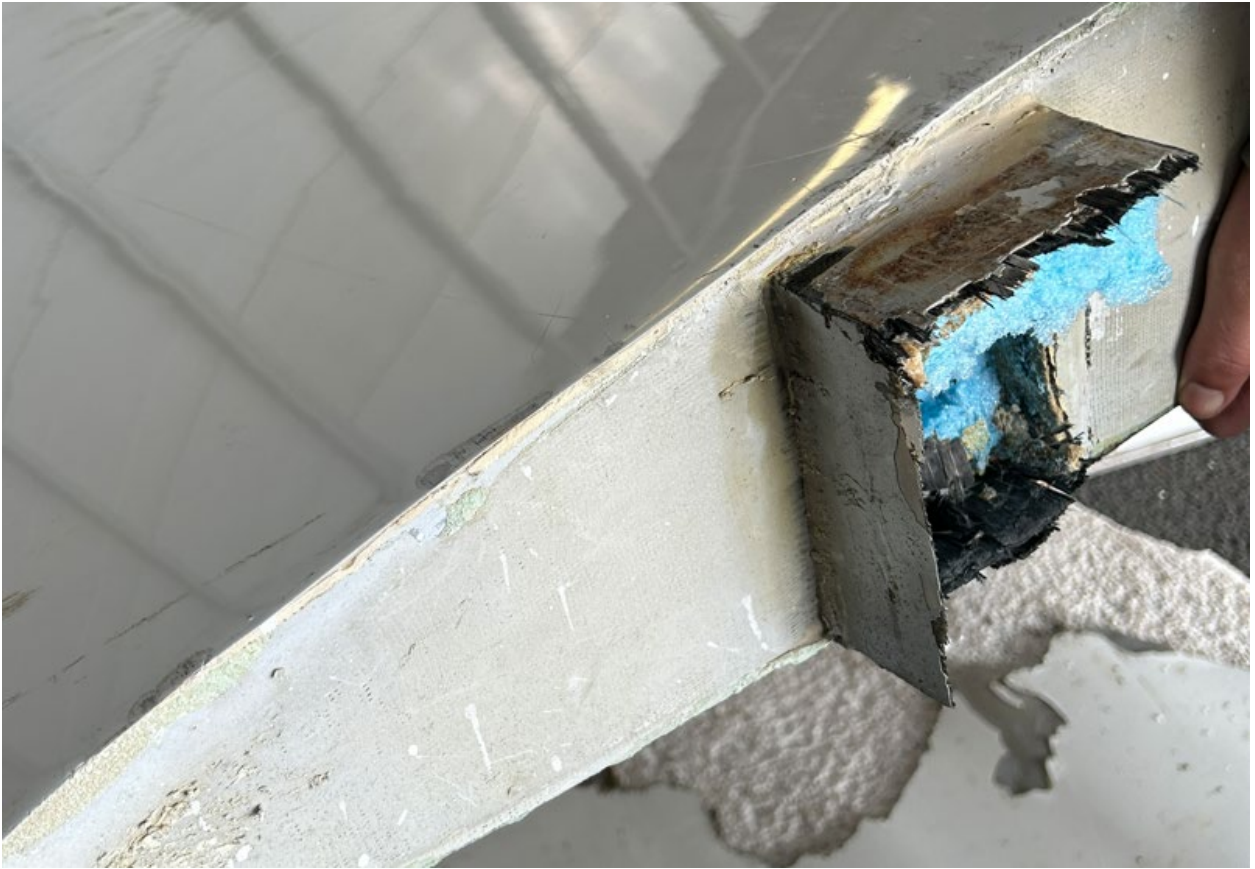
Figure 8 - Main Left Wing Spar Separation (Courtesy of Pilot)

The left wing separated mostly intact during the accident. The upper trailing edge skin was separated and not recovered above the location of the aileron torque tube. The upper trailing edge skin was torn at the forward end, separated along the skin bond at the trailing edge, and fractured through the foam core in the middle. The main spar fractured just outboard of the attach bracket. The photos show fiber tearing and crushing consistent with overload failure (figure 8). The aft spar attach bolt pulled inboard through the wood lug in double shear and fractured the carbon fiber face sheet on the aft side (figure 9). The carbon fiber face sheet on the forward side was not fractured and was damaged consistent with the head of the bolt or nut pulling through. The aft spar attach bolt remained intact in the fuselage lug.
