WPR23LA128

## INVESTIGATION PHOTOGRAPHS

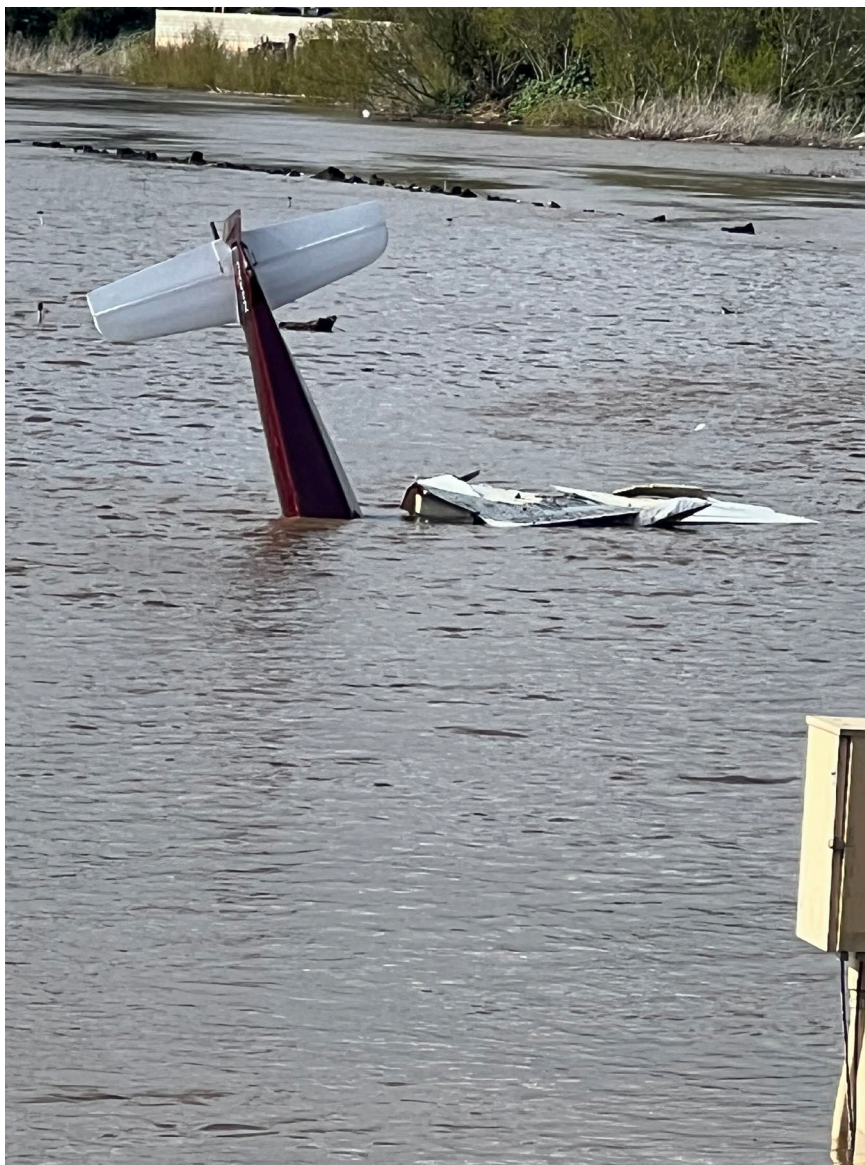
**Photograph 1 - Wreckage in Water (Courtesy of Pilot)**

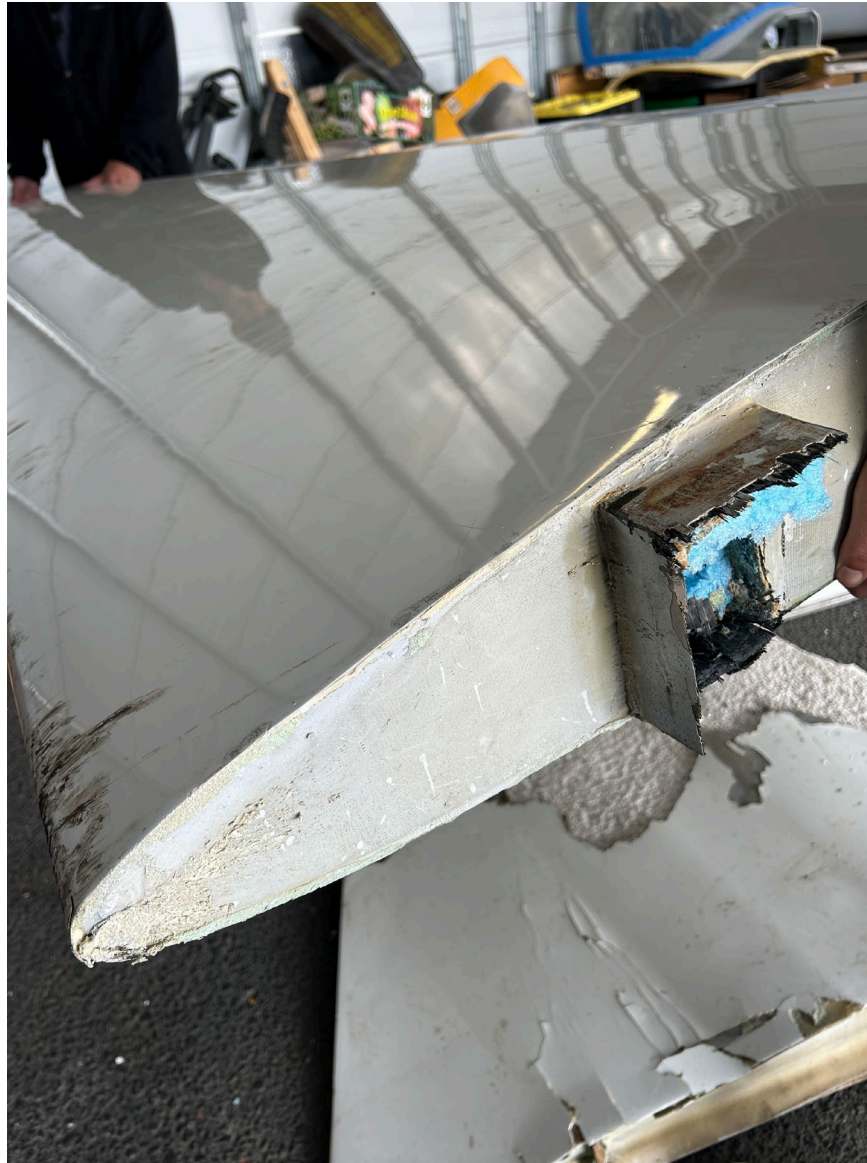
**Photograph 7 - Left Wing Main Spar Separation (Courtesy of Pilot)**
