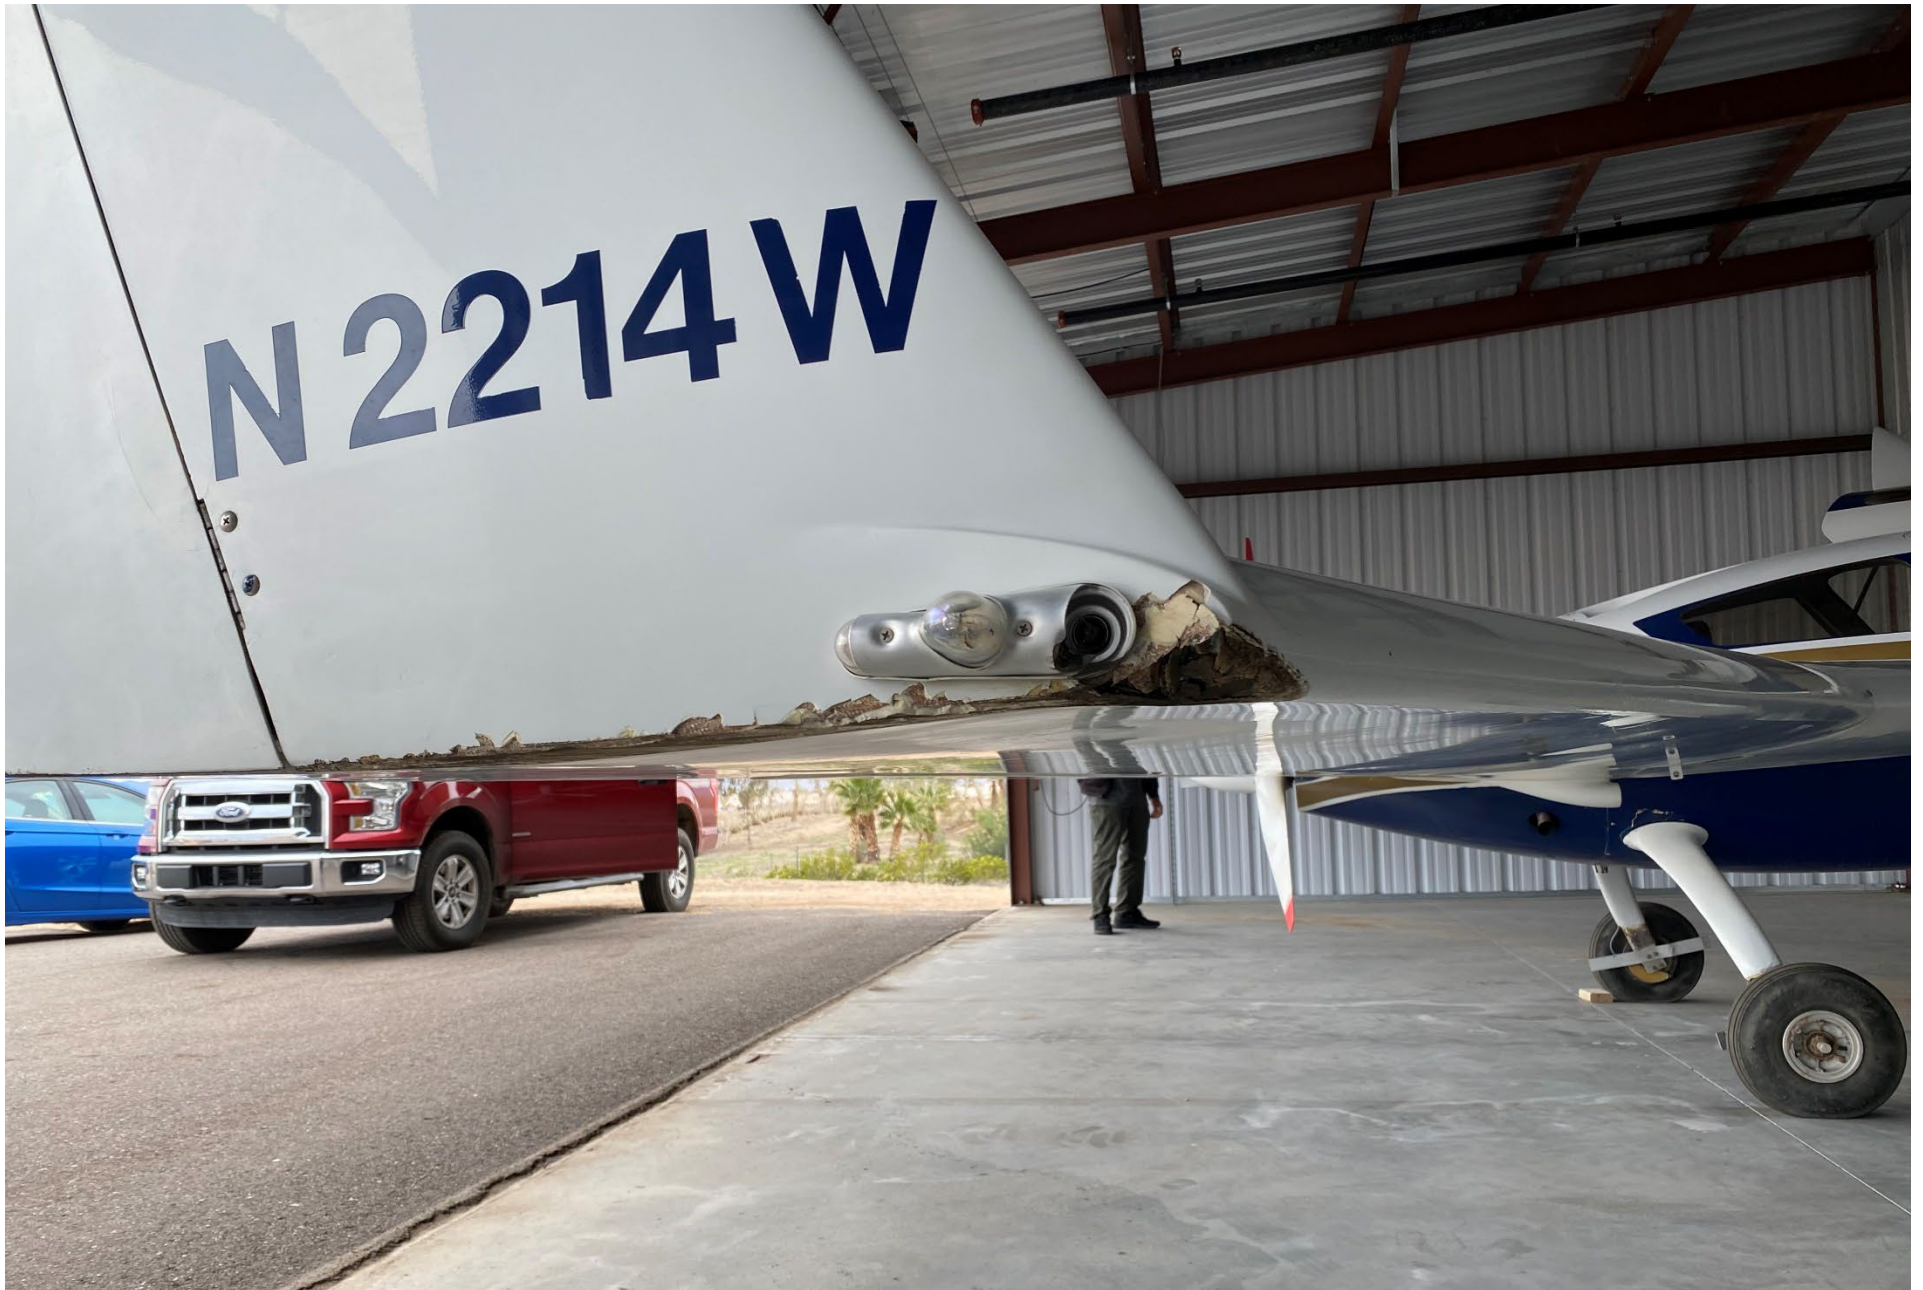
**Photo 1 – View of damage to left wing tip (Courtesy of Owner)**
