# National Transportation Safety Board

WPR23LA134

## **AIRFRAME AND ENGINE EXAMINATION**

Location: Brigham City, Utah  
Date: March 11, 2023  
Time: 1845 mountain daylight time  
Airplane: Experimental amateur-built Zenith CH 801, N638BH

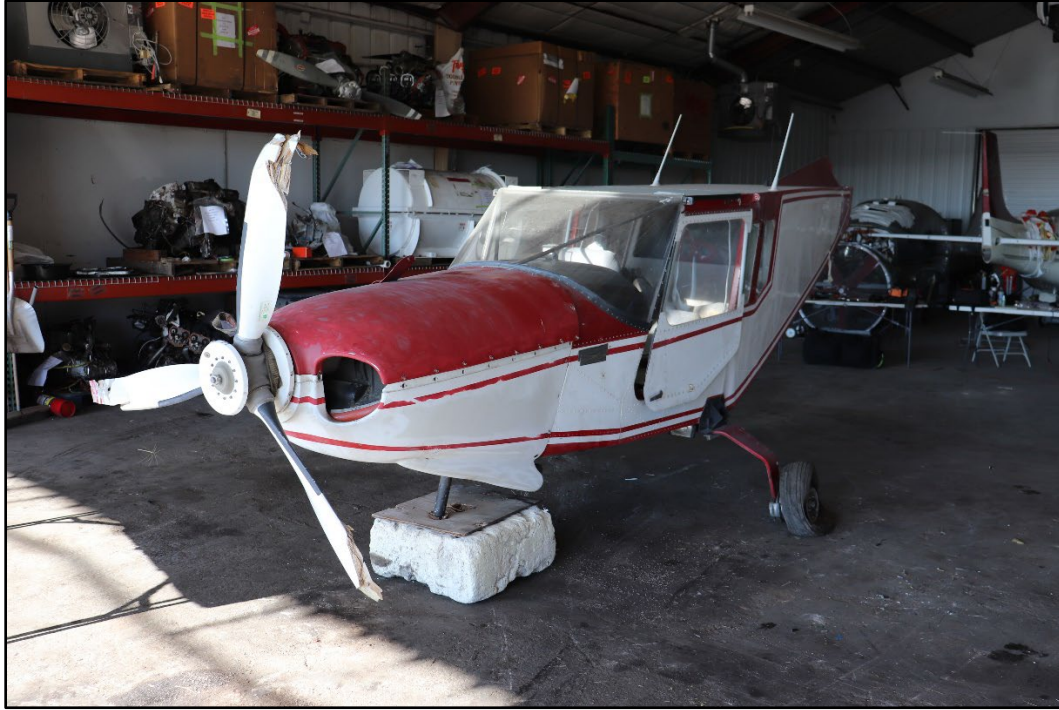
Examination of the recovered wreckage revealed that the nose landing gear was fracture separated and both main landing gear were impact damaged. The fuselage near the main landing gear exhibited buckling. Both wings, horizontal stabilizer, vertical stabilizer/rudder, and elevator were removed by recovery personnel, no visible damage was observed. Additionally, the recovery personnel noted that the airplane was void of fuel during recovery.

**Figure 1: View of accident airplane during exam.**

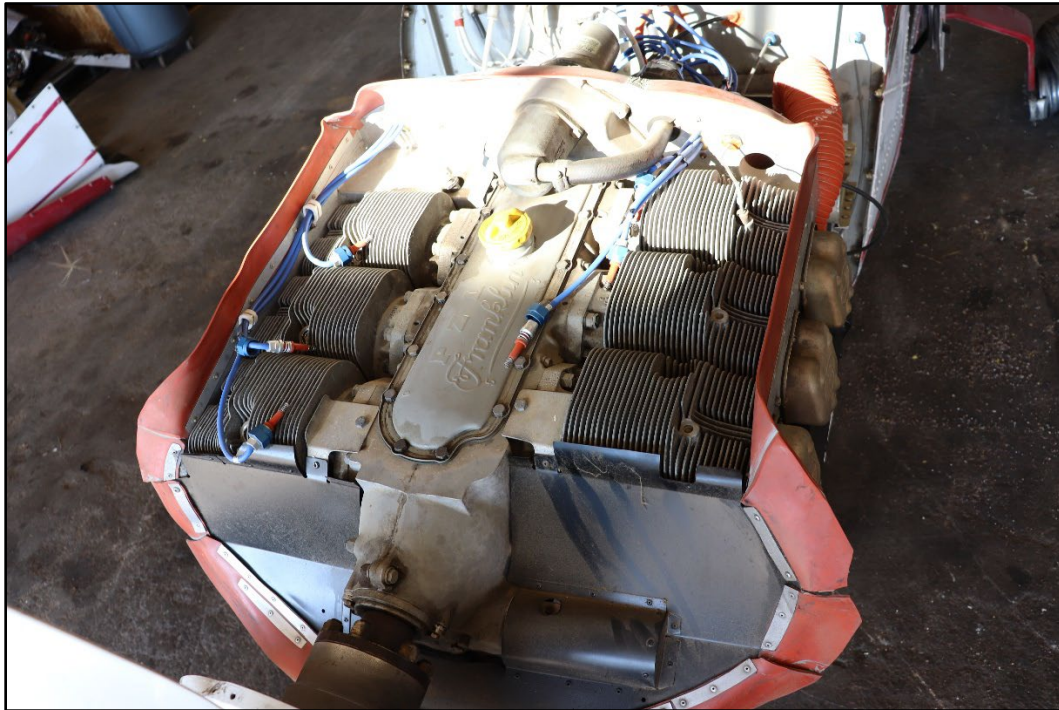
Examination of the recovered engine revealed that it remained attached to the engine mounts. All six cylinders and all engine accessories remained attached. All fuel and oil lines appeared attached to their respective fittings and were tight. No evidence of any mechanical damage was observed to the engine crankcase.

**Figure 2: View of engine during exam.**

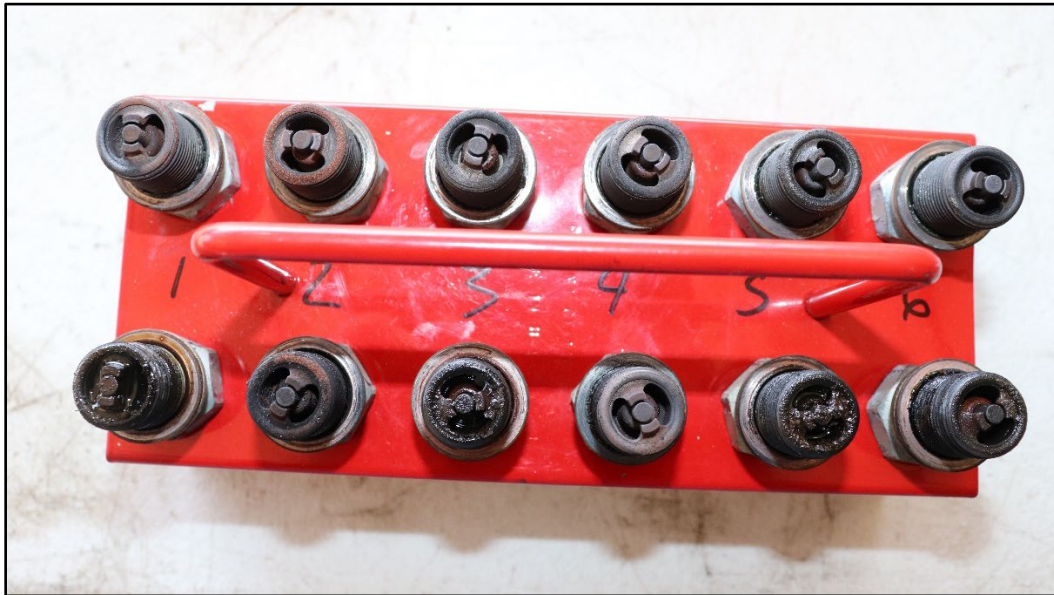
The top spark plugs were removed from the engine and they were the massive electrode type. Dark gray coloration within the electrode areas was observed. When compared to the Champion Check-A-Plug chart, the sparkplugs exhibited NORMAL use signatures.

The bottom spark plugs were removed from the engine and they were the massive electrode type. The No 1, 3, and 5 cylinder spark plugs were oil soaked. Dark gray coloration within the electrode areas was observed in the No. 2, 4 and 6 spark

plugs. When compared to the Champion Check-A-Plug chart, the sparkplugs exhibited WORN OUT-NORMAL use signatures.

**Figure 3: View of engine spark plugs.**

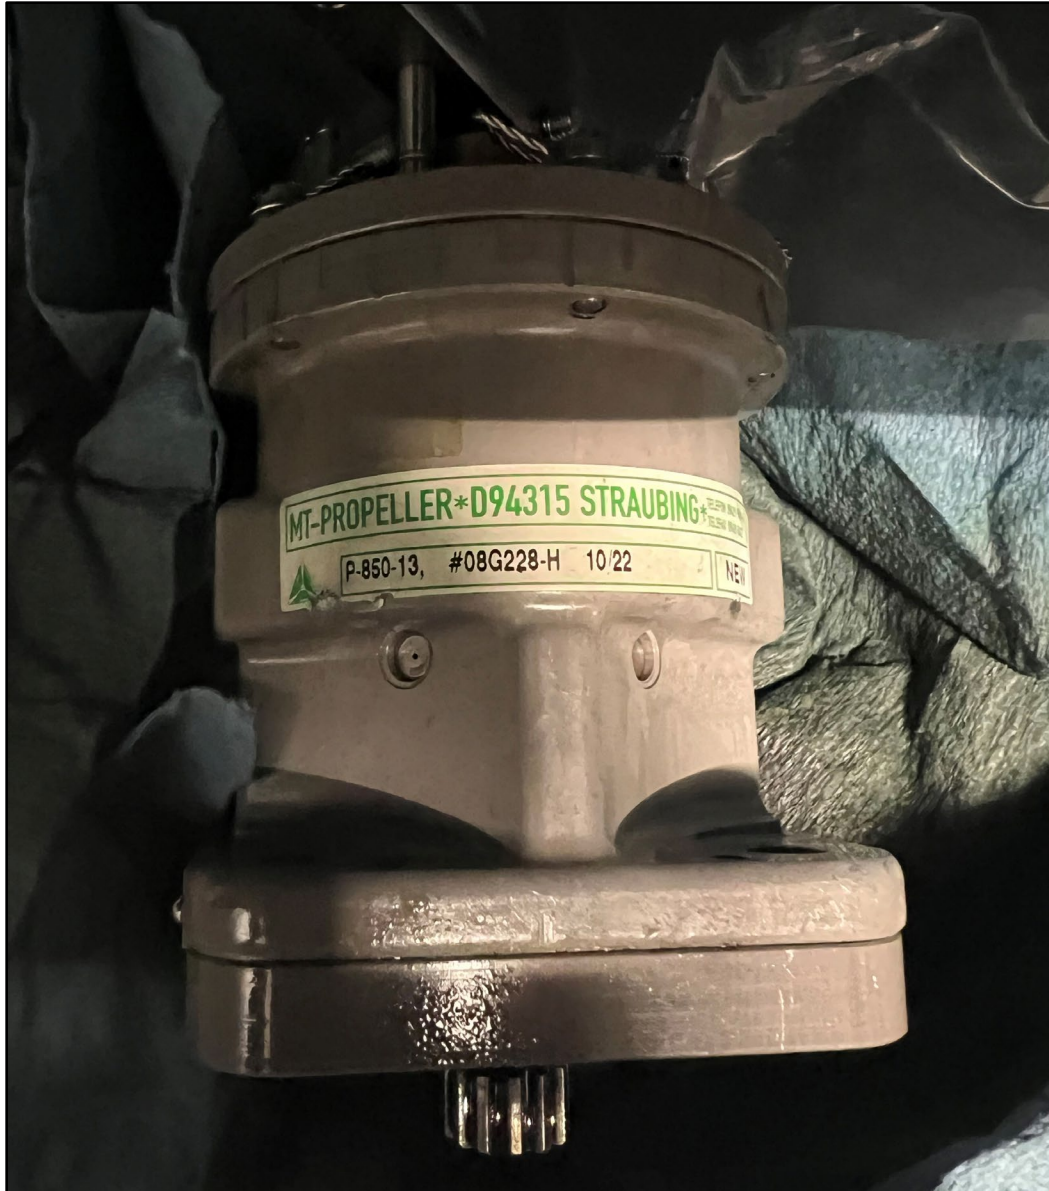
The propeller governor was retained for further examination.

**Figure 4: View of propeller governor.**

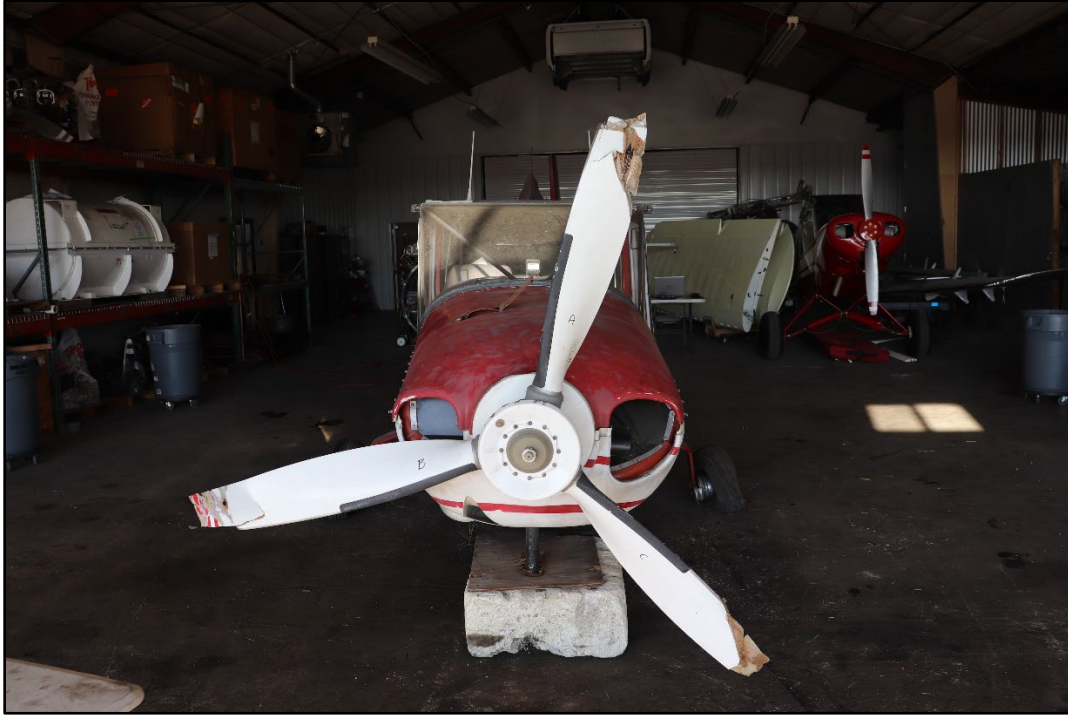
The airplane was equipped with a three blade MT propeller; for the purposes of this report the propeller blades were labeled A, B, and C. All blades remained attached to the propeller hub. All the propeller blades exhibited impact damage to the propeller tips. All the propeller blades splintered near the propeller tips.

**Figure 5: View of airplane propeller blades.**
