# National Transportation Safety Board

WPR23LA149

## **MATERIALS LABORATORY**

Factual Report 24-034

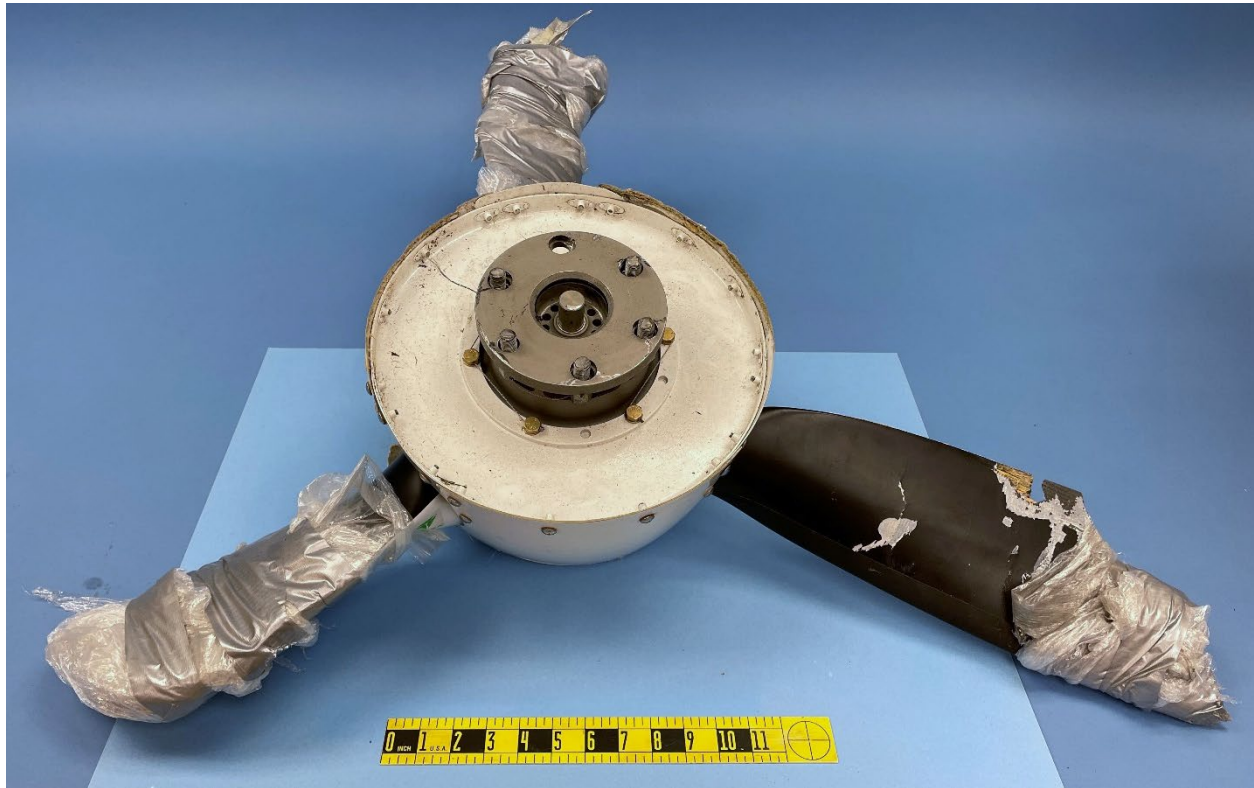
Figure 1 shows the propeller assembly as received. All three blades had been damaged such that approximately half of the outboard portions had been destroyed. The fractures of these blades were jagged with multiple impact marks along and near the fracture, as well as on both sides of the airfoils.

Figure 1. Separated propeller hub and blades, as received, viewed from the aft-facing side with fractured bolts and hub face.

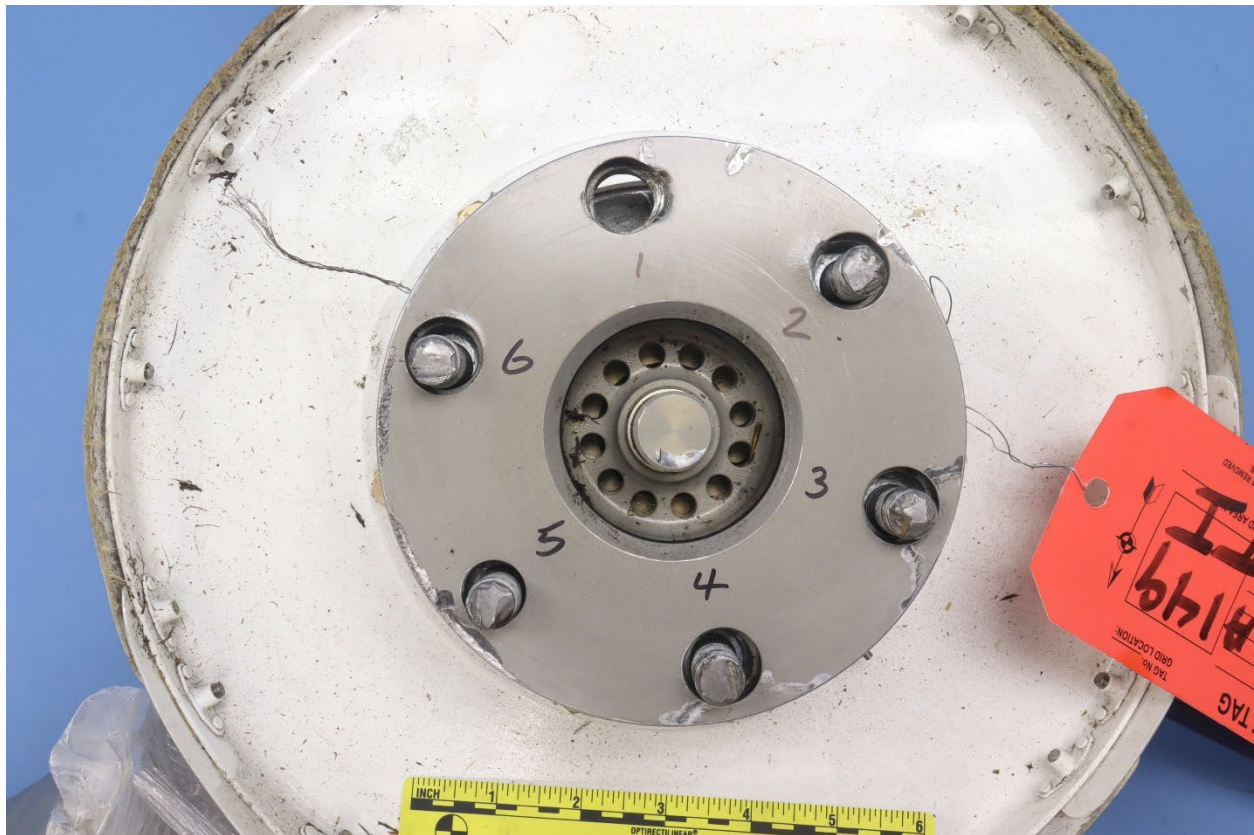
Of chief concern in this examination was the condition of the attachment bolts on the hub. Figure 2 shows these bolt remnants as received. Five bolt remnants remained in the hub, whereas one of the bolts was completely missing. For the purposes of this

report, the bolts were labeled 1 through 6, numbered clockwise from the missing bolt location, as illustrated in Figure 2. All bolts had fractured between 0.25 and 0.50 inches aft of the aft hub face.

Figure 2. Closer view of the fractured bolt surfaces remaining in the hub, showing the positions labeled 1 through 6.

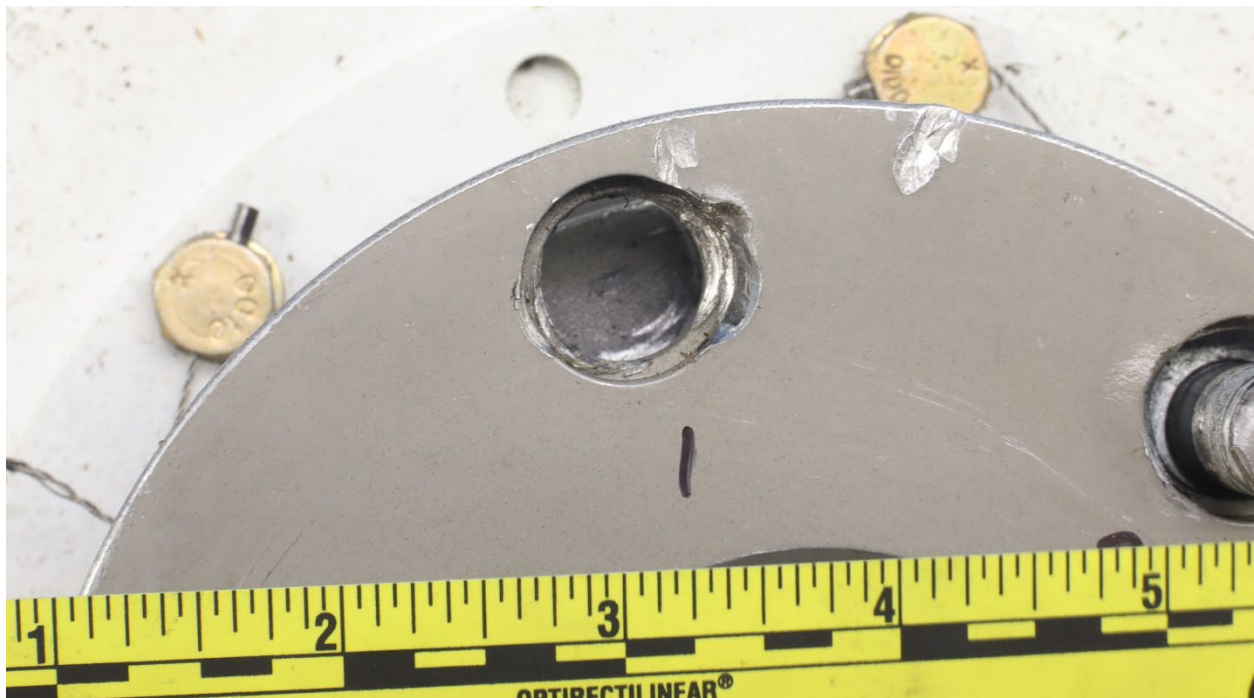
Figures 3 through 9 show closer views of the six bolt positions. Figure 3 shows the missing bolt (#1 location). This area exhibited outward plastic deformation along the bolt hole edge in the clockwise direction, displayed in Figure 3. There were also two smaller impact marks on the hub face near bolt hole #1.

Figure 3. View of the #1 bolt position, absent the bolt remnant with deformation in the hole.

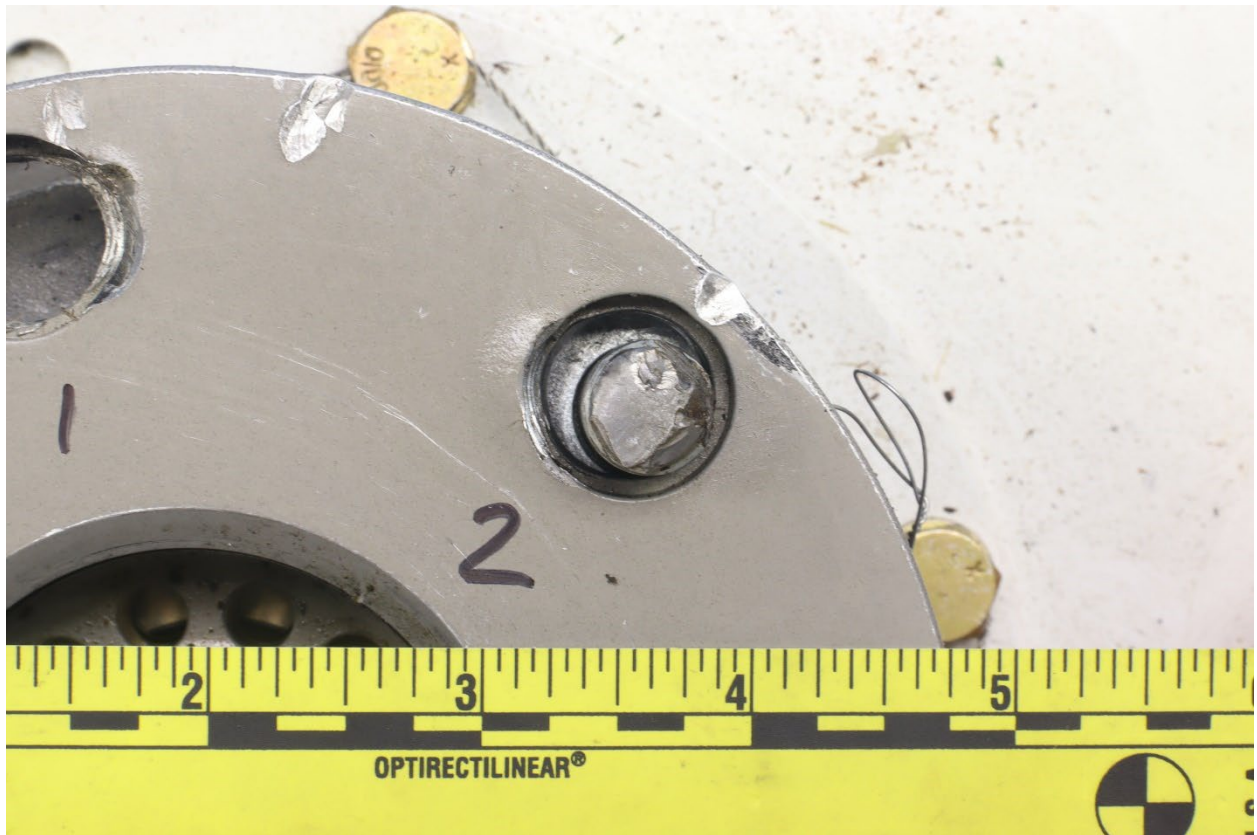
Bolt hole #2 also exhibited outward-oriented plastic deformation, but in the counterclockwise direction, demonstrated in Figure 4. The fractured bolt from the head side remained inside the bolt hole. This bolt exhibited a flat fracture on part of the surface, with impact damage in the form of smearing and batter on the lower right or clockwise side.

Figure 4. View of the fracture surface of the #2 bolt.

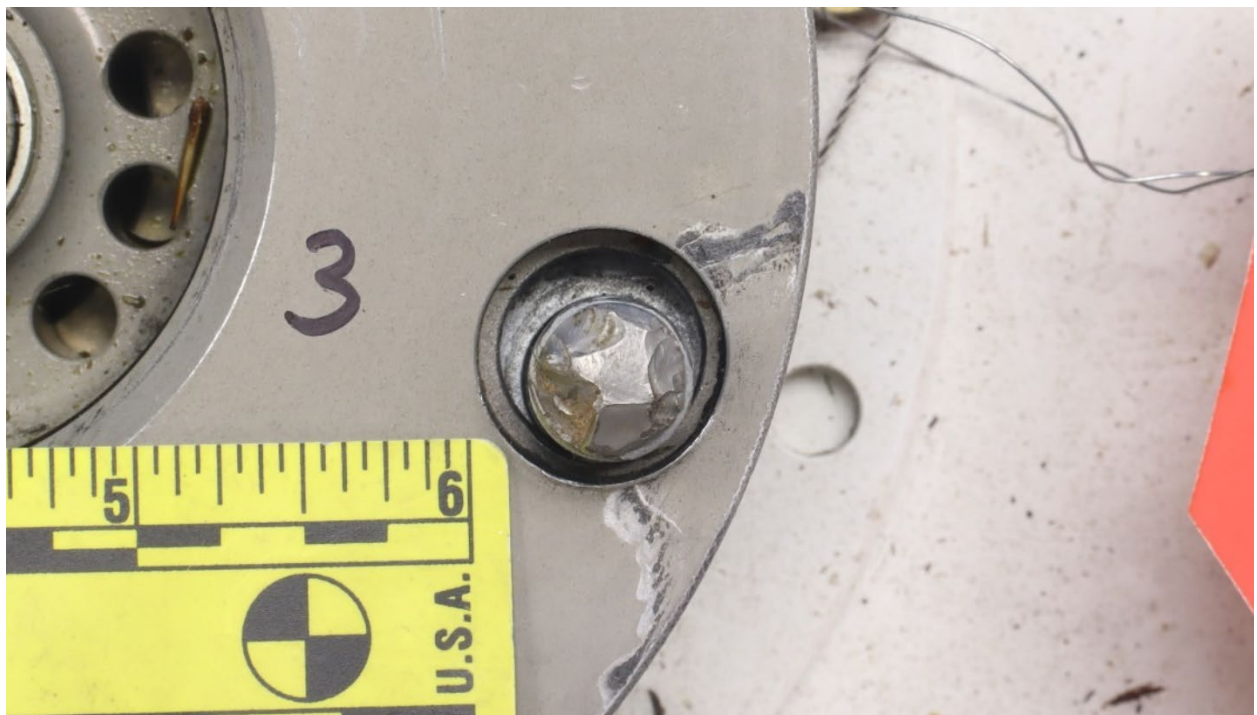
Figure 5 shows the fractured bolt from the #3 position. This fracture was generally conic in shape, with the outer areas exhibiting multiple thumbnail-shaped cracks and the center region being relatively flat and perpendicular to the bolt direction. The hub face exhibited two angled gouge marks from the bolt hole to the hub edge. Bolt 4 also exhibited two angled gouge marks emanating from the bolt hole to the hub edge (see Figure 6). However, the fracture surface morphology differed, with two flat regions perpendicular to the bolt direction, separated by an upward protruding ridge.

Figure 5. View of the fracture surface of the #3 bolt.

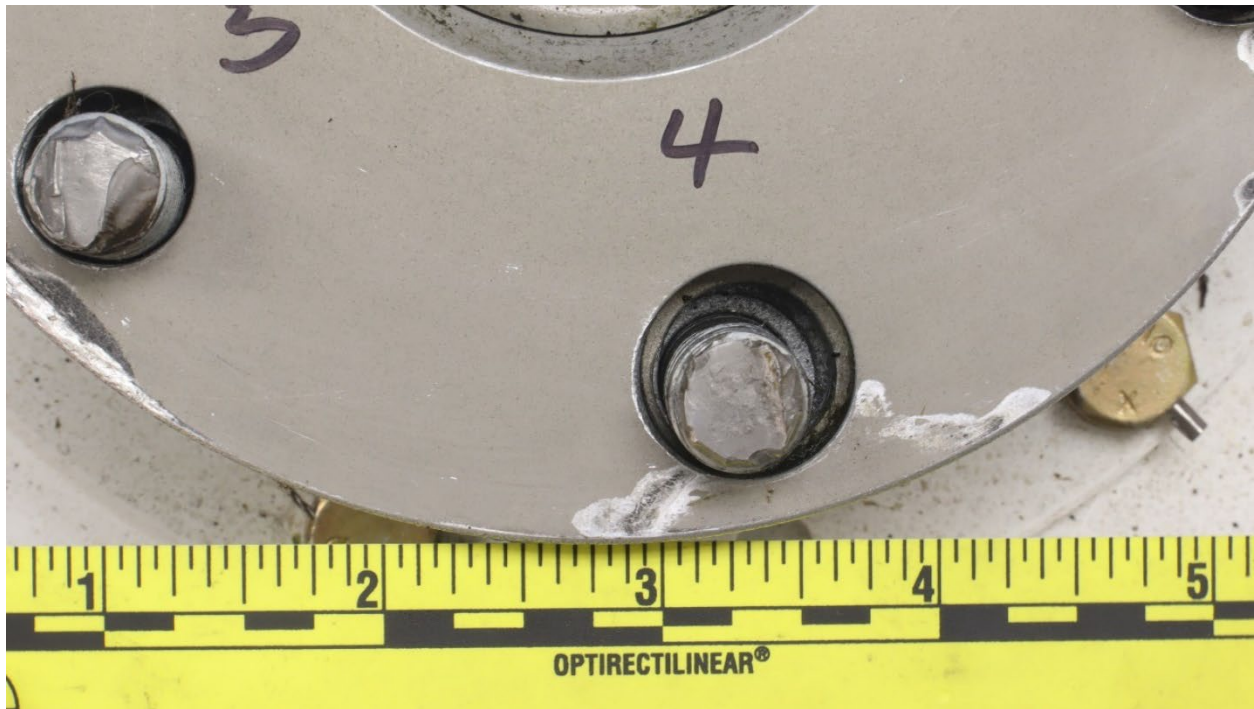
Figure 6. View of the fracture surface of the #4 bolt.

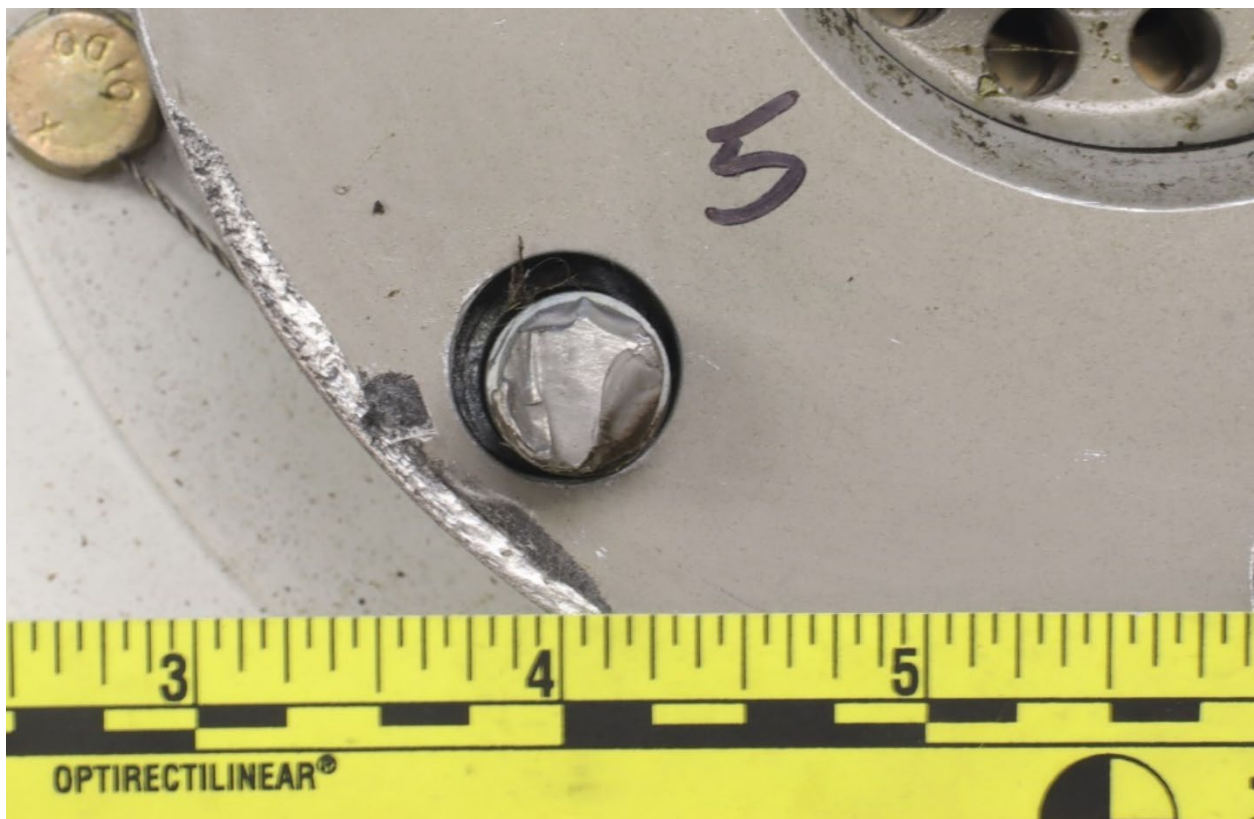
Bolt 6 in Figure 8 exhibited a similar morphology to Bolt 4, whereas Bolt 5 exhibited a shape closer to Bolt 3, being conic in morphology (Figure 7). Both the edges of the hub near Bolts 5 and 6 exhibited circumferential abrasive wear.

Figure 7. View of the fracture surface of the #5 bolt.

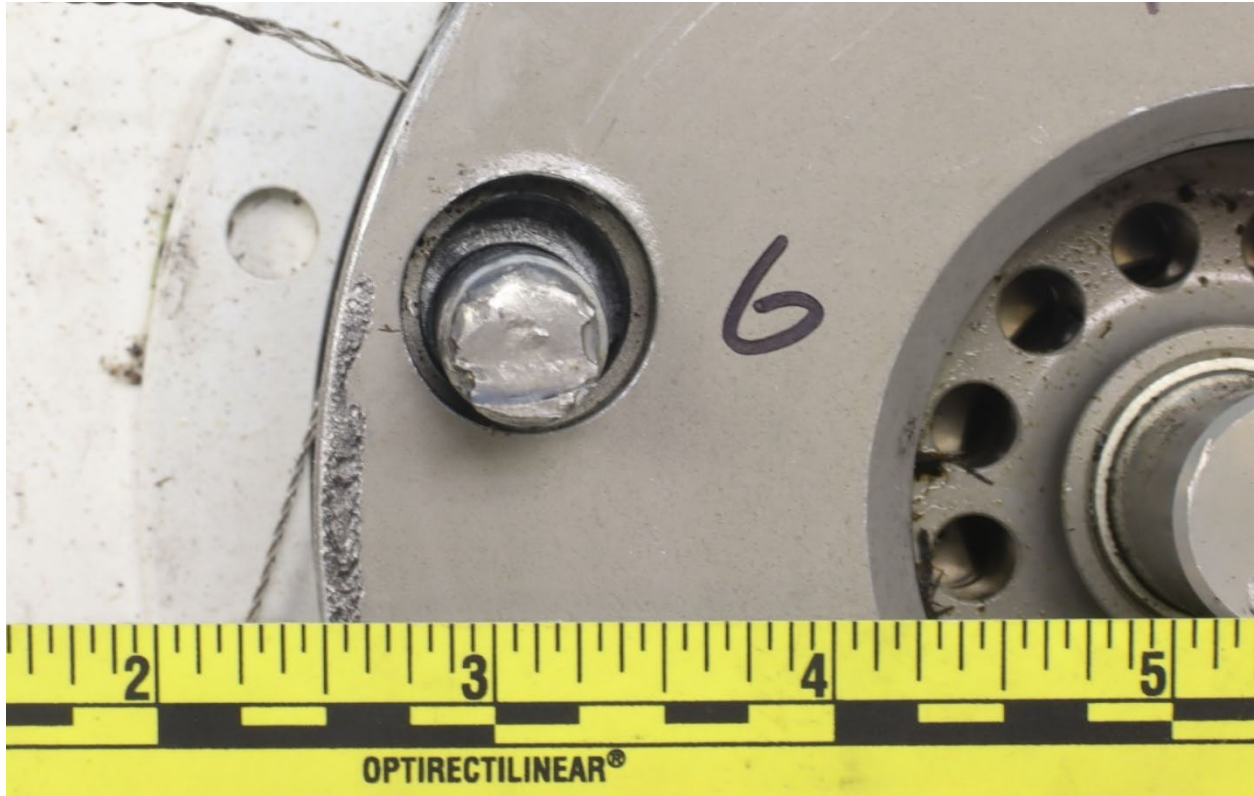
Figure 8. View of the fracture surface of the #6 bolt.

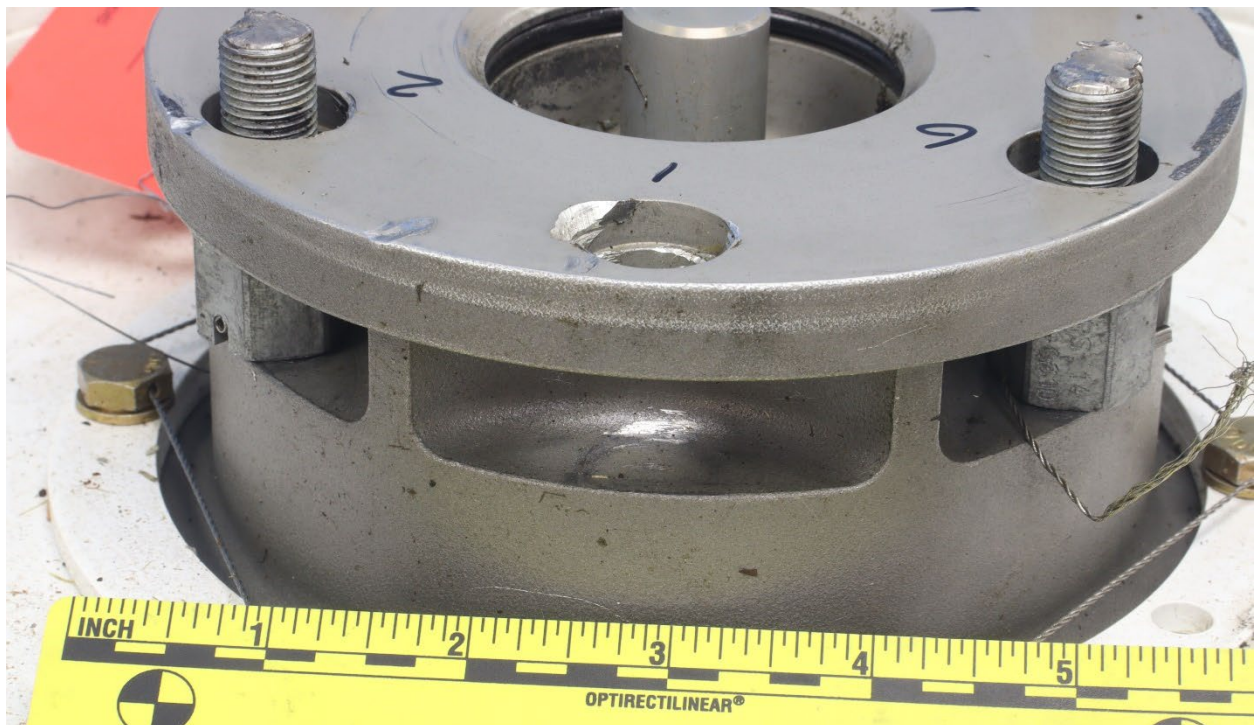
Figure 9 shows an angled view of the hub at the #1 bolt hole location. Besides the deformation on the clockwise edge of the hole (left in Figure 9), the forward face exhibited circumferential gouge marks, consistent with impact against the nut from the missing bolt. This interaction between the nut and this hub surface is demonstrated from the #5 bolt position in Figure 10.

Figure 9. Angled view of the hub at the #1 bolt position, showing side wall deformation of the hole and impact marks on the underlying hub face.

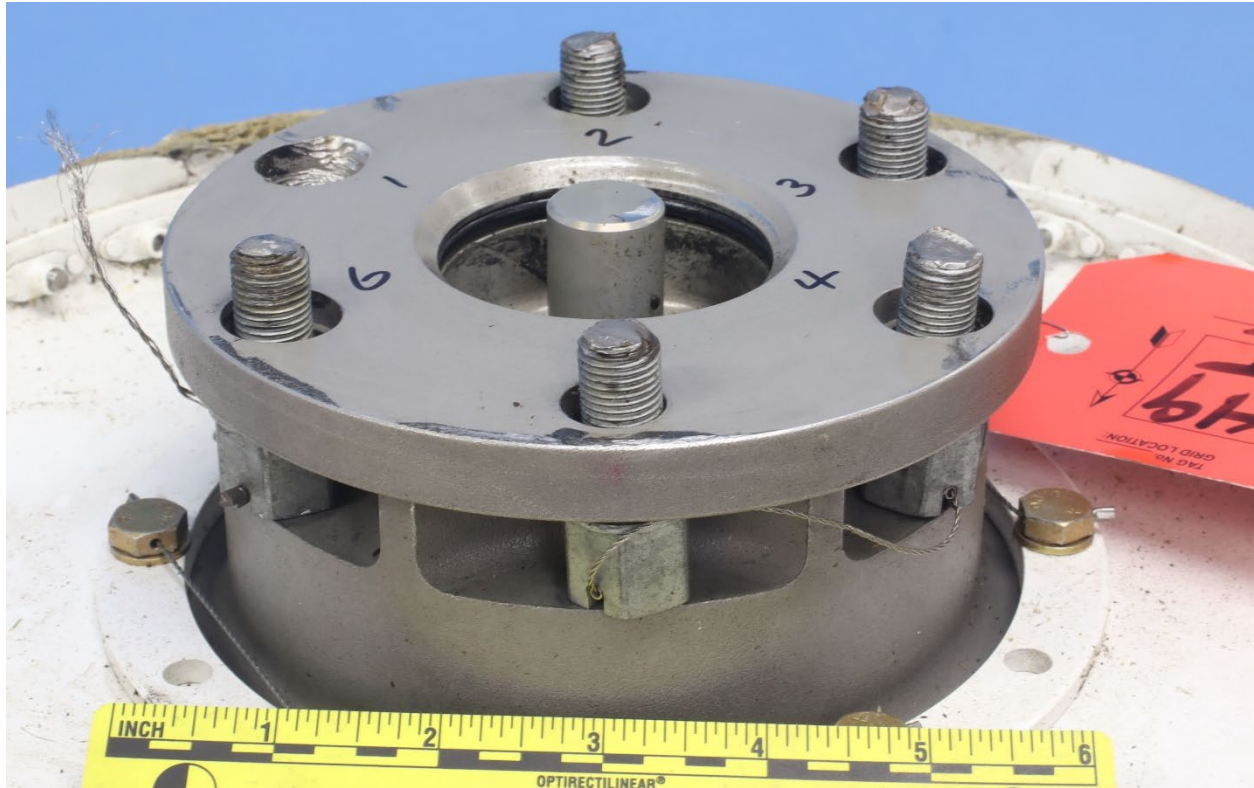
Figure 10. Angled view of the hub and fractured bolts from the #5 bolt position.

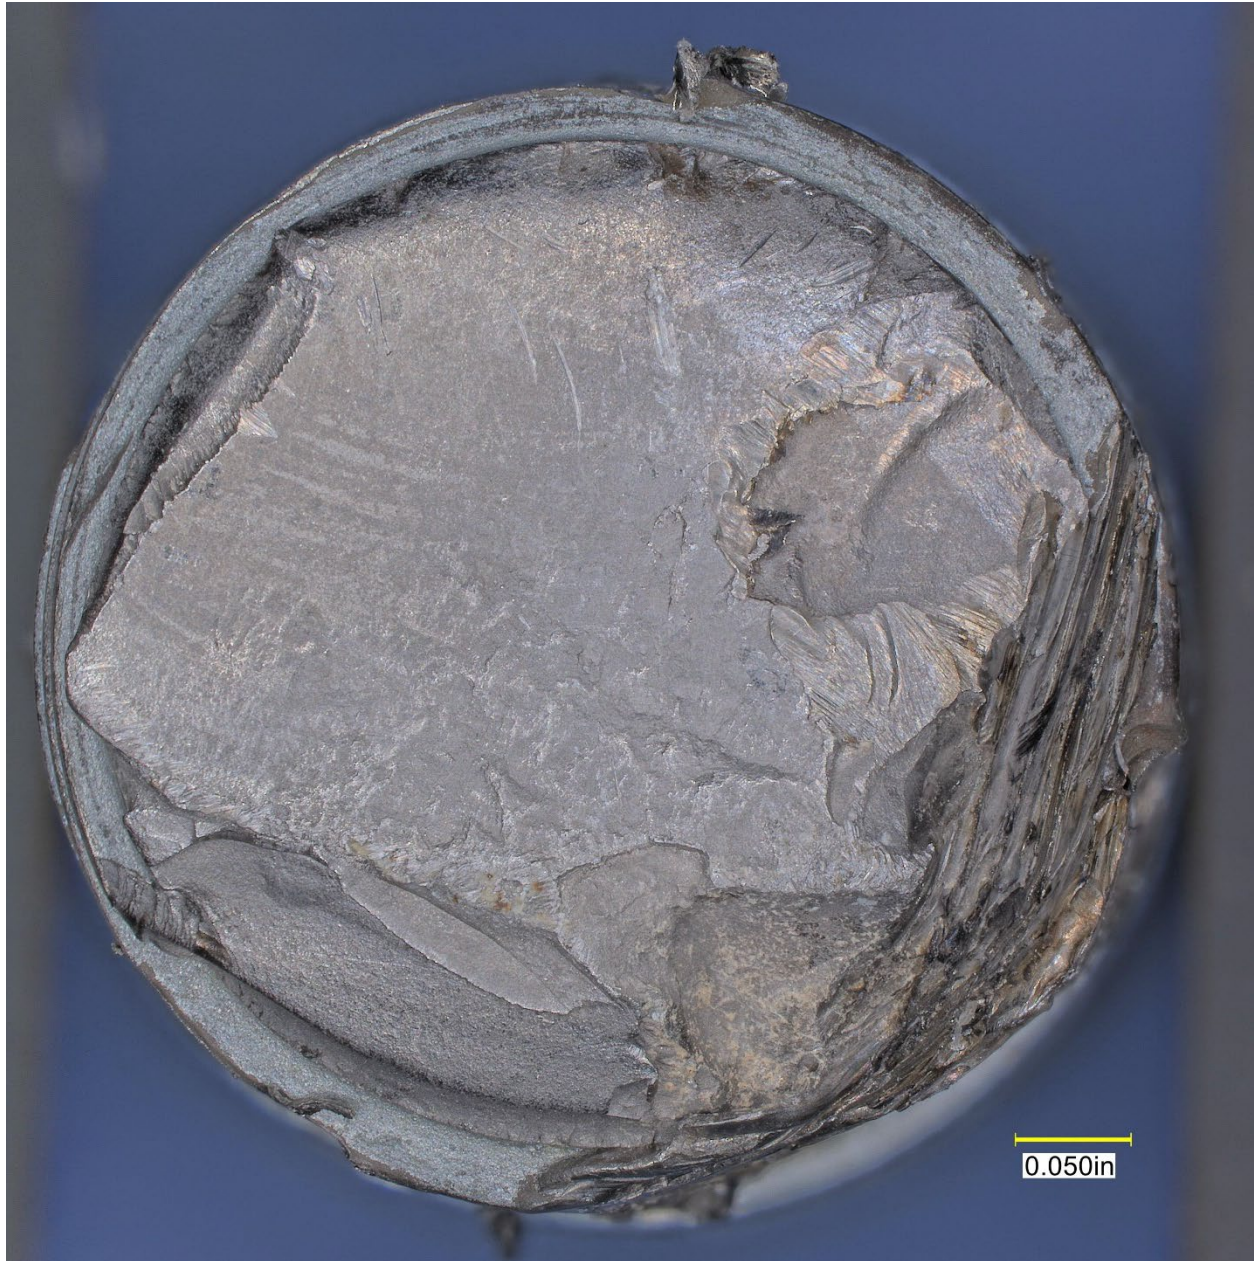
All bolt fracture surfaces exhibited features consistent with progressive cracking—crack arrest marks, ratchet marks, and multiple thumbnail-shaped cracks. Figure 11 and Figure 12 show the fracture surfaces of bolts 2 and 3, respectively. Each exhibited a generally conic shape, with a flat center region and angled periphery. The angled edges were consistent with individual thumbnail cracks, crack initiation, and

propagation from the thread roots at the edge. While Bolt 2 exhibited four prominent thumbnail cracks, Bolt 3 exhibited six.

Figure 11. The fracture surface of bolt 2.

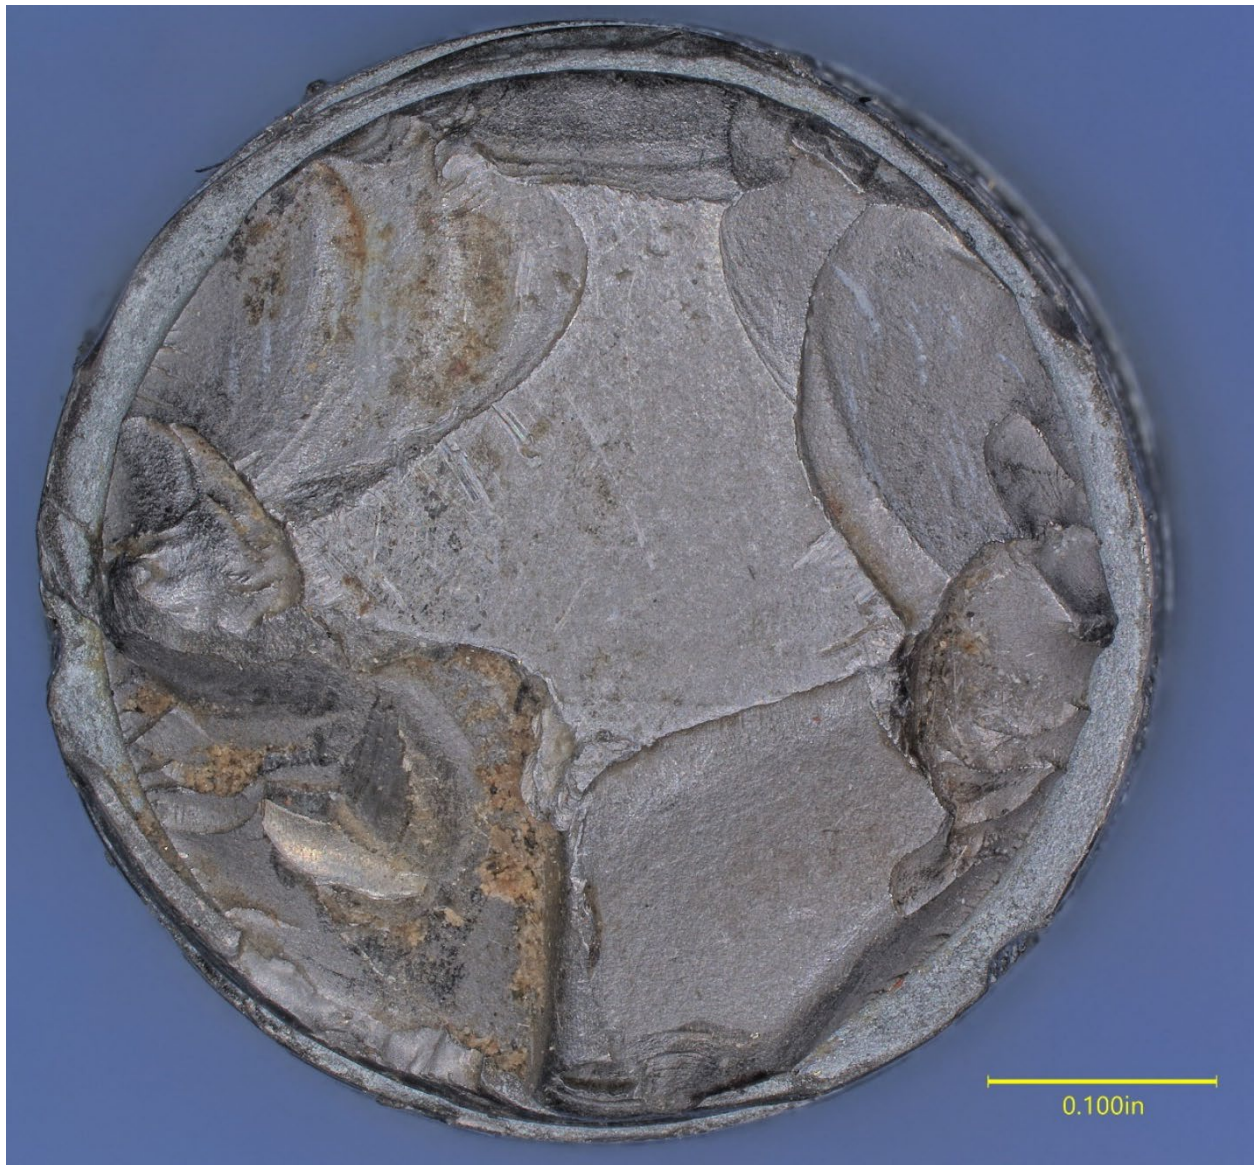
Figure 12. The fracture surface of Bolt 3.

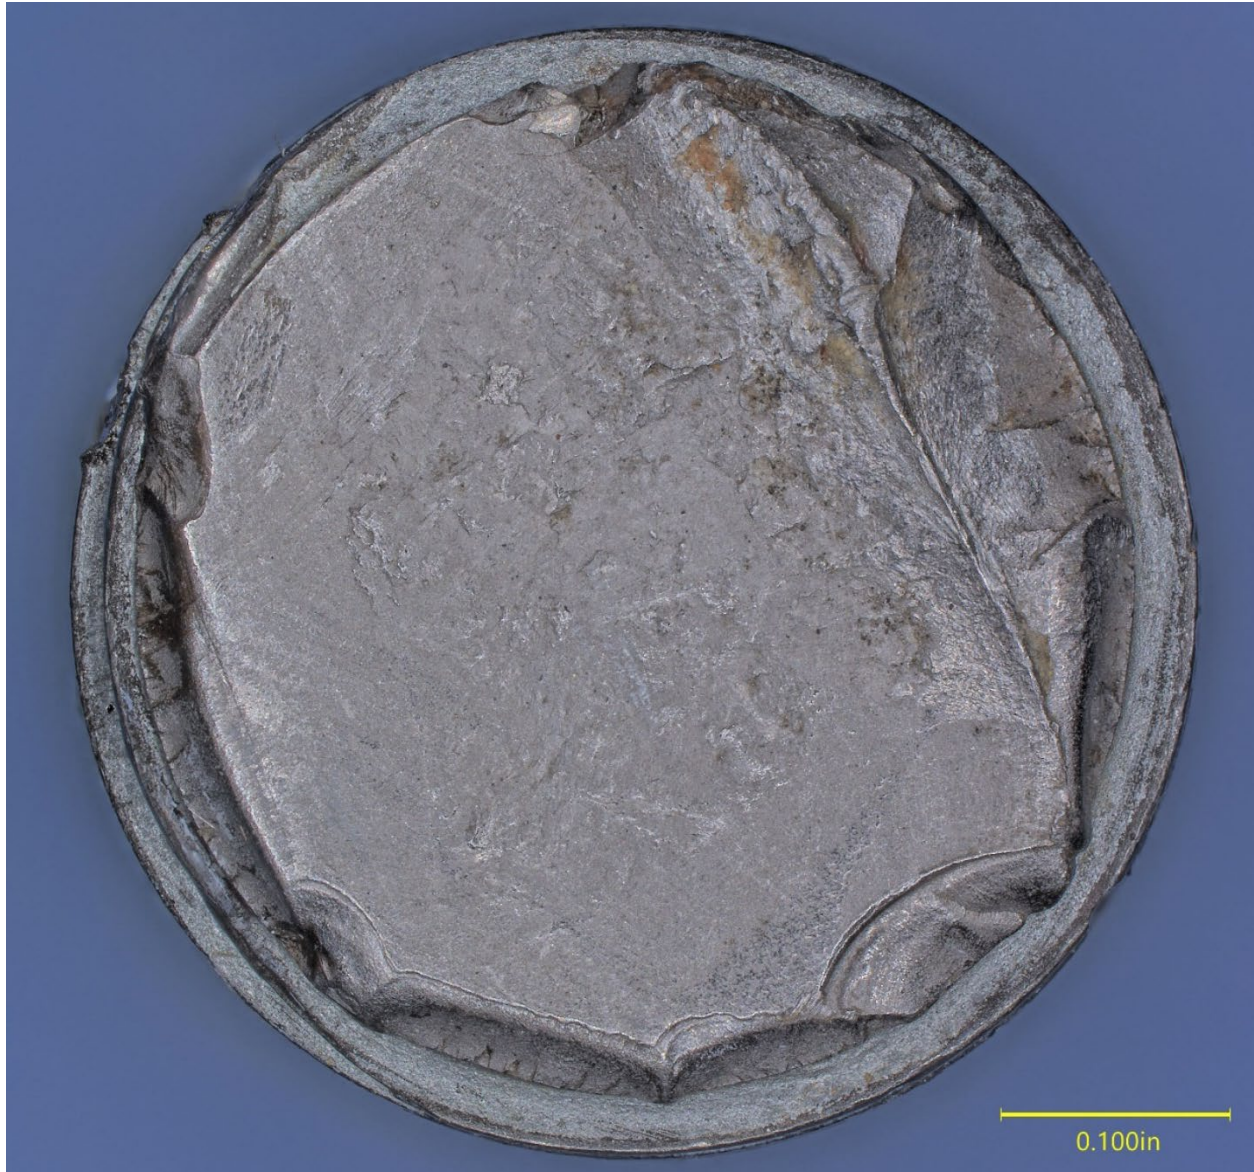
The Bolt 4 fracture surface exhibited a different pattern, with a larger portion of the surface flatter rather than angled. The ridge in the upper right of Figure 13 separated a larger flat area of the fracture surface from a smaller one. On both sides were angled thumbnail cracks, though smaller than those in Figures 11 and 12. Several of these smaller thumbnail cracks are shown in Figure 14, located along a thread root while also exhibiting individual ratchet marks. The larger flat area exhibited faint crack arrest marks, consistent with propagating from the thumbnail cracks in Figure 14. The smaller flat region of the fracture surface also exhibited individual thumbnail cracks, shown in Figure 15. As shown in Figure 16, these cracks exhibited crack arrest and ratchet marks consistent with initiating along the thread root.

Figure 13. View of the Bolt 4 fracture surface.

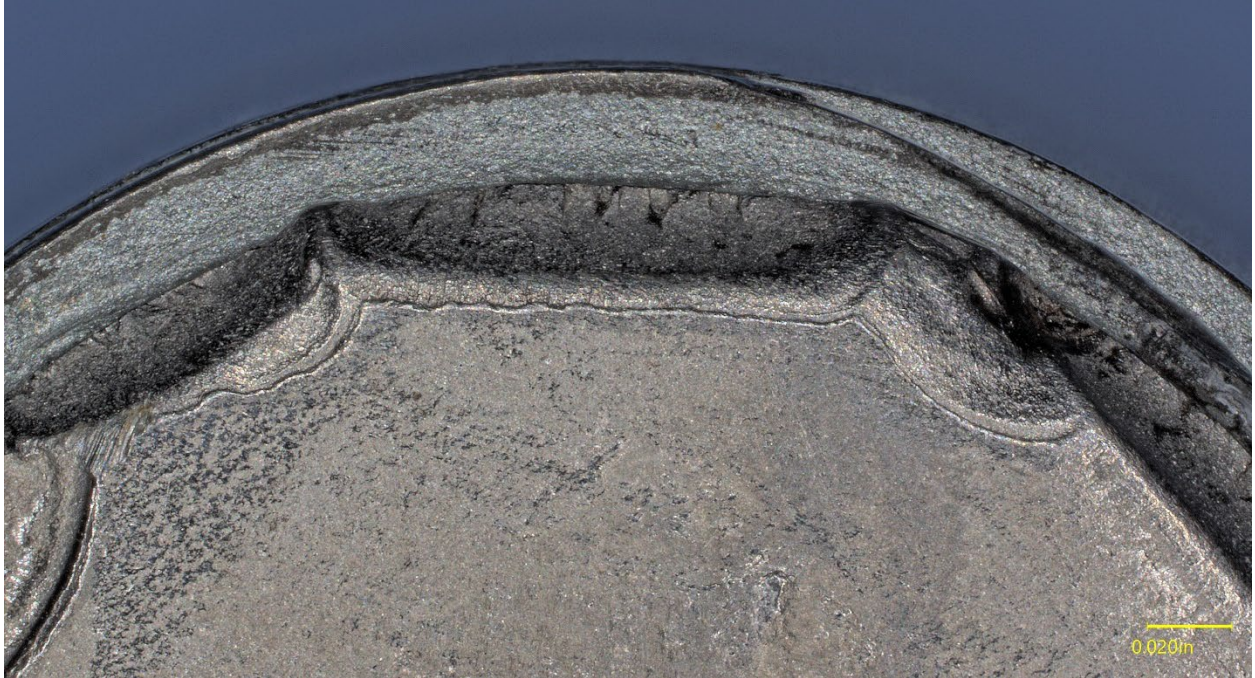
Figure 14. Smaller thumbnail cracks along the periphery of the Bolt 4 fracture surface.

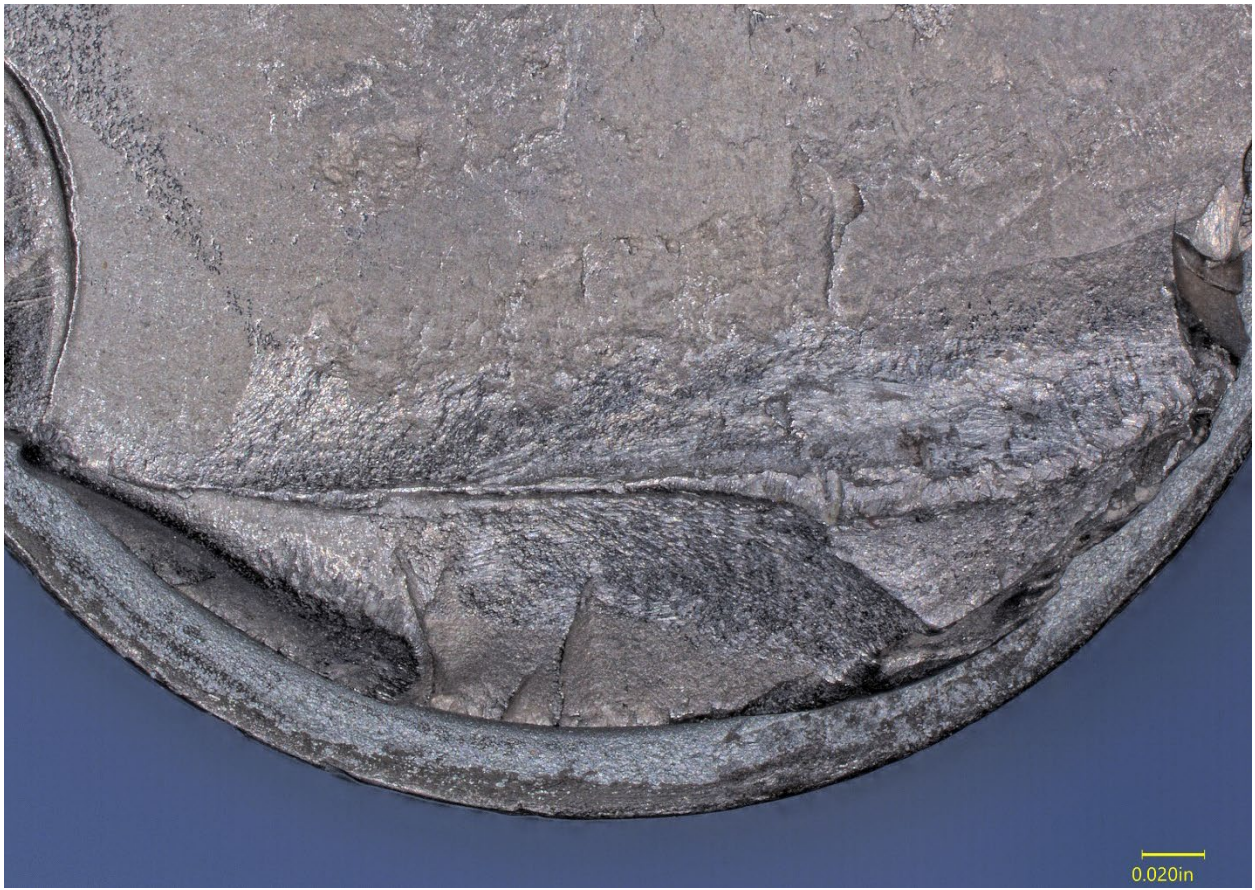
Figure 15. The upward facing ridge on the fracture surface of Bolt 4 (upper right in Figure 13).

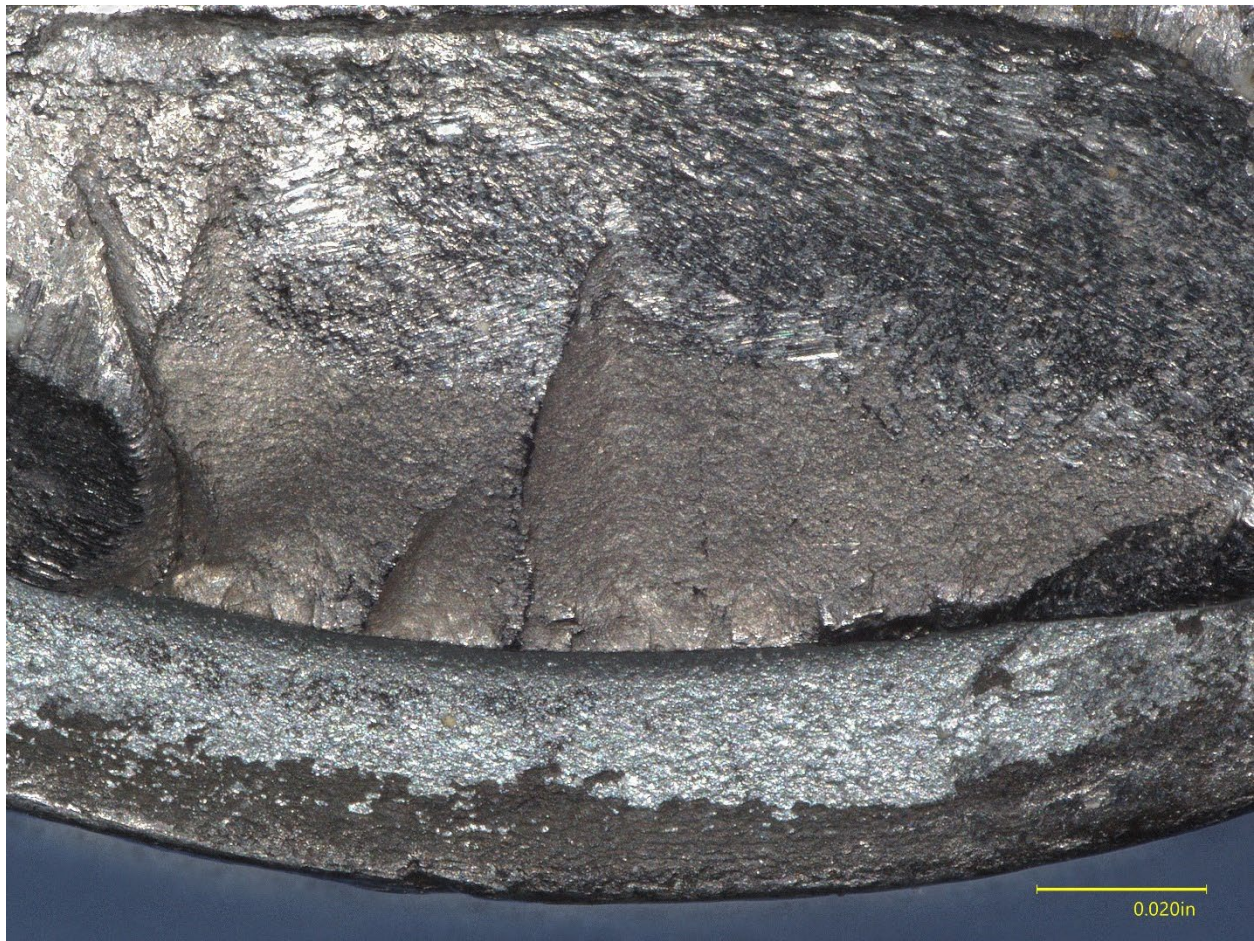
Figure 16. Closer view of ratchet marks near the edge of the Bolt 4 fracture surface.

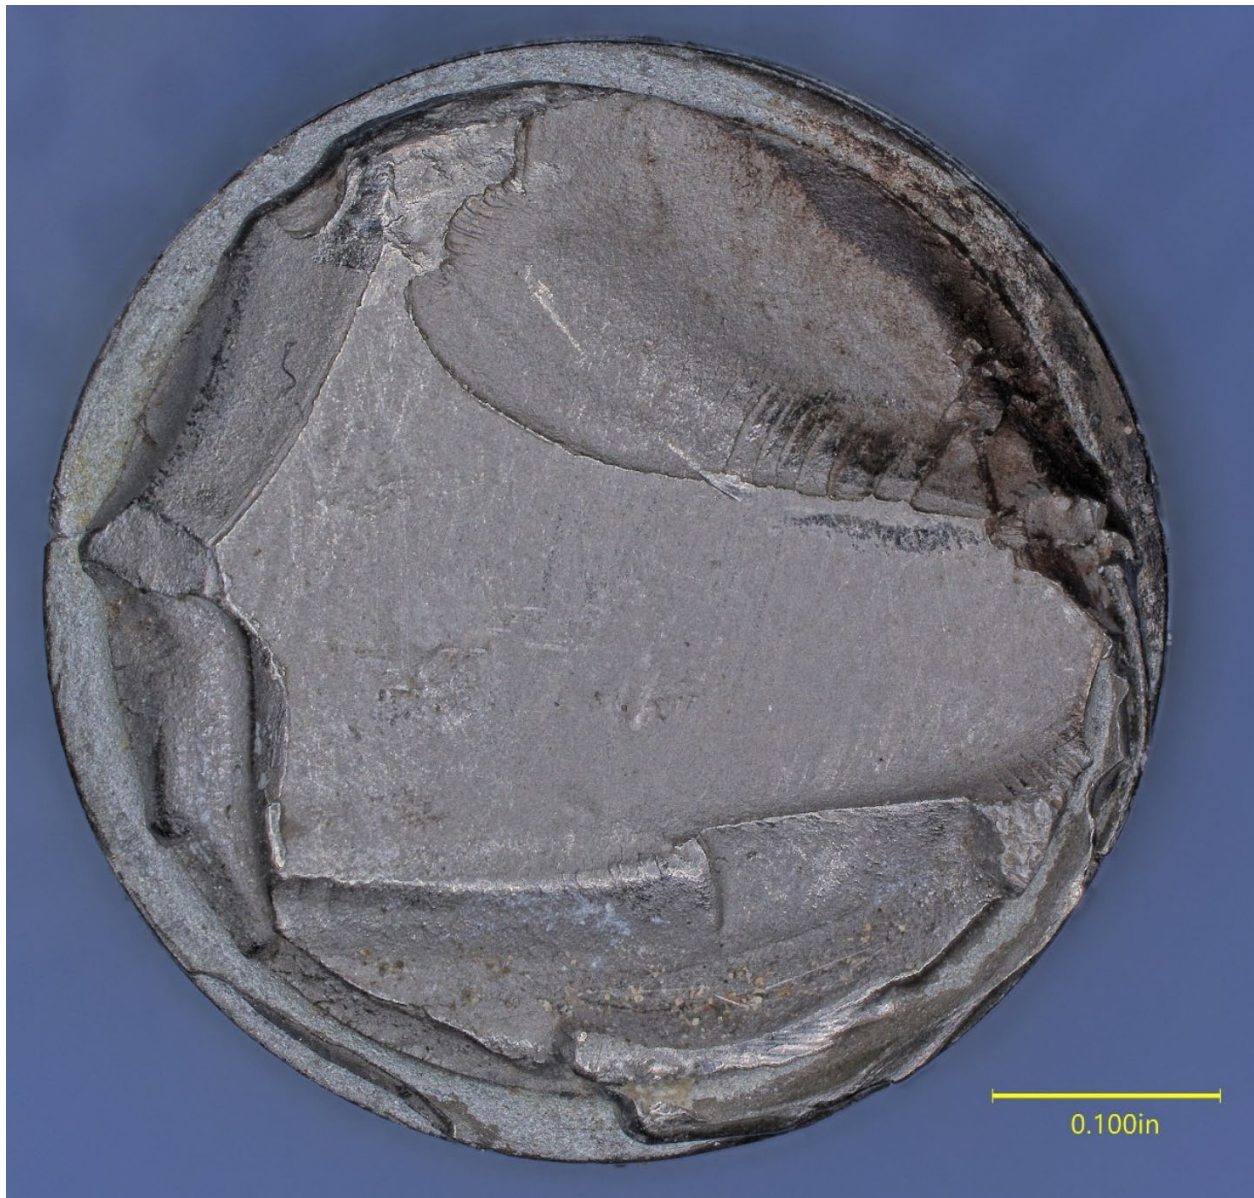
Figures 17 and 18 show the fracture surfaces of Bolts 5 and 6, respectively. Both exhibited several angled thumbnail cracks along the edge, and while Bolt 5 exhibited a shape similar to Bolt 3, Bolt 6 exhibited a larger flatter region. The ridge shape similar to Bolt 4 is shown closer in Figure 19. This feature exhibited coalescing river marks, consistent with crack propagation from the large flatter area (downward in Figure 18). This pattern would be consistent with crack propagation along a different height rather than the two opposite-facing cracks that occurred in Bolt 4. This flatter region exhibited crack arrest marks consistent with propagation from smaller thumbnail cracks on the opposite side in Figure 20.

Figure 17. The fracture surface of Bolt 5.

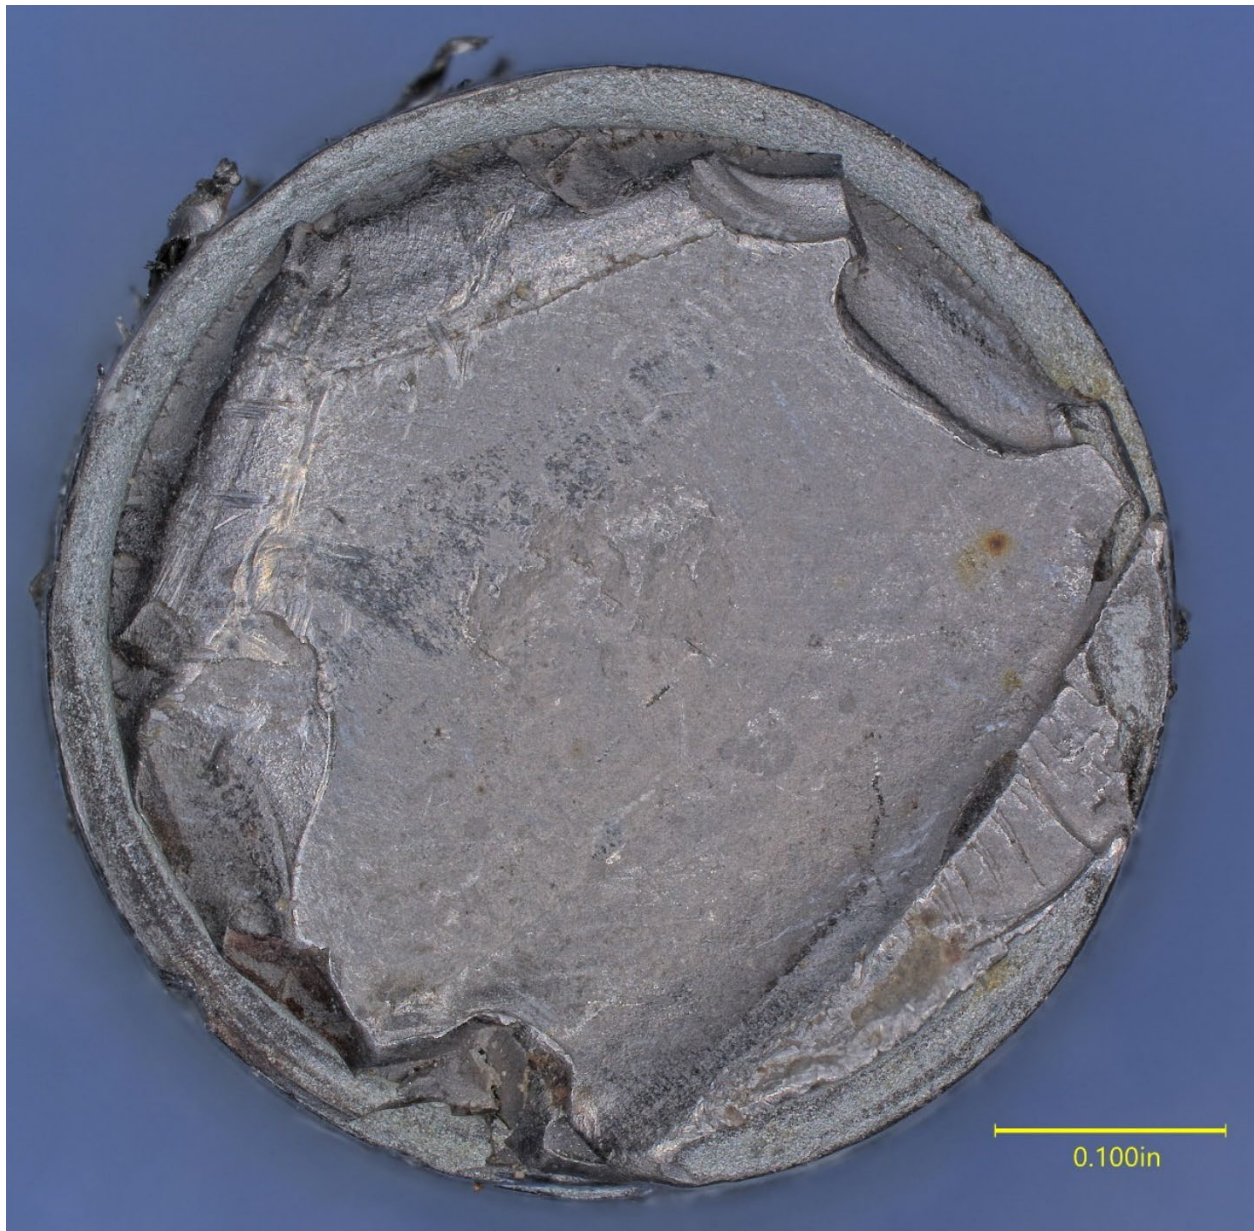
Figure 18. View of the Bolt 6 fracture surface.
